DAILY FIELD REPORT

BCP Project No:	C241173	Date:	February 10 to 11, 2022
Project Name:	ABC Block 25 – SRI No.5		
Consultant: Langan Engineering, Environmental, Surveying, Landscape Architecture and Geology, D.P.C. (Langan)	Langan Field Personnel: Alex Nolan Andrew Nesci		
Subcontractor: AARCO Environmental Services Corp. (AARCO)

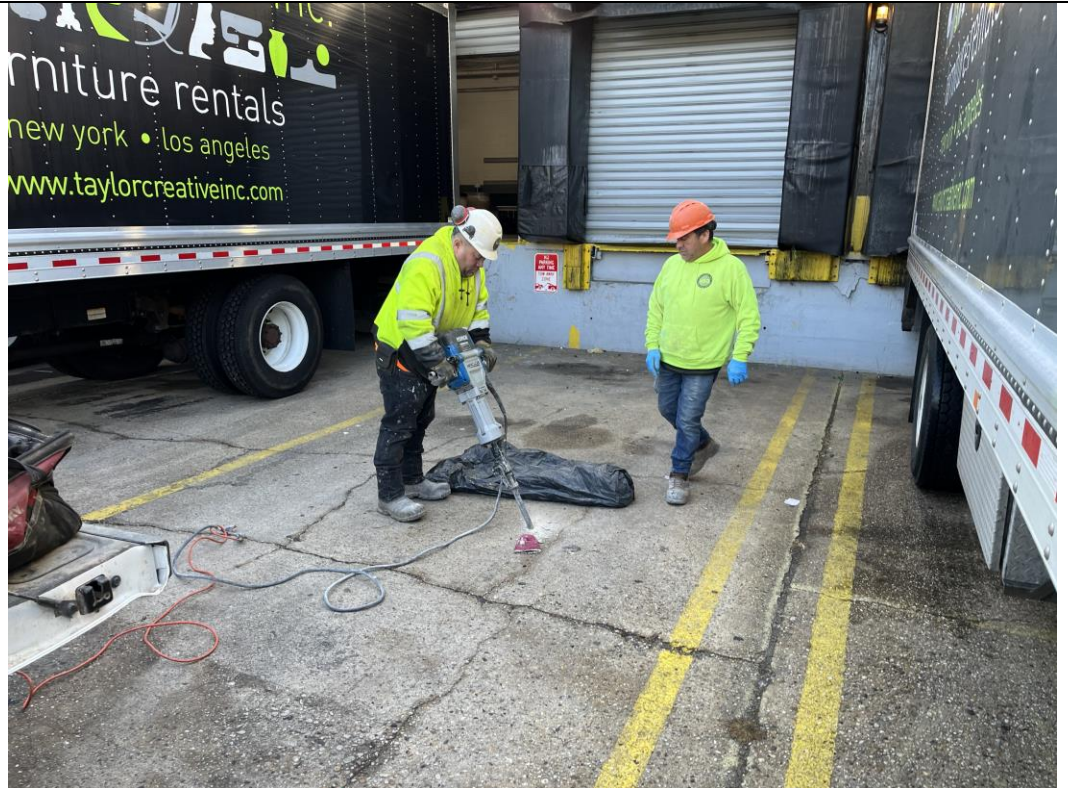
Photo 1:

- AARCO used hand tools to install one permanent soil vapor point (SV03) and three permanent sub-slab vapor points SSV05, SSV06, and SSV10.
 - SV03 was installed to a depth of about 4 feet below grade surface (bgs) using a 6-inch stainless steel implant and teflon lined tubing, the annulus around the soil vapor implant and tubing was filled with No. 2 clean sand from about 4 feet bgs to about 1 foot bgs followed by a hydrated bentonite seal to 0.5 feet bgs. The soil vapor point was finished with a flushed-mounted removable access cover. The soil vapor sample was collected over a duration of 8 hours into a batch-certified 2.7-liter SUMMA® canisters and analyzed for by United States environmental Protection Agency (USEPA) Method TO-15 for volatile organic chemicals (VOC).

View of AARCO installing SV03 (facing north).

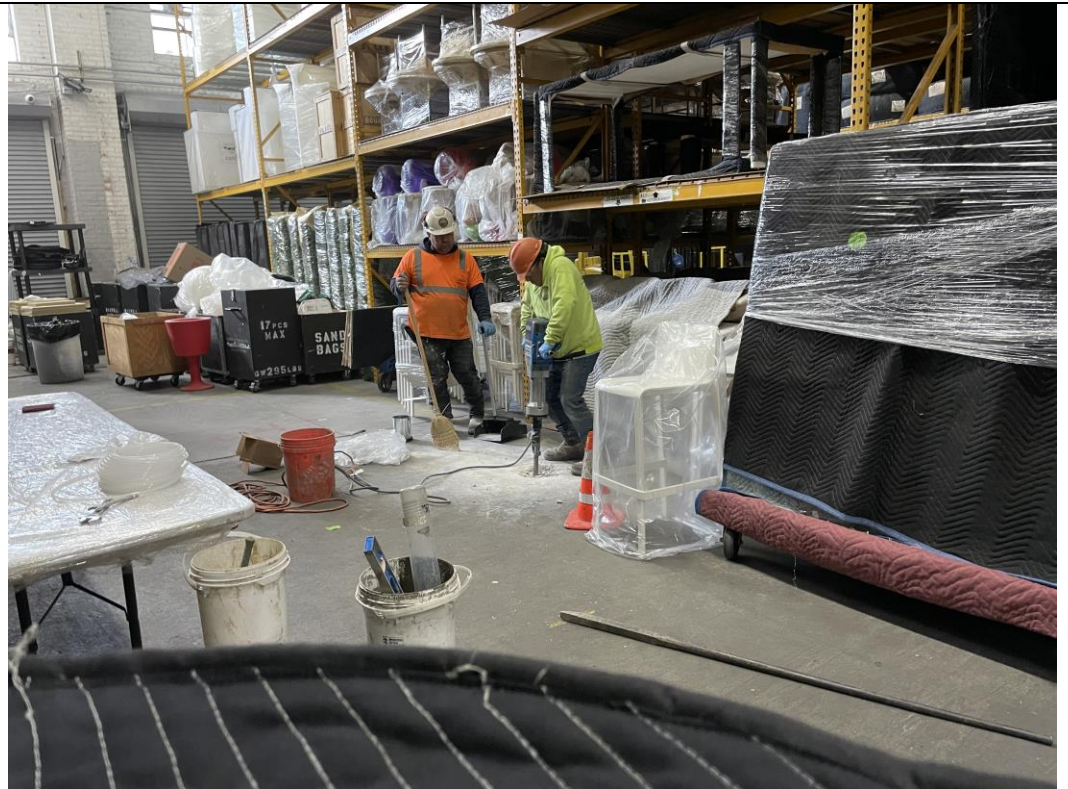
Photo 2:

- SSV06 was installed to a depth of about 1 foot bgs (about 6 inches below base of slab) using a 6-inch stainless steel implant and Teflon-lined tubing, the annulus around the soil vapor implant was filled with No. 2 clean sand followed by a hydrated bentonite seal. The soil vapor point was finished with a flushed-mounted removable access cover. A sub-slab soil vapor sample and co-located indoor air sample were collected over a duration of 8 hours into batch-certified 2.7-liter SUMMA® canisters and analyzed for by USEPA Method TO-15 for VOCs.

View of AARCO installing SSV06 (facing north).

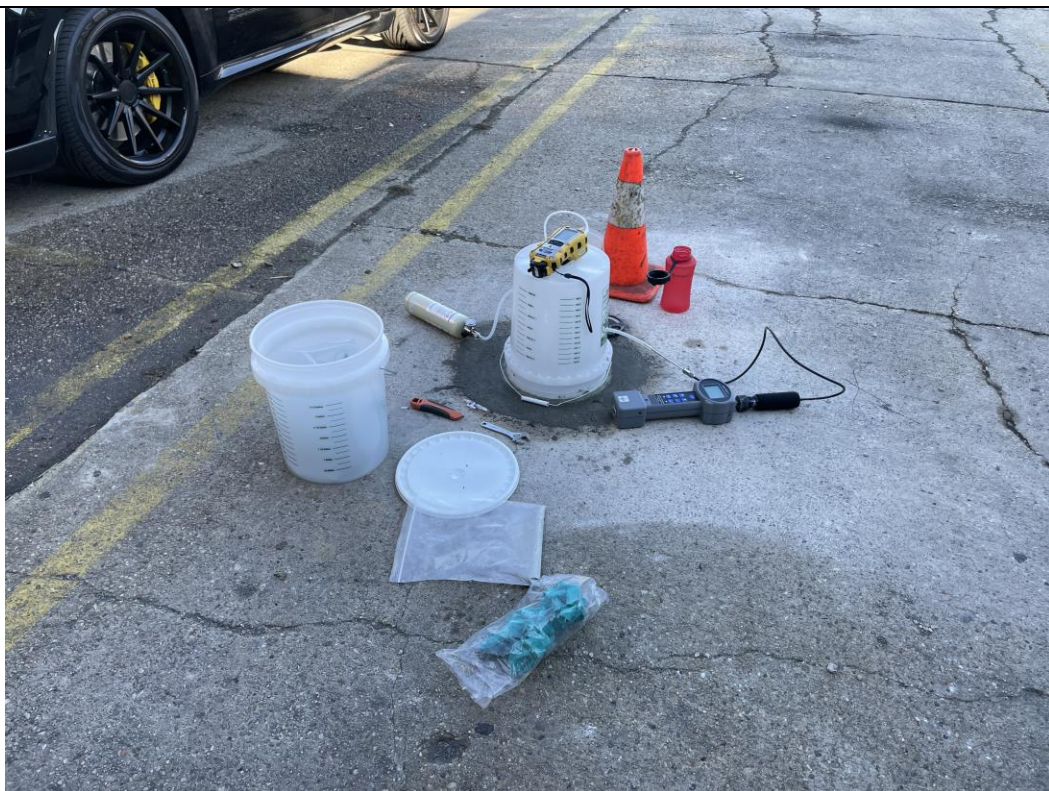
Photo 3

View of helium shroud test at SV03 prior to sample collection (facing south).

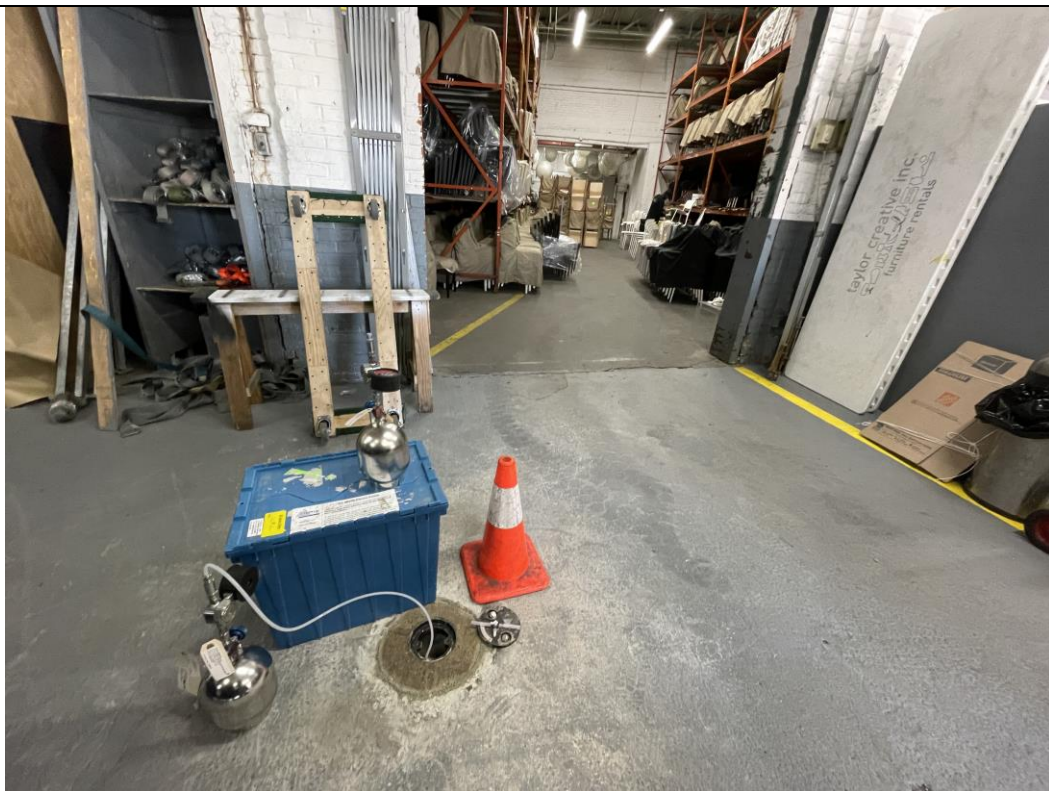
Photo 4

- SSV10 was installed to a depth of about 1 foot bgs (about 6 inches below base of slab) using a 6-inch stainless steel implant and Teflon-lined tubing, the annulus around the soil vapor implant was filled with No. 2 clean sand followed by a hydrated bentonite seal. The soil vapor point was finished with a flushed-mounted removable access cover. A sub-slab soil vapor sample and co-located indoor air sample were collected over a duration of 8 hours into batch-certified 2.7-liter SUMMA® canisters and analyzed for by USEPA Method TO-15 for VOCs.

View of sub-slab vapor sample collection at SSV10 (facing north.)
