DAILY STATUS REPORT

NYSDEC BCP Project No.:	C241199	NYCOER Project No.:	17CVCP044Q	Date:	6/29/2023
Project Name:	148-28 Hillside Avenue

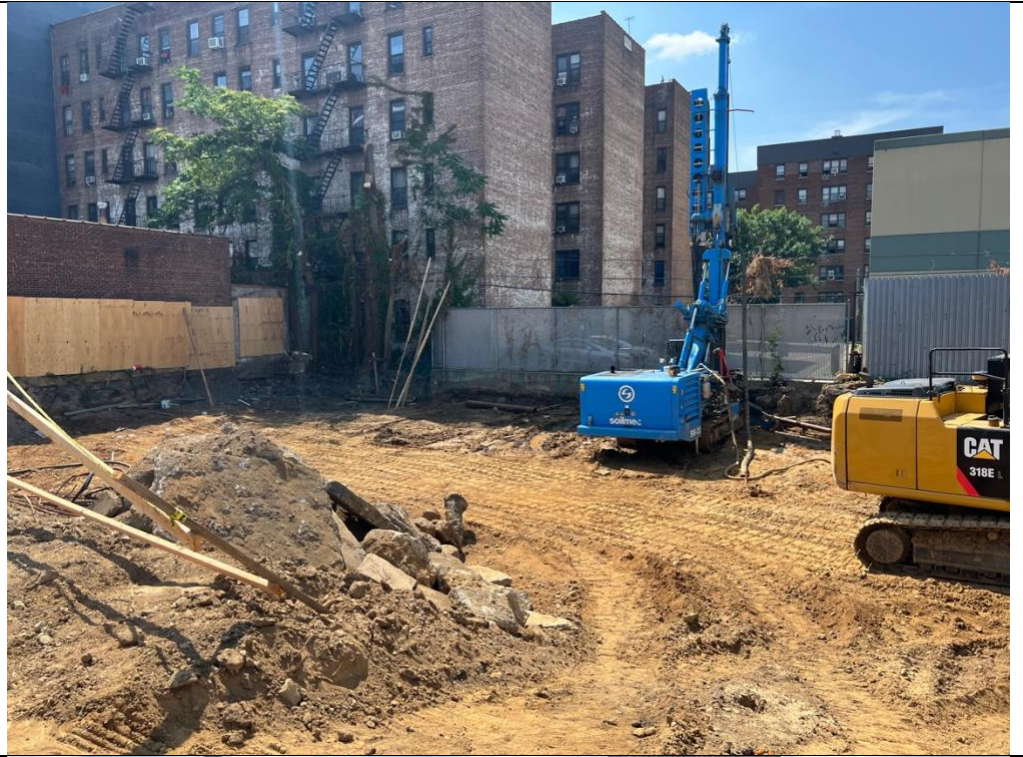
Photo 1 – An overview of the site at the end of the workday.

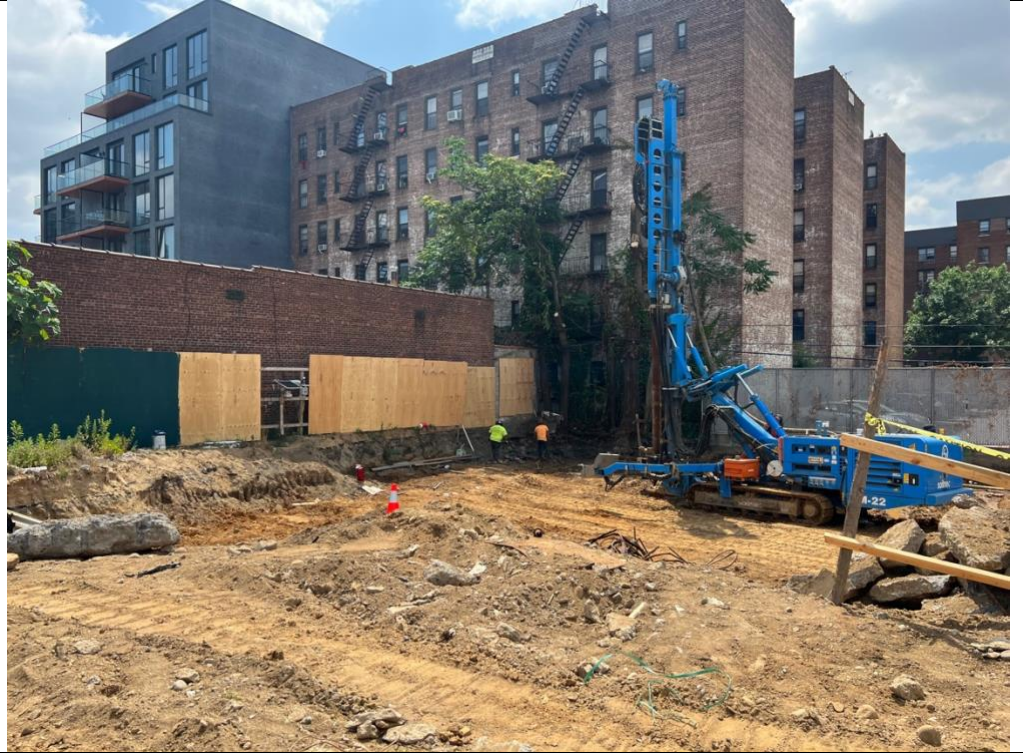
Photo 2 – Installing shoring piles along the southern perimeter, in C4 and D4.

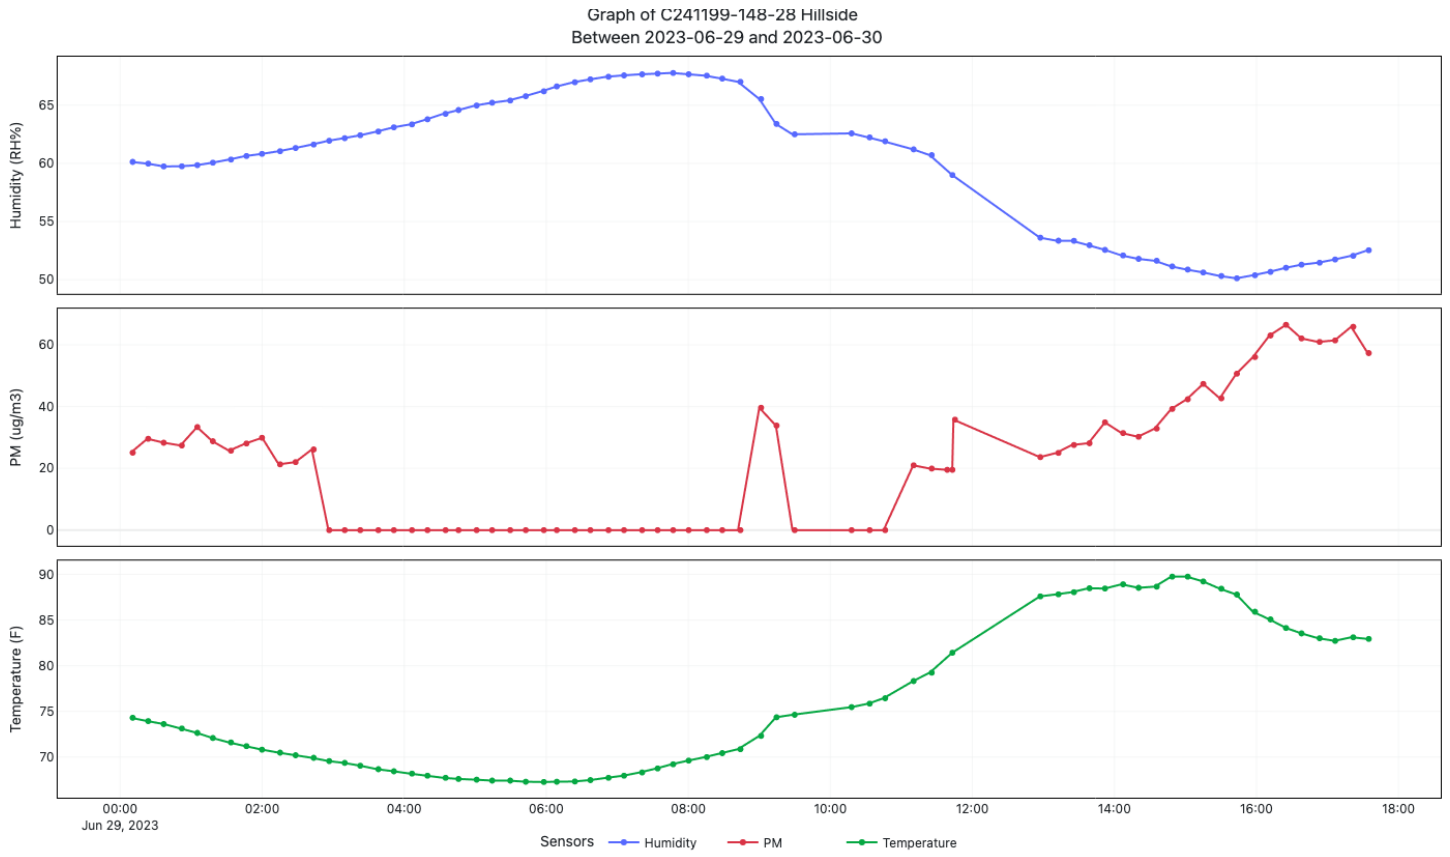
Attachment 1.

Graph of the Permanent Downwind CAMP station readings

No dust or VOC exceedances were observed over a 15-min period during monitoring, except for the start of day when a spike in dust levels (182 µg/m³) was noted before any ground intrusive work was performed. The dust levels reduced to 79 by 8:30.

- The PID and PDR dust monitors at the CAMP stations, including Permanent Downwind station, were turned off due to battery issues. The CAMP stations were operated while charging them to perform continuous monitoring, but the equipment’s battery became depleted.
- Due to a low charge at the beginning of the day, the solar-powered permanent down-wind dust monitor began operating at 8:45. The dust monitor will be altered/fix to operate during the entire workday.
