FPM Group, Ltd.
FPM Engineering Group, P.C.
formerly Fanning, Phillips and Molnar

Re: **Phase II Investigation Report
Queens Block 15857, Lot 1
51-17 Rockaway Beach Boulevard, Far Rockaway, New York
FPM File No. 1214g-17-08**

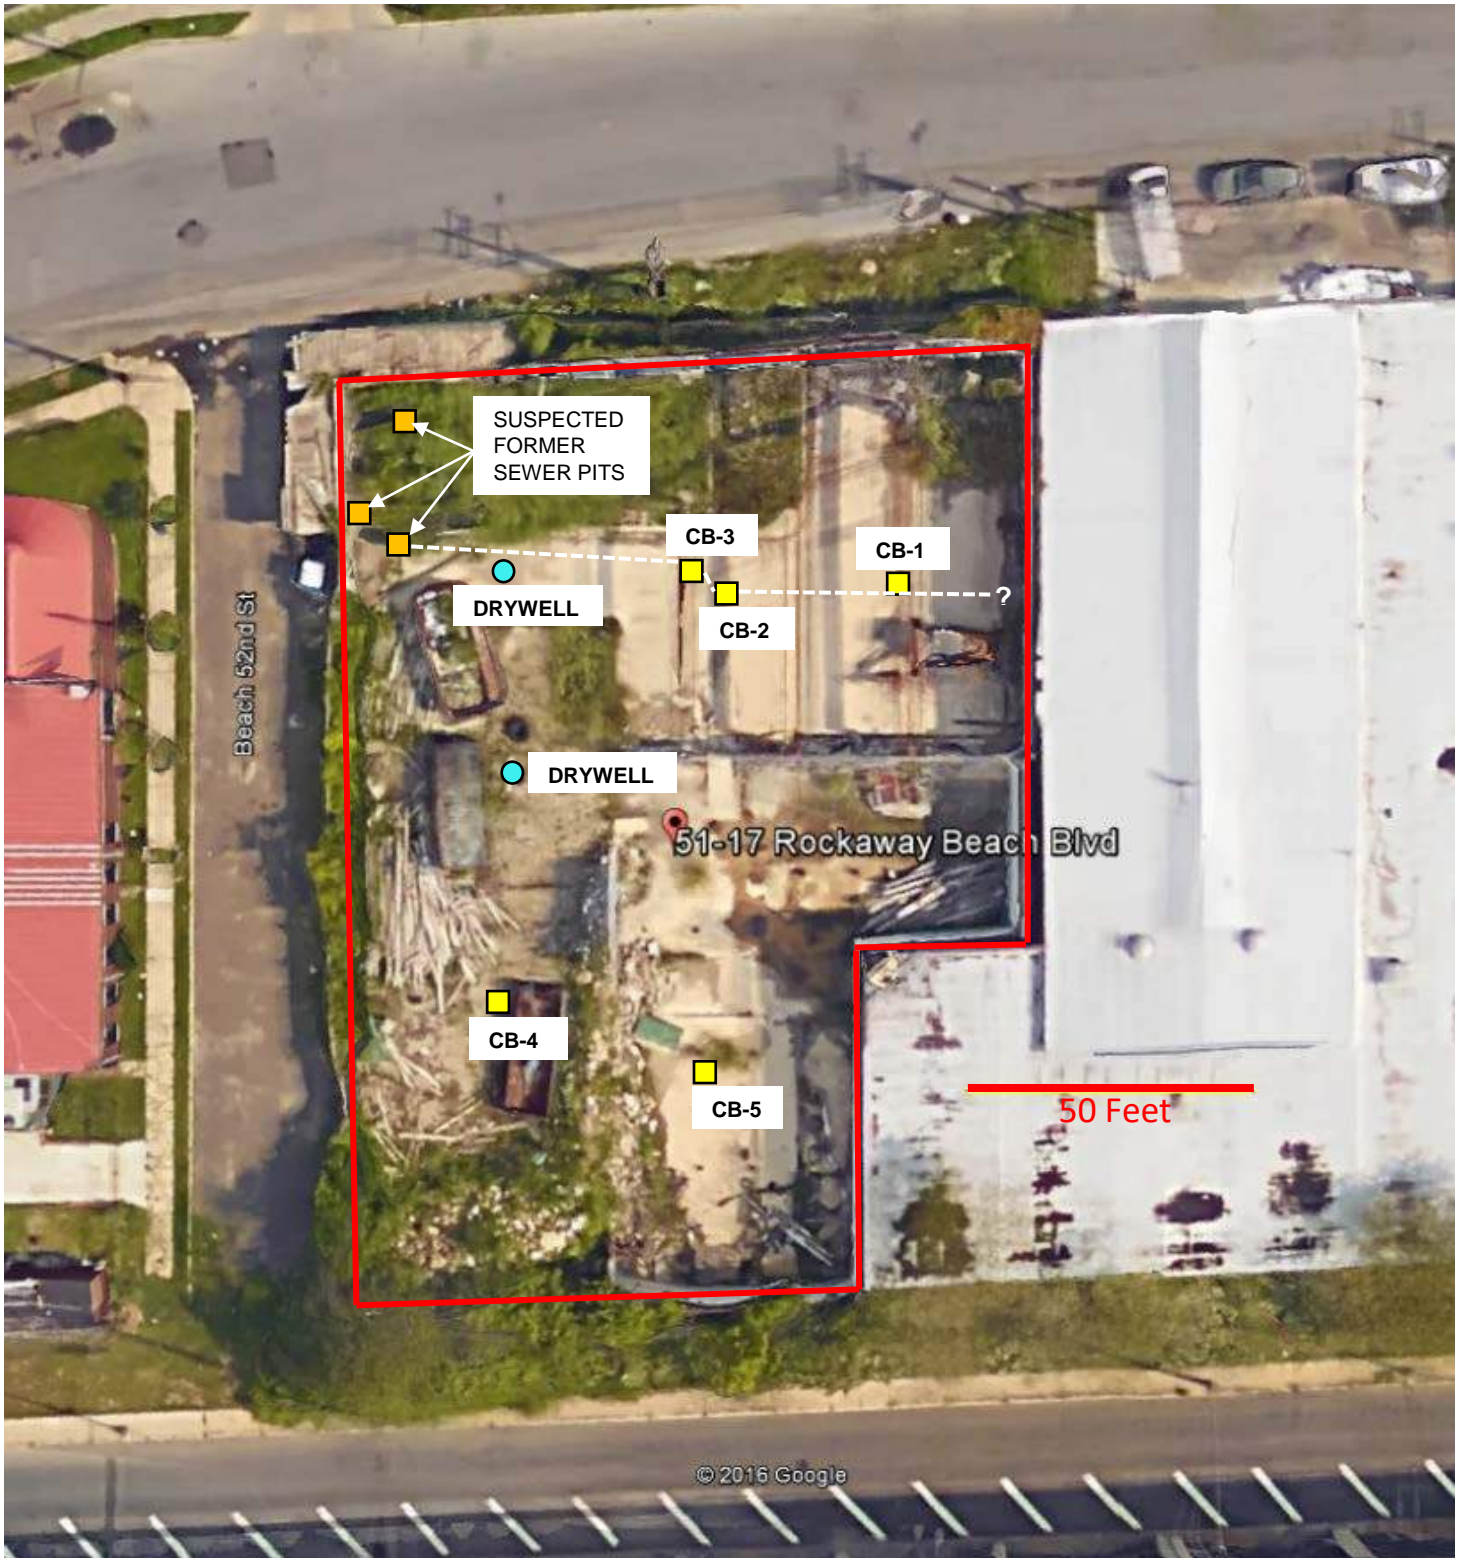
Figure 1
GEOPHYSICAL SURVEY RESULTS
51-17 ROCKAWAY BEACH BOULEVARD
FAR ROCKAWAY, NY

A geophysical survey was conducted on the accessible portions of the property to locate subsurface obstructions that may be present, including underground storage tanks (USTs), drainage structures, and/or underground utilities. The results of this survey were marked on the ground for use during the investigation to evaluate and sample select structures and areas. The structures identified during the geophysical survey are shown on the attached Figure 1.

Five suspected catch basins were noted on the property and are identified on Figure 1 as CB-1 through CB-5. Each of these structures was noted to have a solid bottom ranging in depth from 1 to 3 feet below grade. Sediments were present in each of the structures and, in most cases, the structures were filled to grade. Catch basins CB-1 through CB-3 were observed to be connected in sequence and the piping appears to lead toward one of the suspected sewer pits on the northwest corner of the property. The pipe connected to CB-1 also appeared to lead toward the east; however, the detected signal ended just before the property boundary. No pipes were observed within CB-4 and CB-5 and it is not clear whether piping was previously present.

Three shallow solid-bottom square pits were observed on the northwest corner of the property; these features may have formerly served as sewer connections or cleanouts.

Two drywells that appear to discharge to the subsurface were observed; one is located on the northwest portion of the property and one is located on the west-central portion of the property. No inlet or outlet pipes were observed inside these structures.

- The sediments within the catch basins, drywells, and other subsurface discharge structures on the property are located below grade within the structures and do not present an exposure concern at present. In the event that the property is redeveloped, these materials may require proper management; and

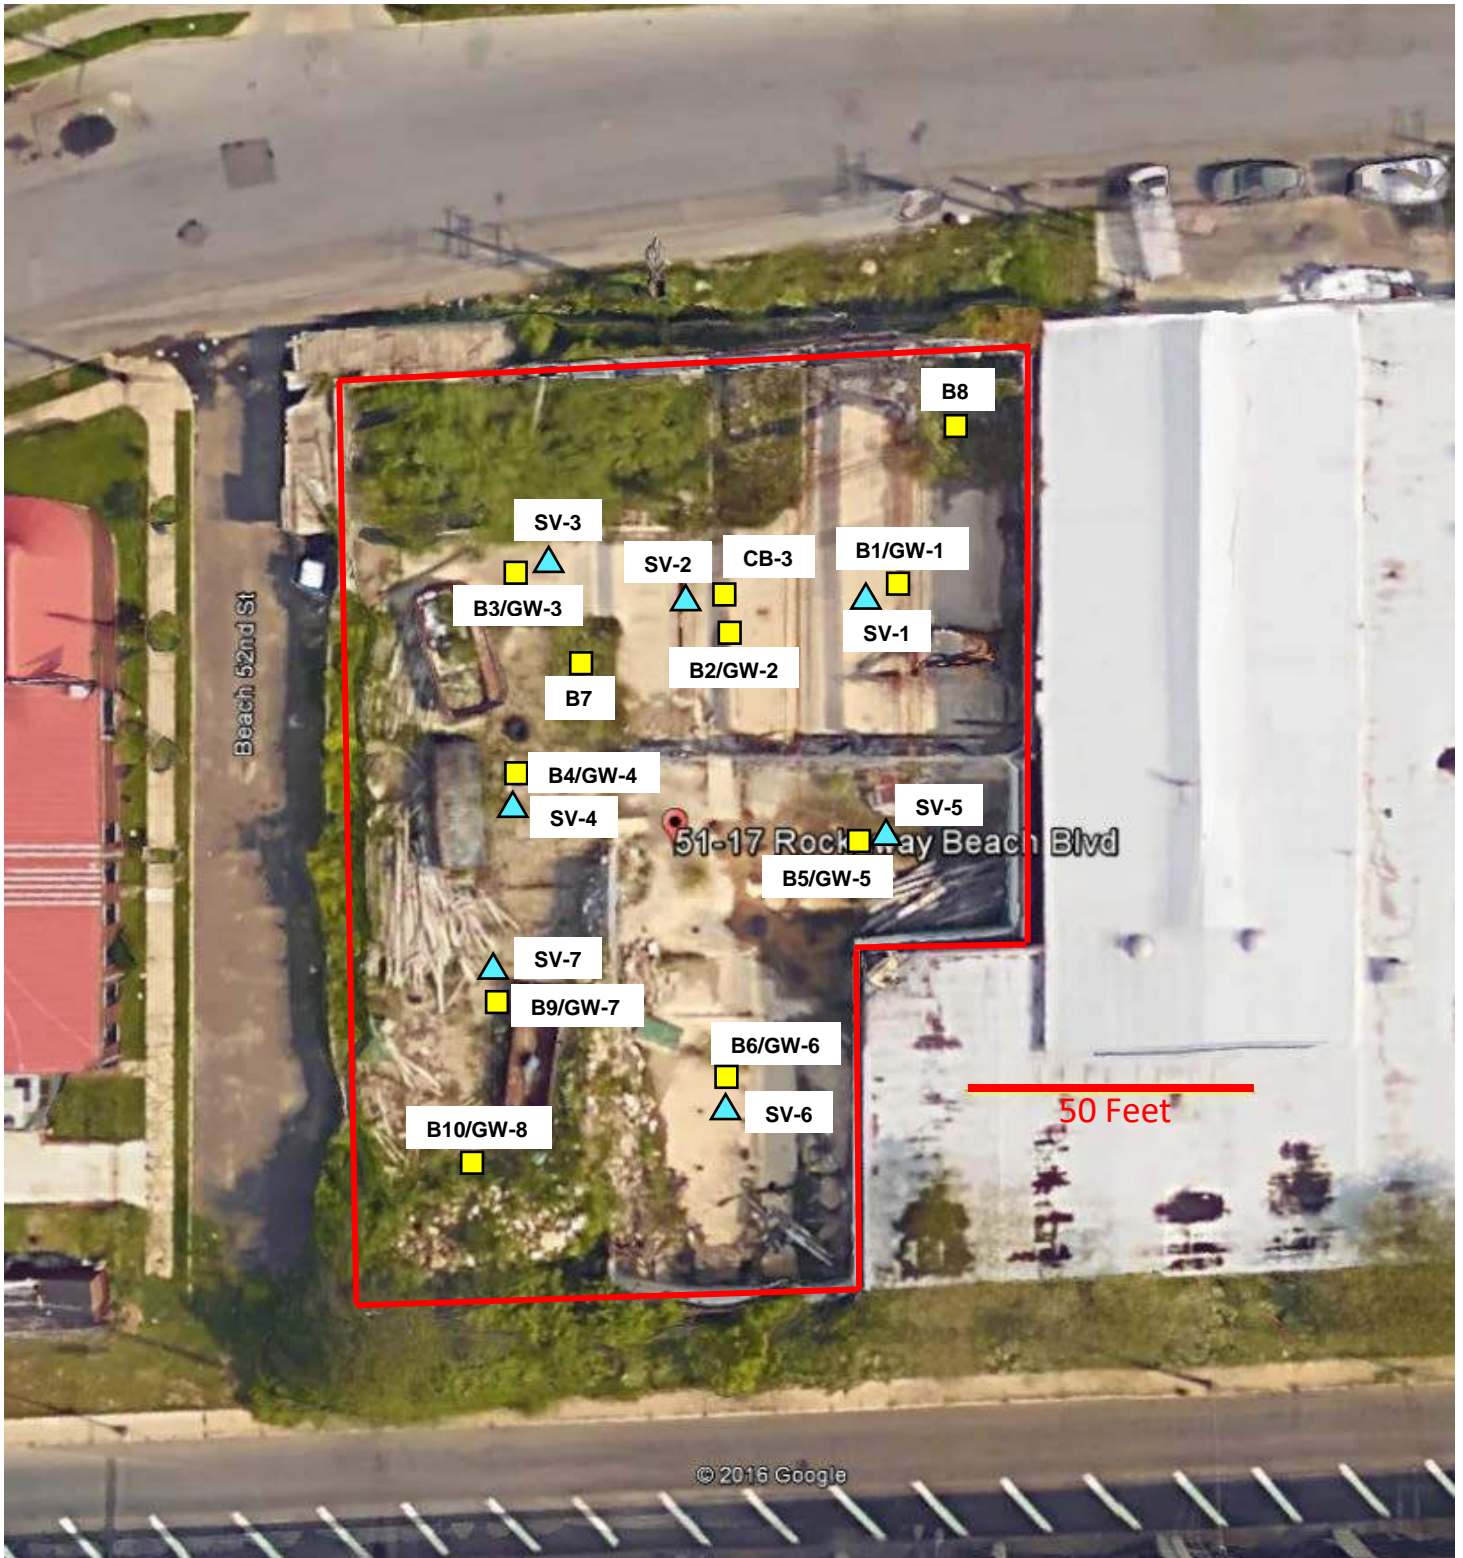
Figure 2
SAMPLE LOCATIONS
51-17 ROCKAWAY BEACH BOULEVARD
FAR ROCKAWAY, NY

Groundwater sampling was conducted at the GW-1 through GW-9 locations throughout the property, as shown on Figure 2. At each location, a direct-push rig was utilized to install a one-inch diameter PVC temporary well screen from grade to 10 feet below grade. Prior to sampling, the temporary well screen was purged of approximately three volumes using dedicated polyethylene tubing and a decontaminated check valve. No visible indications of potential contamination were noted during the groundwater purging or sampling, with the exception of GW-7 where a paint/petroleum odor was noted.

Soil vapor samples SV-1 through SV-7 were collected throughout the property from beneath the concrete slab of the former buildings; the locations are shown on Figure 2. Each sample was collected via a soil gas implant installed to a depth of one foot below the concrete slab in accordance with NYSDOH protocols. Following installation, each implant was helium-tested to confirm that ambient air was not bypassing the implant seal. The implant was then purged of three to five volumes at a rate of less than 0.2 liters per minute, attached via polyethylene tubing to a laboratory-supplied Summa canister with a calibrated one-hour flow controller, and allowed to fill at a rate of less than 0.2 liters per minute. The filled canisters were sealed with some vacuum remaining, as per NYSDOH protocol. Canister sampling forms documenting the soil vapor sampling procedures are included in Attachment A.
