Phase II Environmental Site Assessment

Rossville Shopping Center

990-1026 Rossville Avenue
Staten Island New York

EBI Project No. 1219000387

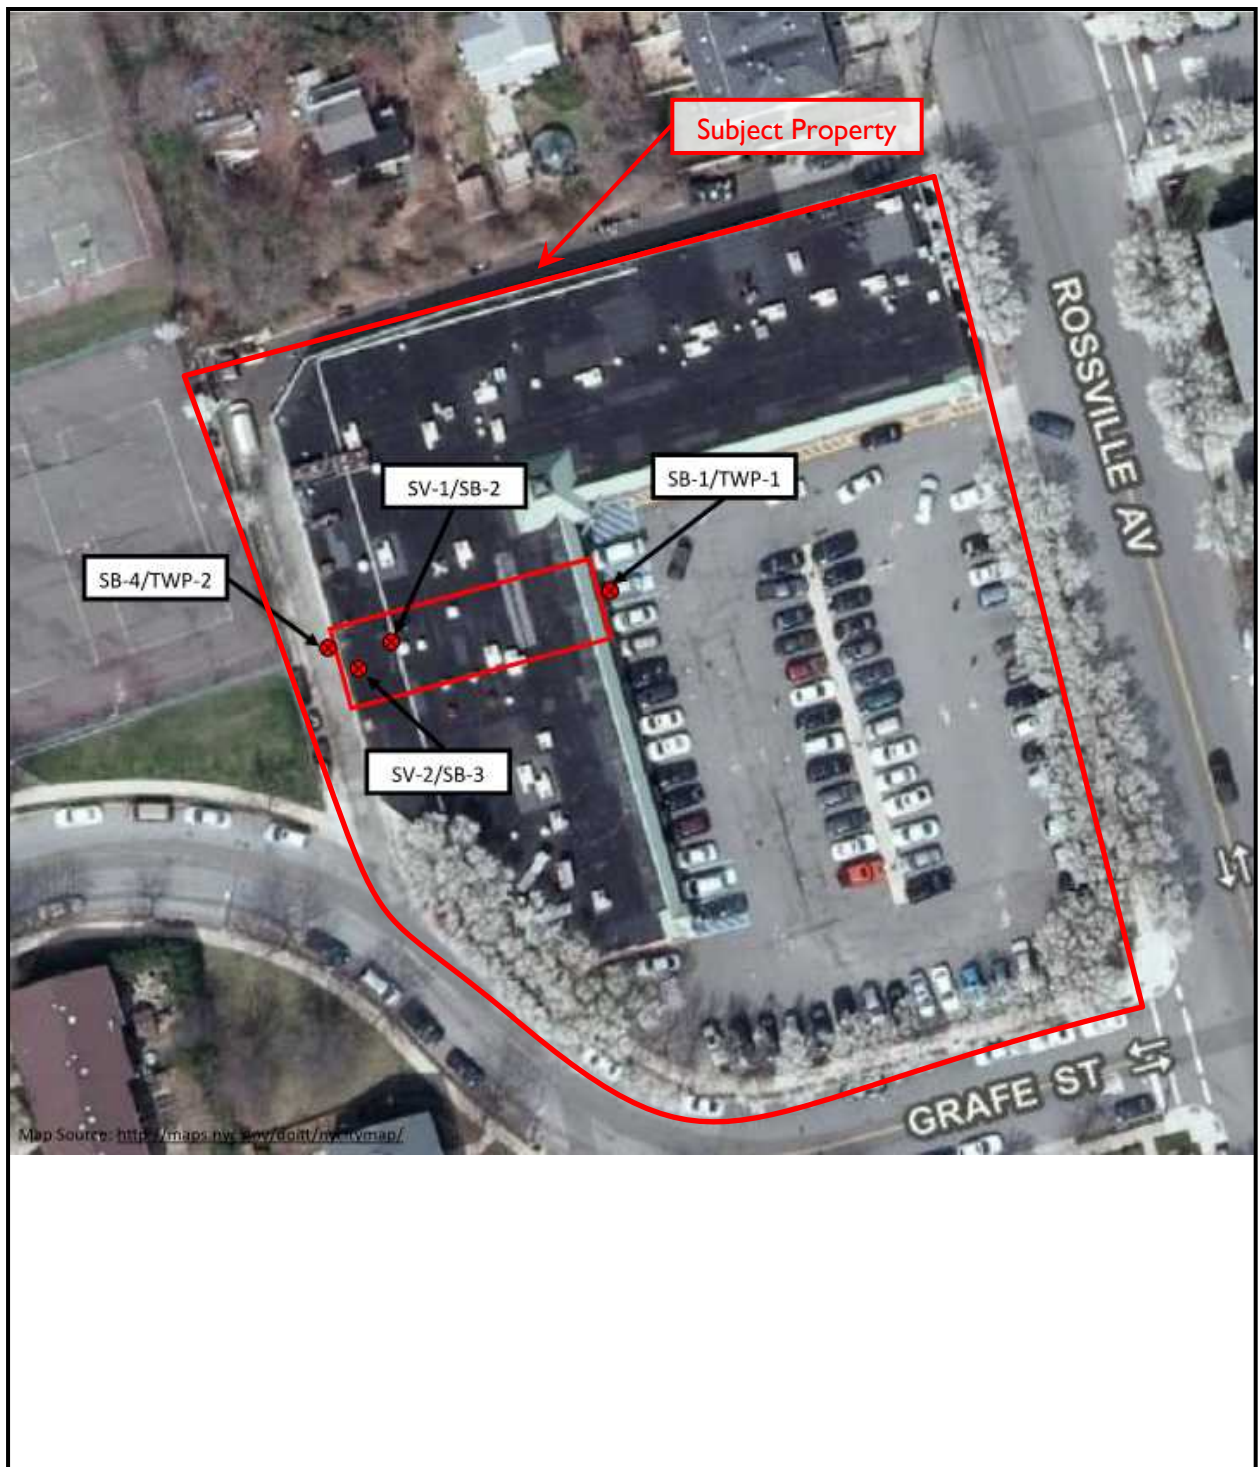
FIGURE 3 – SAMPLE LOCATION MAP

- On October 21, 2019, EBI conducted a Phase II ESA to assess subsurface conditions in the area of the existing dry cleaners along the western portion of the Subject Property. A total of four soil borings were advanced at the Subject Property. Groundwater was only encountered in two of the borings located in the front and rear of the dry-cleaning facility (SB-1/TWP-1 and SB-4/TWP-2) at depths of 10-feet bgs and 22-feet bgs respectively. All of the soil borings were advanced using direct push drilling methods. The samples were submitted to a New York certified laboratory, Alpha Analytical, for analyses. The soil, groundwater, and soil vapor samples were analyzed for CVOC (PCE and its daughter products) analysis via EPA Method 8260 (soil and groundwater) and via EPA TO-15 for soil vapor samples.

- Based on the presence of concentrations PCE identified in sub-slab vapor, EBI recommends the implementation of vapor intrusion mitigation measures, such as the design and installation of a sub-slab-depressurization system (SSDS).
