Re: 178 Richmond Terrace, Staten Island, NY & 24 Stuyvesant Place, Staten Island, NY

Block 13, Lots 75, 78, 79, 80, 81, 82, 92, 100, 103 and 104

Phase II Environmental Site Assessment

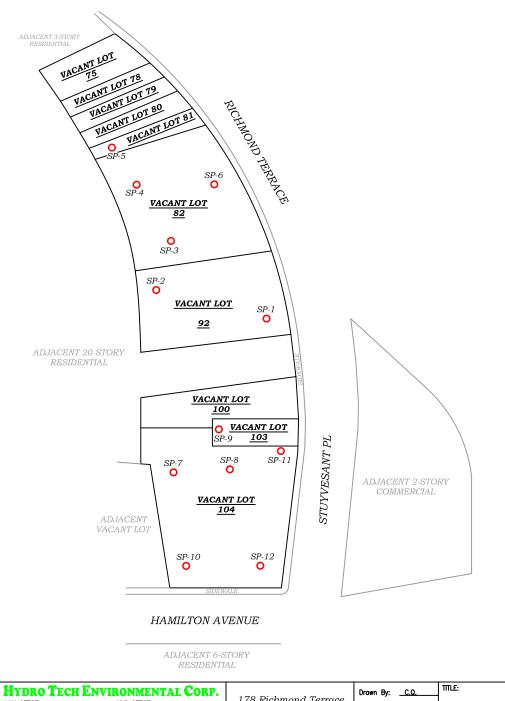
FIGURE 1: SITE & SAMPLING PLAN

Access to the Subject Property is via Richmond Terrace and Stuyvesant Place to the east and Hamilton Avenue to the south. The Subject Property is not connected to the municipal water, gas and electric services. The topography of the Subject Property is uneven throughout the Site and the topography of the vicinity is sloping towards the northeast. **Figure 1** provides a Site Plan.

Twelve (12) soil probes, designated SP-1 to SP-12, were installed at the Site. Soil probes SP-1 to SP-6 were installed in the northern portion of the Site and soil probes SP-7 to SP-12 soil probes were installed in the southern portion of the Site. Previous **Figure 1** provides a sampling plan.
