Periodic Review Report

Austin Avenue Landfill BCP Site

BCP Site #C360066

September 27, 2017 to September 27, 2018

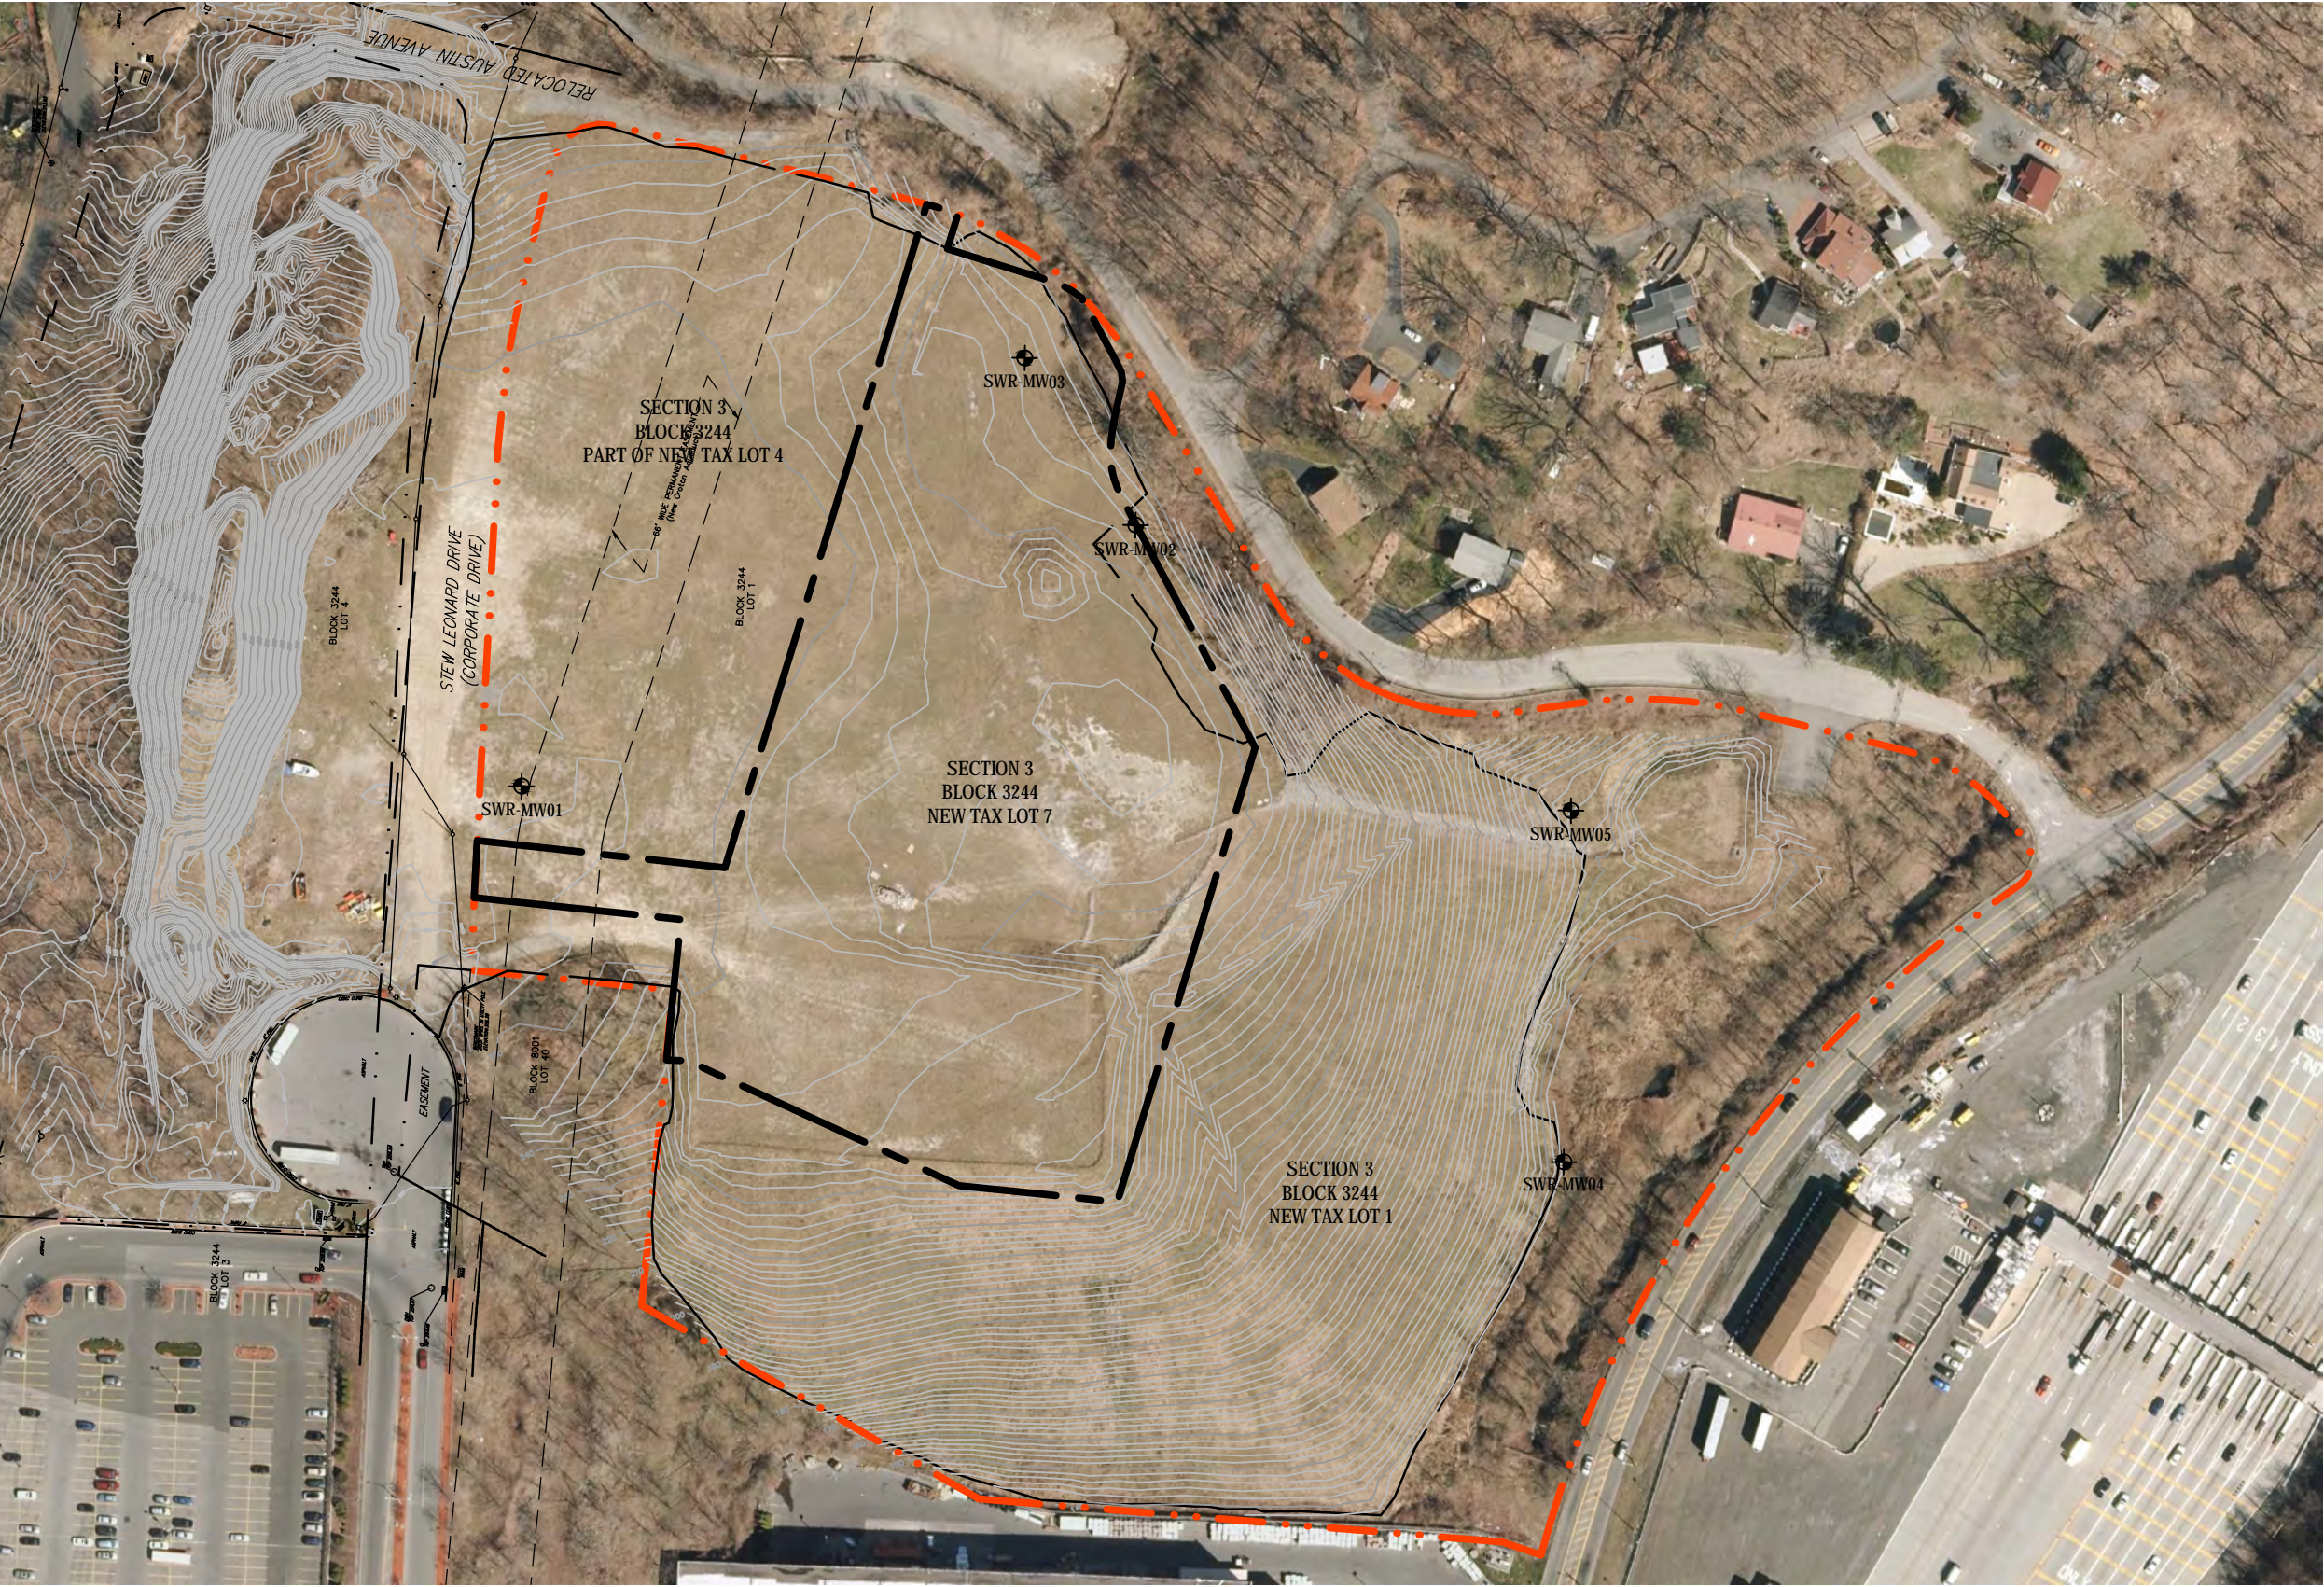
- Property Boundary (Approximate)
- New Subdivided Tax Parcels (Approximate)
- Extent of Lot 1 Geotextile Demarcation Layer and BCP Site (Approximate)
- SWR-MW01 Groundwater Monitoring Well Location and ID (Approximate)

The Property as a whole is approximately 18.26 acres and was investigated with approximately 14.1 acres being remediated to a Track 4 Restricted Residential Use, which represents the area of the BCP Site. Figure 2 depicts the location and extent of each parcel, the extents of the BCP Site and engineering controls, and the extents of the property. The Site is bound by Austin Avenue to the north, Home Depot's back parking lot to the south, Sprain Brook and Sprain Road to the east, and an unimproved road and similar vacant land (Lot 4 – Austin Avenue and Prior Place BCP Site, Site #C360116), to the west (Figure 2).
