**Brownfield Remedial
Investigation
221 Main Street
City of White Plains
Westchester County,
New York**

BCP Site # C360073

WORK PLAN

BROWNFIELD REMEDIAL INVESTIGATION
221 MAIN STREET
CITY OF WHITE PLAINS
WESTCHESTER COUNTY, NEW YORK

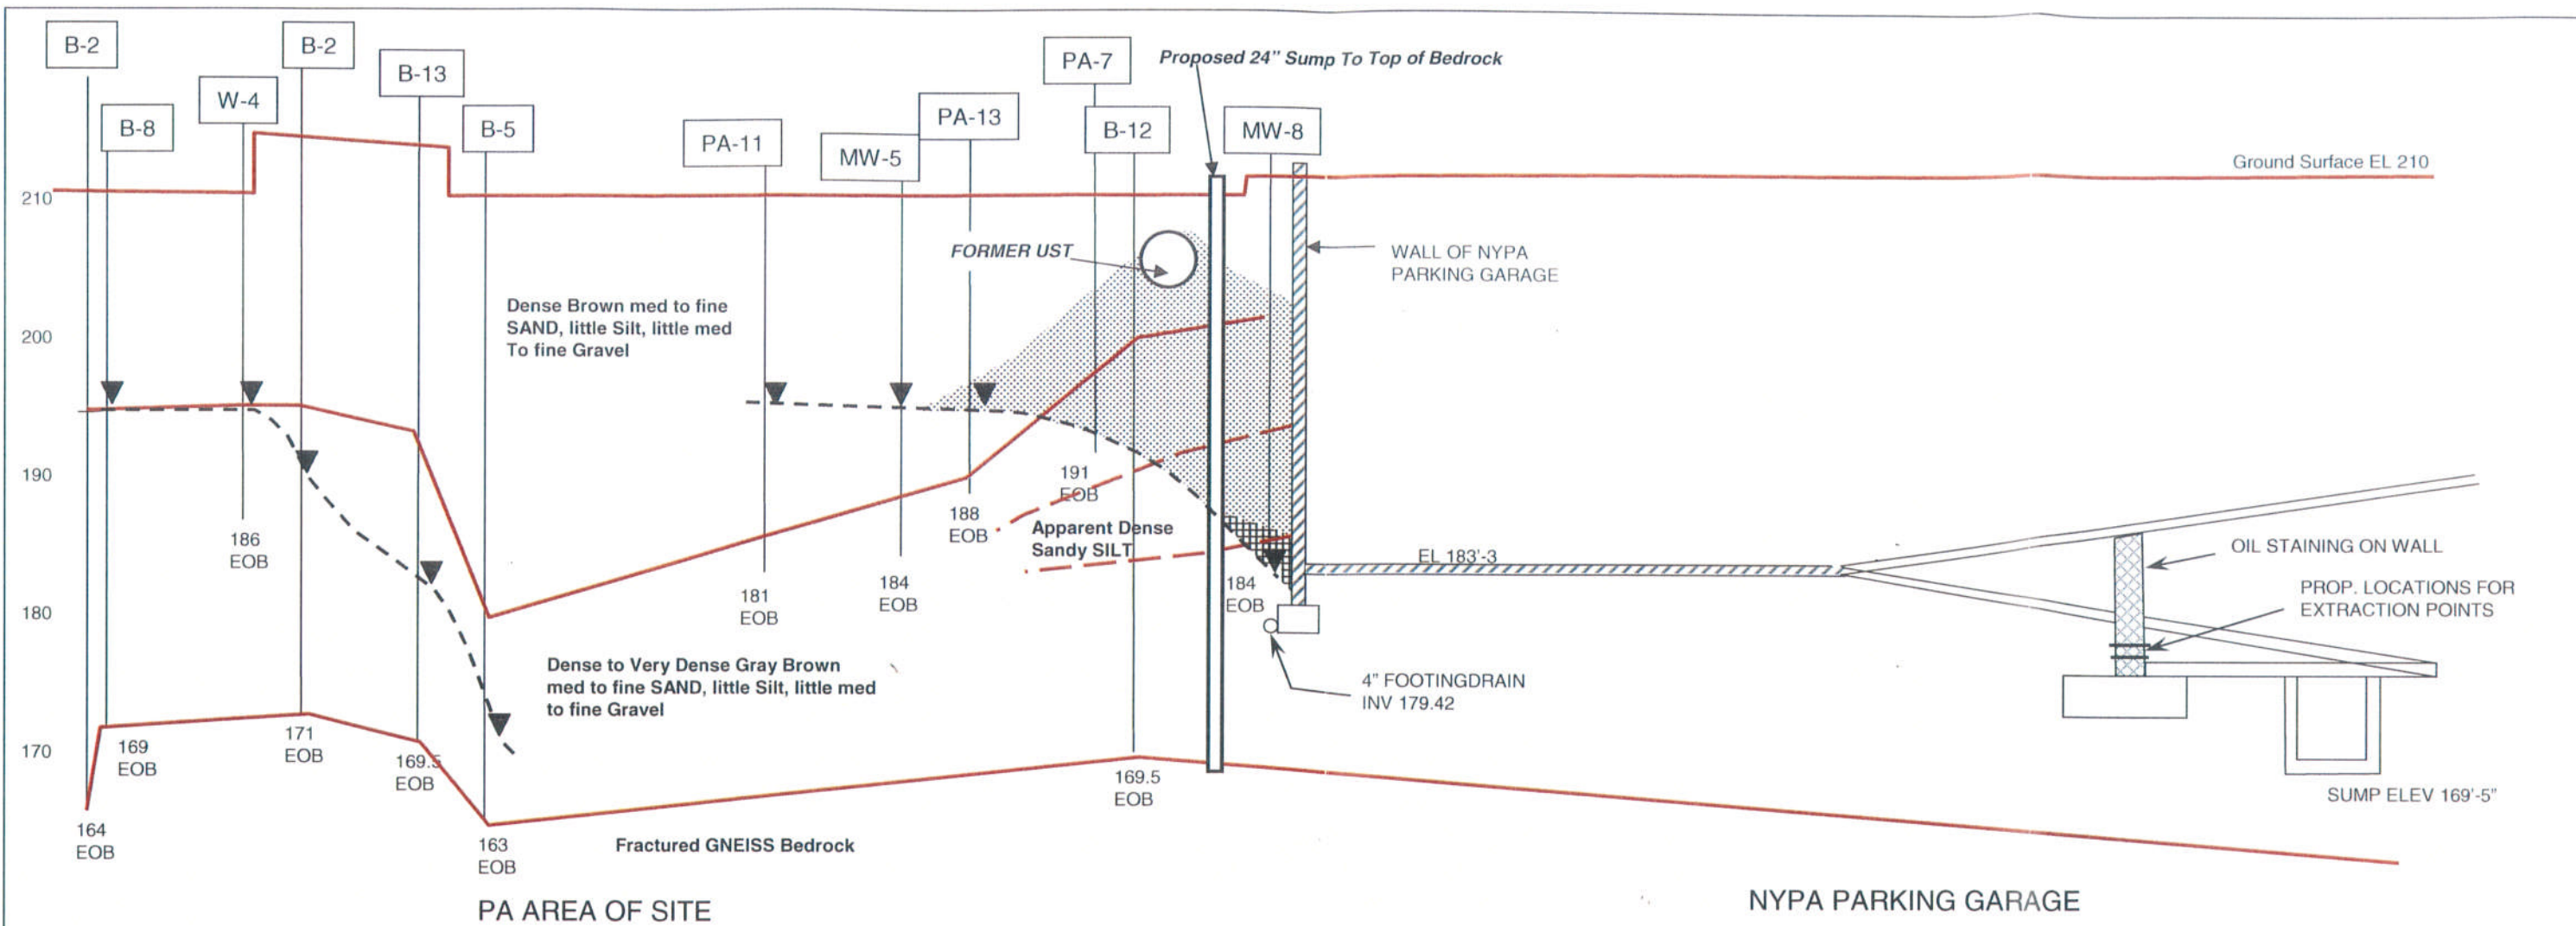
S&W Redevelopment of North America, LLC Syracuse, New York	REMEDIAL INVESTIGATION (RI) WORK PLAN 221 MAIN STREET CITY OF WHITE PLAINS WESTCHESTER COUNTY, NEW YORK
	FIGURE 4 GENERAL STRATIGRAPHIC SEQUENCE
DEC 05	N5023

General stratigraphic sequence of site, in cross section. Figure is Based on data provided by JM Associates, and SESI Engineering.

The break in the transect between borings B-5 and PA-11 forces the Disconnect in the depicted water table.

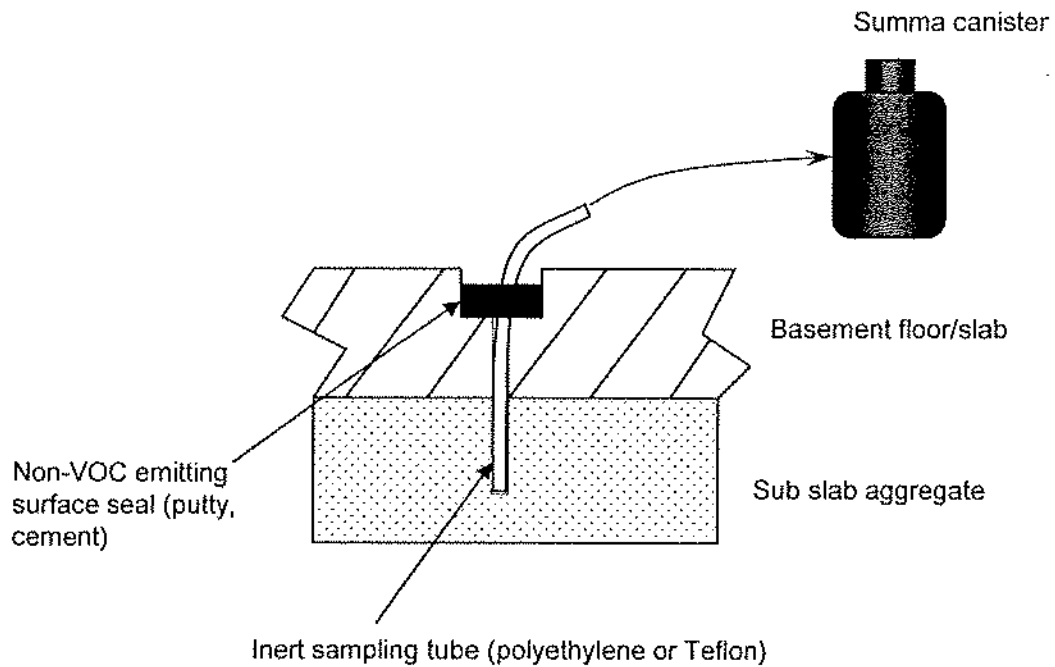
FIGURE 11
SUB-SLAB/SOIL VAPOR SAMPLING

Typical sub-slab sampling setup

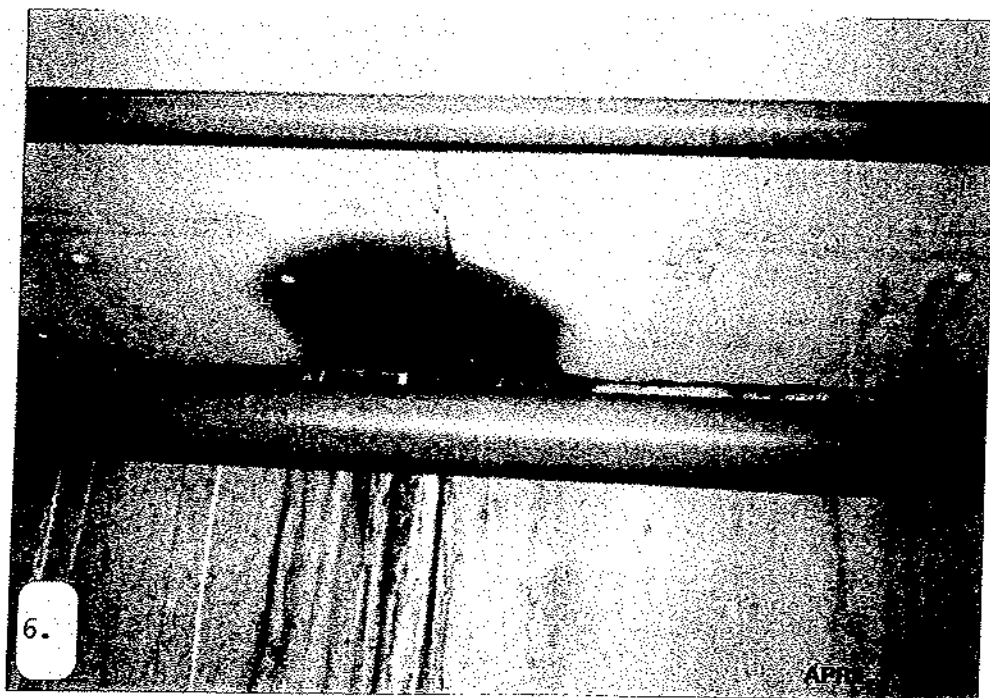
APPENDIX C
PHOTOGRAPHS OF EAST GARAGE WALL

Although the two USTs and contaminated soil at the former police station in the PA area were reportedly removed sometime between 1987 and 1988, contamination has evidently migrated off site to the NYPA garage. The GZA Report indicates that a Phase I ESA conducted by Malcolm Pirnie at the NYPA garage in 1991 identified an oily sheen in water collection troughs in the lowest level of the garage, and a tar-like material was observed on the eastern wall of the parking garage level B-2. It was concluded by Malcolm Pirnie that the parking garage footing drain had lowered groundwater along the eastern wall of the garage, causing gasoline to collect there.

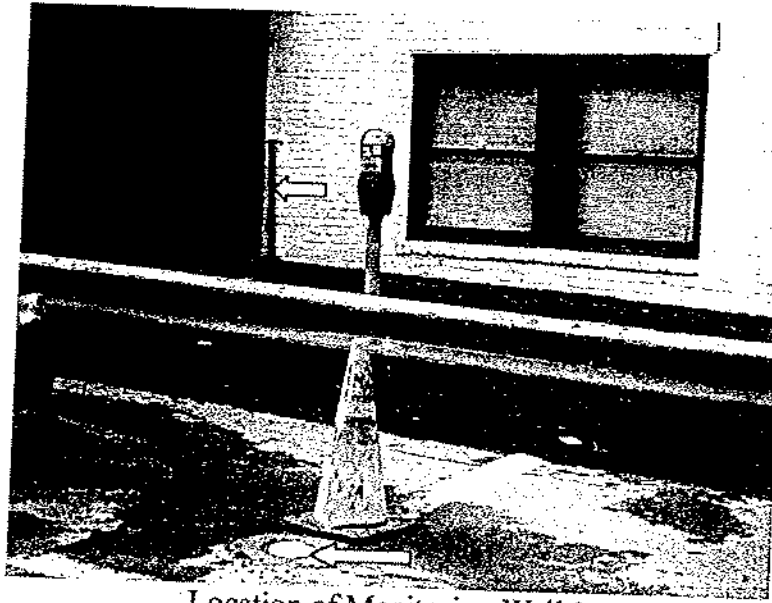
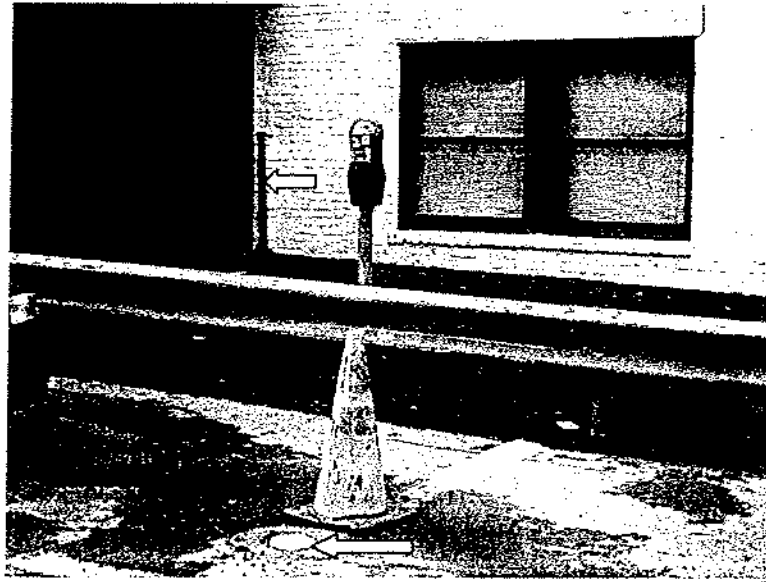
Location of Monitoring Well 1
Notice Proximity to Fuel Oil
Underground Storage Tank Vent Line

A UST is known to exist adjacent to the Annex, on the west side of the building. The tank is located outside of the building, under the sidewalk. The condition of the tank is unknown.

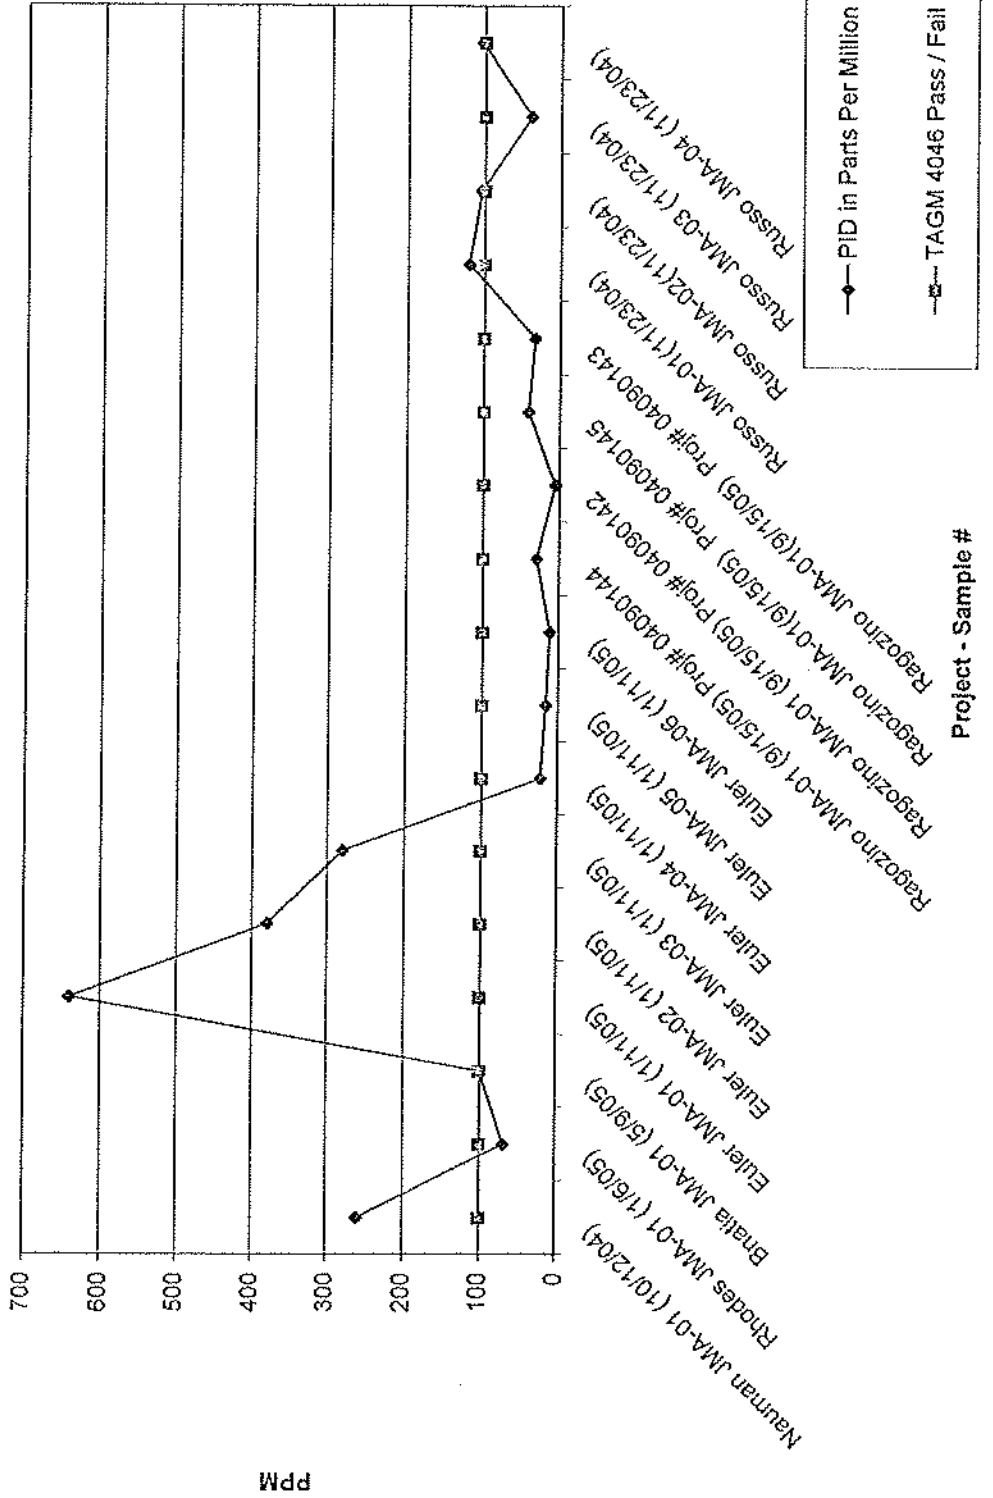
PID Levels - TAGM 4046
 Comparison Chart
 (Various Sites)

PID - TAGM 4046
Comparison Graph
