Interim Remedial Measure
(IRM)
221 Main Street
City of White Plains
Westchester County,
New York

BCP Site # C360073

WORK PLAN

INTERIM REMEDIAL MEASURE (IRM)
221 MAIN STREET
CITY OF WHITE PLAINS
WESTCHESTER COUNTY, NEW YORK

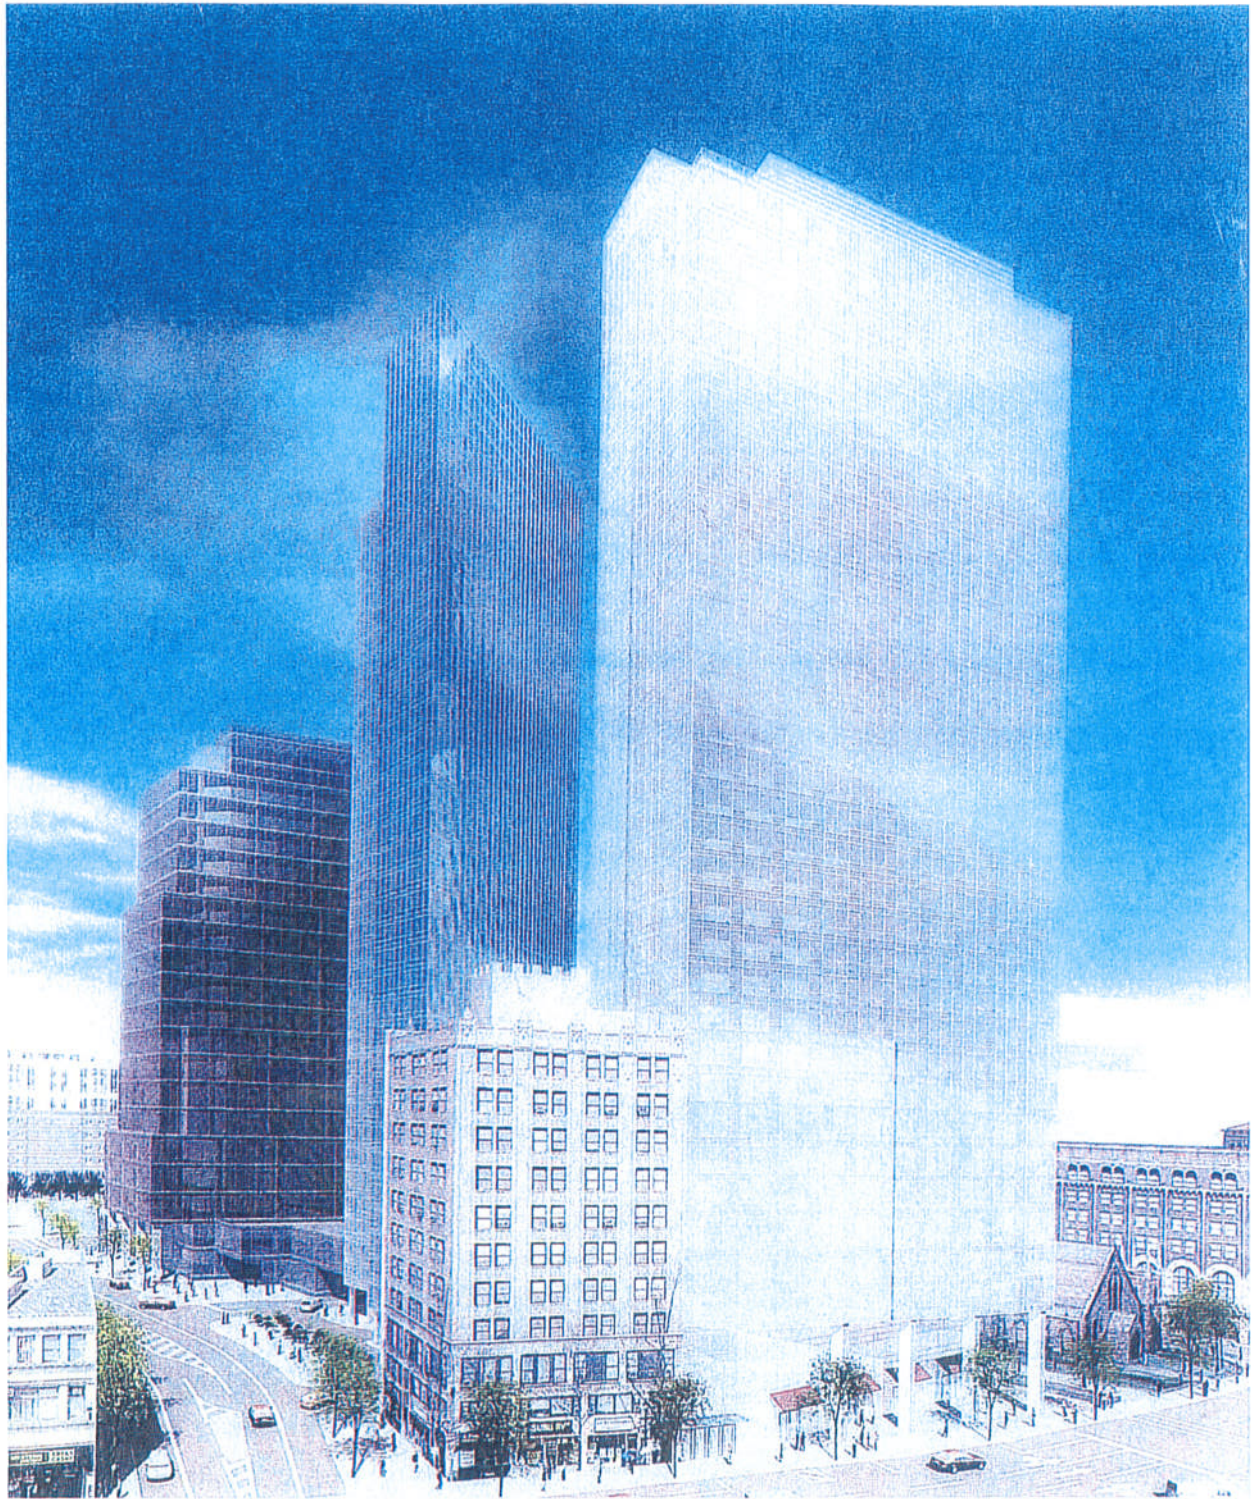
Figure - 2
Site Plan

These two site areas are shown on Figure 2. The northwest site area in which soil and groundwater contamination has caused off-site contamination is referred to hereinafter as the "PA area". The balance of the site, where contamination confined to on-site soils, is referred to hereinafter as the "221 area".

As indicated previously, the site is divided into two main areas, the PA area and the 221 area, as shown on Figure 2. This Work Plan describes the process for removing and disposing of USTs and impacted soils that are encountered during the implementation of this IRM.

The 221 area will be excavated in most areas down to bedrock to accommodate the construction of the new buildings. Based on the depth to bedrock, excavation across most of the site will reach 30 to 35 feet deep, but in some areas the excavation may approach 50 feet deep. The planned limits of excavation extend up to the site boundary (see Figure 2).

The site (BCP Site # C360073) is currently improved with several commercial buildings along Main St and Hamilton Ave, and a municipal parking lot on the west side of the site (Figure 2). Plans have been drawn up to redevelop the site into a hotel and residential condominium complex, which would produce a visually attractive and economically valuable asset to the local community (Figure 3). In order to support such a plan, existing site buildings will be demolished, and a new street, Court Street Extension, will be constructed through the western side of the site.

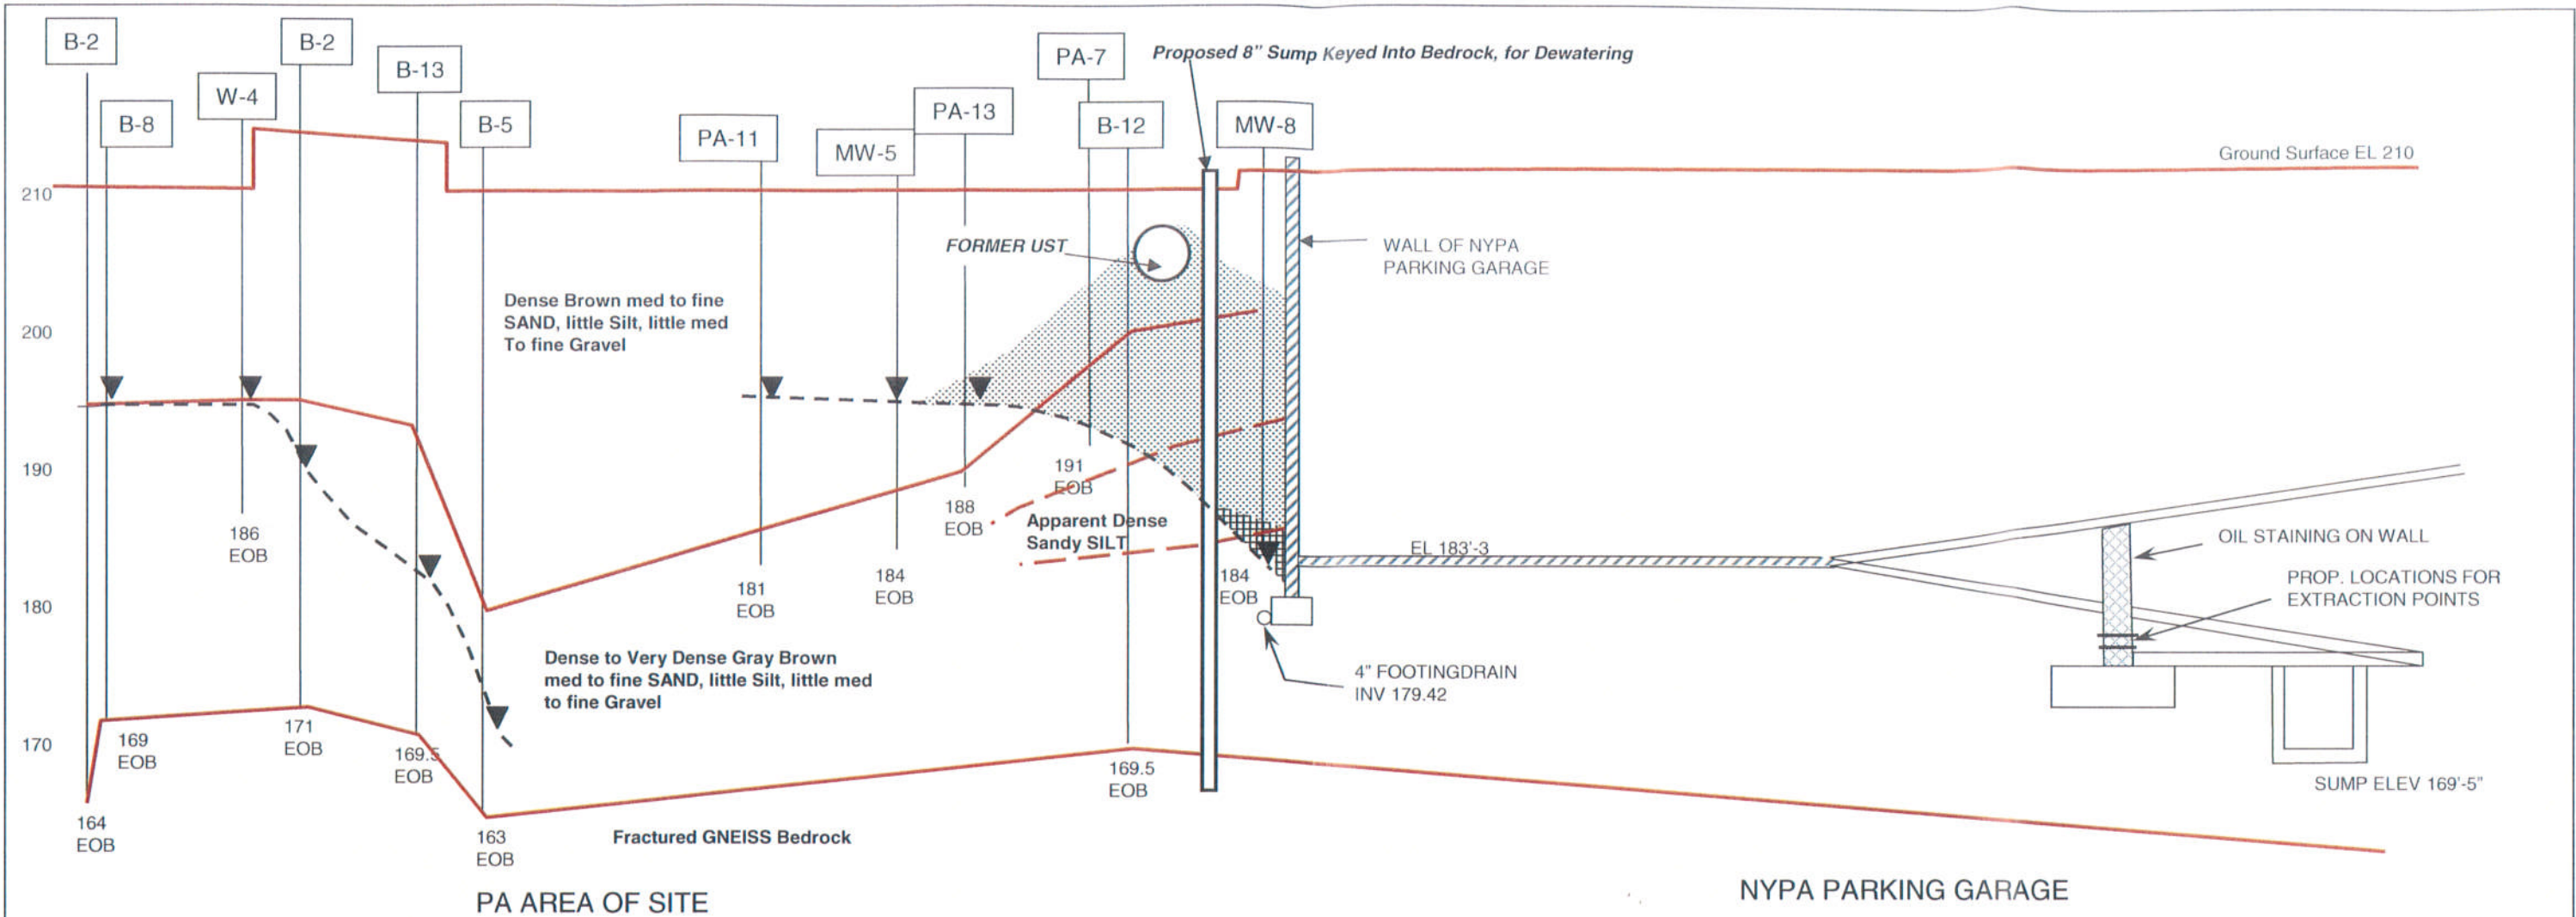
FIGURE 4
GENERAL STRATIGRAPHIC SEQUENCE

General stratigraphic sequence of site, in cross section. Figure is Based on data provided by JM Associates, and SESI Engineering.

The break in the transect between borings B-5 and PA-11 forces the Disconnect in the depicted water table.

A 30-inch sump was previously installed adjacent to the NYPA garage to a depth of 20 feet, corresponding to the top of a relatively low-permeability layer of silt. This well was to provide dewatering of the area near the NYPA garage. After a few initial pump-outs, the well became dry, and has remained dry ever since. This finding substantiates that groundwater was probably perched on the top of the silt unit, and after it was dewatered the zone above the silt unit remains dry. Two deeper sumps will therefore be installed to bedrock to provide for dewatering of this area, as was noted in Section 2.2.1, and as shown on Figure 4.

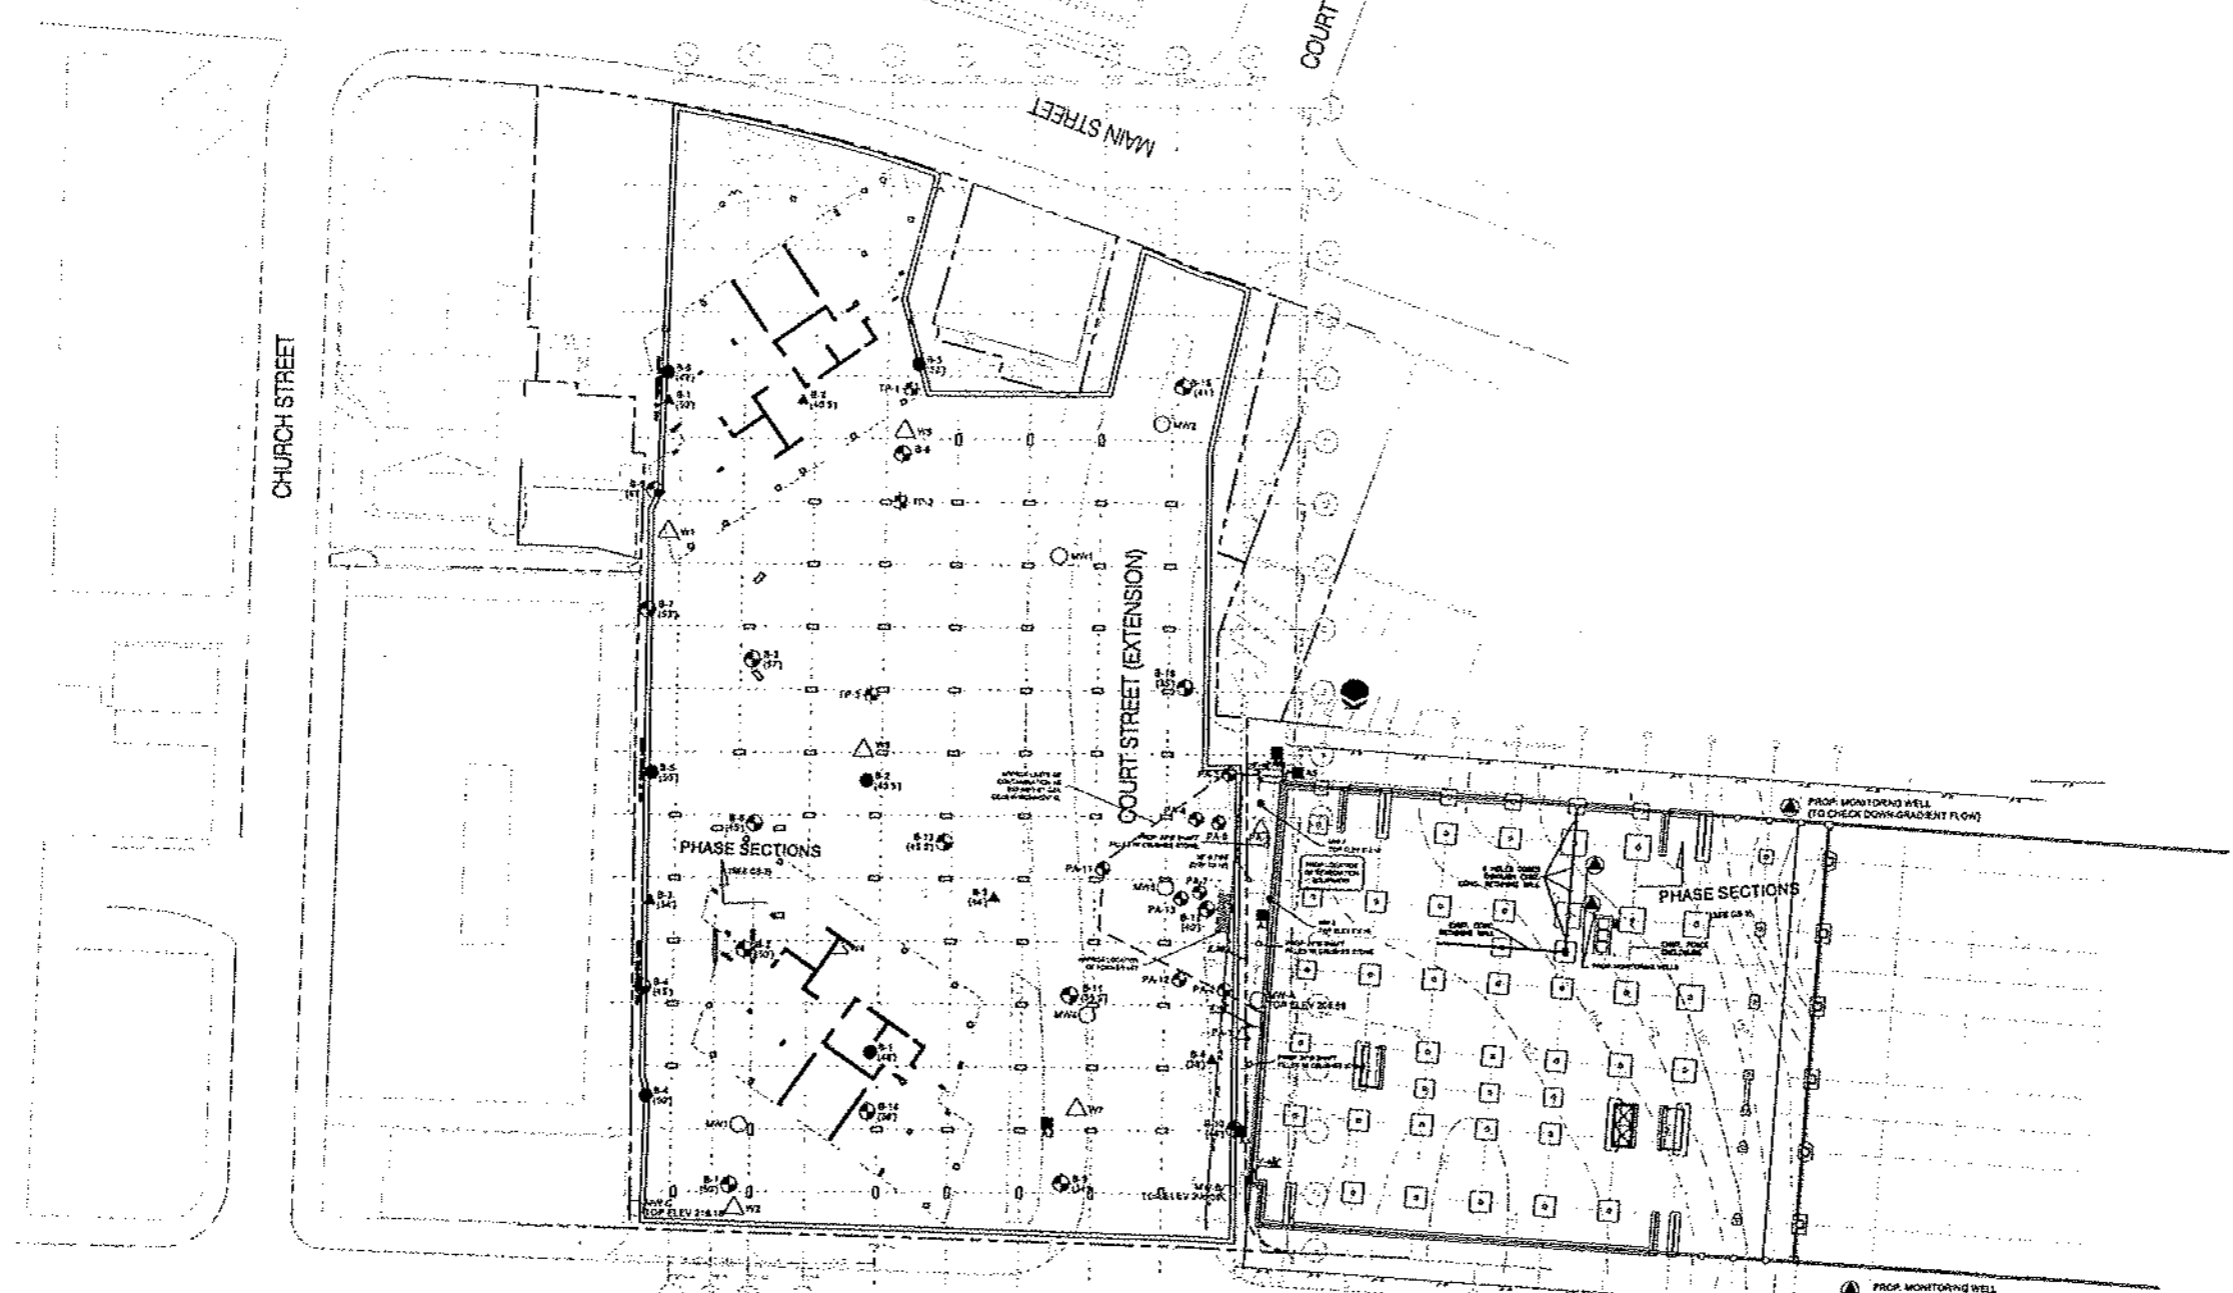
- LEGEND**
- B-2 BORING NO. & APPROX. LOCATION BY SEM (DATE)
 - BORING DONE BY GENERAL BORINGS IN FEB 1994
 - ▲ BORING DONE IN MAR 1993
 - (H) REFUSAL DEPTH TO ALICOR PENETRATION ON COBBLES/ROCK
 - ⊖ TP-3 TEST PITS DONE IN MAR 1993
 - ⊙ MW-4 WELL LOCATION AS REPORTED BY CONTRACTORS LINE & GRADE SOUTH, LLC
 - △ MW1 MONITORING WELL LOCATION (BY OTHERS) WELL NUMBERS ASSIGNED BY SEM
 - PA-3 WELL LOCATION BY GZA GEOTECHNICAL, INC (JAN 1993)
 - PA-1 BORING LOCATION BY GZA GEOTECHNICAL, INC (JAN 1993)
 - MW1-1 WELL LOCATION AS REPORTED BY JM ASSOCIATES
 - A1 WELL LOCATION AS REPORTED BY SEM (MAY 2005)
 - ▲ PROP. MONITORING WELL LOCATIONS
