# SPILL REMEDIATION REPORT

2101 AND 2103 PALMER AVENUE  
LARCHMONT, NEW YORK  
NYSDEC SPILL No. 1006787

December 2011

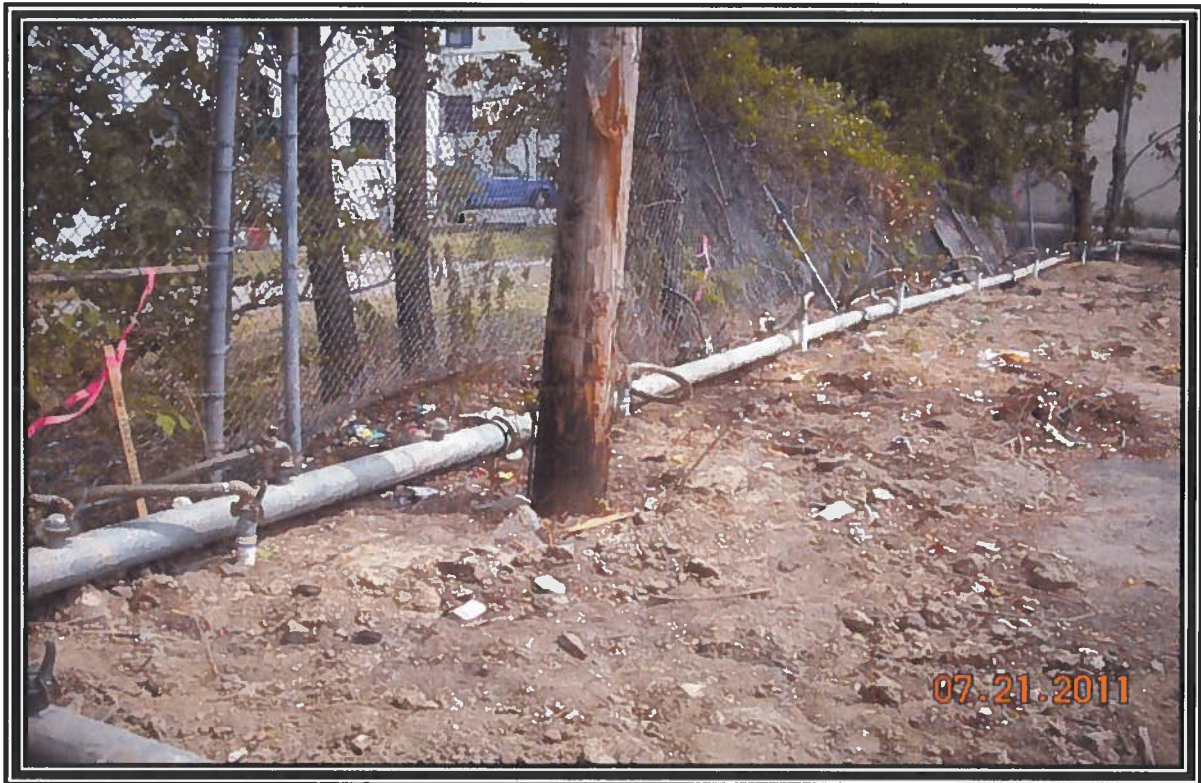
**FIGURE 3**

Photograph taken of dewatering wells and header pipe

Following the installation of the dewatering well array, HES designed and supervised the installation of a dewatering system during August 2011. The subject dewatering system consisted of a header pipe manifold and swing line well head connections to each dewatering well, a 21,000-gallon fractionation tank (settling tank), a Godwin<sup>®</sup> critically silenced model CD100MV suction pump, a Goulds<sup>®</sup> ½ horsepower transfer pump and four Carbtrol<sup>®</sup> 10 gallon per minute (gpm) granular activated carbon treatment vessels plumbed in sequence prior to proposed discharge to the Westchester County sanitary sewer located west of the site. The discharge was metered using an Elster<sup>®</sup> C700 flow meter set prior to the carbon treatment vessels. The dewatering system layout along with the location of the dewatering wells and sanitary sewer discharge location are shown on **Figure 2**. Photographs taken of the dewatering system are included on **Figure 3**.

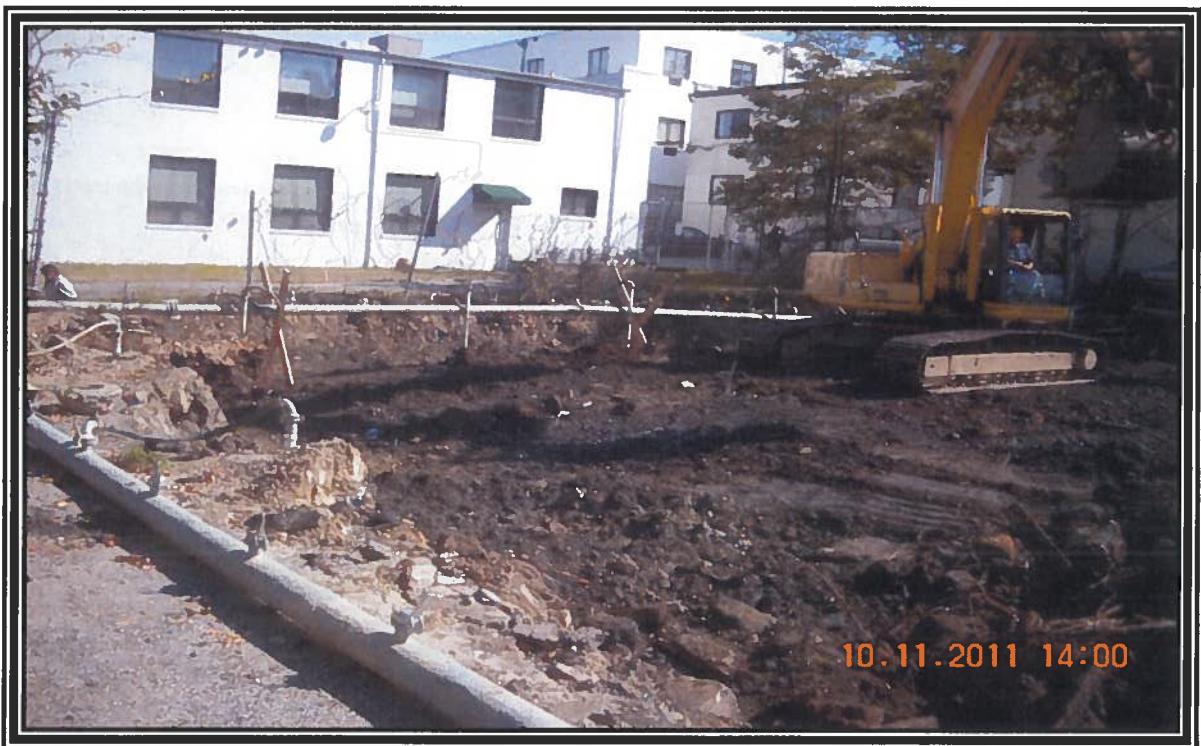
Photograph taken of dewatering wells and header pipe during excavation activities

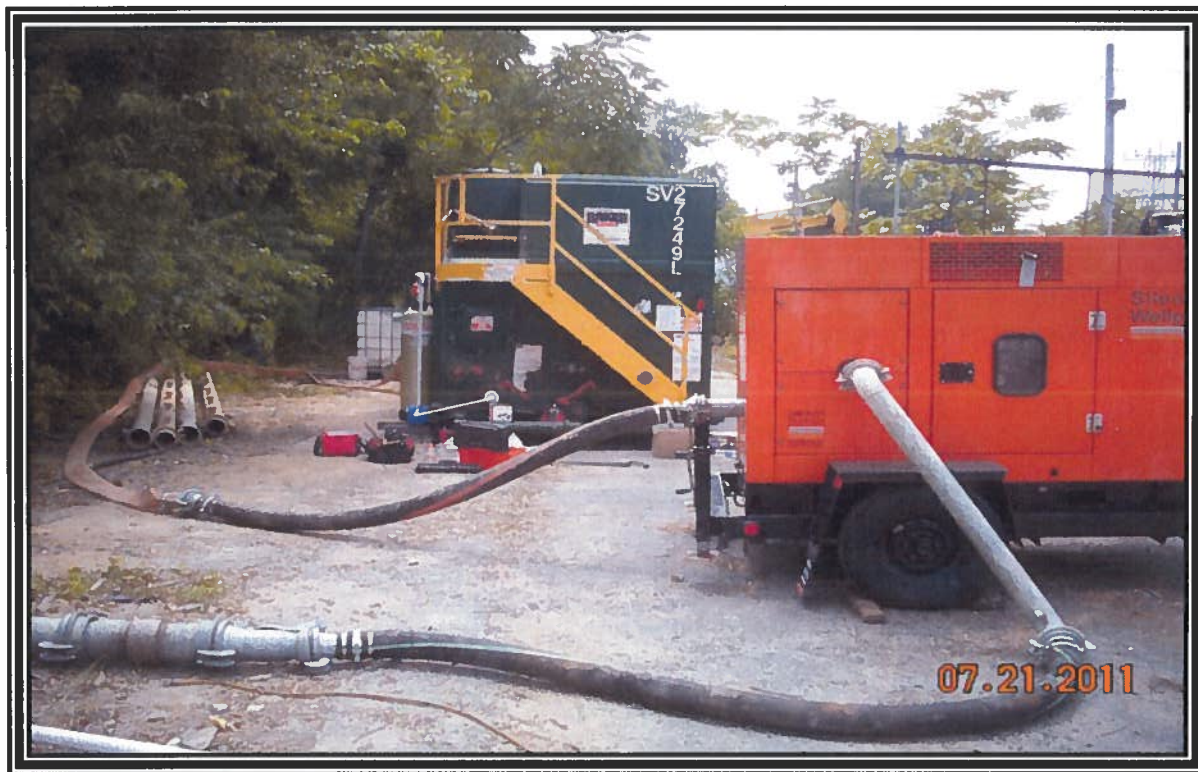
**FIGURE 3**

**Photograph taken of the on-site dewatering system (pump and frac tank)**

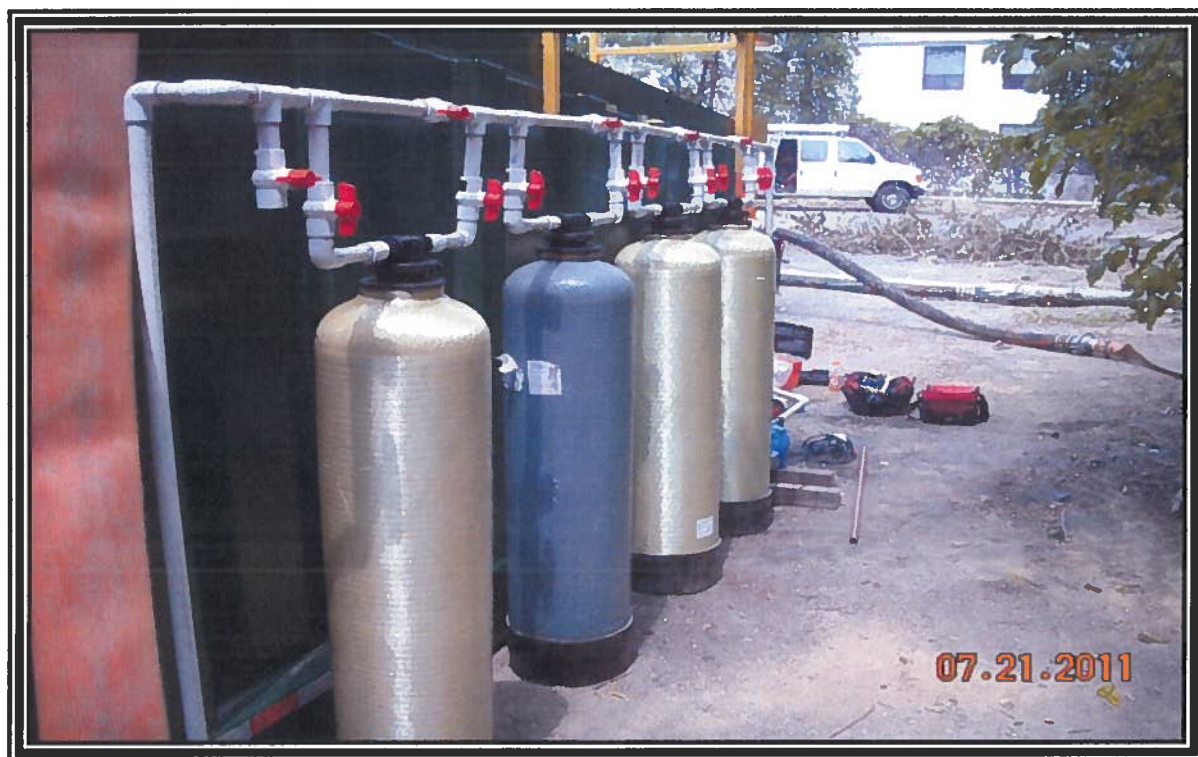
**Photograph taken of the carbon filtration installed on the dewatering system discharge vessels**

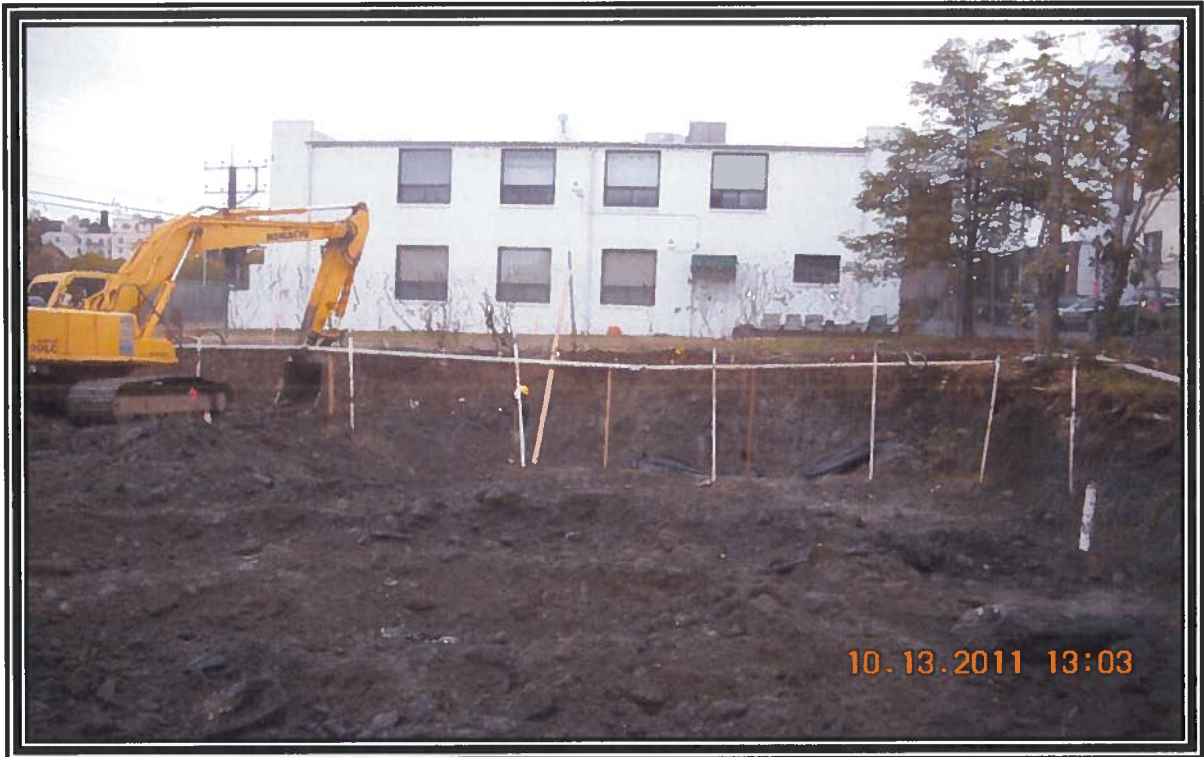
**FIGURE 3**

Photograph taken during dewatering and soil excavation activities

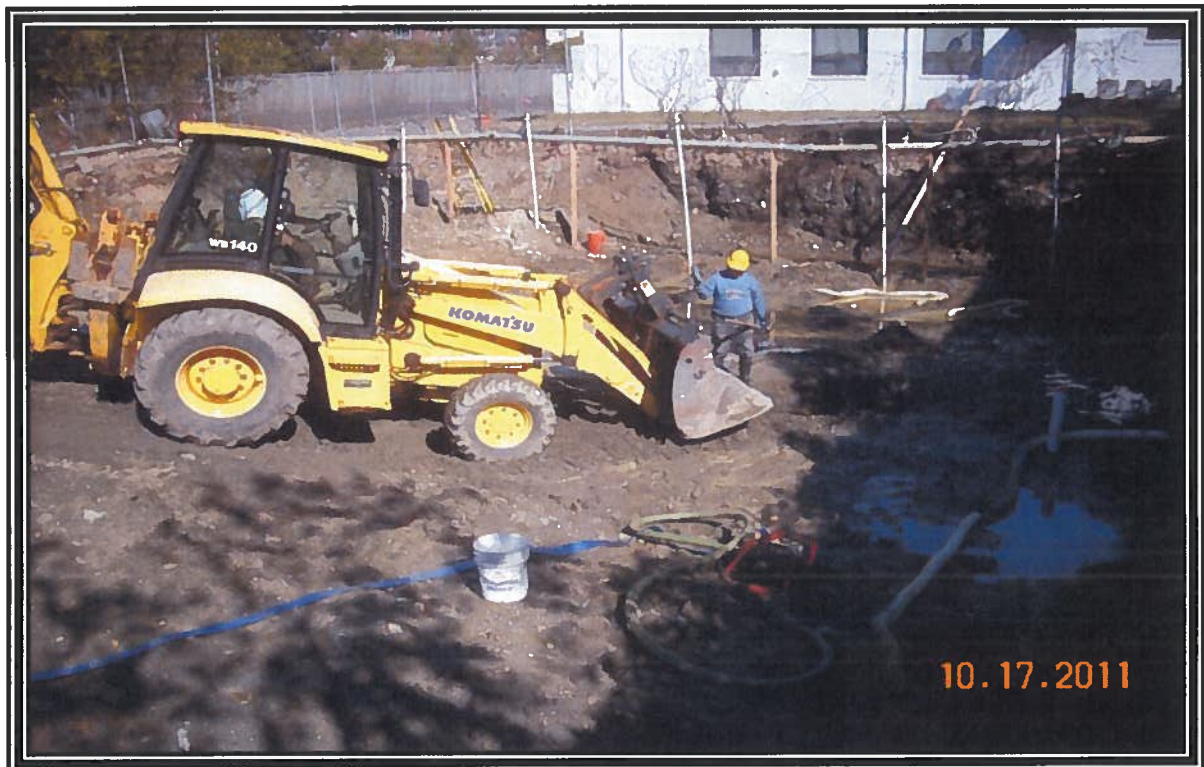
Photograph taken during soil excavation activities

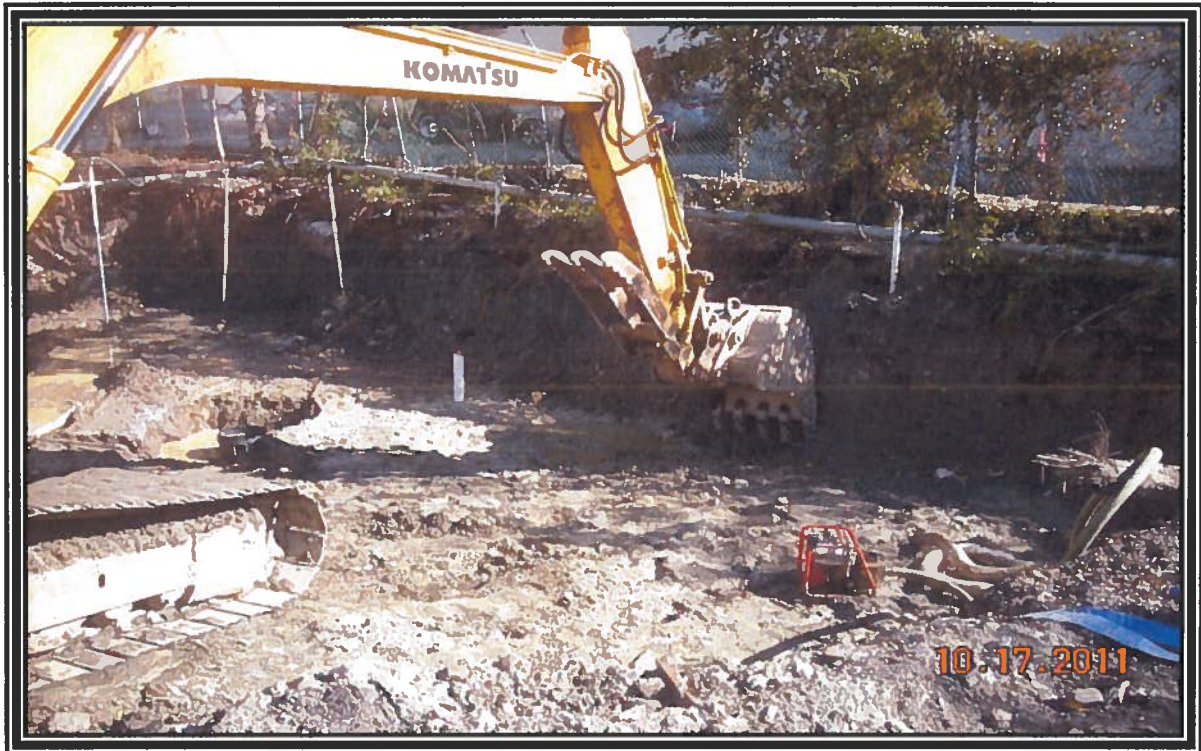
**FIGURE 3**

**Photograph taken during soil excavation activities**

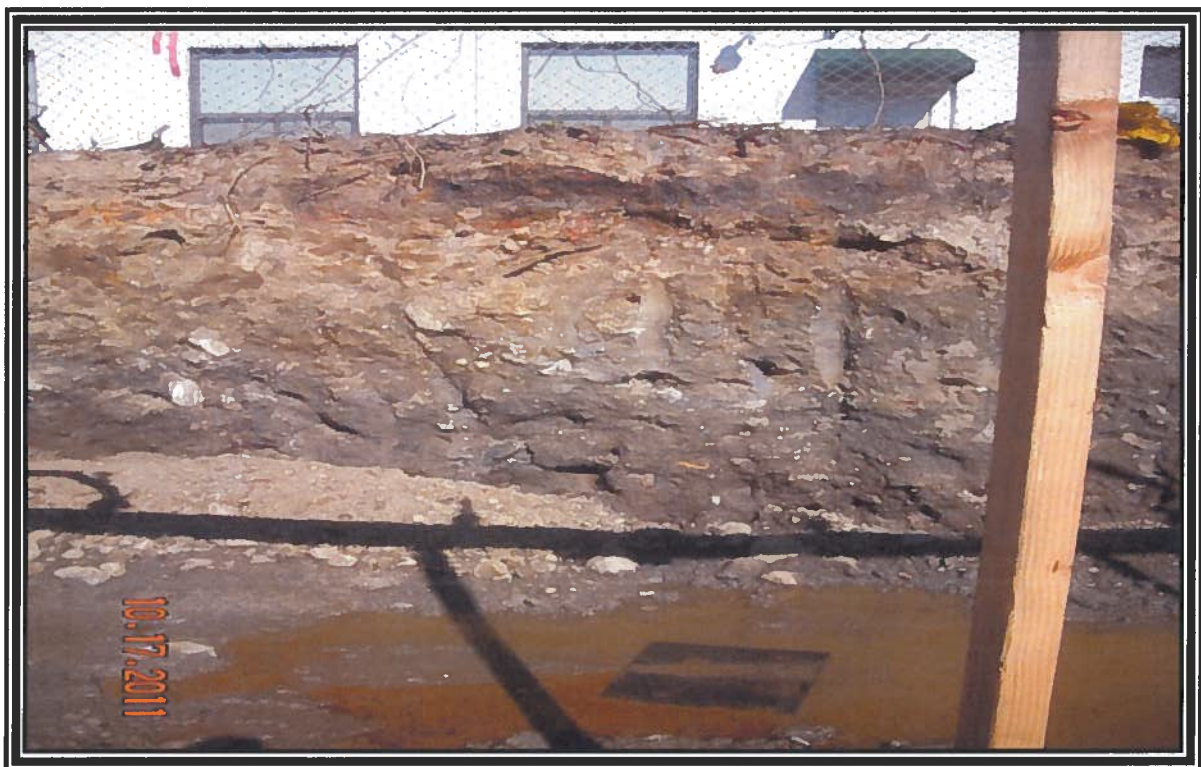
**Photograph taken of free-phase product entering the excavation along the eastern sidewall**

Due to the presence of free-phase product observed entering the excavation from two upgradient properties adjacent to the site, a 10-foot wide 80 mm (millimeter) thick polyethylene barrier was installed along the southern and western sidewalls during excavation backfilling operations. The barrier was installed to prevent the future migration of PHCs onto the subject site following the cleanup. Photographs of the barrier installation activities are included on **Figure 3**.

1. Based on observations made during excavation activities, free-phase petroleum was entering the excavation with groundwater along the southern and western sidewalls. The newly installed polyethylene barrier along these sidewalls is designed to prevent future petroleum migration onto the subject site.

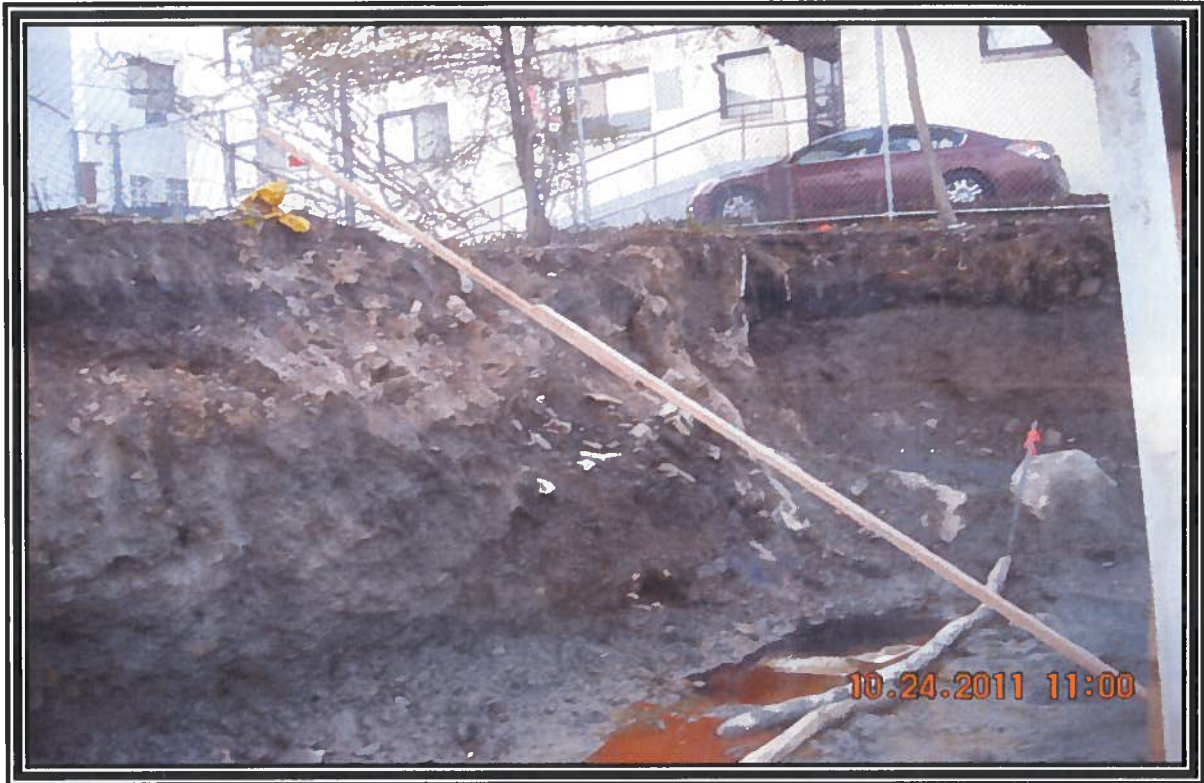
**FIGURE 3**

Photograph taken of free-phase product entering the excavation along the eastern sidewall

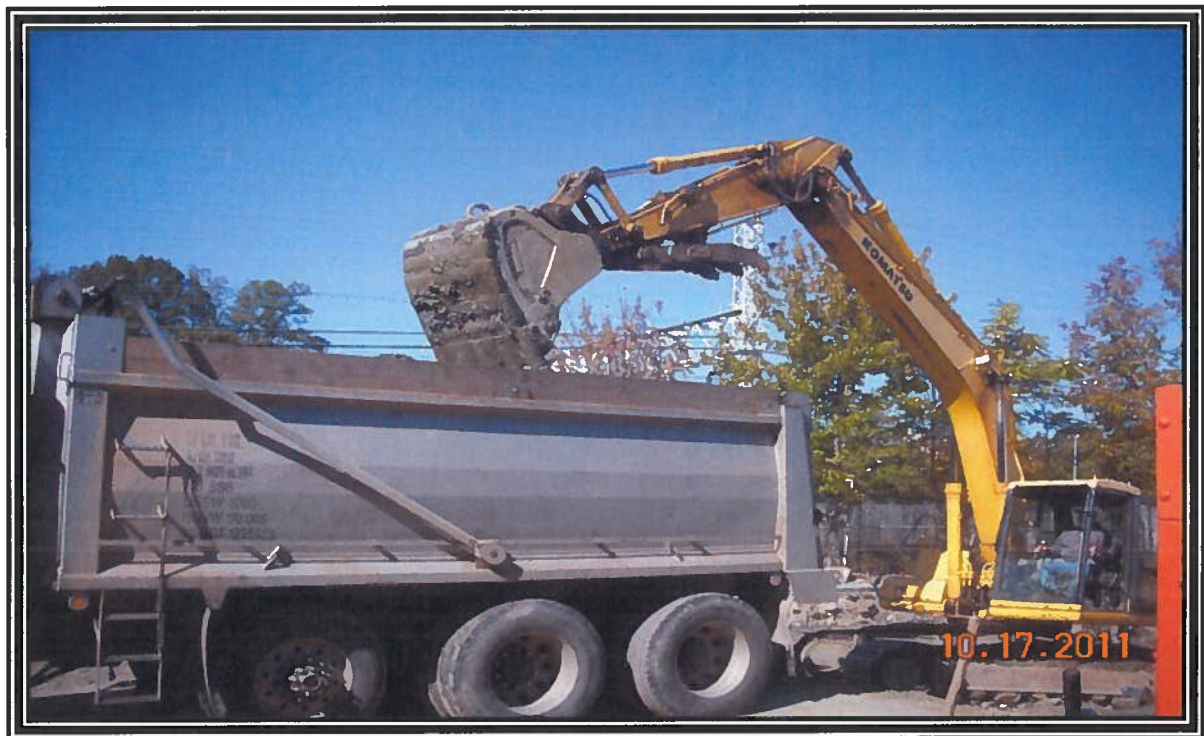
Photograph taken during soil loading and removal activities

On October 13, 14 and 17, 2011 twenty-nine (29) trucks operated by Rainbow, removed a total of 956.67 tons of petroleum impacted soil and transported it off-site to Clean Earth. The Non-Hazardous Material Manifests and facility weight tickets are included in **Appendix 5**. Photograph taken during soil excavation and loading activities are included on **Figure 3**.

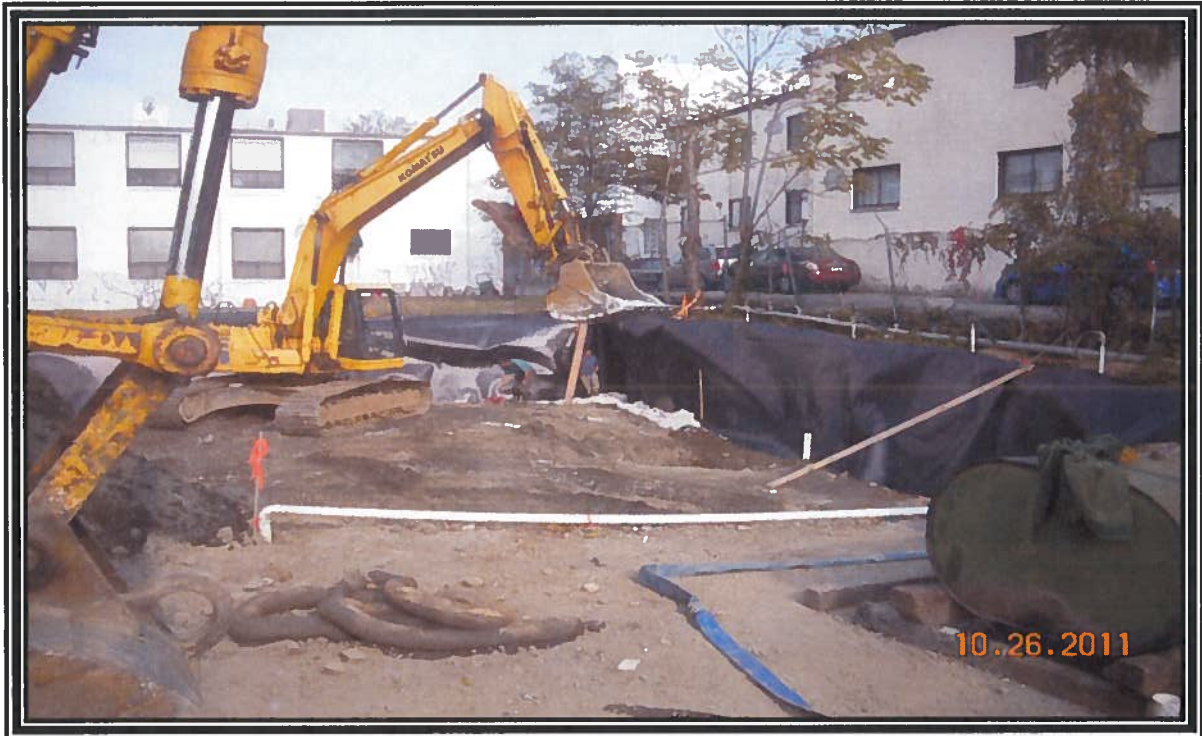
**FIGURE 3**

**Photograph taken during backfilling and polyethylene barrier installation along the eastern and southern sidewalls**

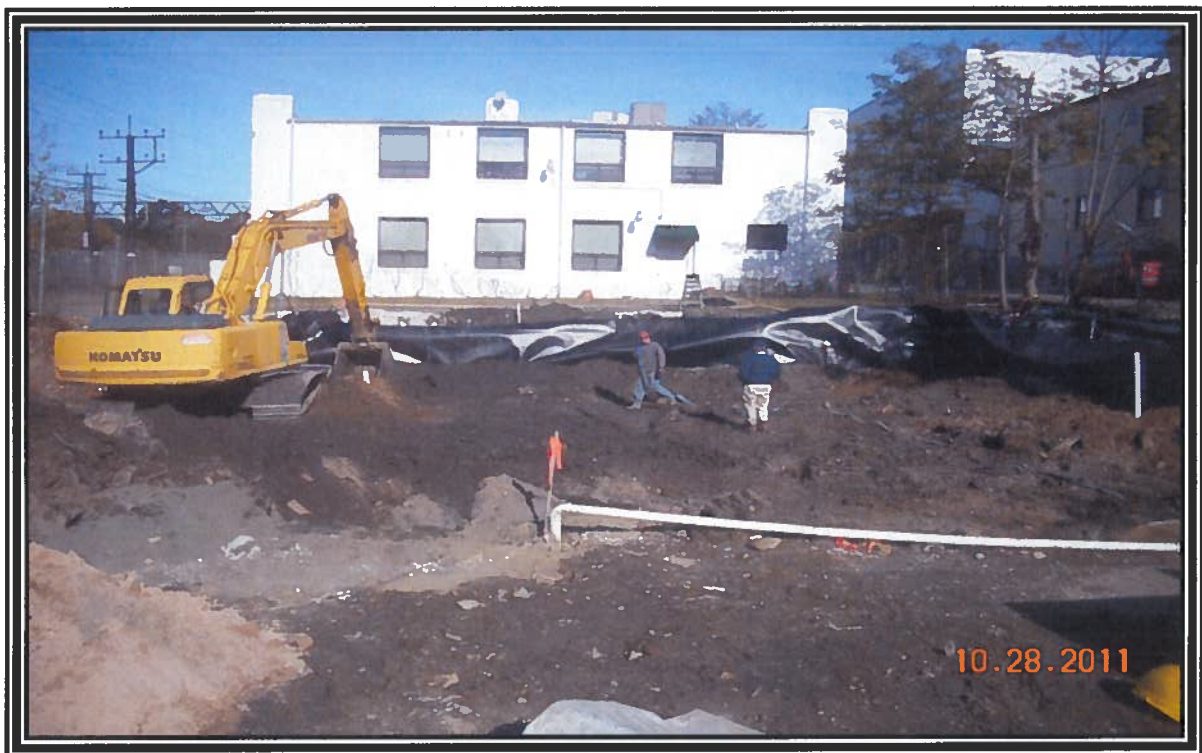
**Photograph taken during backfilling and polyethylene barrier installation**
