**PHASE II**  
**SUBSURFACE**  
**INVESTIGATION**

COMMERCIAL PROPERTY  
325 and 327 YONKERS AVENUE  
YONKERS, NEW YORK, 10701

JUNE 7, 2005

LEA PROJECT # 05-160.1

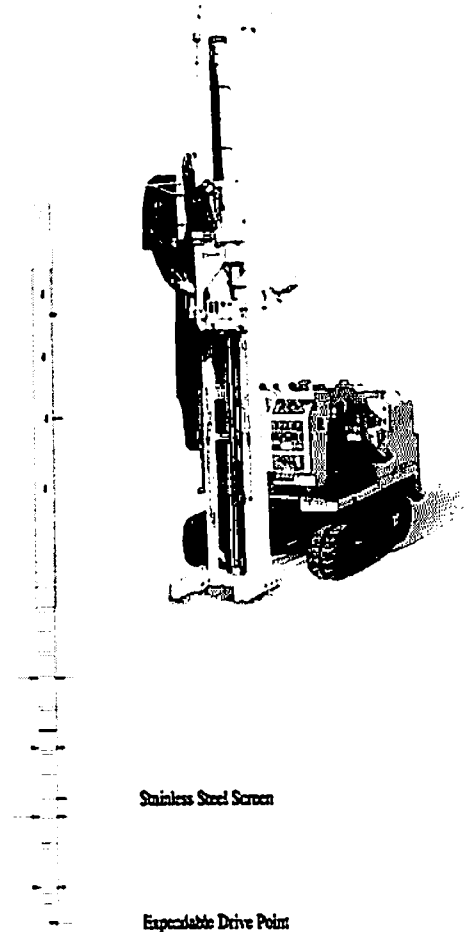
**Figure 3.0: GeoProbe Operating System**

- ◆ Hydraulic powered probe unit is operated from a engine driven pump
- ◆ Remote vehicle ignition allows operator to start engine from probe unit
- ◆ Light driven hydraulic pump supplies 10 gpm @ 2000 rpm, 3000 psi operating pressure
- ◆ Probe unit folds for transport
- ◆ Unit utilizes static weight of vehicle and percussion hammer to advance probing tools.
- ◆ Hydraulic hammer delivers percussion rate of 30 Hz
- ◆ Probes have greater than 18,000 lbs of down force and 25,000 lbs of retraction force
- ◆ Drives multiple diameter probes (1", 1.25" and 2.25") to depths over 100 feet.

- ◆ **Soil Probing Tool**  
The tools are advanced and a sample is acquired in a non reactive plastic sheathing. The system offers two sizes of sample retrieval.

Large bore - 1.5" x 2"  
 Main - 2.25" x (2.25" x 4")

- ◆ **Groundwater SP-15 Sampler**  
The tool allows a stainless steel 4" screen to be delivered to the underlying groundwater. At the desired depth the screen is retracted and samples are obtained via a check valve available.

Subsurface probes were sited using a GeoProbe® hydraulically powered probing tool (see **Figure 3: Geoprobe Operating System**). Mechanized, vehicle mounted probe systems apply static force and hydraulically powered percussion hammers for tool placement (static down forces up to 35,000 pounds combined with percussion hammers of eight horsepower continuous output). Recovery of sample volumes was facilitated with a five foot, open ended probe driven sampler.
