## Remedial Investigation Work Plan

Greenport Crossings  
181 Union Turnpike (Route 66)  
Town of Greenport, New York

LaBella Project No. 210408

August 2010

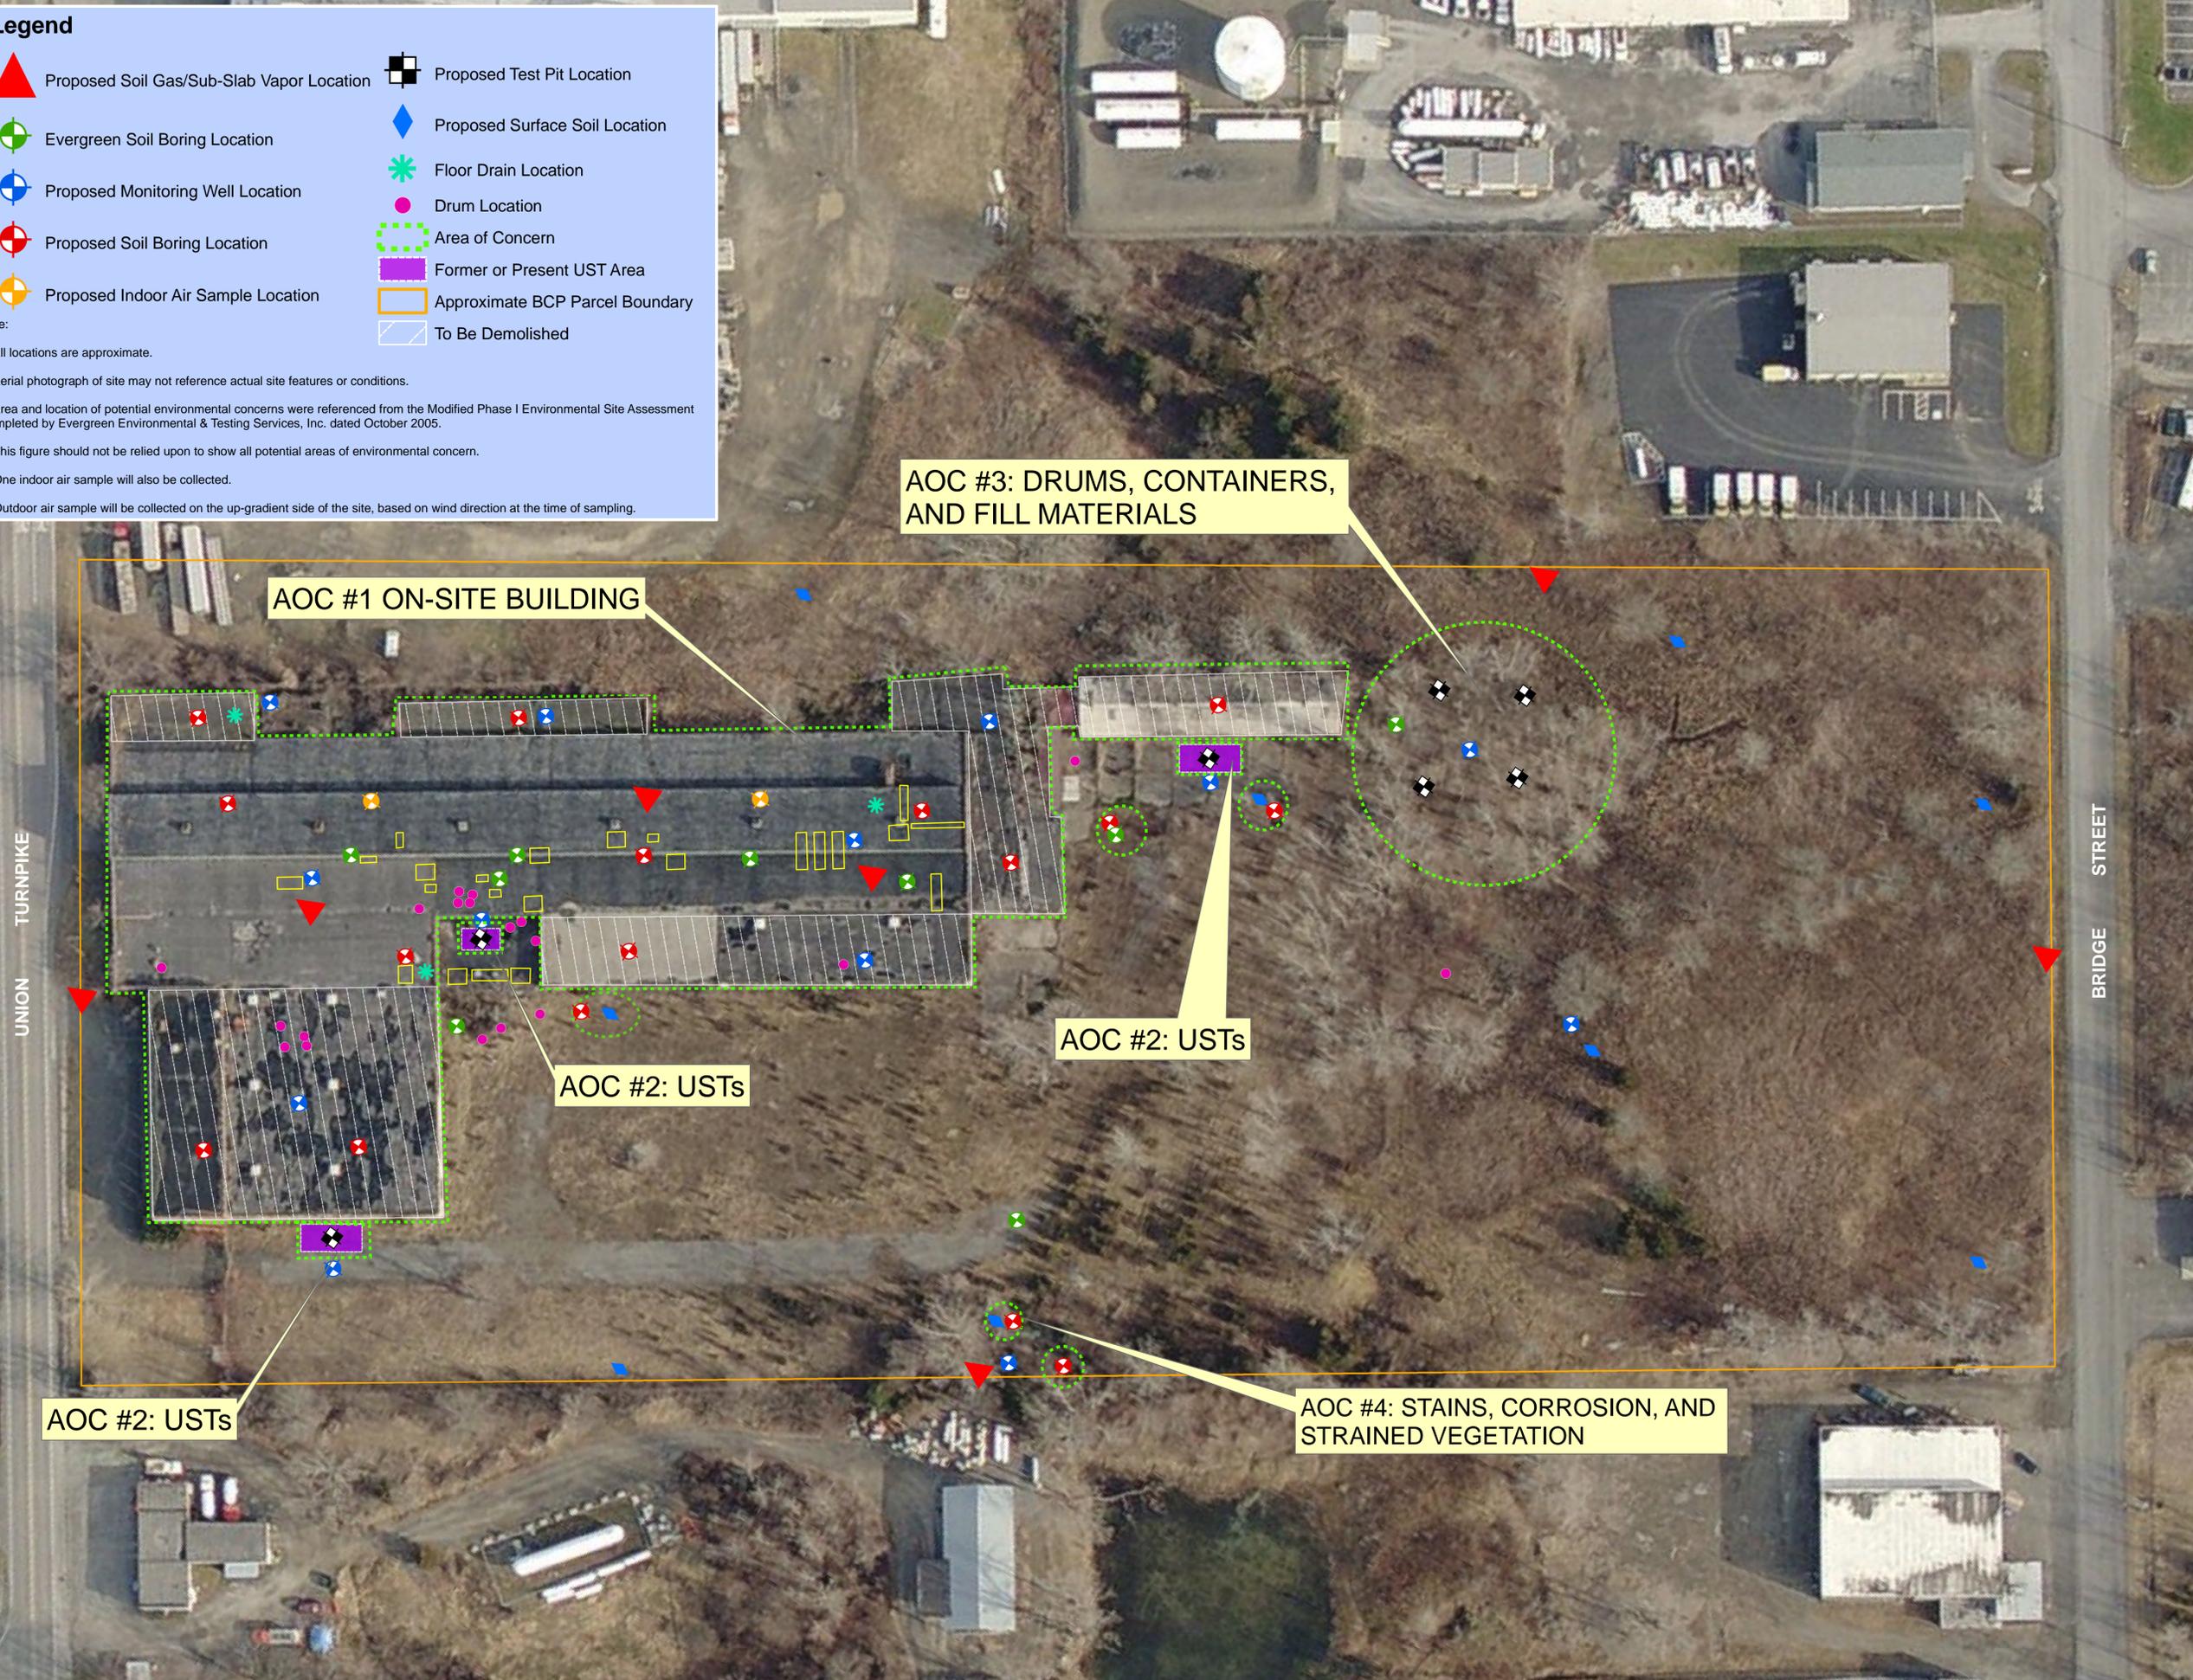
- Figure 1 Site Location Map  
Figure 2 Areas of Concern, Site Features, and Proposed Sampling Plan

Nine (9) surface soil sample locations are proposed. Figure 2 presents the proposed locations of the surface soil samples. [Note: At the time of the fieldwork, the areas proposed will be evaluated for worst-case locations of staining, stressed vegetation, etc. Numerous surface locations may initially be 'scratched' to select a worst-case location for sampling.] As discussed with the NYSDEC and NYSDOH on August 3, 2010, only the 0 to 2 inch bgs depth interval will be sampled. The following describes the method that will be used to collect the surface soil samples:

As required by NYSDEC DER-10 surface soil sampling will be conducted as part of the exposure assessment. The surface soil sampling will also assist with evaluating AOC #4; however, soil borings will also be completed to evaluate AOC #4. It should be noted that the Site is proposed for commercial use and is located in an urban/commercial setting, and it is understood that the majority of the Site will be finished with impervious surfaces (e.g., asphalt, concrete) and as such, the surface soil sampling plan is based on these factors.

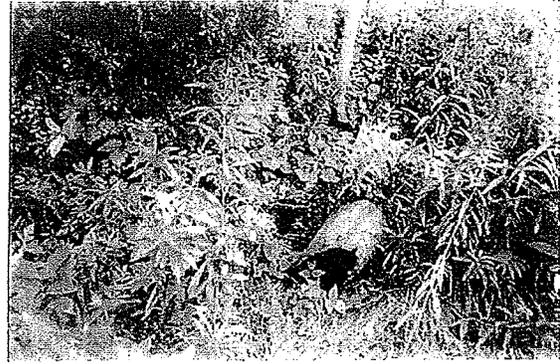
PHOTO 22

Also, several corroded buckets of roof cement were observed on the ground surface in the vicinity of the pad-mounted transformer on the west side of the building (photos 22 & 24). These containers contained residues. The buckets were corroded and roof cement residue was visible on the ground surface. The abandoned and corroded roof cement containers represent a release to the property and are considered a REC in connection with the subject property.

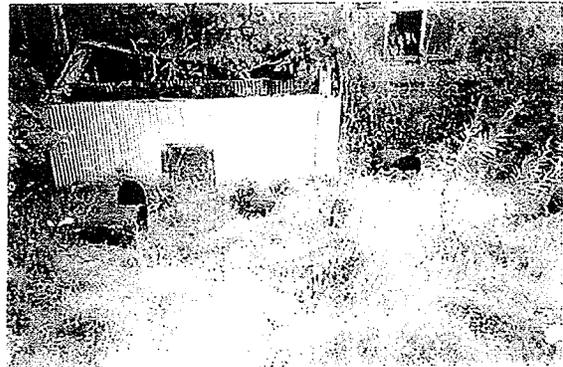
PHOTO 24

Evidence of the first unknown size UST was observed in the form of a vent and fill pipe located along the west side of the northwest addition (photo 25). Evidence of a second unknown size UST was observed in the form of a vent and fill pipe located along the west side of the southern shed addition (photo 34). The USTs have been vacant/abandoned along with the building for at least 15 years. Assuming they were installed during the building additions in the 1960s, they are at or beyond the typical life expectancy of a UST (20 to 30 years), therefore a material threat exists the USTs are leaking or are likely to release their contents due to the age of the tanks.

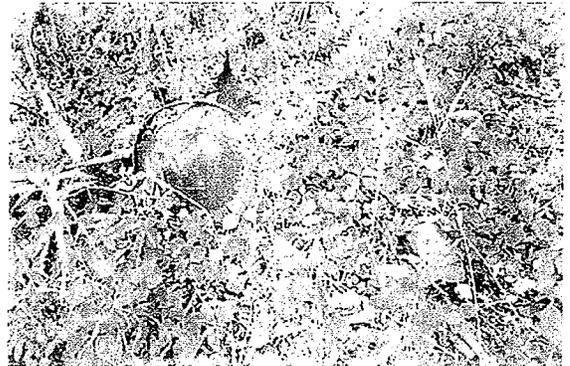
PHOTO 30

Outside the building at least 20 drums were observed abandoned and half buried in the site soils behind the southern limits of the subject building (photo 30). The portions of the drums that were able to be accessed were observed and appeared to be dry without evidence of residue or a release, however, Evergreen was not able to observe below the drums because they were partially buried. The buried drums represent a material threat of a release of contents from dumping, and as such, the partially buried drums represent a REC in connection with the subject property.

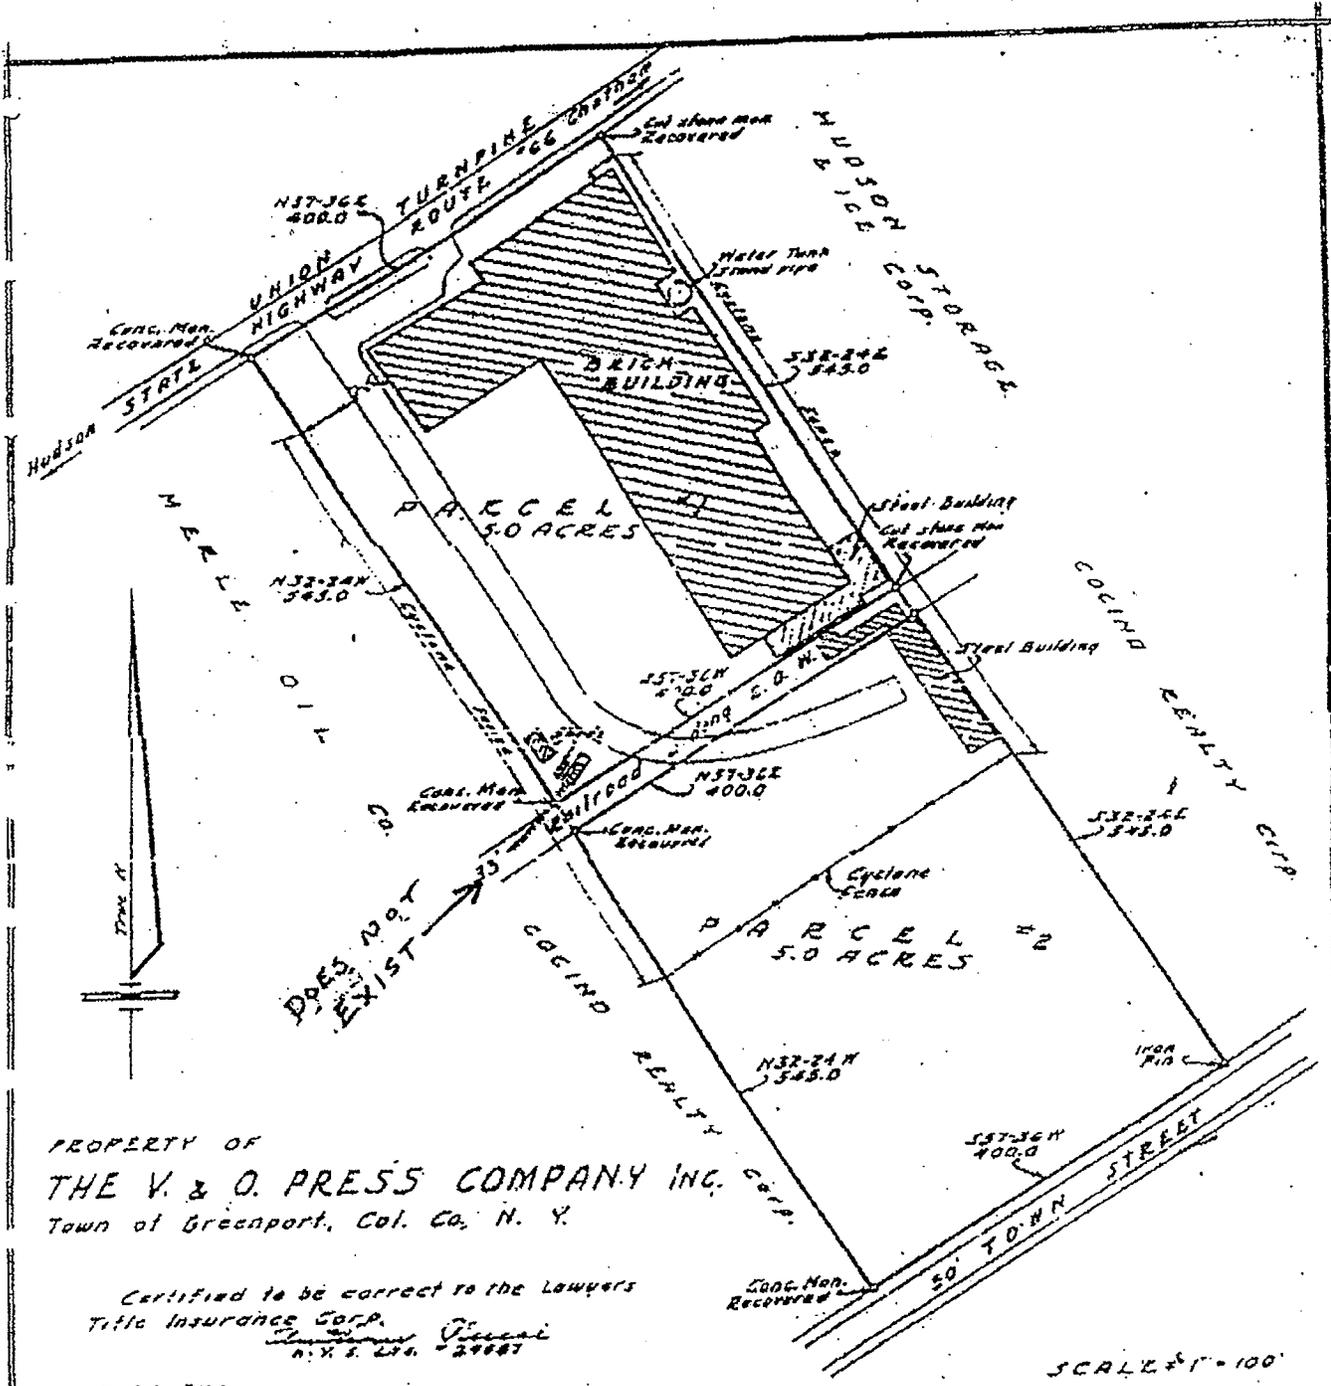
SURVEY MAP

PROPERTY OF  
**THE V. & O. PRESS COMPANY INC.**  
 Town of Greenport, Col. Co., N. Y.

SCALE 1" = 100'  
 Nov. 20, 1963

As shown on the figure in Appendix F, a recent wetland delineation identified the southern portion of the Site as a regulated wetland.

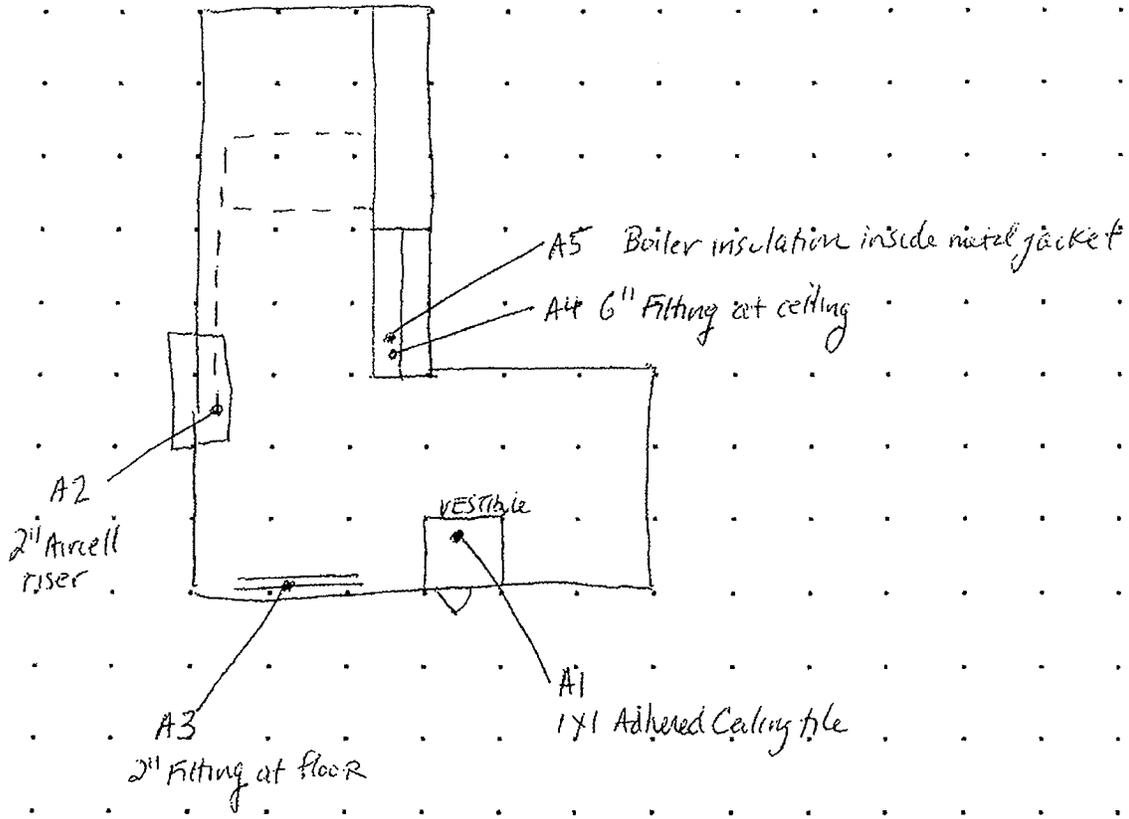
PROJECT NAME: V+O Press Building	PROJ. NO: ETE-05-132
CLIENT: Leslie Couper	DATE: 8/24/5
DESCRIPTION: Asbestos Sampling; Location Map	PAGE NO.: 1

Did not measure quantities.  
All 6" Fittings considered positive, All 2" pipe or fittings positive.  
1x1 Ceiling tile negative, Boiler insulation fibrous glass
