Re: 2020 Monitoring Well Decommissioning

110 Luther Avenue BCP Site

**BCP Site #C734118**

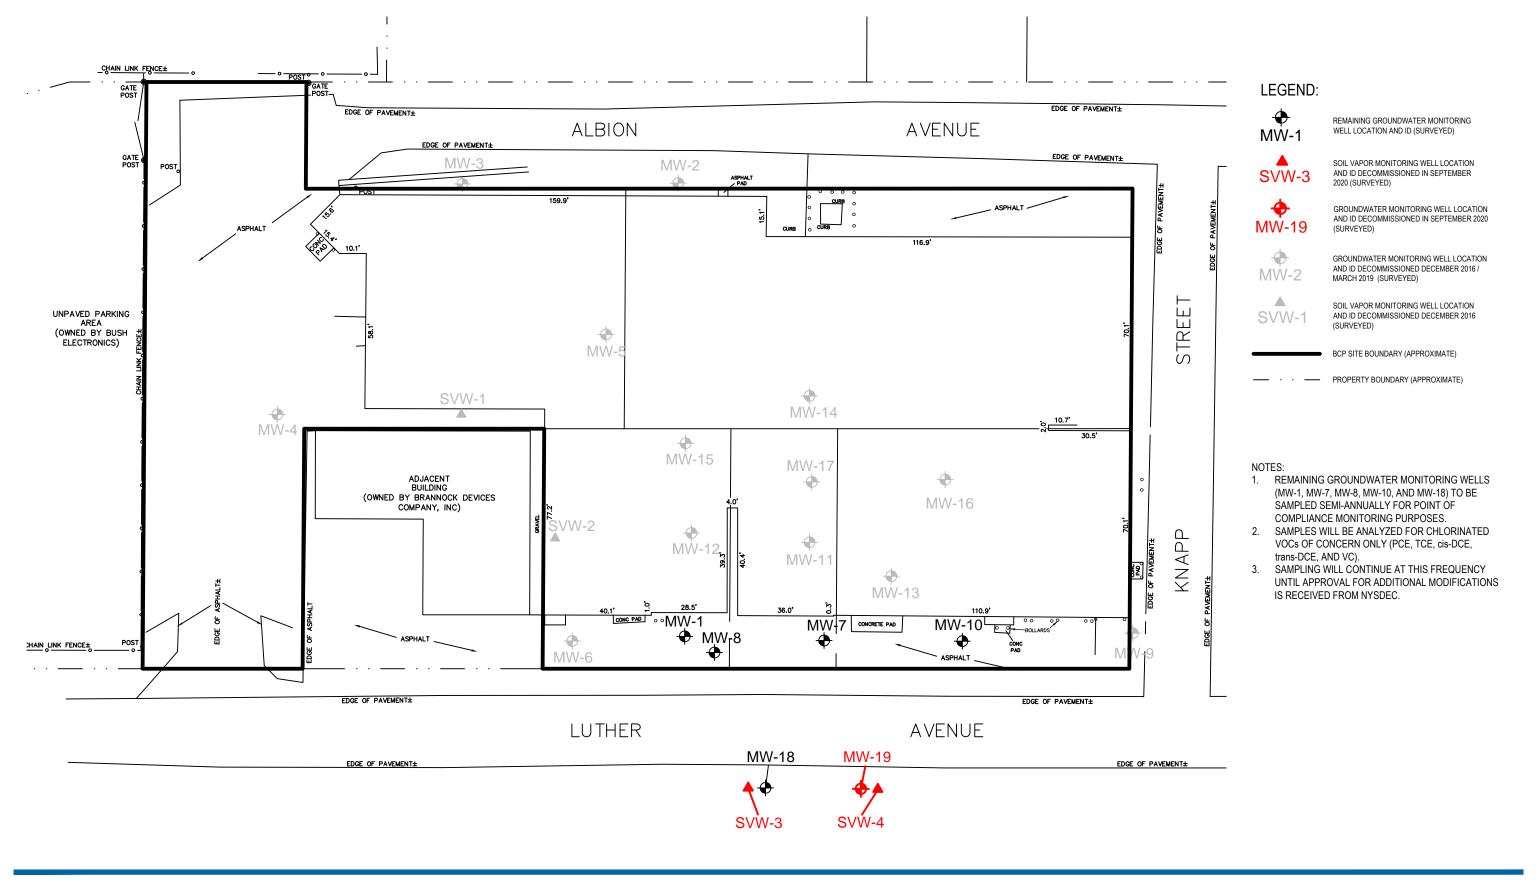
Figure 1

The following table lists the wells that were decommissioned or modified, their diameters, approximate depths, and type of surface restoration. The attached figure shows where the wells were located prior to decommissioning and also includes the locations of monitoring wells that remain on-Site.

Site Layout

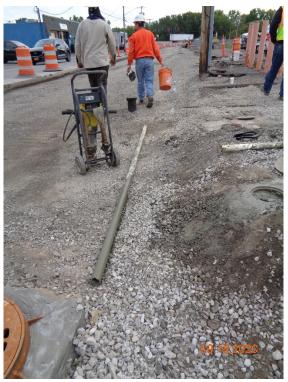
Photo 1 - The PVC well screen and riser was removed from exterior monitoring well location (MW-19) and the void was grouted.

Groundwater monitoring well MW-19 decommissioning was proposed to proceed in accordance with CP-43: Groundwater Monitoring Well Decommissioning Policy (NYSDEC November 3, 2009) by puncturing the bottom of the well, filling with a bentonite/cement grout, removing the well screen and riser from the boring, and filling the void with grout. Decommissioning of MW-19 proceeded as proposed, and the PVC well screen and riser was able to be pulled in its entirety, with the resulting void backfilled with cement/bentonite grout.

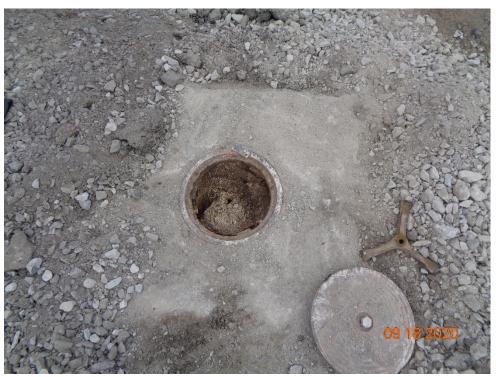
Photo 2 - Soil vapor monitoring well tubing pulled from SVW-4.

The Teflon well tubing of SVW-4 was pulled out of the ground until its breaking point, as proposed, and the surrounding soils were allowed to collapse in and fill the void. The stainless steel soil vapor well screen remained in the subsurface.

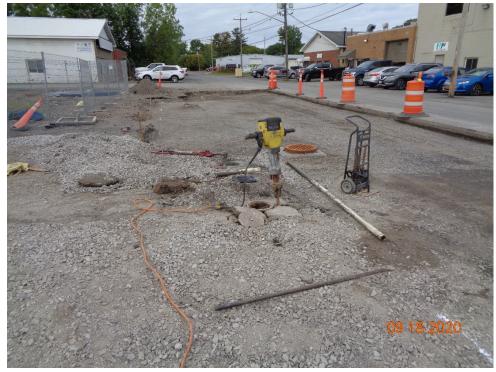
Photo 3 - The flush mount covers and associated concrete pads were removed.

At each of these locations, the flush mount curb box, cover, and concrete pad were removed and the surface was left similar to surrounding conditions. At a later date, these monitoring point locations were regraded and either paved with asphalt pavement or transitioned to landscaped areas by others as part of the development of the adjacent property south of Luther Avenue.

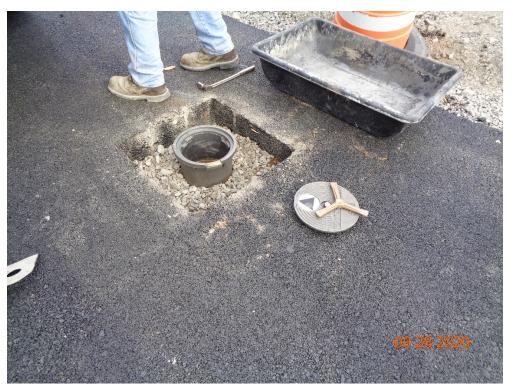
Photo 4 - New flush mount surface casing installed to bring monitoring well (MW-18) up to the newly developed asphalt grade.

The remaining off-site groundwater monitoring well (MW-18) had the flush mount protective casing, cover, and concrete pad replaced to accommodate the newly installed asphalt pavement. Following removal of the curb box, cover, and concrete pad at MW-18, a wooden form was built around the well by others and paving activities were completed by others associated with the development of the adjacent property south of Luther Avenue. Once paving was completed, GHD and Parratt-Wolff returned to the Site on September 28, 2020 and installed a new concrete pad, flush mount curb box, and cover at MW-18.

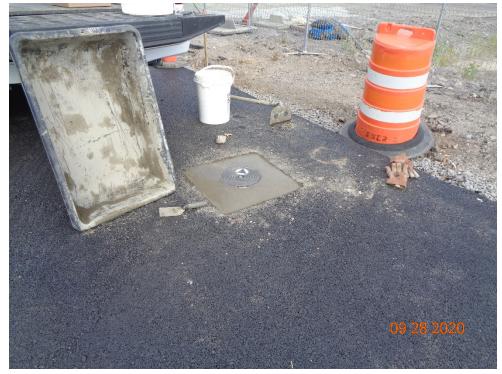
Photo 5 - Finished concrete pad and cover at MW-18 flush with surrounding grade.
