# **Third Addendum to the Supplemental Sewer Investigation Work Plan**

Ex-Eaton Site  
34-40 Clinton Street  
Batavia, New York  
Site No. C819022

CNH Baumaschinen GmbH  
Berlin, Germany

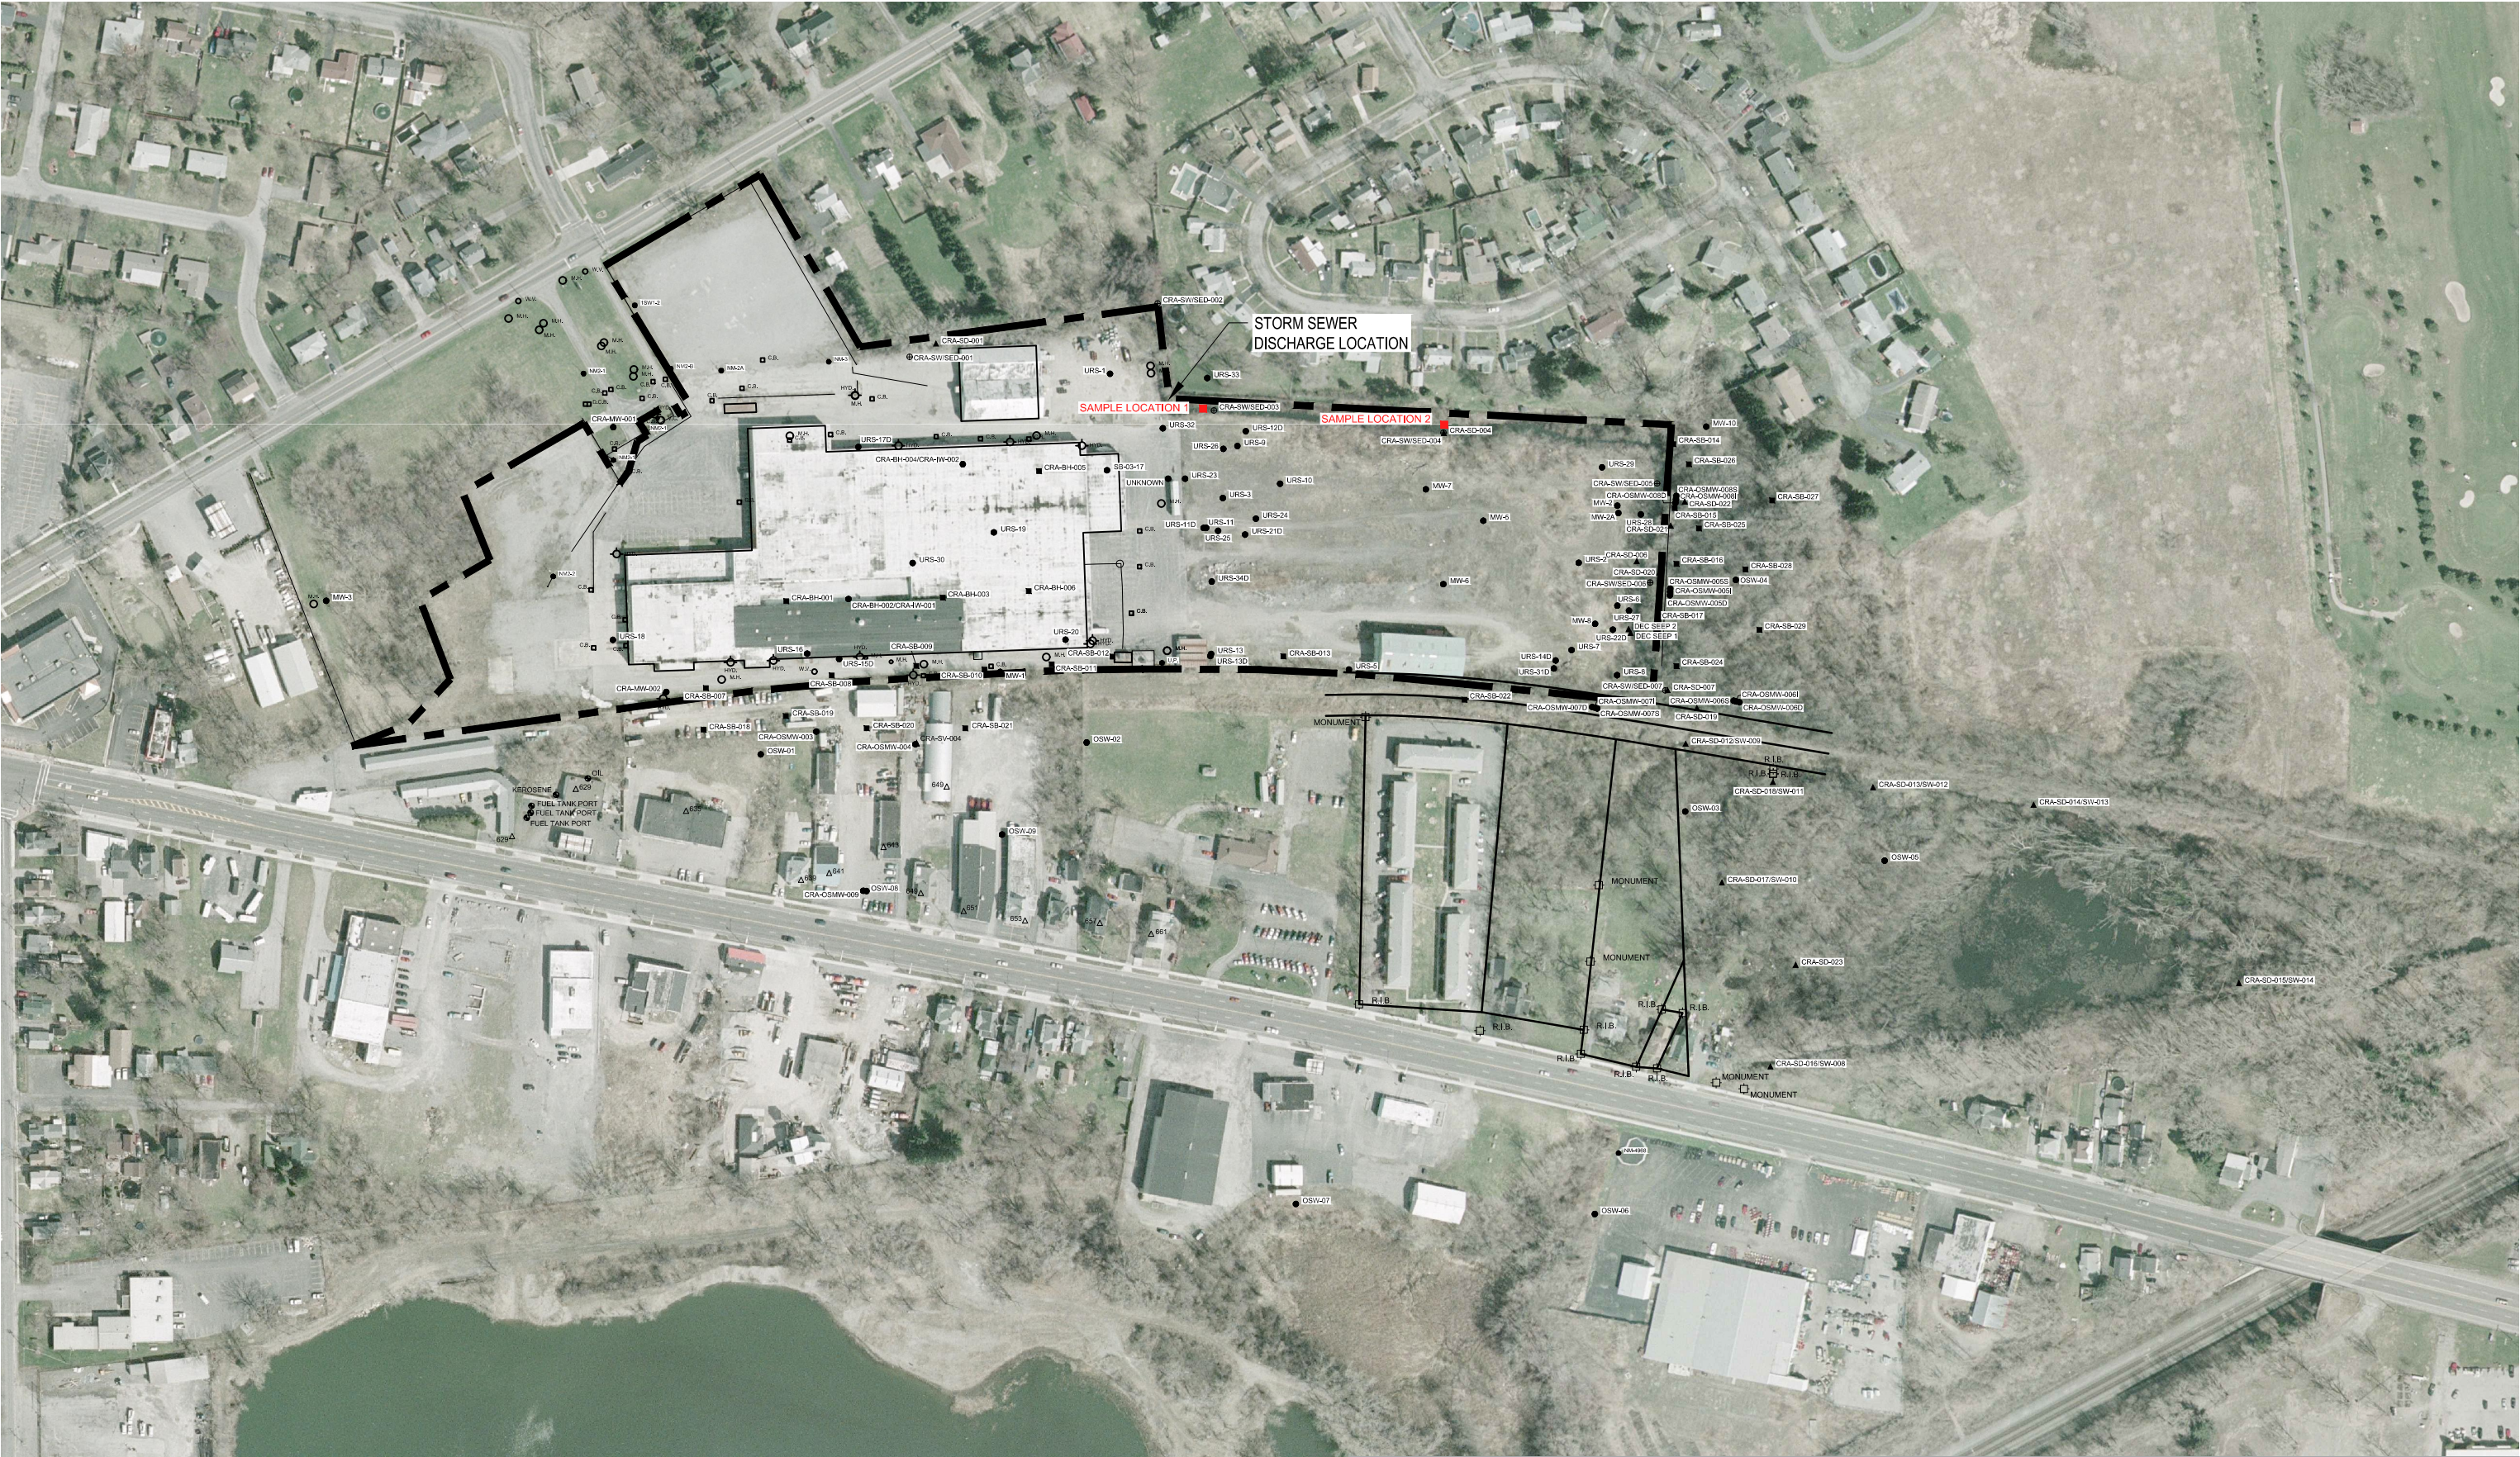
FIGURE 4.1

EX-EATON SITE  
34-40 CLINTON STREET  
BATAVIA, NEW YORK  
2019 PCB SEDIMENT SAMPLE  
LOCATIONS

Sediment samples will be collected from two locations in the drainage ditch that were sampled during the FWRIA investigation and documented in the final report submitted to the NYSDEC. These sample locations are identified as CRA-SW/SED-003 and CRA-SW/SED-004 on Figure 4.1.

Sediment was sampled from location CRA-SW/SED-003 in 2008 and from location CRA-SW/SED-004 in 2008 and again in 2010. To ensure that the sediment samples are collected from the same locations as in 2008 and 2010, a hand-held global positioning system (GPS) unit will be used to identify the historical sampling locations in the field. One duplicate sample will also be collected. The purpose for selecting the two sample locations is to have a direct comparison between data collected in 2010 and data to be collected in 2019.
