Re: 2022 Periodic Review Report  
NYSDEC BCP Site No. C828135  
1440 Empire Boulevard, Penfield, New York  
LaBella Project No. 2223231

2021 Annual Site  
Inspection Report

Electrical Line  
Installation Location

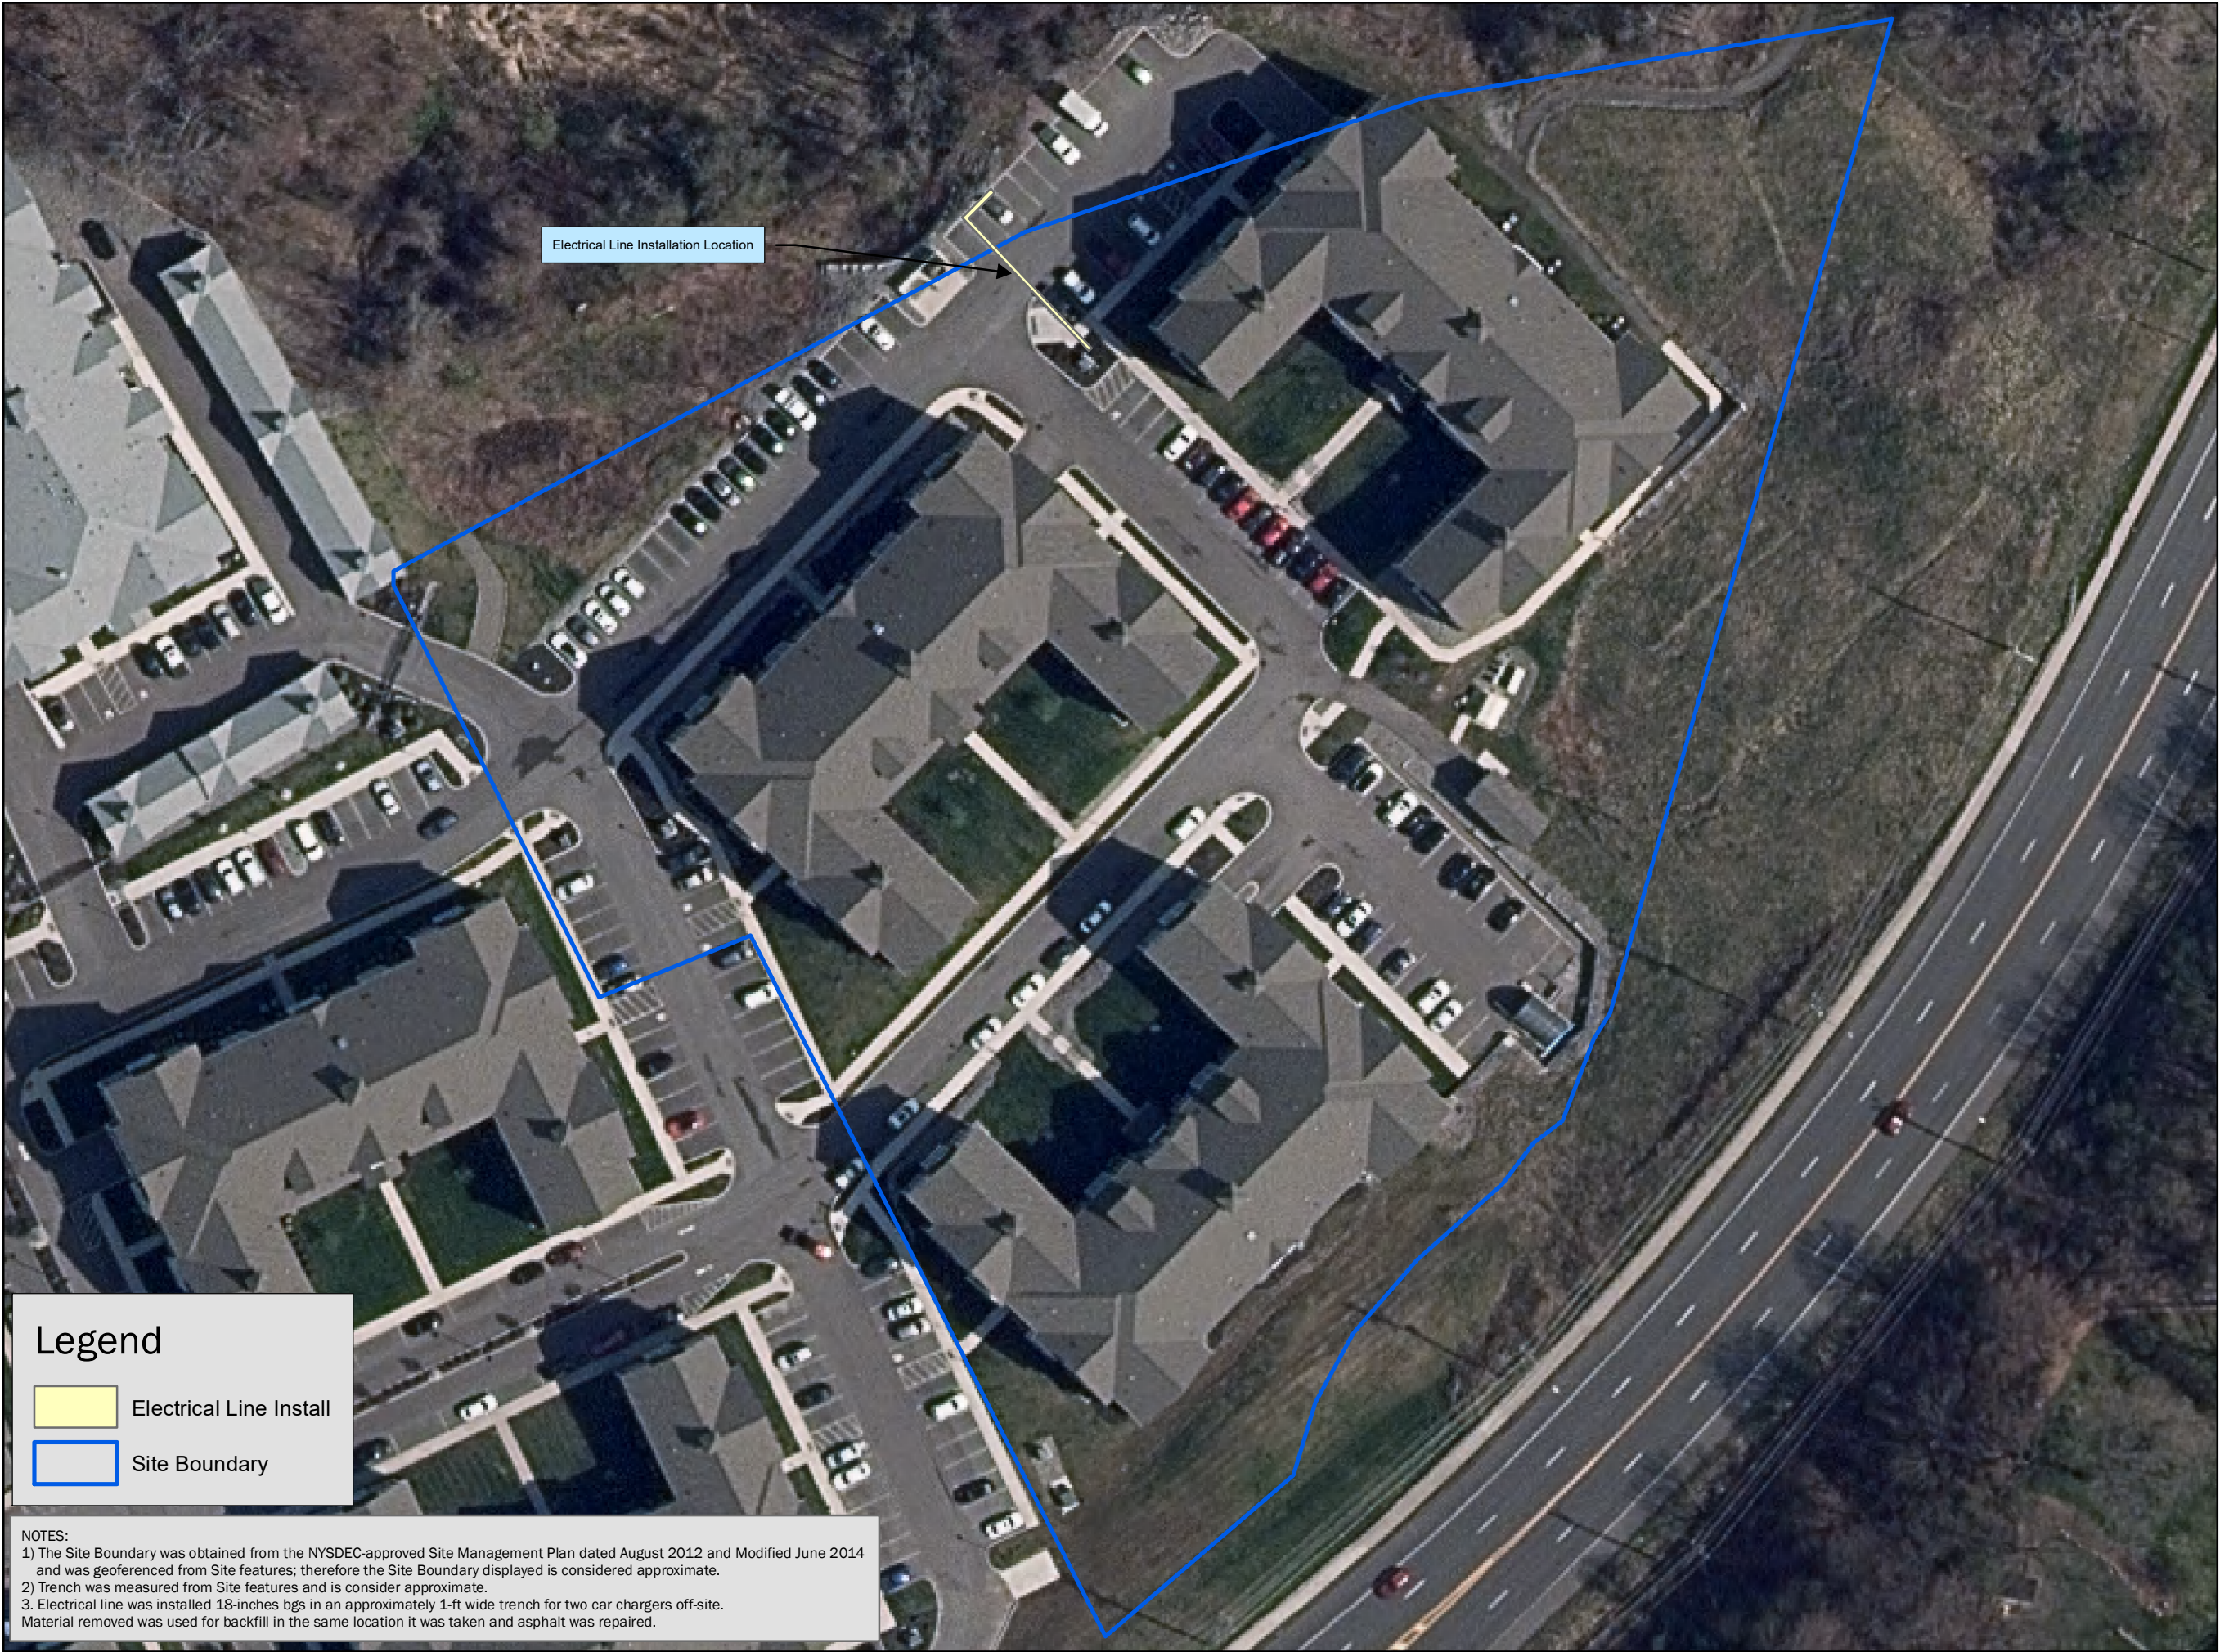
FIGURE 2

Based on the SMP and subsequent PRR updates, the location of work should have approximately 2-ft of clean cover in the area. Refer to Figure 2 showing the location of the work

NOTES:  
1) The Site Boundary was obtained from the NYSDEC-approved Site Management Plan dated August 2012 and Modified June 2014 and was georeferenced from Site features; therefore the Site Boundary displayed is considered approximate.  
2) Trench was measured from Site features and is consider approximate.  
3. Electrical line was installed 18-inches bgs in an approximately 1-ft wide trench for two car chargers off-site. Material removed was used for backfill in the same location it was taken and asphalt was repaired.

- length and 1-ft wide to a depth of 18-inches below ground surface (bgs).
- The trench was completed proximate to the transformer through a garden bed and asphalt parking lot area.
- No demarcation layer was encountered during the work.
- Material was temporarily staged next to the trench and backfilled in the same locations it was taken out.
- No material was imported to site for backfill or removed from the Site during the work.
- Following installation, the asphalt was repaired.

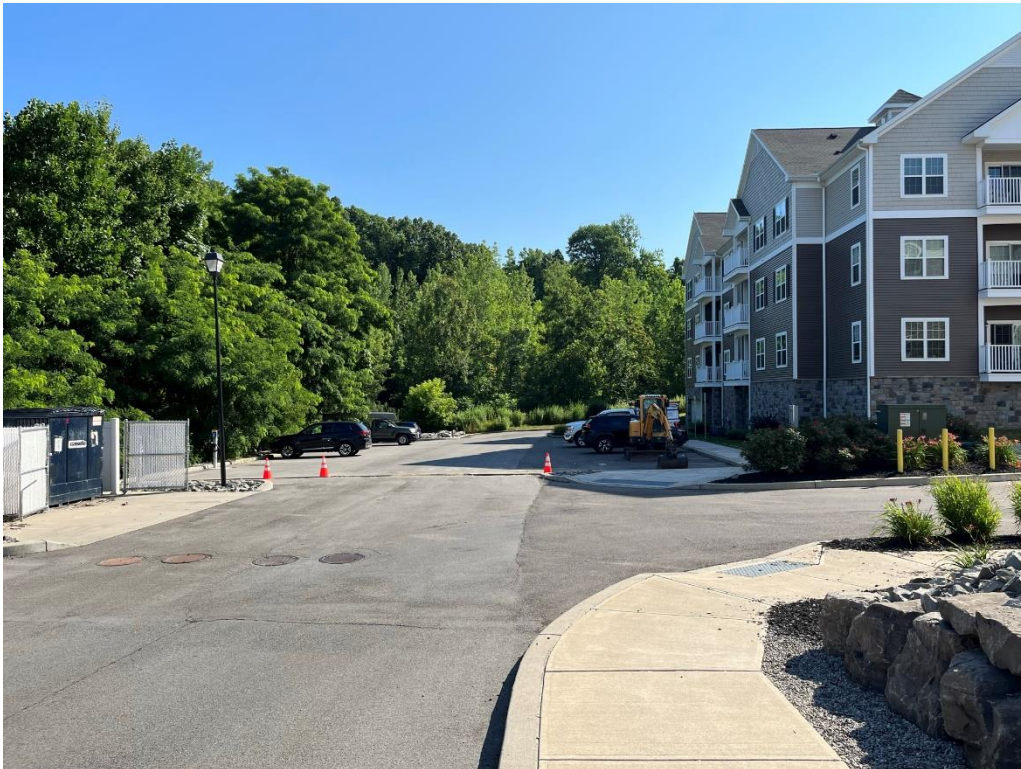
Small trench shaped cut in asphalt near northern portion of site boundary, will follow up with owner to determine work completed.

Photo 12 (7/15/22): View facing northeast taken with building 900 (right). Small trench location center in asphalt.

It was reported that an electrical line was installed for a electric car charger which involved minor excavation (i.e., no demarcation was encountered and excavation was 18-inches deep). The excavated material was placed back in the same trench from which it was removed and the asphalt was repaired.
