# **2021 Annual Report**

### G.W. Lisk Facility

NYSDEC Site Number C835026

15 April 2022

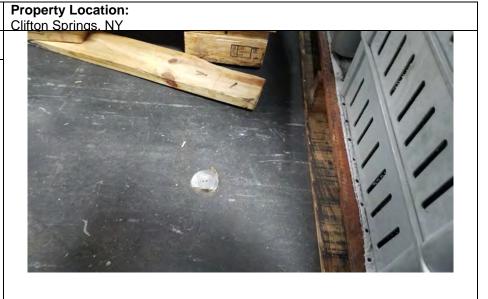
Property ID:
GW Lisk
Photo #:6
Date: 15February-2021
Description:

Building 4A –Sub-slab sampling point – needs repair.

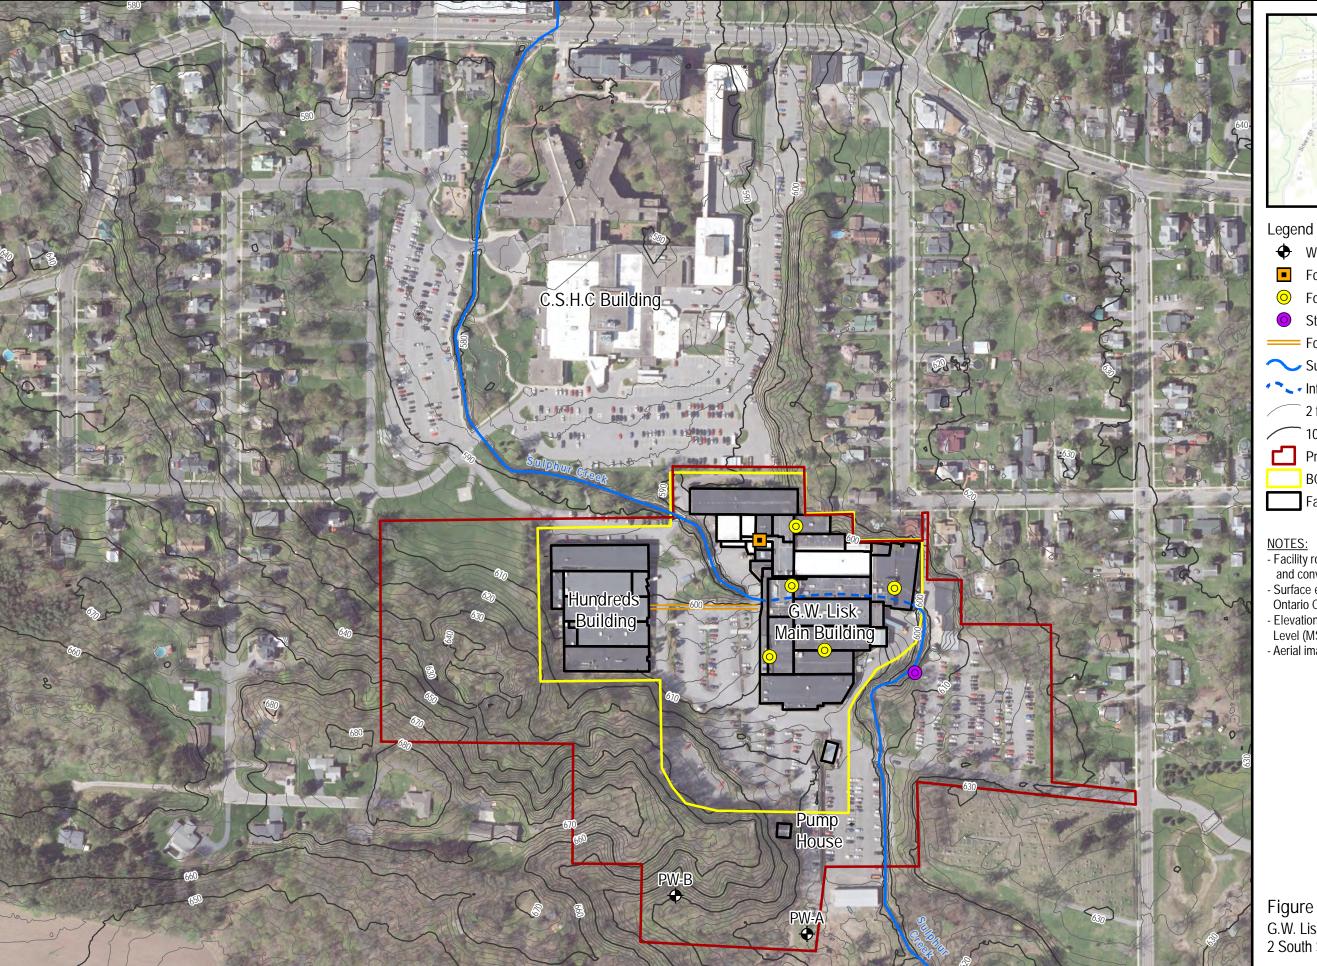
Figure 2: Site Layout Map G.W. Lisk Company, Inc. 2 South Street, Clifton Springs, NY ERM

The Site is located in the south-central portion of the Village of Clifton Springs in Ontario County, New York. Figure 1 shows the location of the Site and adjacent areas. Figure 2 shows the layout and land use of the Site including the parcel boundary and surrounding areas.
