**RE: UST CLOSURE REPORT
TENNECO PACKAGING, MACEDON, NY**

**SITE ASSESSMENT AND CLOSURE
OF TWO CHEMICAL BULK STORAGE TANKS
CBS Registration NO. 8-00025**

FINAL REPORT

**TENNECO PACKAGING
MACEDON FACILITY**

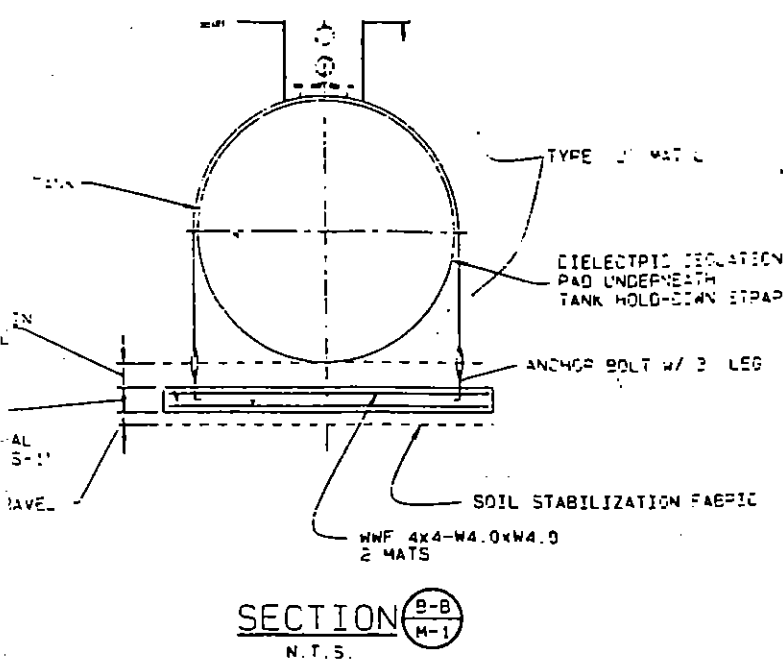
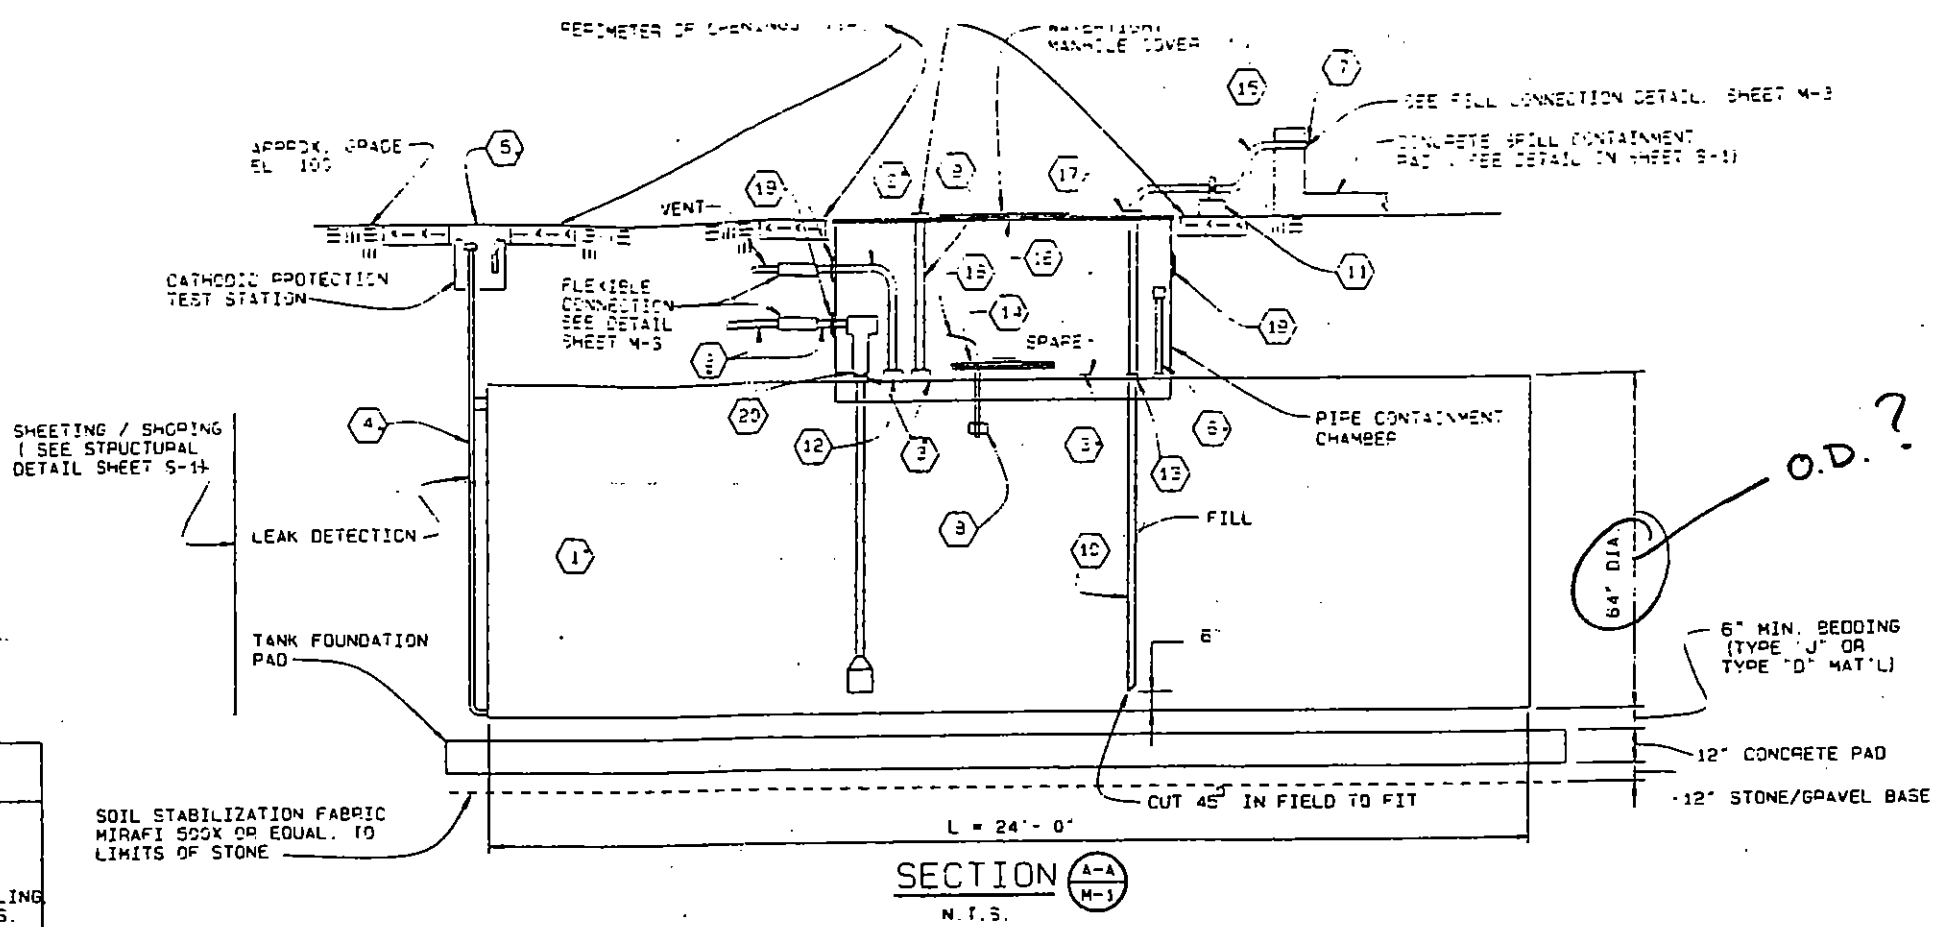
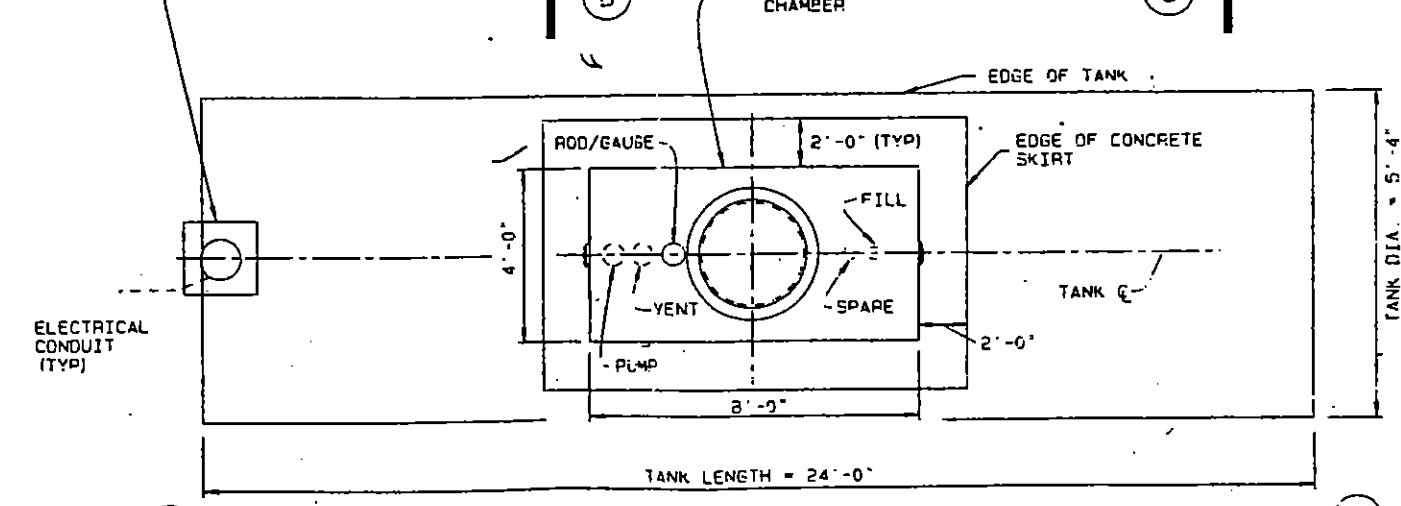
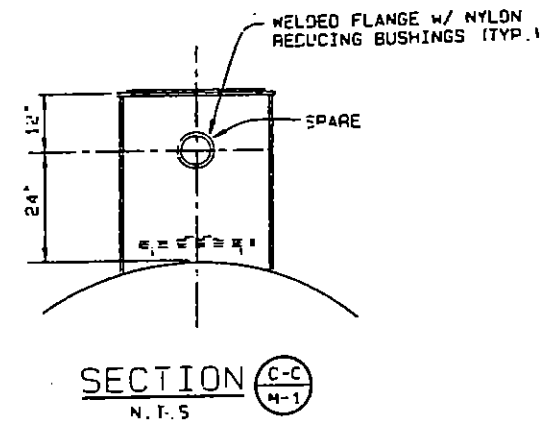
SOLVENT TANK DETAILS

QUANTITY	DESCRIPTION
5 PER'D.	4000 GAL. UNDERGROUND TANK WITH PROTECTIVE COATING CATHODIC PROTECTION SYSTEM AND TESTING STATION UL APPROVED ELECTRICAL ISOLATION OF ALL OPENINGS. LIFTING LUGS, INTEGRAL PIPING CONTAINMENT CHAMBER, LABELING ETC AS SPECIFIED, SCHEDULED, AND SHOWN ON CONTRACT DWGS.
2/TANK	2" DIA. EPOXY RESIN PIPE AND FITTINGS, SUPPLY AND VENT WITH 3" DIA. EPOXY RESIN PIPE AND FITTINGS SECONDARY CONTAINMENT, SECONDARY CONTAINMENT PIPING TERMINATES AT CONNECTION TO PIPING CONTAINMENT CHAMBER.
1/TANK	5" TH'D. CONNECTION WITH 5" x 4" DIELECTRIC BUSHING PROVIDE TH'D PLUG ON SPARE CONNECTION.
1/TANK	2" DIA. STEEL LEAK DETECTION PROBE RISER, PROBE CONNECTION TO BE NEAR SURFACE, LEAK DETECTION PROBE TO BE POLLULERT MODEL FD221PA.
1/TANK	EMCO WHEATON SEALED MANHOLE MODEL #A719-002 OR APPROVED EQUAL
1/TANK	2" RISER PIPE TO BE INSTALLED AT LOW POINT IN FLOOR OF PIPING CONTAINMENT CHAMBER, RISER PIPE TO BE INSTALLED WITH LEAK DETECTION SENSOR PROBE, POLLULERT MODEL FD241PRA.

1/TANK	3" DIA. CAMLOCK DRY DISCONNECT FILL CONNECTIONS, MALE END, SUPPLY WITH DUST CAP CHAINED TO PIPING.
1/TANK	HIGH LEVEL ALARM SWITCH, GEMS MODEL LSP-54000 WITH KYNAR FLOAT AND STEM, SWITCH NO. 63725, OR APPROVED EQUAL.
1/TANK	4" DIA. SCHEDULE 30 TYPE 316L STAINLESS STEEL RISER LENGTH TO SUIT, RISERS TO BE ONE PIECE.
1/TANK	SEYFERTH MFG. INC. 3" DIA. SUBMERGED, REMOVABLE DROP TUBE, CUT IN FIELD TO LENGTH REQUIRED.
AS PER'D.	PIPE SUPPORTS FOR 3" DIA. FILL PIPES SEE DETAIL SHEET G-6.
1/TANK	3" DIA. HALF COUPLING WITH 3" x 2" DIELECTRIC BUSHING ON TOP
1/TANK	4" DIA. FULL COUPLING WITH 4" x 3" DIELECTRIC THREADED BUSHINGS ON EACH SIDE
1/TANK	24" I.D. TANK MANHOLE WITH HANDLES AND BOLTED COVER
AS PER'D.	3" DIA. THREADED GALVANIZED STEEL FILL PIPING AND FITTINGS
1/TANK	30" DIA. WATERTIGHT MANHOLE COVER AND GASKET, TO BE PROVIDED BY TANK MANUFACTURER.
1/TANK	WELDED FLANGED WITH 4" x 3" DIELECTRIC COUPLING

AS PER'D.	CABLE FOR HIGH LEVEL ALARM SWITCH, CONNECT TO HIGH LEVEL ALARM PANEL, INSTALL W/ SLACK IN CABLE FOR MANHOLE OPENING
3/TANK	WELDED FLANGE WITH 4" x 3" DIELECTRIC REDUCING BUSHINGS
1/TANK	RED JACKET DISMANTLEABLE PUMP MODEL LP23RI PROVIDED WITH RED JACKET INTEGRAL LEAK DETECTOR

In May 1987, two 4,000 gallon underground storage tanks (USTs) were installed at the facility now owned by Tenneco Packaging in Macedon, New York. Both tanks were manufactured by Buffalo Tank Corporation, model P340 DW 360. The double walled underground tank design included protective coating, cathodic protection system, testing station, UL approved electrical isolation of all openings, lifting lugs, integral piping containment chamber, and labeling as specified in contract drawings provided in Appendix B. Detailed specifications of the tank excavation and spill containment pad are also included in the Appendix B drawings. The only significant difference between the plan drawings and the actual tank installation was that only two tanks were installed instead of the three shown on the drawing.

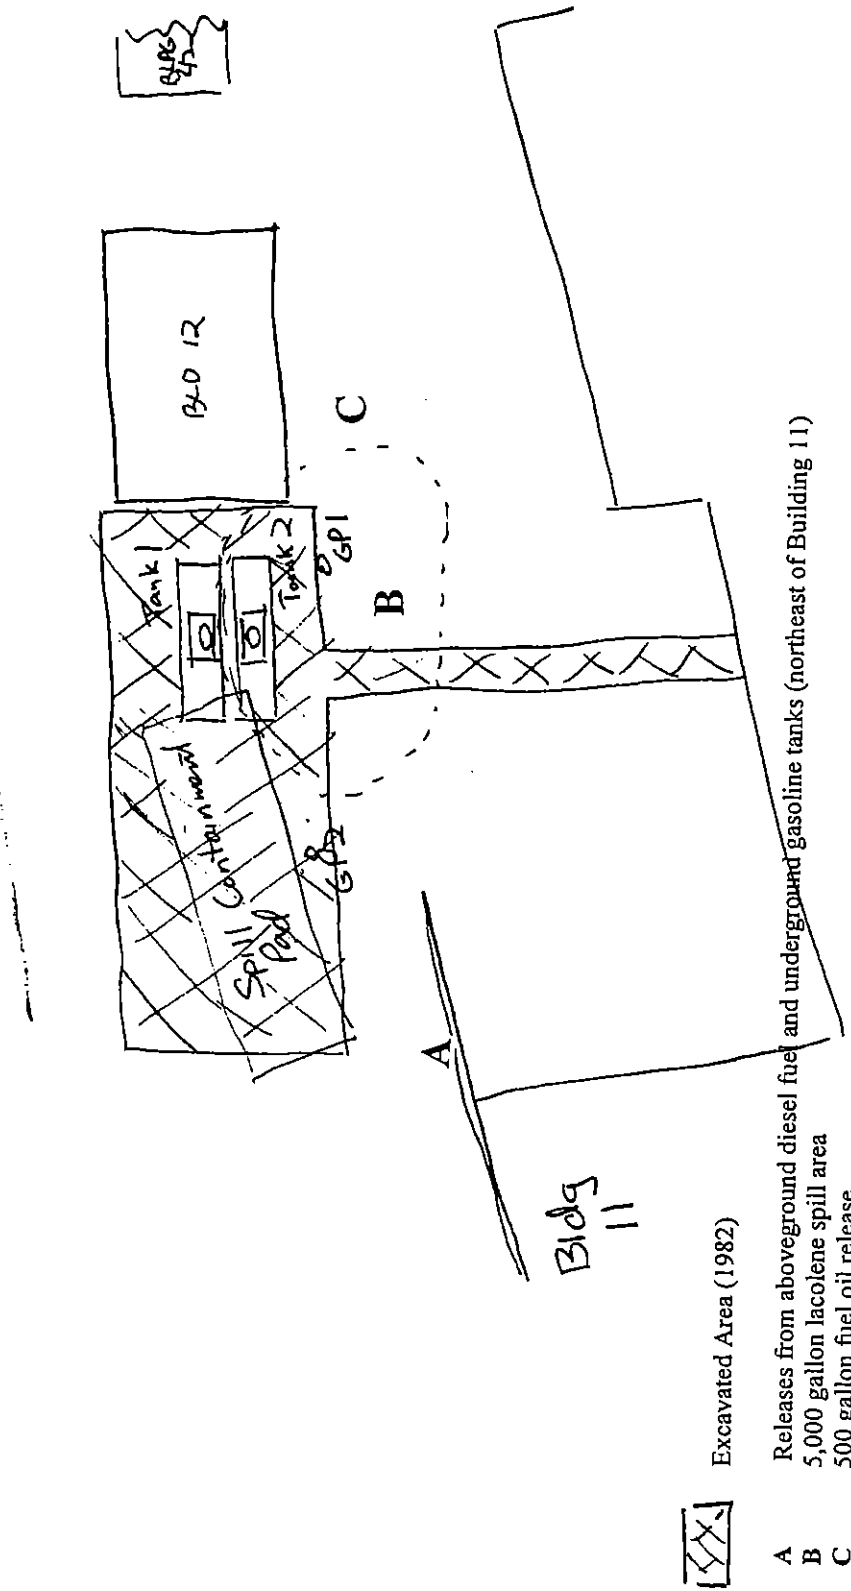
SITE SCHEMATIC
 Tank Closure Area and Approximate Location of Historical Releases
 Tenneco Packaging
 Macedon, NY

The schematic provided in Appendix C depicts the approximate location of these releases with respect to the recently closed tanks. Documentation for past excavation activities at the site indicated that soil excavation limits were generally based on visual observations rather than confirmatory sampling. Therefore, there is potential for residual contamination to be present from the historical releases in these areas.

- A Releases from aboveground diesel fuel and underground gasoline tanks (northeast of Building 11)
- B 5,000 gallon lacolene spill area
- C 500 gallon fuel oil release

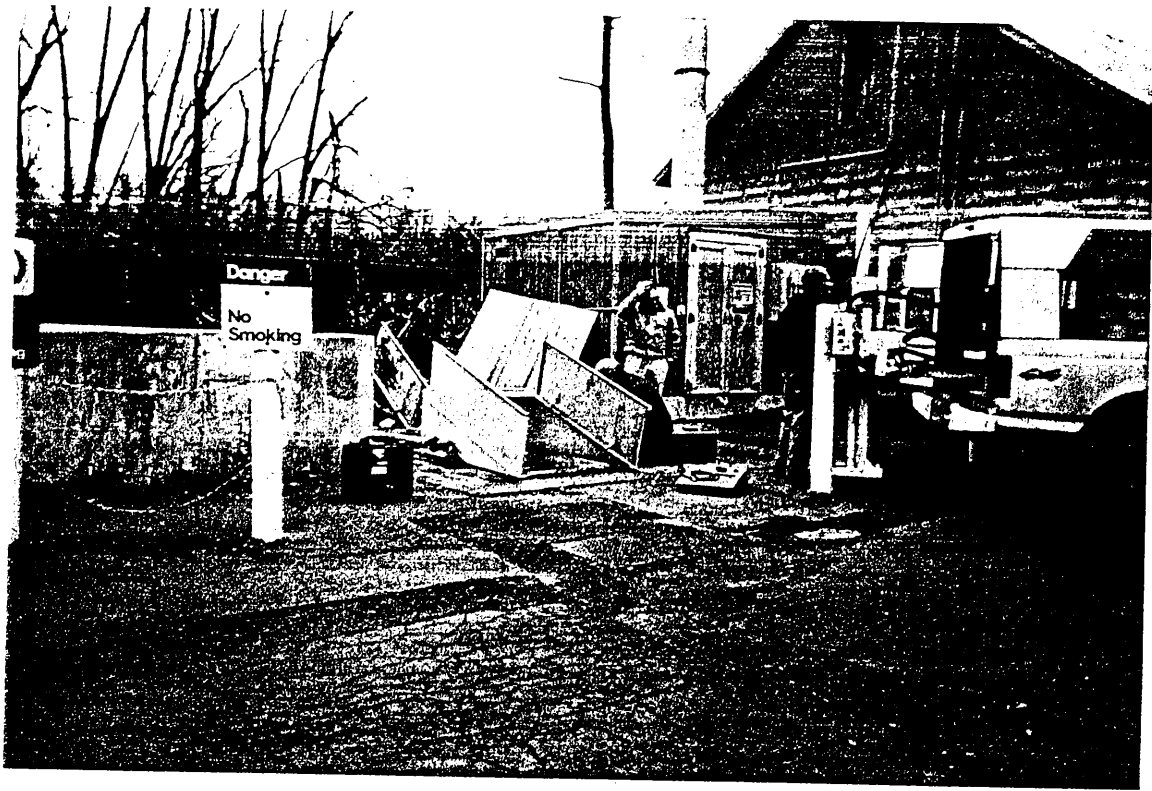
(1)

Photo #	Date	Description
1	11/16/98	Site setup which shows location of tanks, piping, vents, and first Geoprobe [®] sample location.
2	11/16/98	Site setup.
3	11/16/98	Geoprobe [®] sample location number two.
4	11/16/98	Sample core from location number two.
5	11/16/98	View from inside Tank 1.
6	11/16/98	View from inside Tank 1.
7	11/16/98	View from inside Tank 1.
8	11/16/98	View from inside Tank 1.
9	11/16/98	View from inside Tank 1.
10	11/16/98	View from inside Tank 2.
11	11/16/98	View from inside Tank 2.
12	11/16/98	View from inside Tank 2.
13	11/16/98	View from inside Tank 2.
14	11/16/98	View from inside Tank 2.
15	11/16/98	View from inside Tank 2.
16	11/16/98	Tank entry setup.
17	11/16/98	Inside of Tank 2 view from above.
18	11/16/98	Inside of Tank 2 view from above.
19	11/17/98	Flowable fill being added to tank.
20	11/17/98	Flowable fill being added to tank.
21	11/20/98	Topped off with concrete.
22	11/20/98	Tanks filled in place and all piping removed.

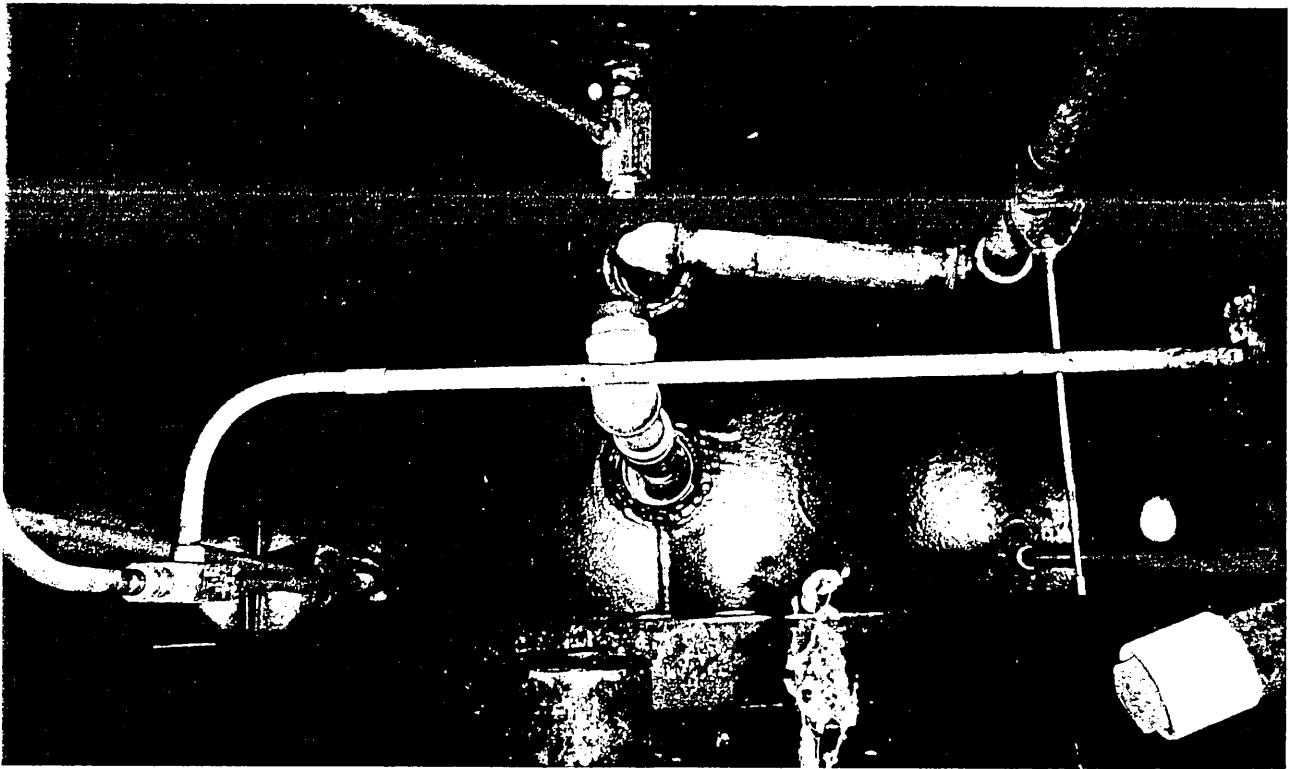
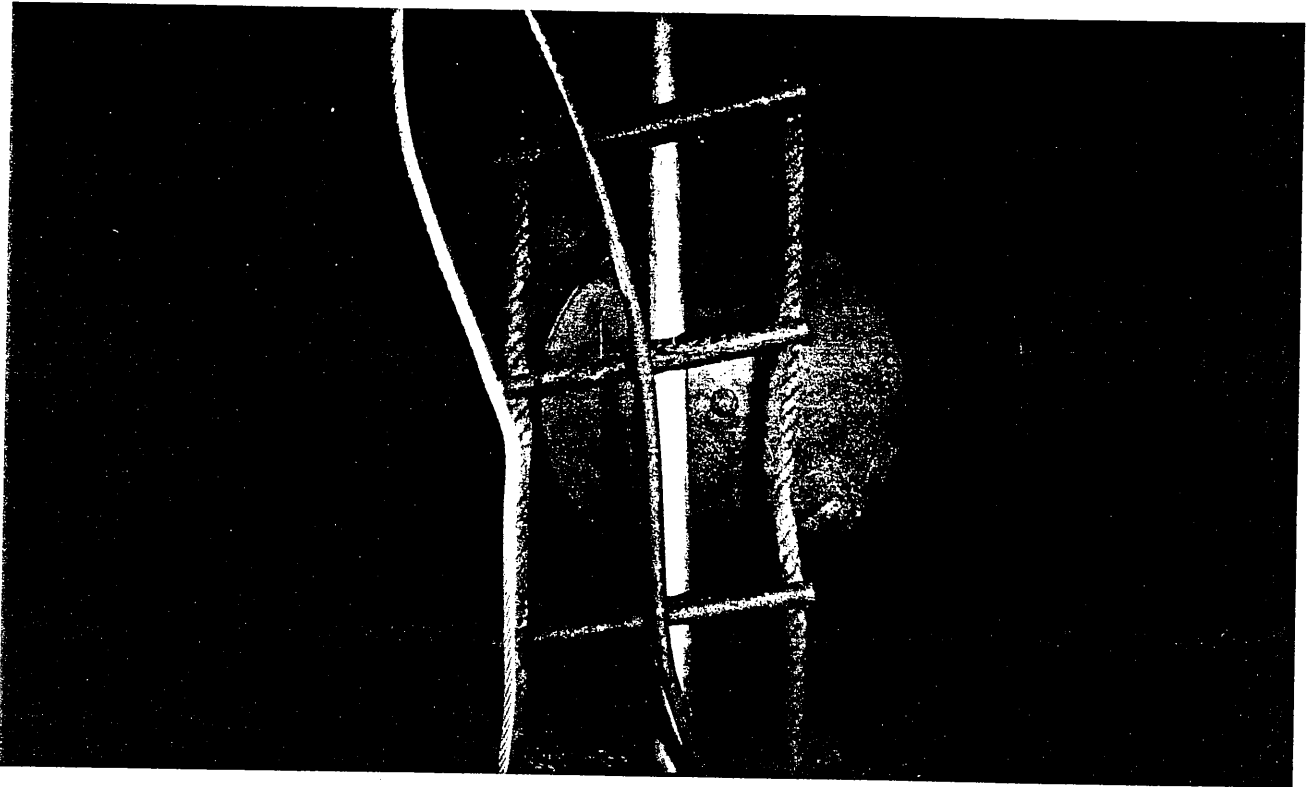
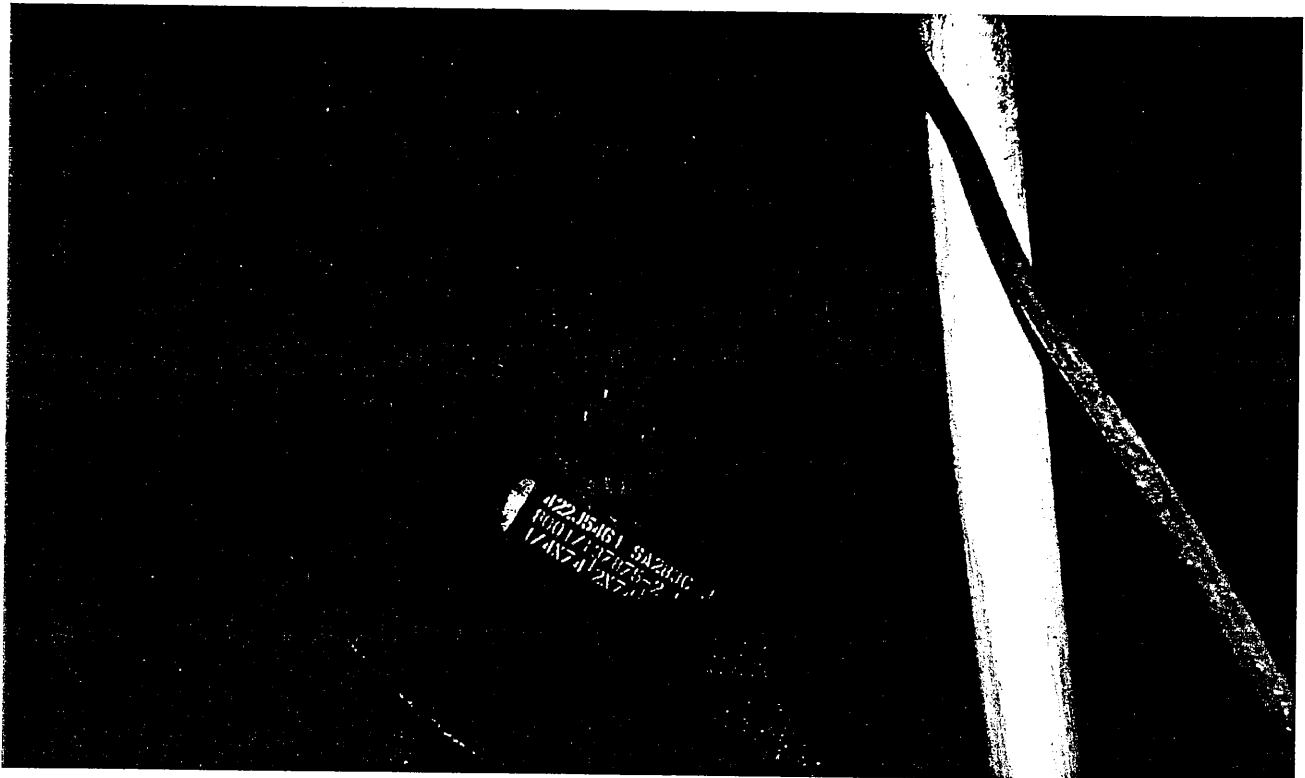
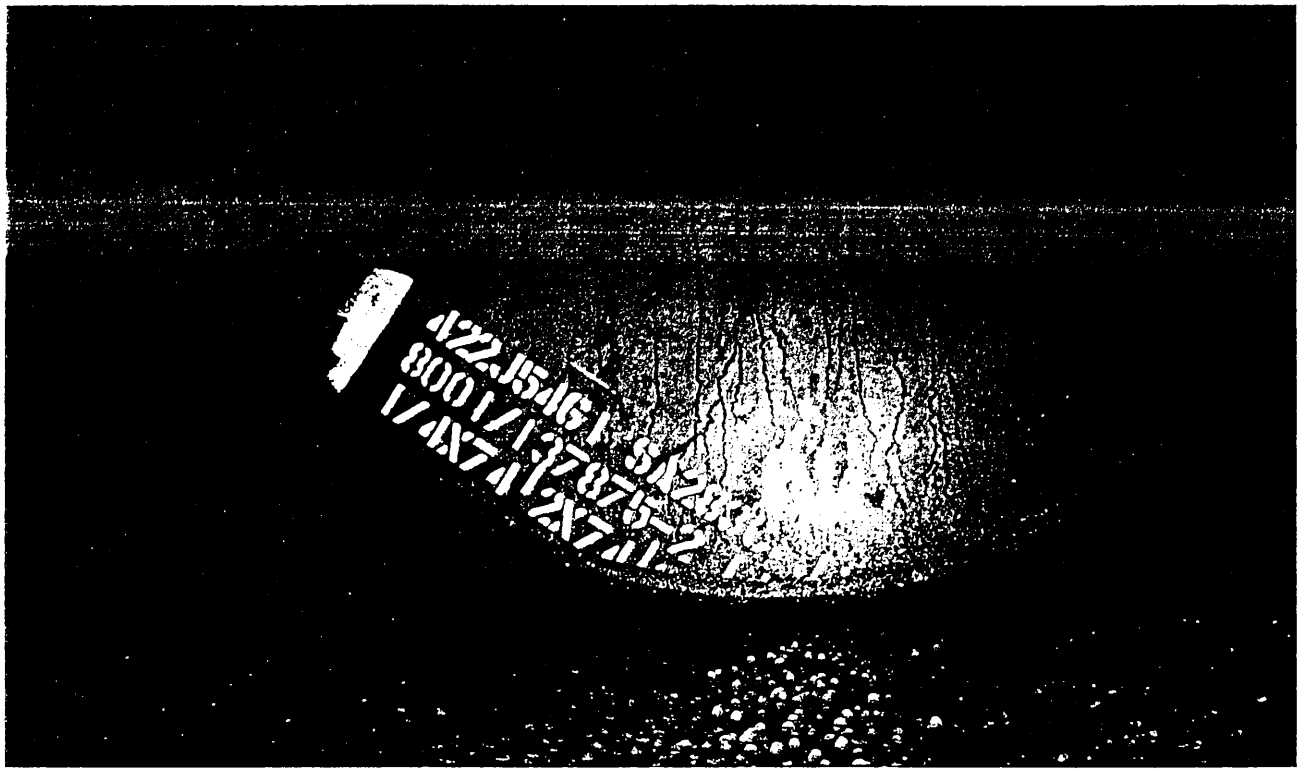
Both tanks were entered by Pete Spagnola. The inside of both tanks was in very good condition. No indications of significant corrosion or other damage were observed. See photographs 5-15. Once all piping was removed the tanks and entry vault area were filled with flowable fill (photos 19 and 20). Concrete was used to top off the flowable fill. Photographs 21 and 22 depict the finished work.

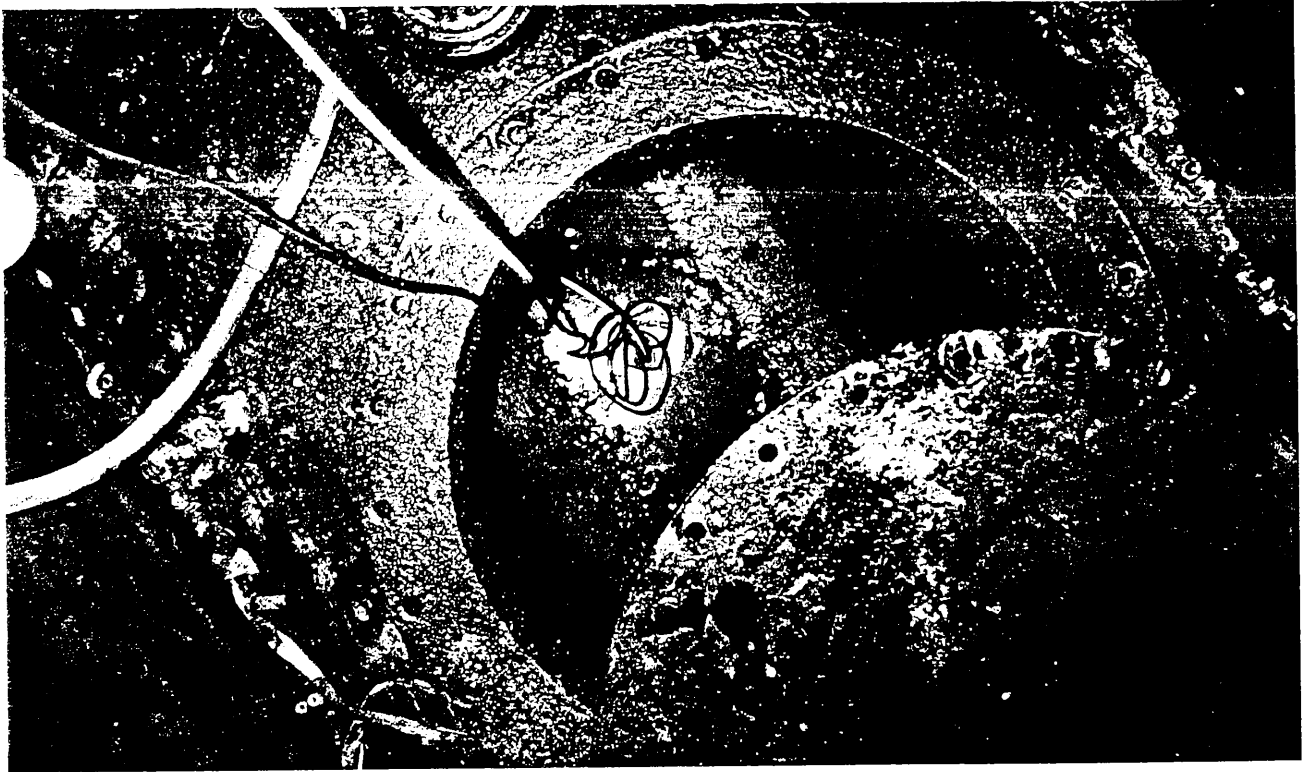
(17)

When opened, Tank 2 appeared very clean and dry. No odors were detected. When Tank 1 was opened it was observed that the tank contained several inches of water. There was also a slight sheen on the water surface. See photographs 17 and 18. The water was pumped out and drummed. The volume of water removed was less than 150 gallons. The three drums were stored in the facility's hazardous waste storage area while awaiting disposal. It is believed that the water in Tank 1 came from precipitation that entered the tank through the vapor vent. Neither the Oxygen/LEL nor OVA meters displayed significant readings to indicate the presence of volatile organic compounds.
