**Contained-In Demonstration Work Plan  
Former Allegany Bitumens Belmont  
Asphalt Plant  
Brownfield Cleanup Program  
Site # C902019  
5392 State Route 19  
Amity, Allegany County, New York**

**RE: Contained-In Demonstration Work Plan  
Brownfield Cleanup Program Site # C902019  
Former Allegany Bitumens Belmont Asphalt Plant  
5392 State Route 19, Amity, New York**

**CONTAINED-IN DEMONSTRATION WORK PLAN  
FORMER ALLEGANY BITUMENS BELMONT ASPHALT PLANT****Table of Contents**

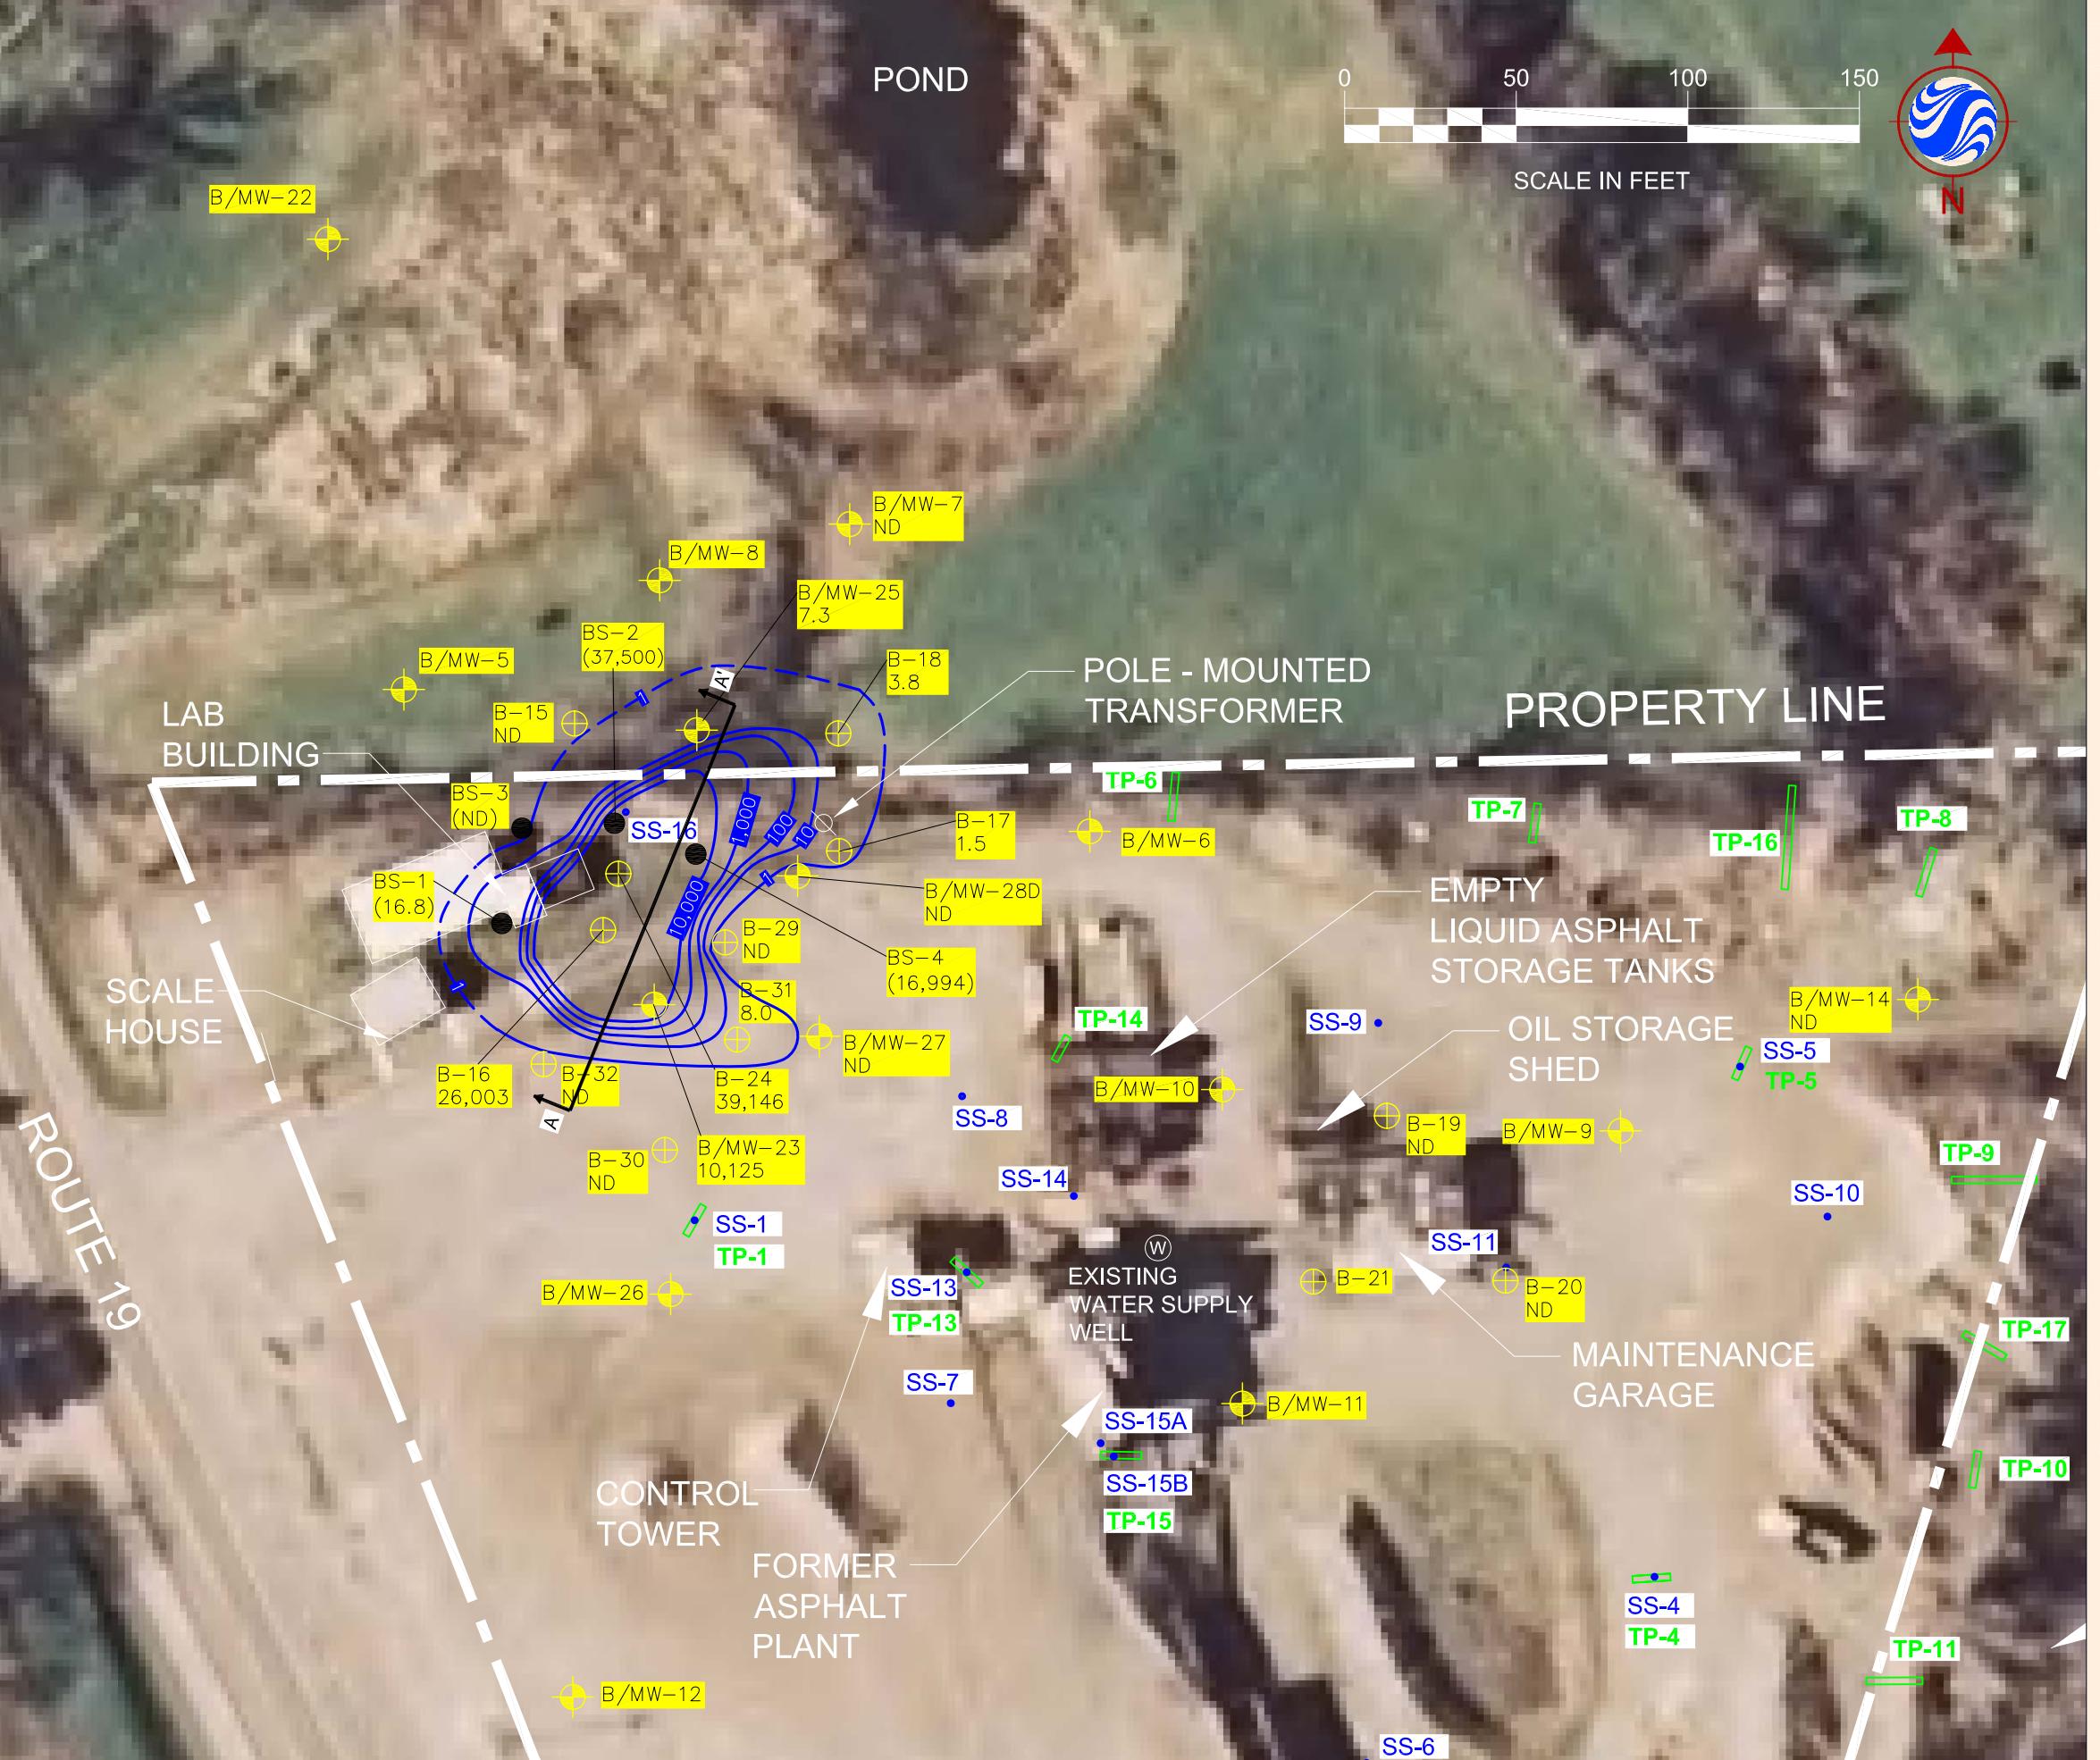
FIG. 9

| Figure 9 | Contour Map of Total Chlorinated VOC Concentrations in Soils At or Near the Water Table ( $\mu\text{g}/\text{kg}$ ), 2009-2011 |

All subsurface soil sample sampling results from the Phase II ESA and RI from the well and soil borings were well below the Commercial and Industrial SCOs. Exceedances of Part 375 POGW SCOs were reported for CVOCs in subsurface soil samples from one monitoring well and four soil borings just to the east and southeast of the laboratory building, including BS-2, BS-4, B-16, B/MW-23, and B-24 (see Table 6). Trichloroethene (TCE) concentrations in the laboratory source area ranged up to 38 ppm. Concentrations decrease significantly away from the source area (see Figure 9). The area with known exceedances of SCOs is approximately 55 ft in the north - south direction and 30 ft in the east - west direction. Based on PID readings

All subsurface soil sample sampling results from the well and soil borings were well below the Commercial and Industrial SCOs. Exceedances of Part 375 POGW SCOs were reported for CVOCs in subsurface soil samples from one monitoring well and four soil borings just to the east and southeast of the laboratory building, including BS-2, BS-4, B-16, B/MW-23, and B-24 (see Table 6). Trichloroethene (TCE) concentrations in the laboratory source area ranged up to 38 ppm. Concentrations decrease significantly away from the source area (see Figure 9). The area with known exceedances of SCOs is approximately 55 ft in the north - south direction and 30 ft in the east - west direction. Based on PID readings and soil sampling results, the estimated depth of the contaminated soil interval in the source area is approximately 4 to 15 ft bgs (see Figure 10).

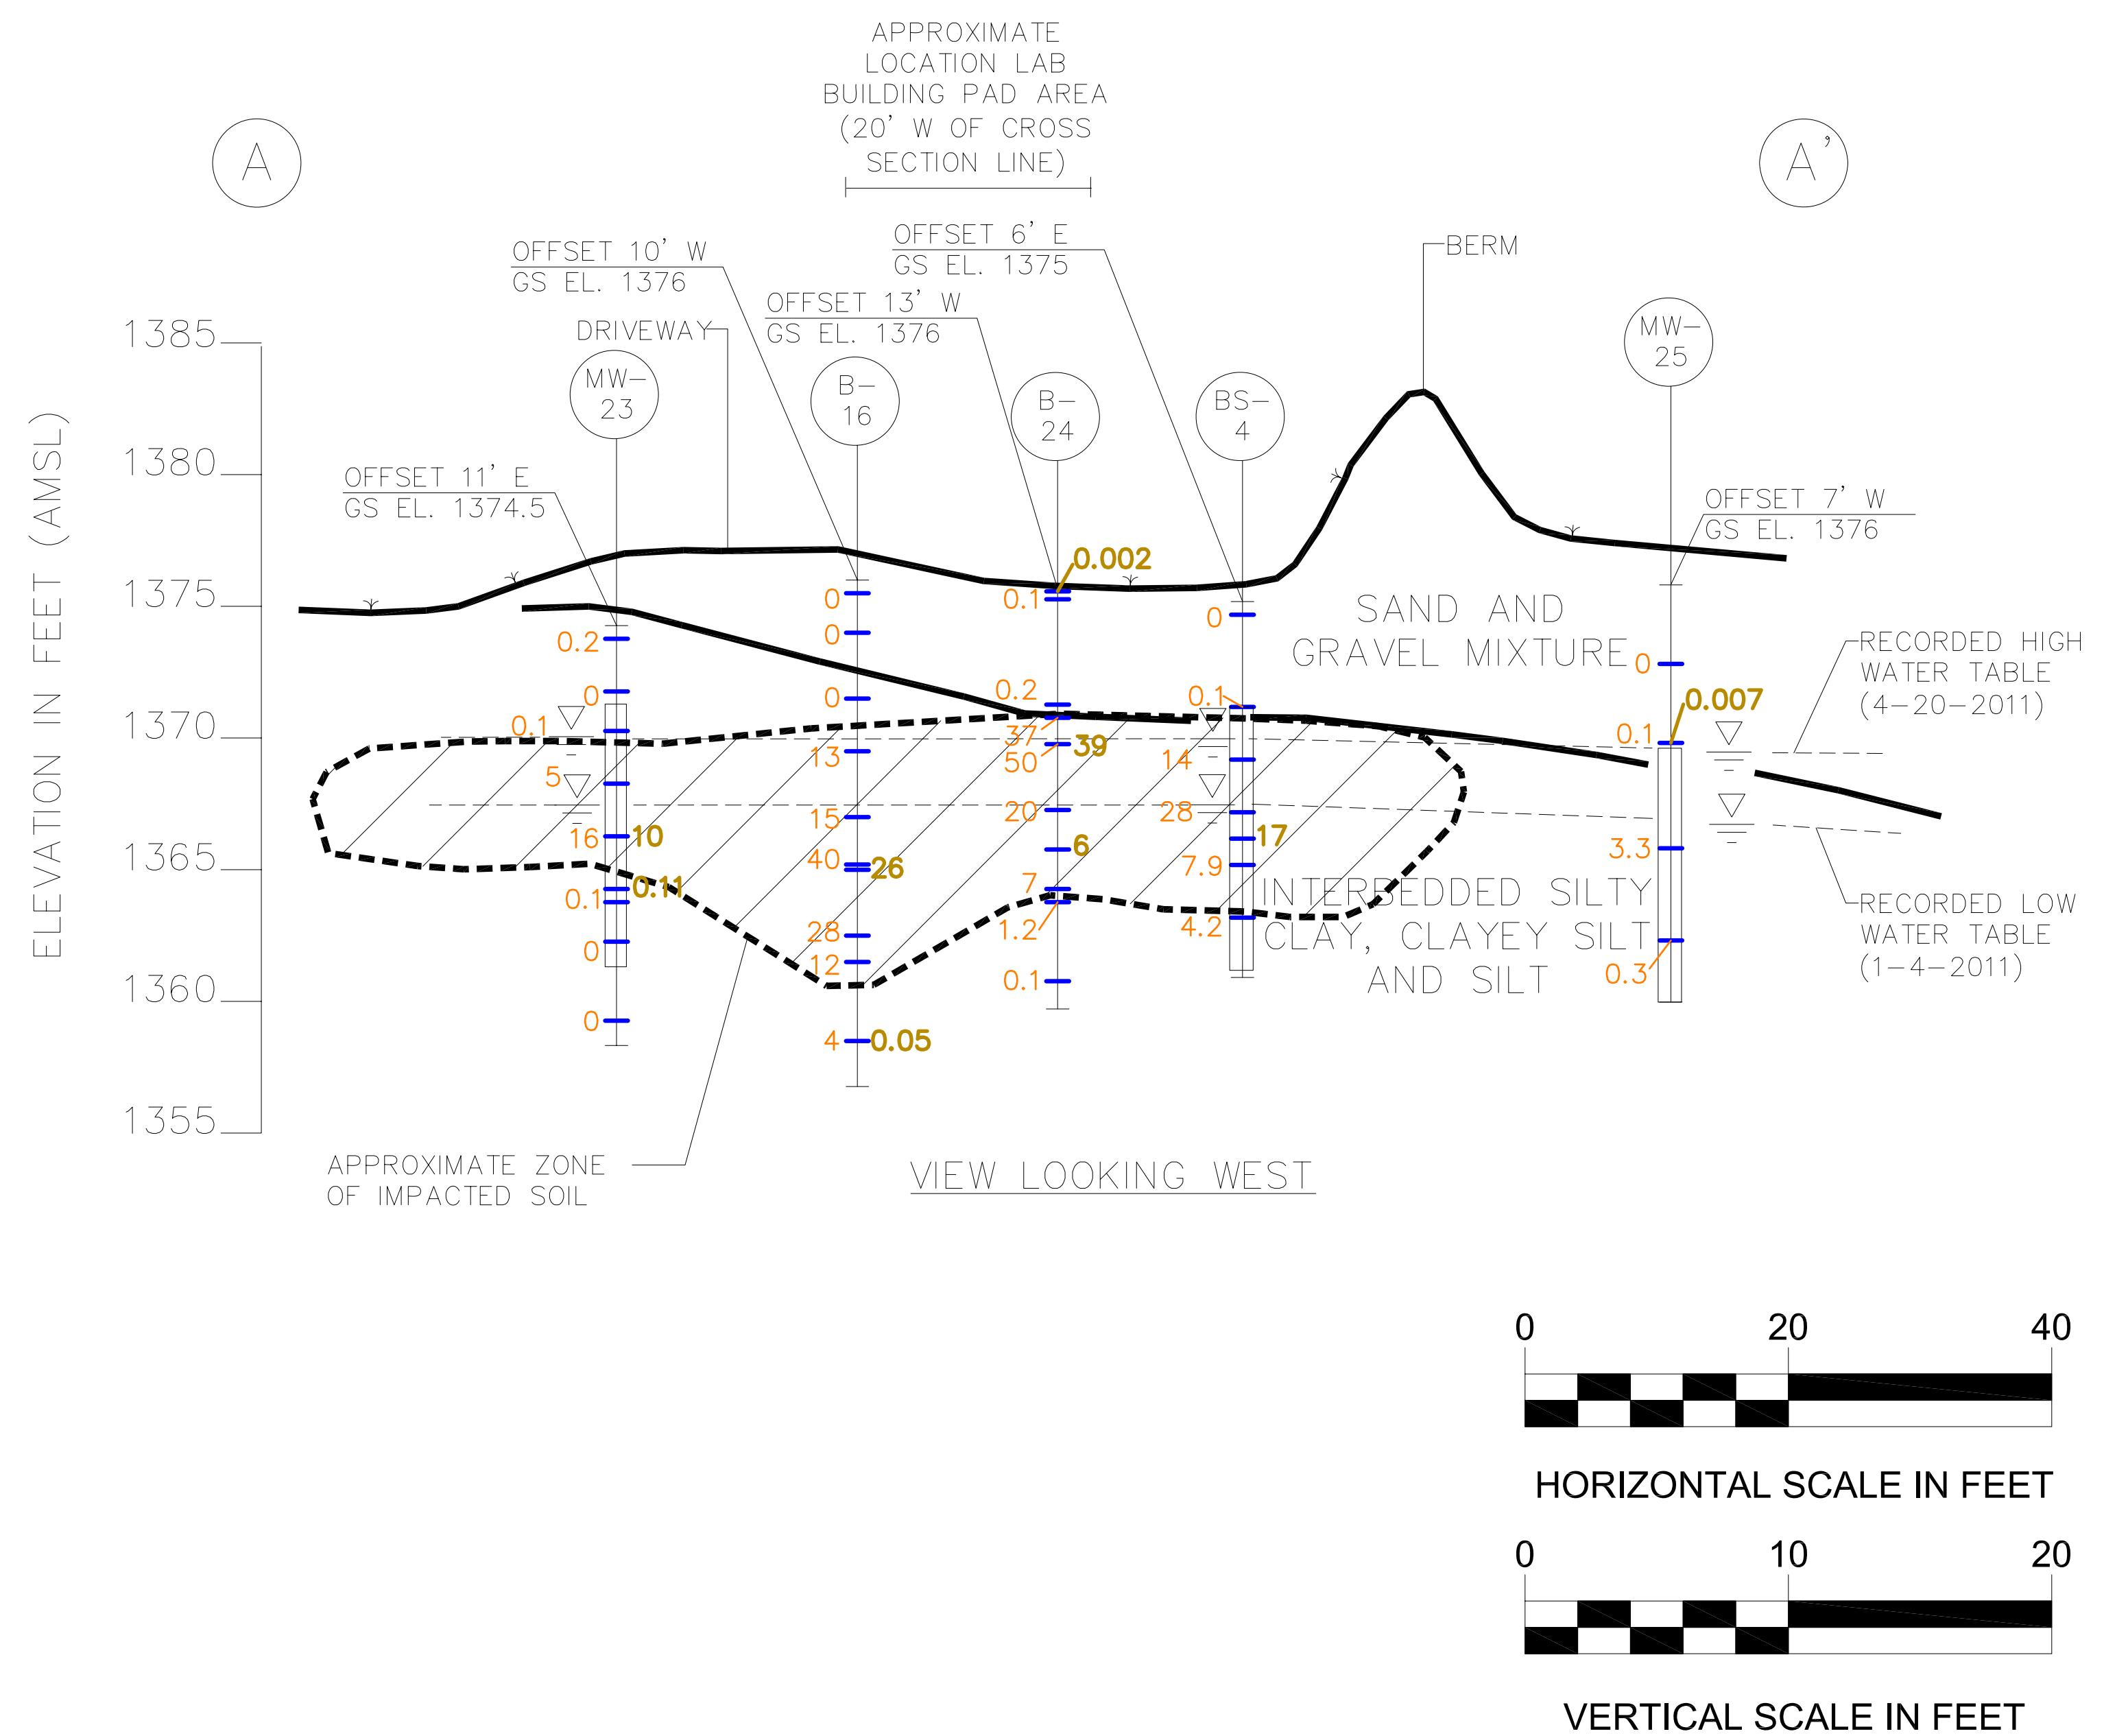
NOTE:  
SEE FIGURE 9 FOR THE LOCATION OF CROSS SECTION A-A

| Figure 10 | Cross Section of Soil Conditions in Laboratory Area |

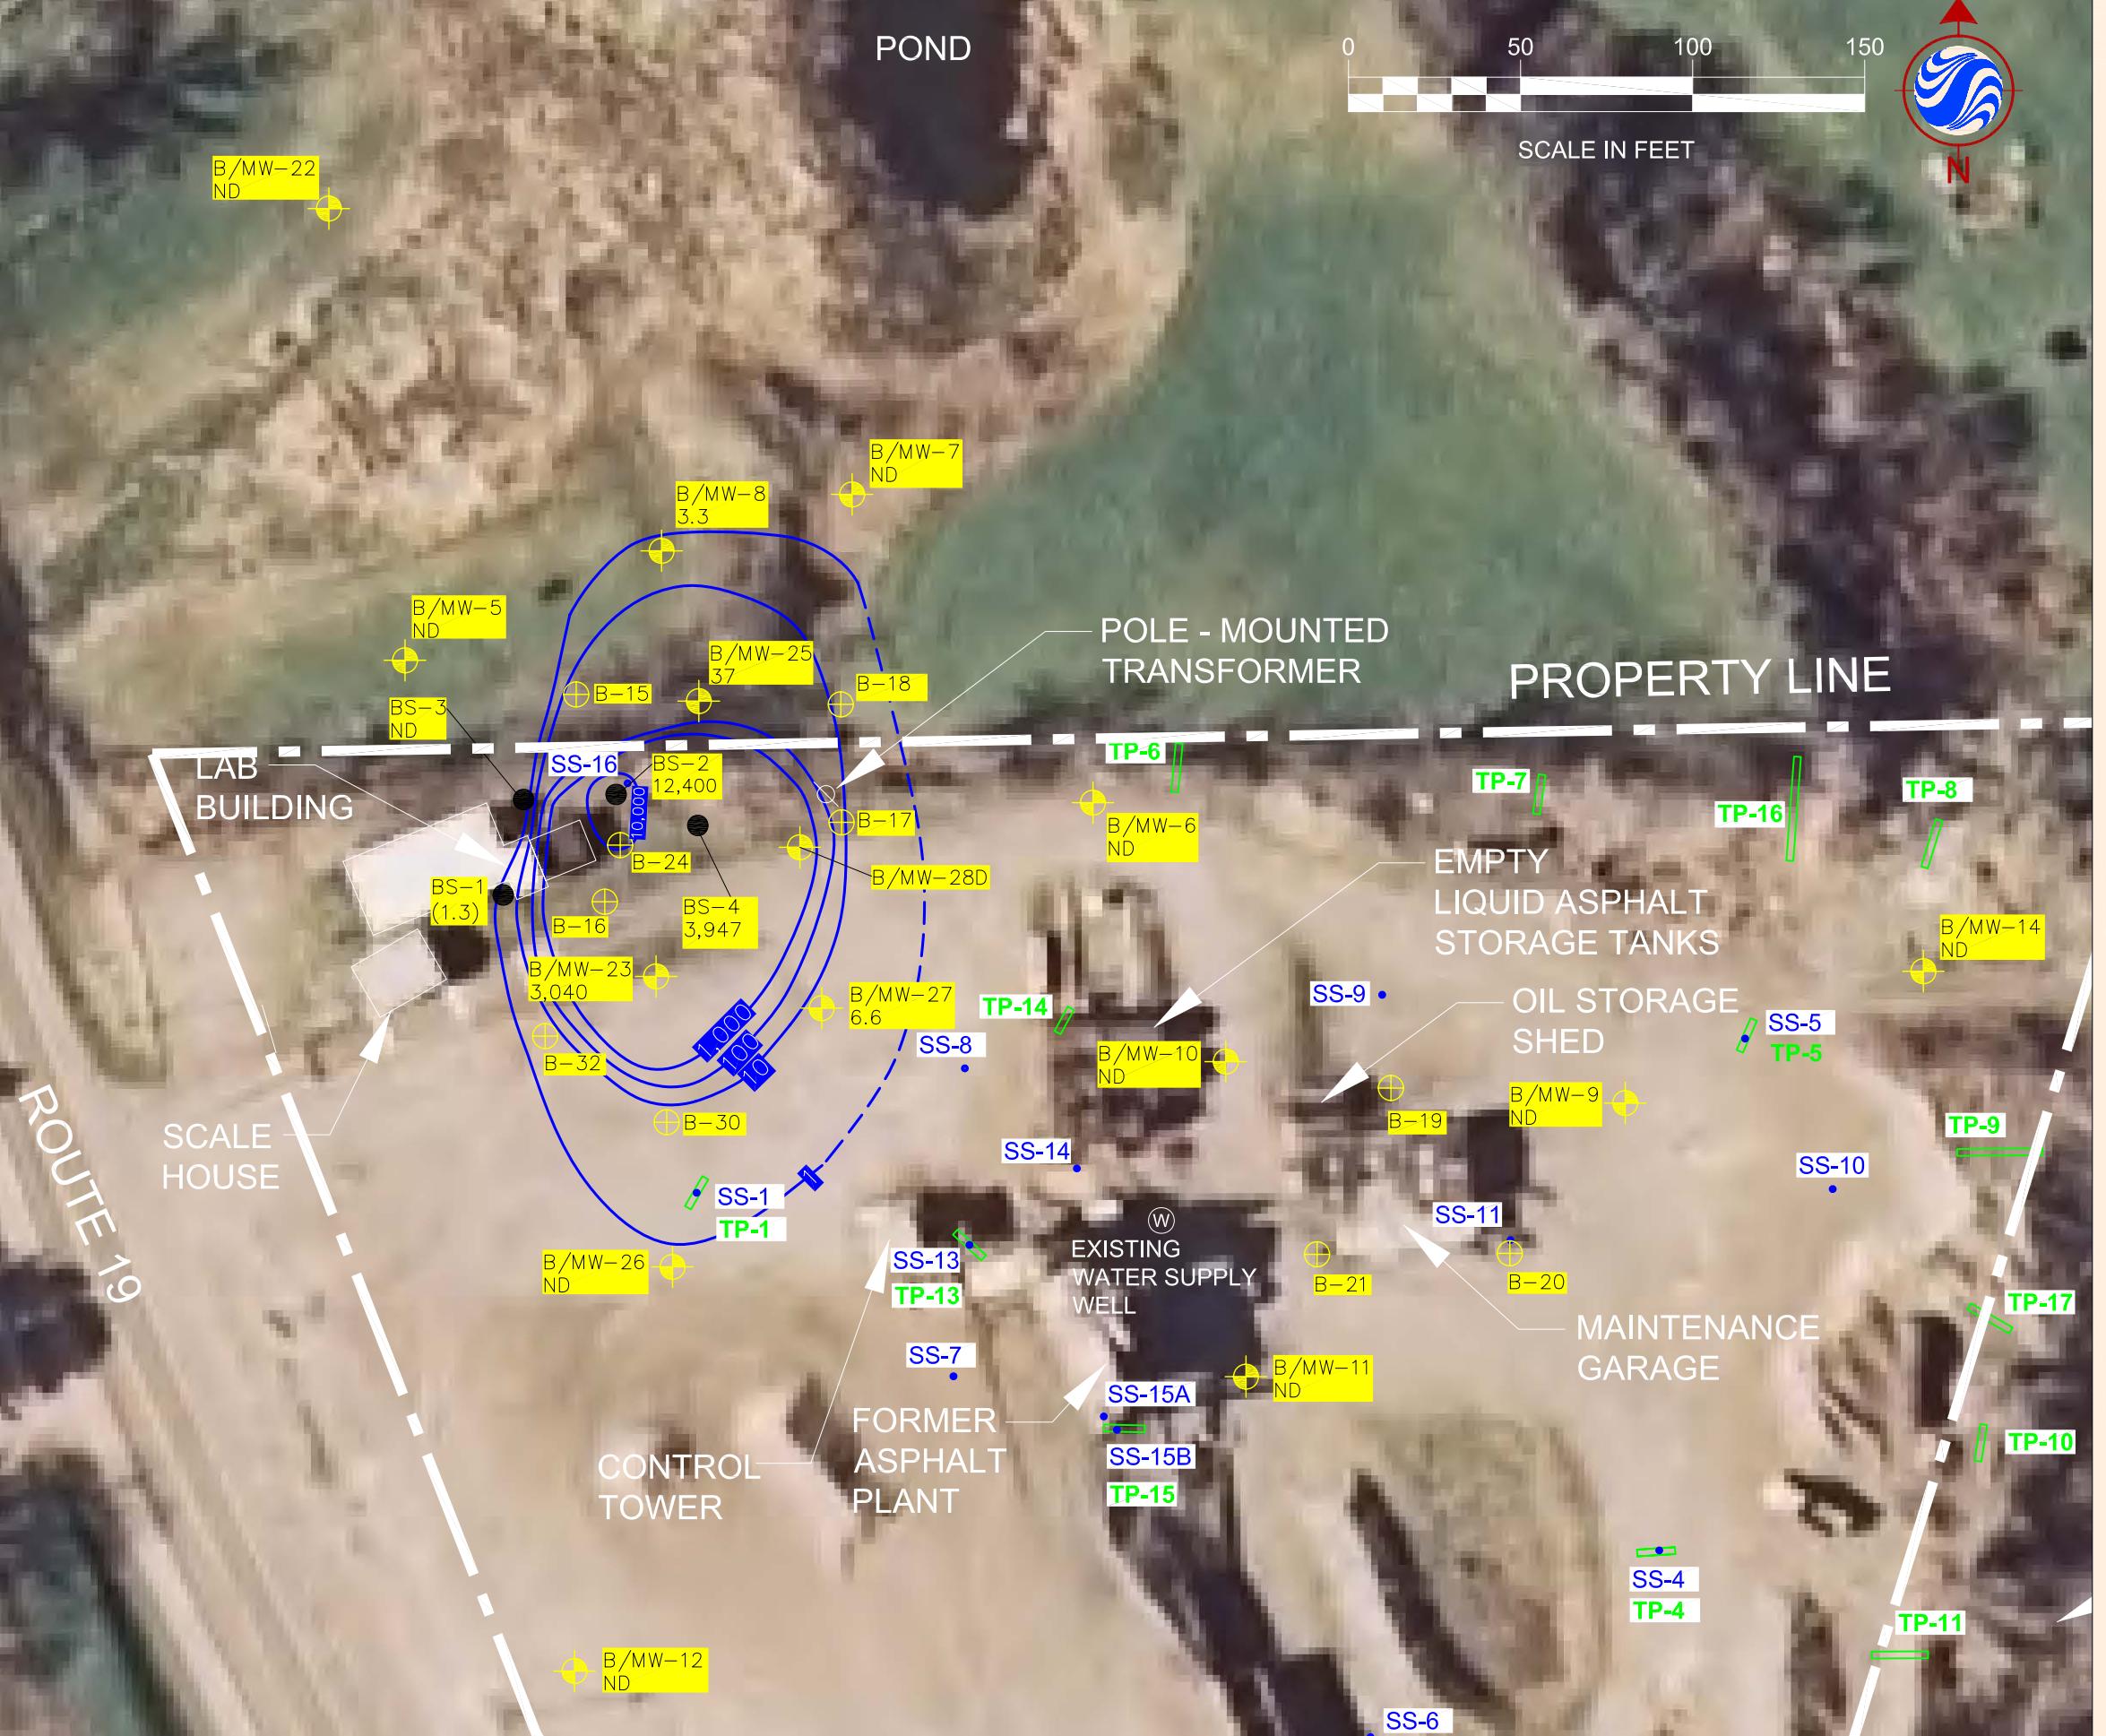
FIG. 11 Revision

| Figure 11 | Contour Map of Total Chlorinated VOC Concentrations in Shallow Groundwater ( $\mu\text{g}/\text{L}$ ), Jan. – Feb. 2011 |

File Name: Figure 11 Contour Map of Total VOC Concentrations in Groundwater-R811.dwg

Two rounds of groundwater sampling were conducted with the first round occurring in January - February 2011. Exceedances of groundwater standards were reported for chlorinated VOCs at four locations at, and downgradient from, the laboratory source area (BS-2, BS-4, MW-23, and MW-25) with total chlorinated ethene and ethane concentrations, predominantly TCE, ranging up to 12.4 ppm. The highest concentrations were at BS-2 and BS-4 (see Table 7 and Figure 11).

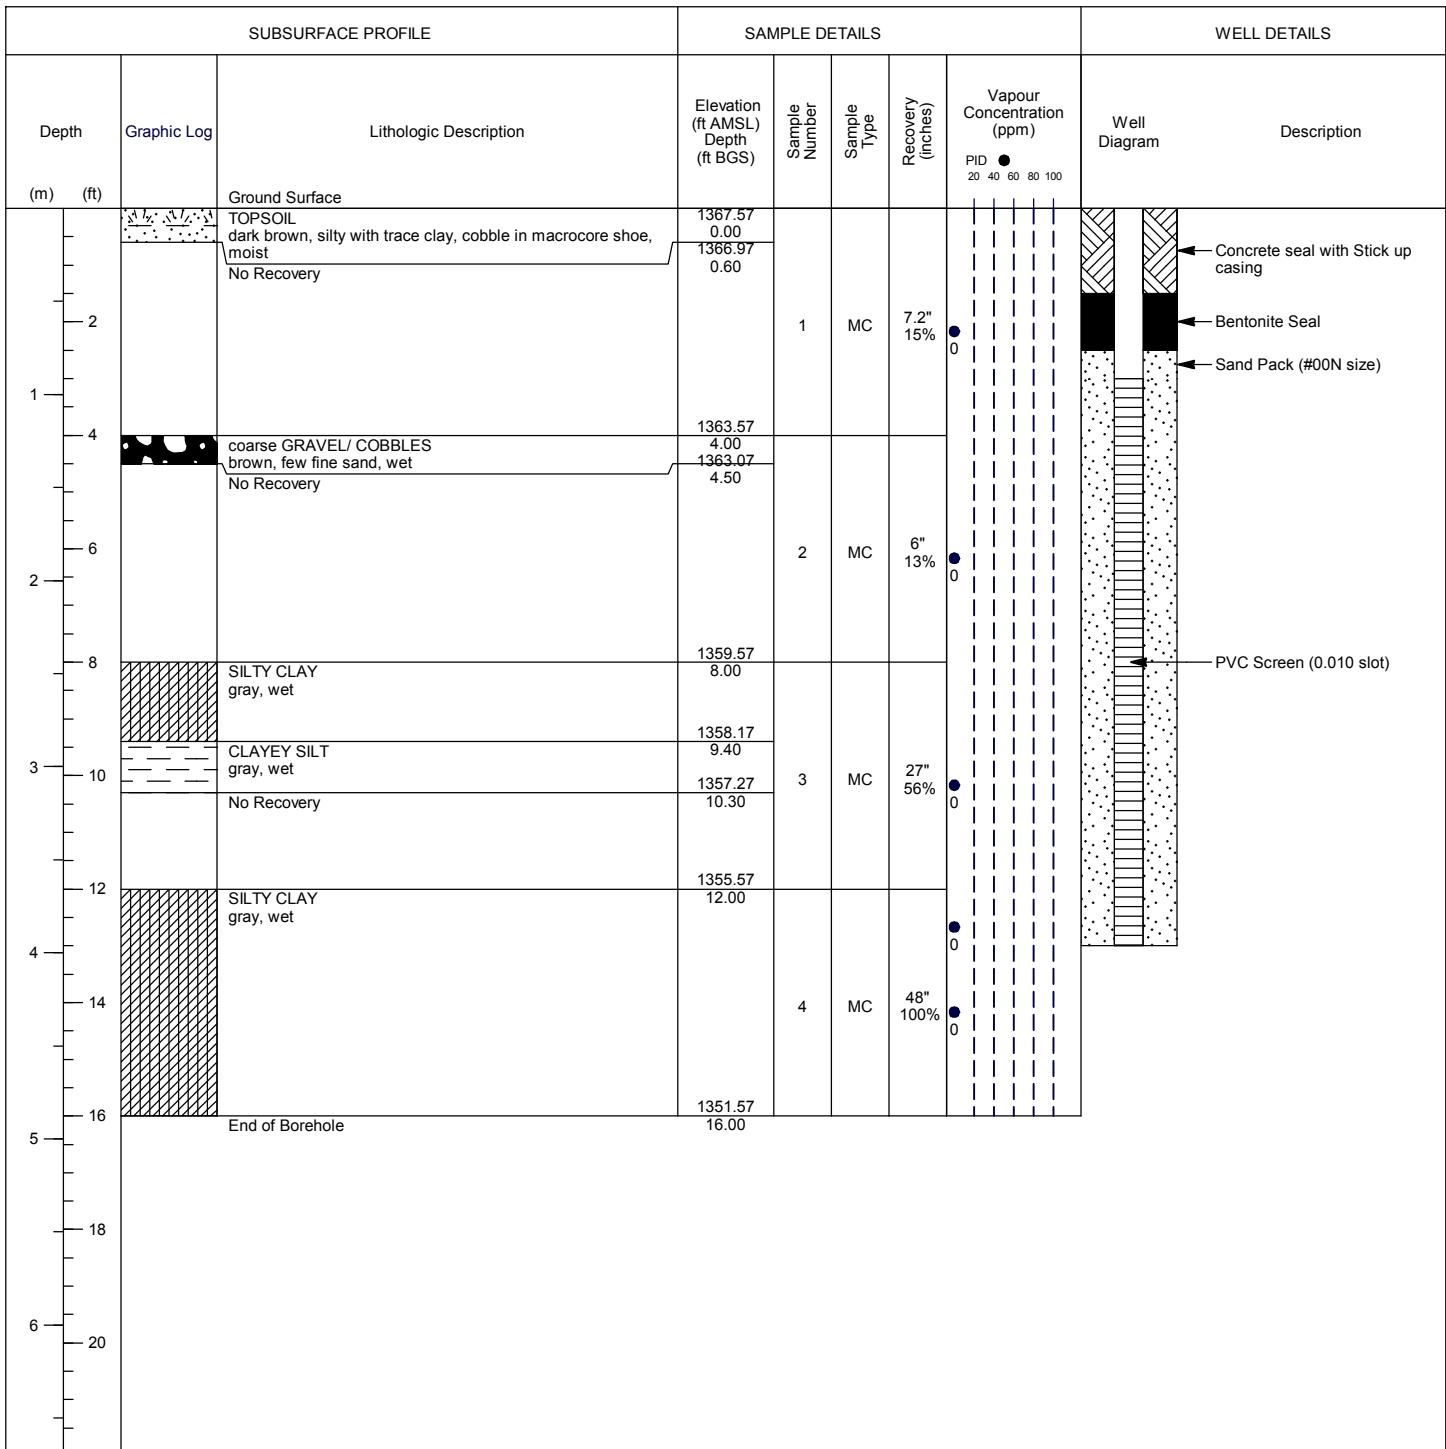
<b>Project:</b>	Remedial Investigation	<b>Drilling method:</b>	Macrocore / Hollow Stem Auger
<b>Client:</b>	Blades Holding Company Inc.	<b>Date started/completed:</b>	02-Dec-2010
<b>Location:</b>	5392 Rt 19, Amity, NY	<b>Ground surface elevation:</b>	1,367.57 ft AMSL
<b>Number:</b>	190500593.300	<b>Top of casing elevation:</b>	1,370.24 ft AMSL
<b>Field investigator:</b>	S. Reynolds-Smith	<b>Easting:</b>	1292546.29
<b>Contractor:</b>	Nothnagle Drilling	<b>Northing:</b>	814116.9

Sand Pack Interval: 2.50 - 13.00 ft BGS  
Screen Interval: 3.00 - 13.00 ft BGS  
Well Seal Interval: 1.50 - 2.50 ft BGS

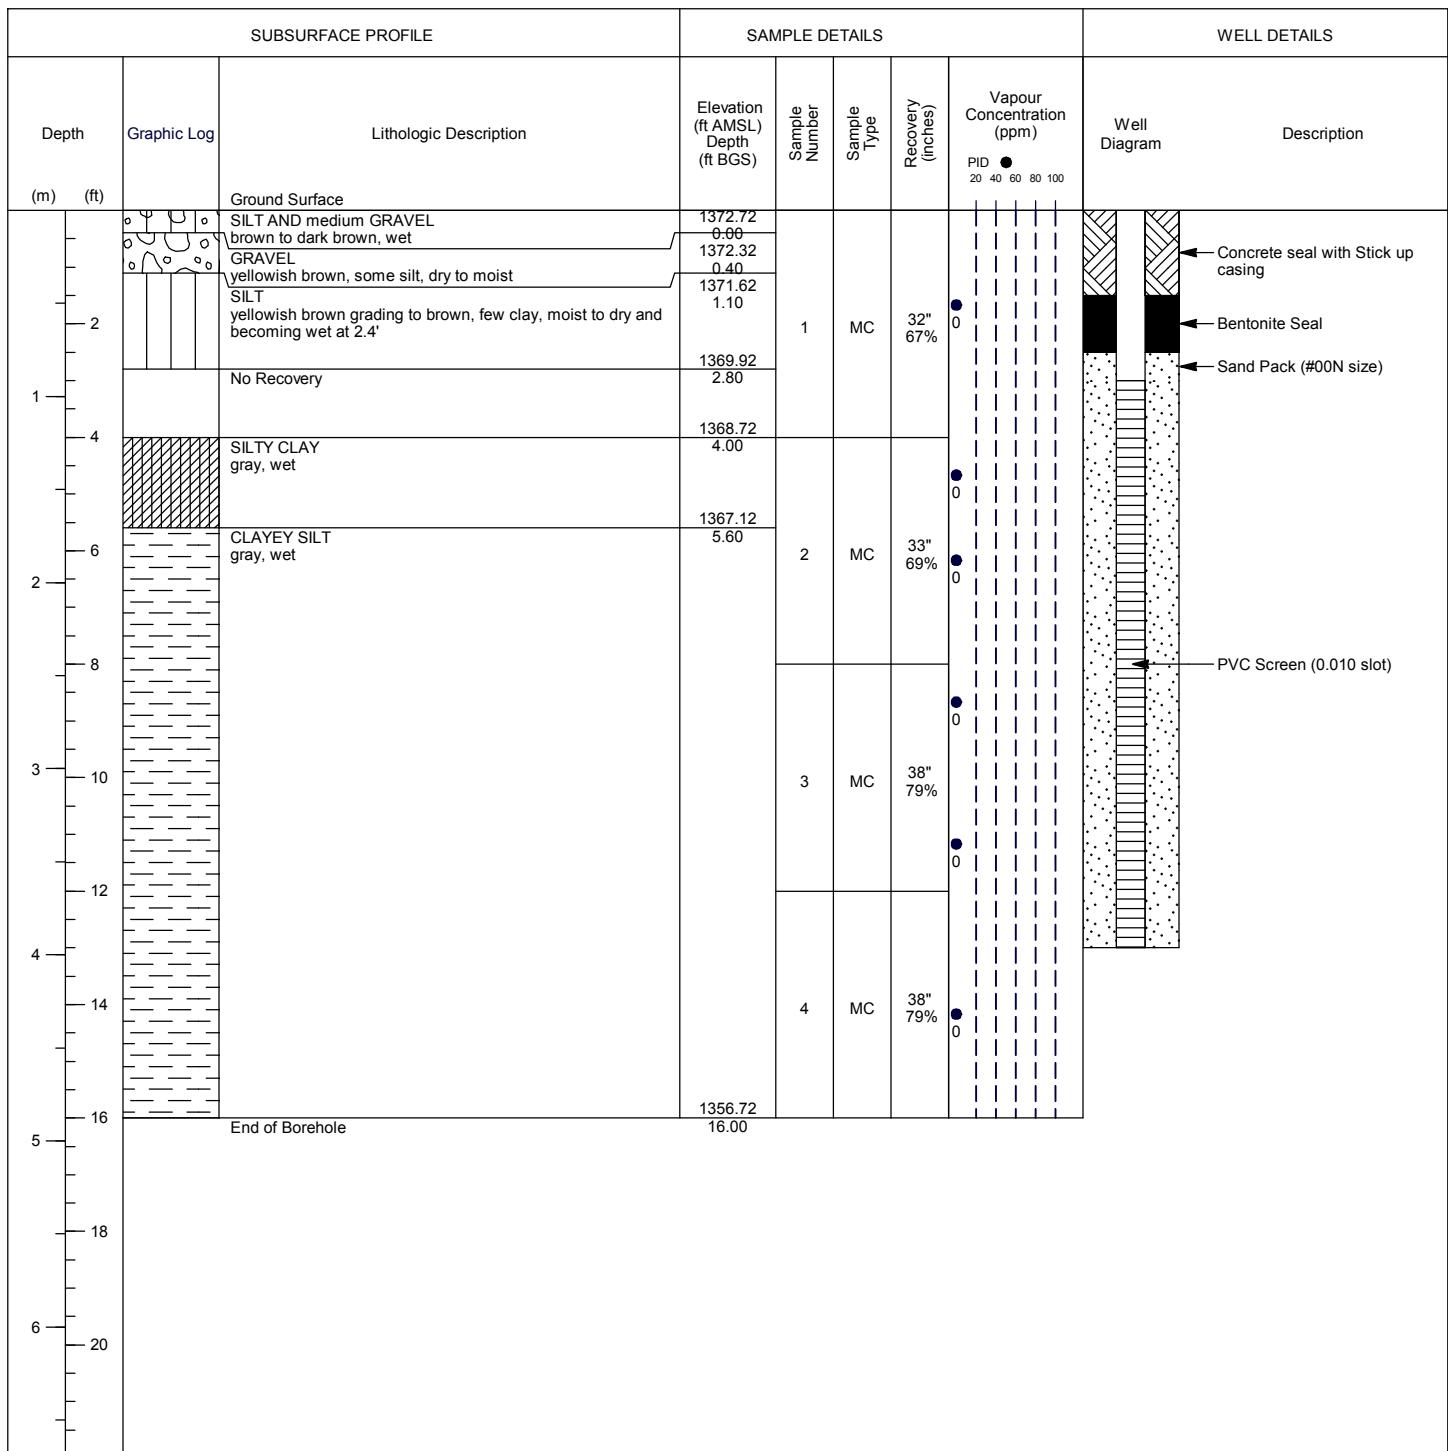
**Drilling method:** Macrocore / Hollow Stem Auger  
**Date started/completed:** 01-Dec-2010  
**Ground surface elevation:** 1,372.72 ft AMSL  
**Top of casing elevation:** 1,375.40 ft AMSL  
**Easting:** 1292746.16  
**Northing:** 814075.47

Sand Pack Interval: 2.50 - 13.00 ft BGS  
Screen Interval: 3.00 - 13.00 ft BGS  
Well Seal Interval: 1.50 - 2.50 ft BGS

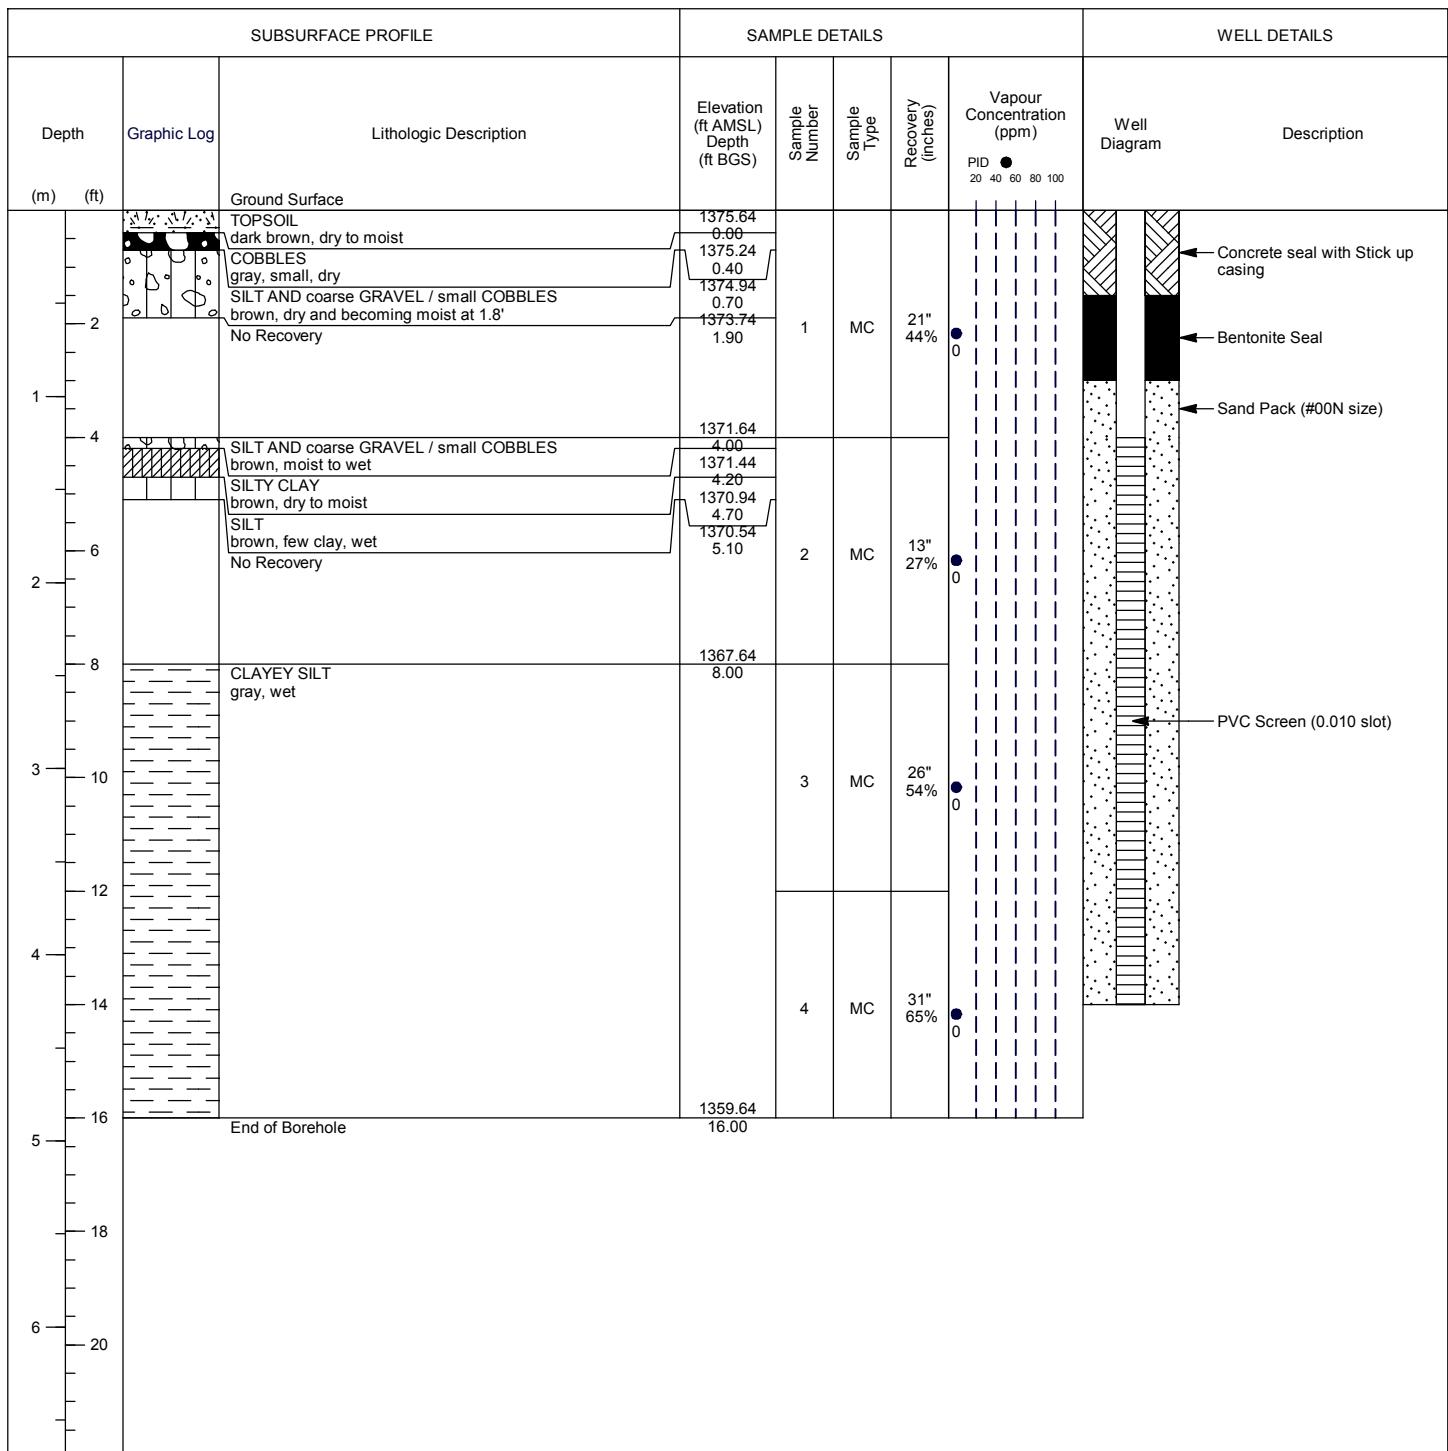
**Drilling method:** Macrocore / Hollow Stem Auger  
**Date started/completed:** 02-Dec-2010  
**Ground surface elevation:** 1,375.64 ft AMSL  
**Top of casing elevation:** 1,378.68 ft AMSL  
**Easting:** 1292676.22  
**Northing:** 814165.19

Sand Pack Interval: 3.00 - 14.00 ft BGS  
Screen Interval: 4.00 - 14.00 ft BGS  
Well Seal Interval: 1.50 - 3.00 ft BGS

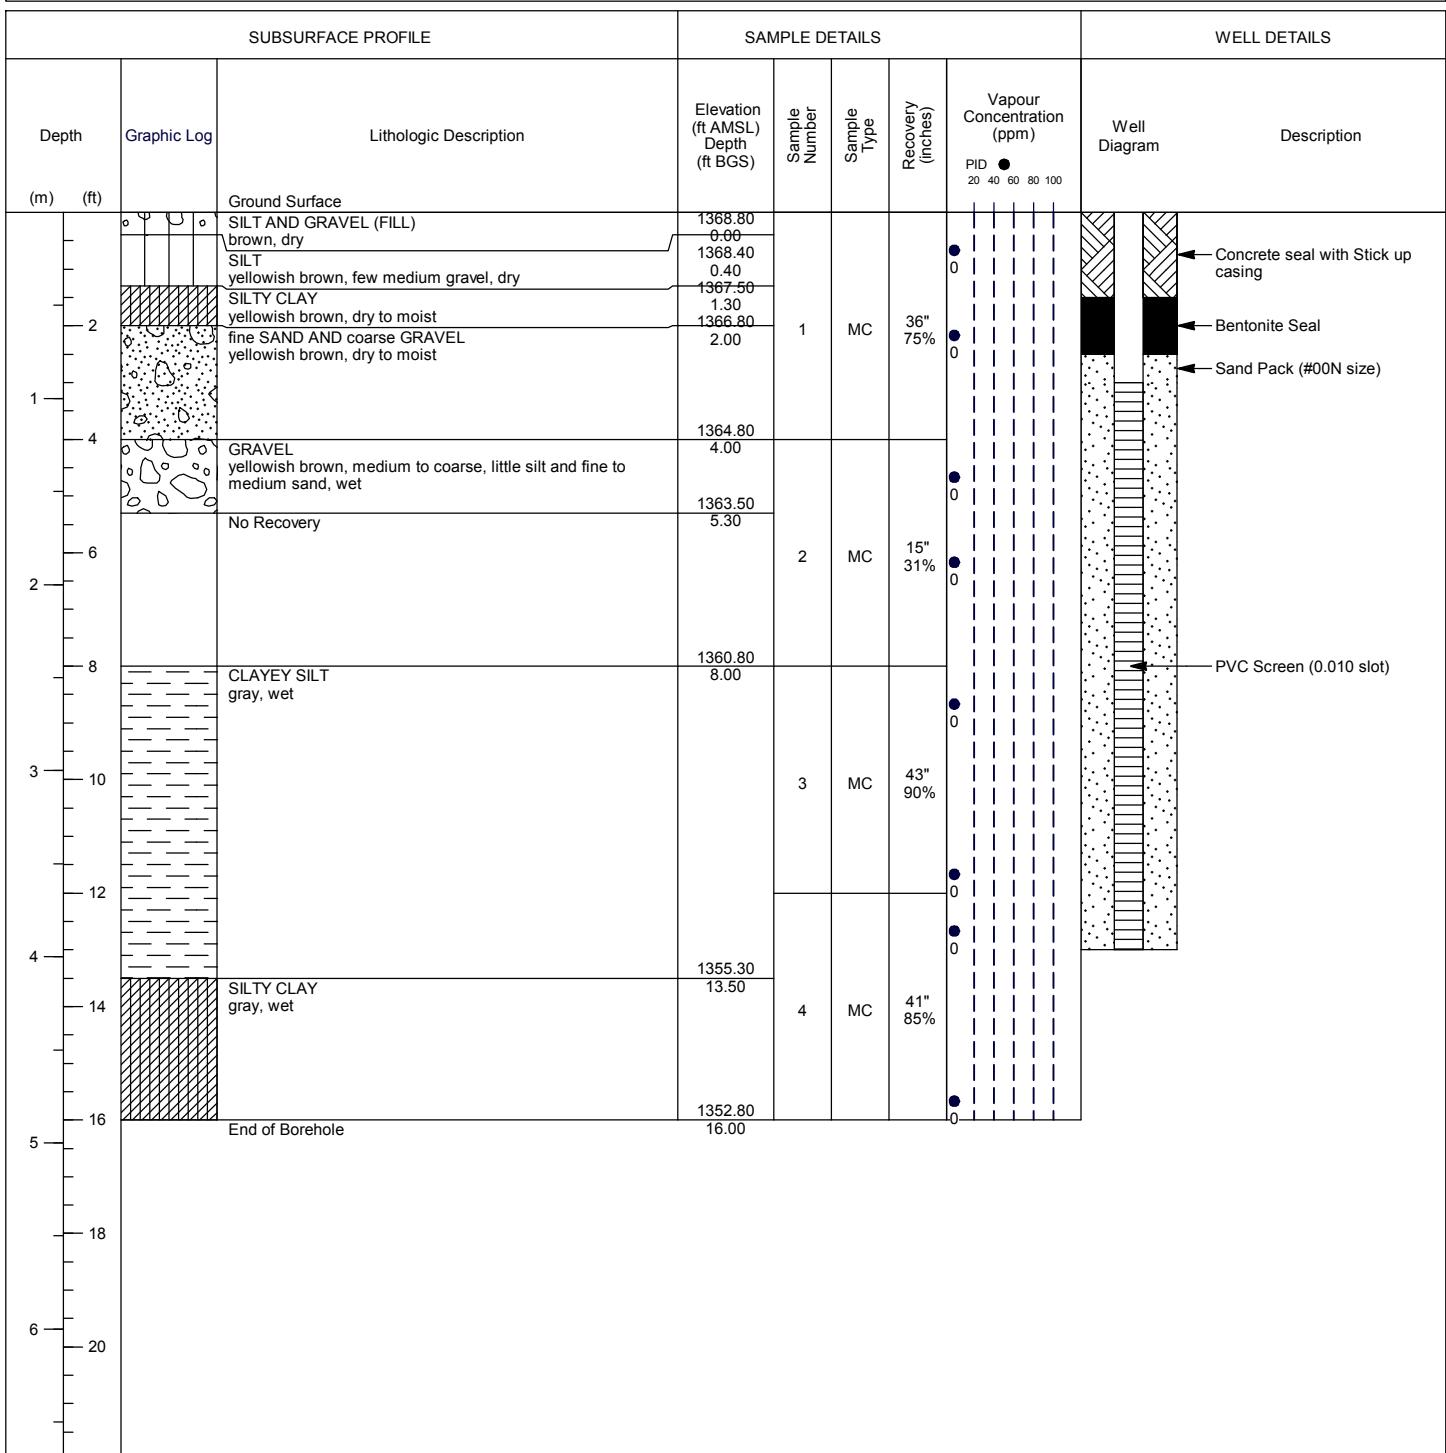
## Monitoring Well: B/MW-9

<b>Project:</b>	Remedial Investigation	<b>Drilling method:</b>	Macrocore / Hollow Stem Auger
<b>Client:</b>	Blades Holding Company Inc.	<b>Date started/completed:</b>	30-Nov-2010
<b>Location:</b>	5392 Rt 19, Amity, NY	<b>Ground surface elevation:</b>	1,368.80 ft AMSL
<b>Number:</b>	190500593.300	<b>Top of casing elevation:</b>	1,371.68 ft AMSL
<b>Field investigator:</b>	S. Reynolds-Smith	<b>Easting:</b>	1292901.29
<b>Contractor:</b>	Nothnagle Drilling	<b>Northing:</b>	813988.81

Sand Pack Interval: 2.50 - 13.00 ft BGS  
Screen Interval: 3.00 - 13.00 ft BGS  
Well Seal Interval: 1.50 - 2.50 ft BGS

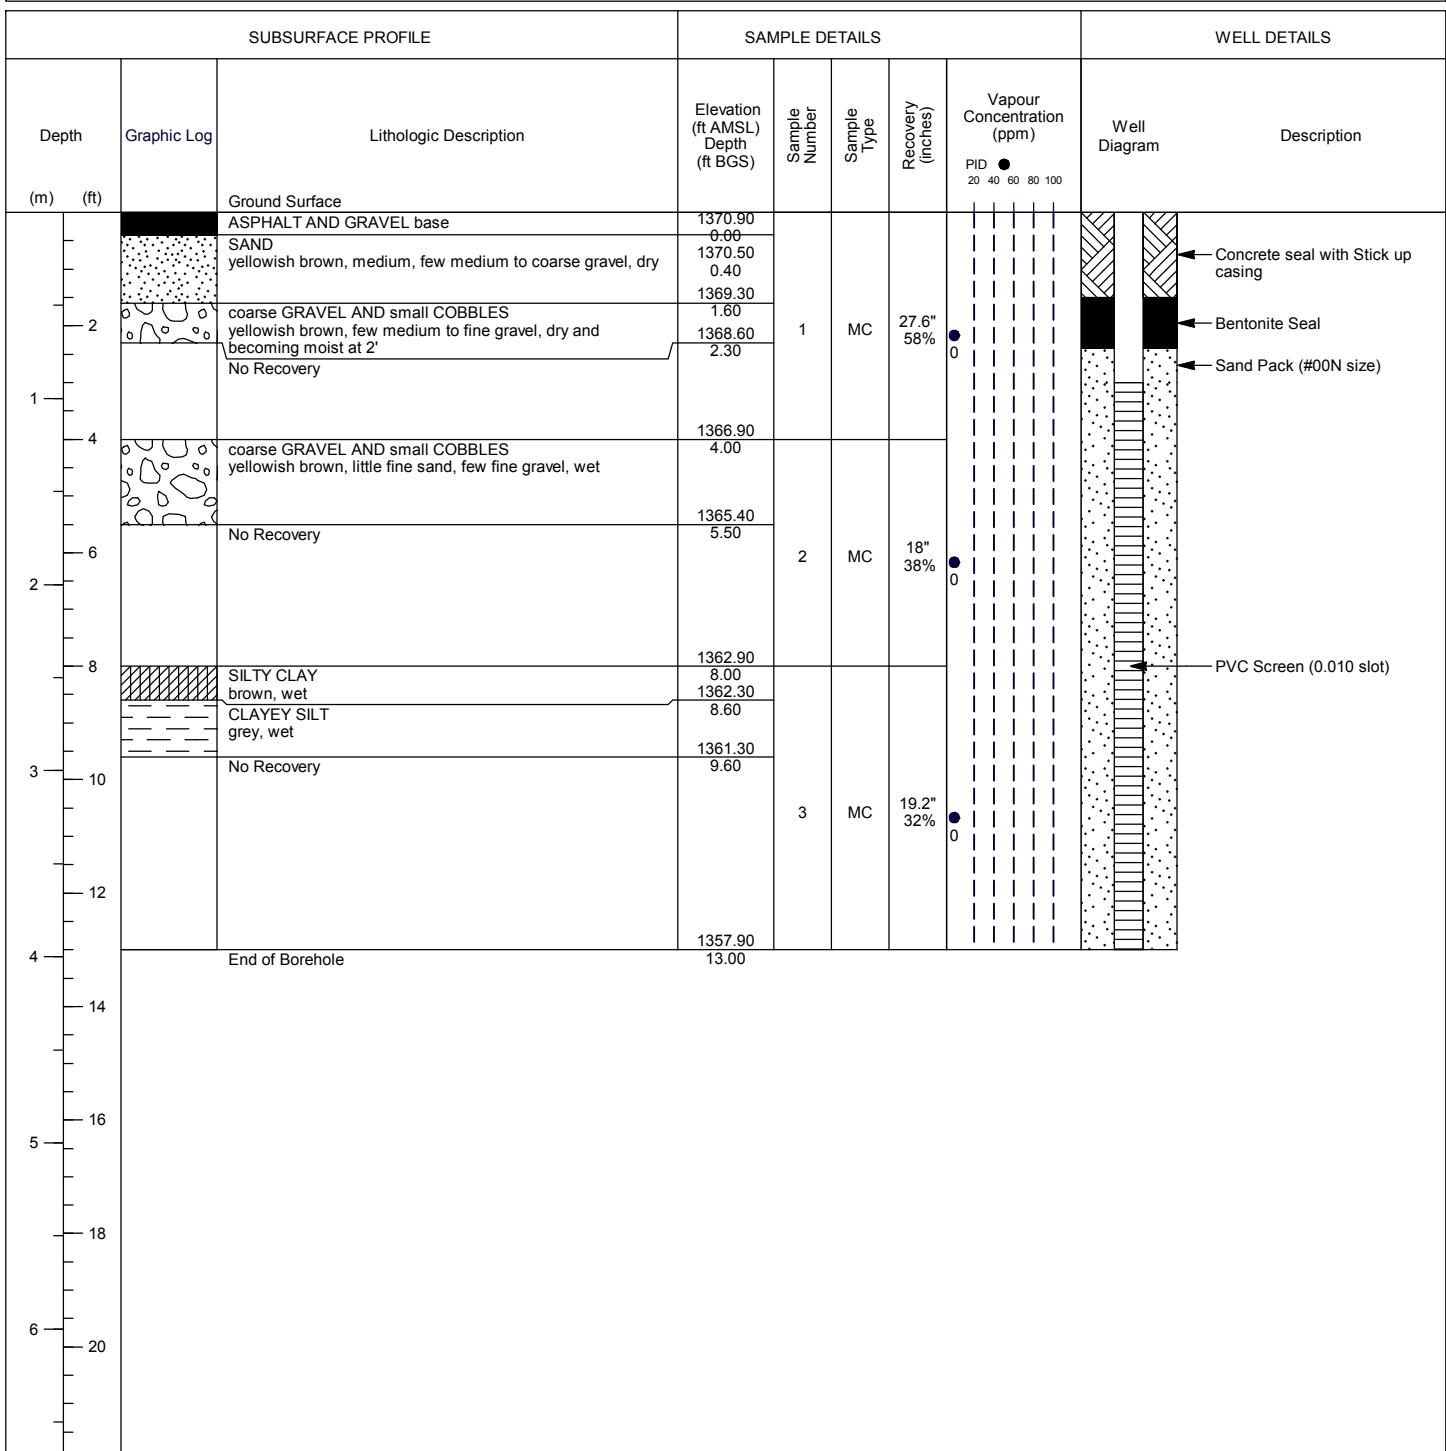
<b>Project:</b>	Remedial Investigation	<b>Drilling method:</b>	Macrocore / Hollow Stem Auger
<b>Client:</b>	Blades Holding Company Inc.	<b>Date started/completed:</b>	30-Nov-2010
<b>Location:</b>	5392 Rt 19, Amity, NY	<b>Ground surface elevation:</b>	1,370.90 ft AMSL
<b>Number:</b>	190500593.300	<b>Top of casing elevation:</b>	1,373.76 ft AMSL
<b>Field investigator:</b>	S. Reynolds-Smith	<b>Easting:</b>	1292784.72
<b>Contractor:</b>	Nothnagle Drilling	<b>Northing:</b>	814000.33

Sand Pack Interval: 2.40 - 13.00 ft BGS  
Screen Interval: 3.00 - 13.00 ft BGS  
Well Seal Interval: 1.50 - 2.40 ft BGS
