**Contained-In Demonstration Work Plan  
Former Allegany Bitumens Belmont  
Asphalt Plant  
Brownfield Cleanup Program  
Site # C902019  
5392 State Route 19  
Amity, Allegany County, New York**

**RE: Contained-In Demonstration Work Plan  
Brownfield Cleanup Program Site # C902019  
Former Allegany Bitumens Belmont Asphalt Plant  
5392 State Route 19, Amity, New York**

**CONTAINED-IN DEMONSTRATION WORK PLAN  
FORMER ALLEGANY BITUMENS BELMONT ASPHALT PLANT****Table of Contents**

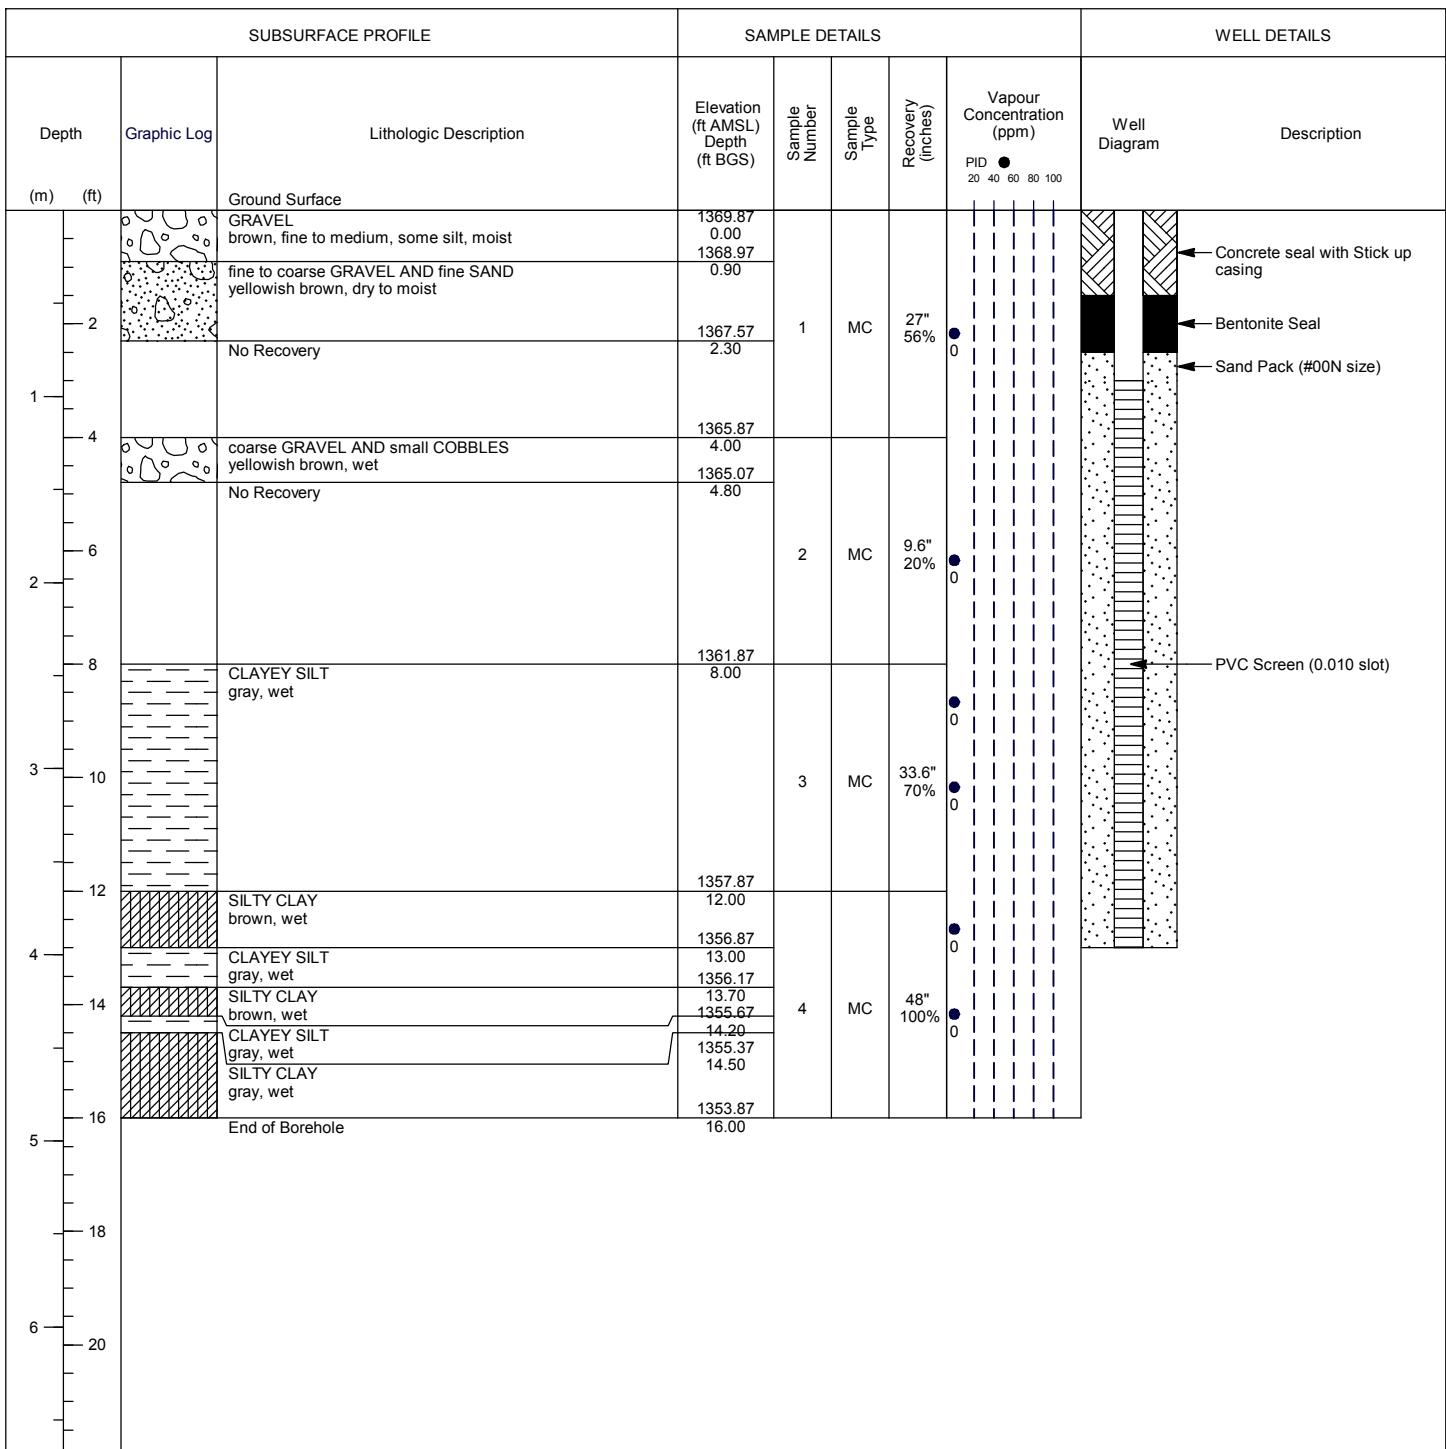
<b>Project:</b>	Remedial Investigation	<b>Drilling method:</b>	Macrocore / Hollow Stem Auger
<b>Client:</b>	Blades Holding Company Inc.	<b>Date started/completed:</b>	30-Nov-2010
<b>Location:</b>	5392 Rt 19, Amity, NY	<b>Ground surface elevation:</b>	1,369.87 ft AMSL
<b>Number:</b>	190500593.300	<b>Top of casing elevation:</b>	1,372.39 ft AMSL
<b>Field investigator:</b>	S. Reynolds-Smith	<b>Easting:</b>	1292790.71
<b>Contractor:</b>	Nothnagle Drilling	<b>Northing:</b>	813908.64

Sand Pack Interval: 2.50 - 13.00 ft BGS  
Screen Interval: 3.00 - 13.00 ft BGS  
Well Seal Interval: 1.50 - 2.50 ft BGS

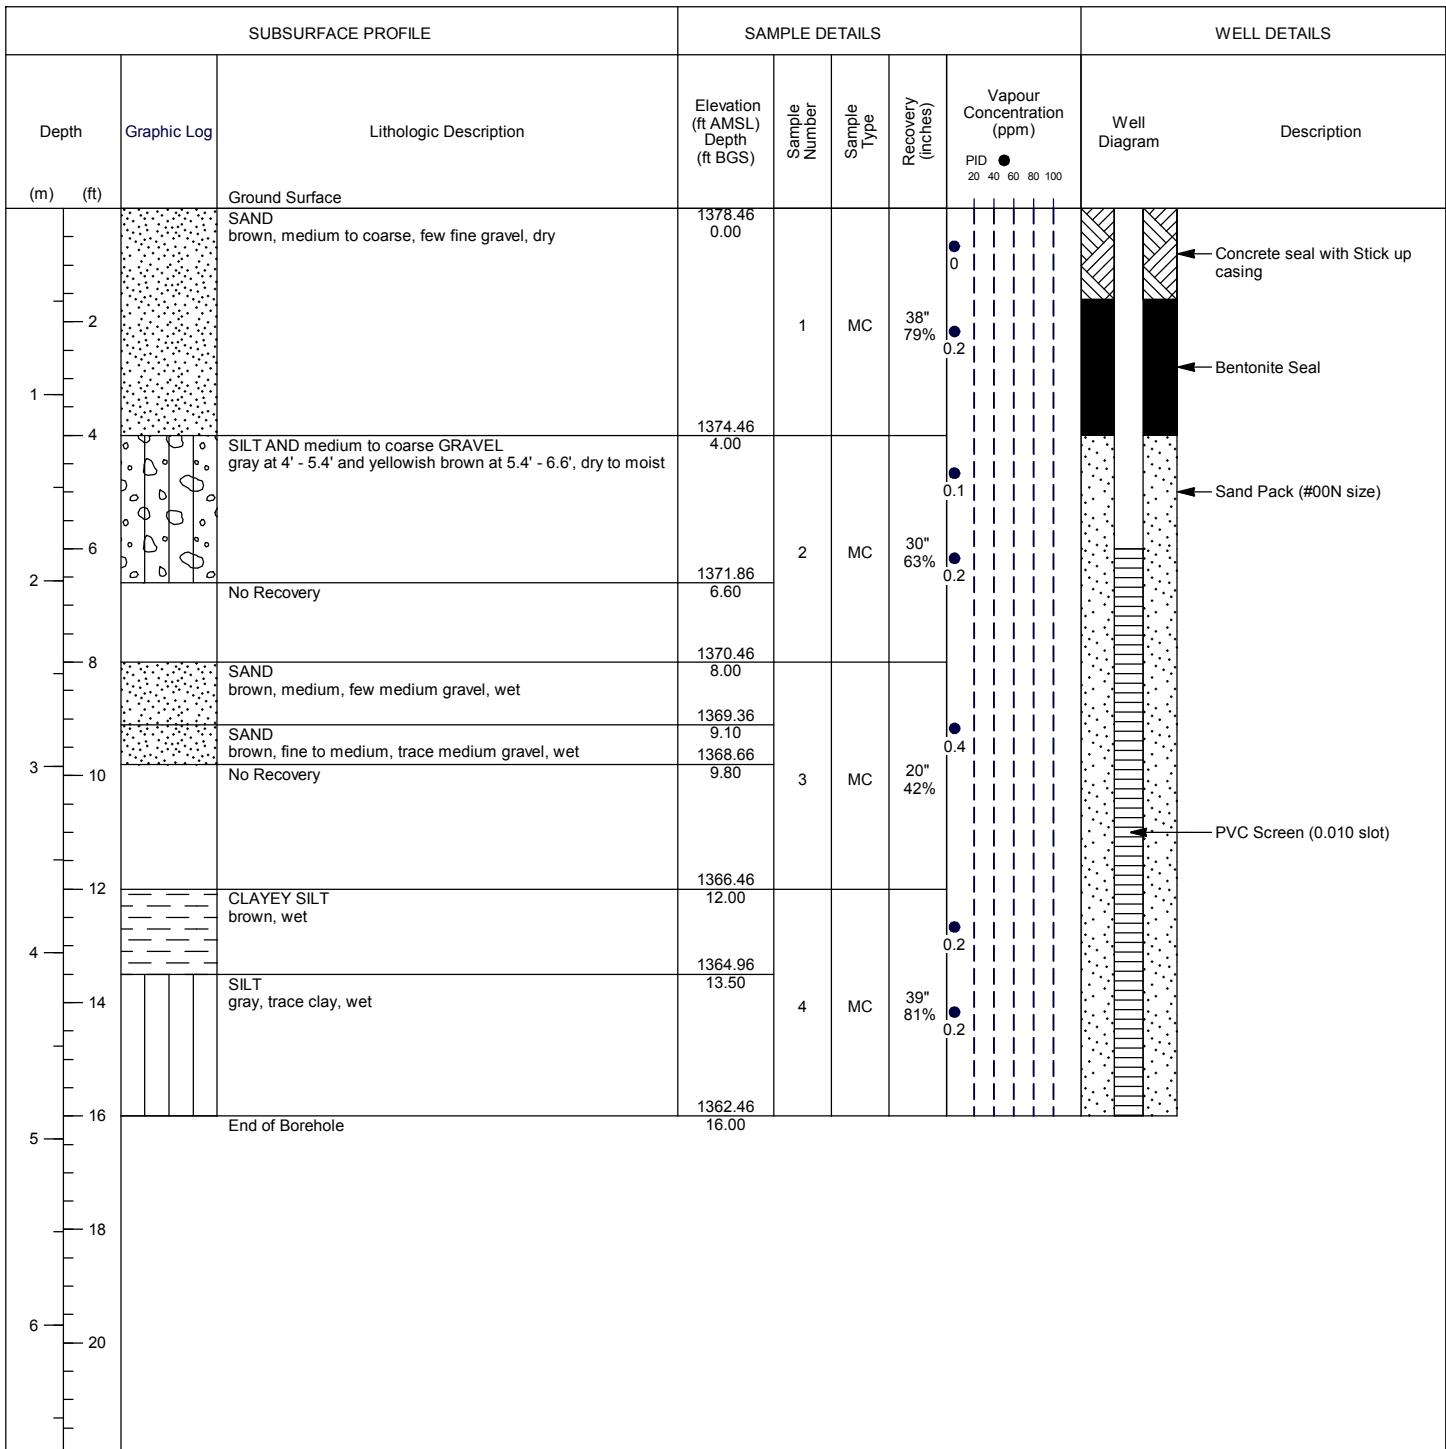
<b>Project:</b>	Remedial Investigation	<b>Drilling method:</b>	Macrocore / Hollow Stem Auger
<b>Client:</b>	Blades Holding Company Inc.	<b>Date started/completed:</b>	29-Nov-2010
<b>Location:</b>	5392 Rt 19, Amity, NY	<b>Ground surface elevation:</b>	1,378.46 ft AMSL
<b>Number:</b>	190500593.300	<b>Top of casing elevation:</b>	1,381.50 ft AMSL
<b>Field investigator:</b>	S. Reynolds-Smith	<b>Easting:</b>	1292595.82
<b>Contractor:</b>	Nothnagle Drilling	<b>Northing:</b>	813823.14

Sand Pack Interval: 4.00 - 16.00 ft BGS  
Screen Interval: 6.00 - 16.00 ft BGS  
Well Seal Interval: 1.60 - 4.00 ft BGS

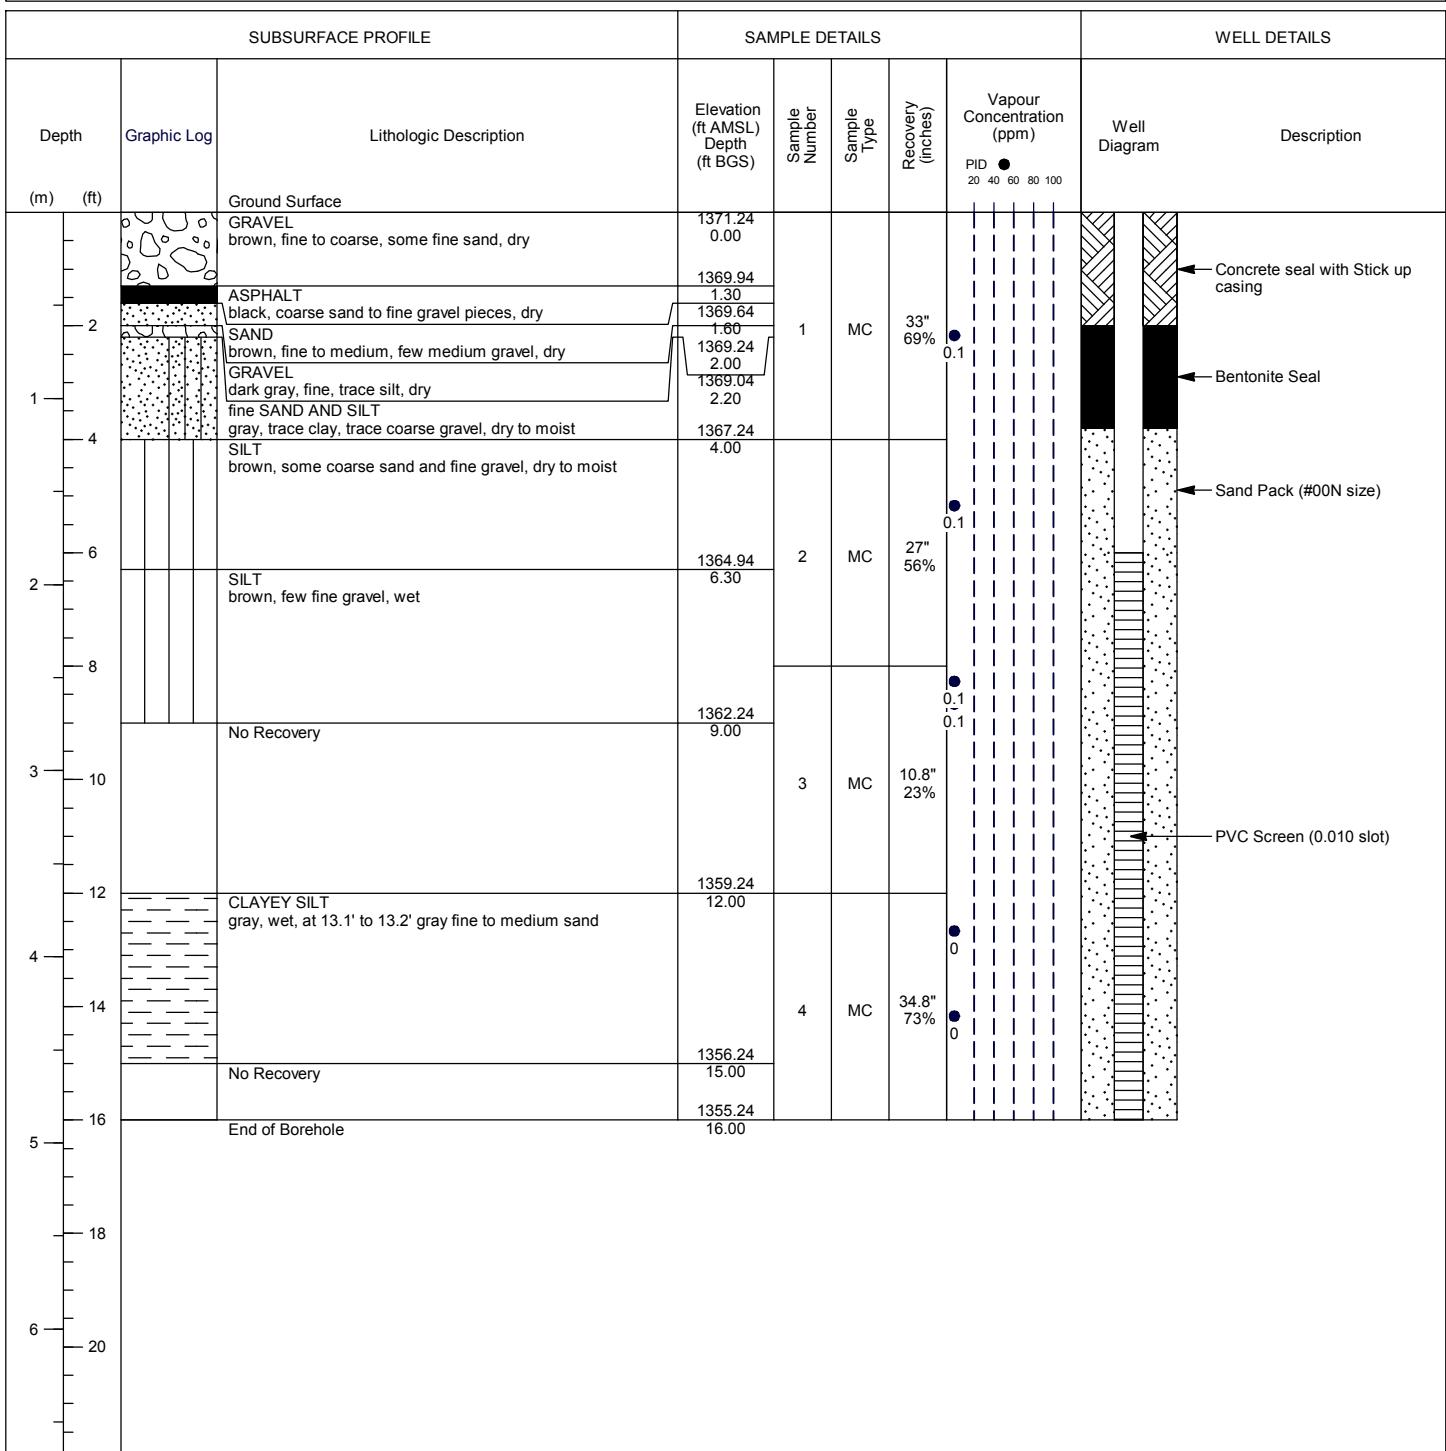
<b>Project:</b>	Remedial Investigation	<b>Drilling method:</b>	Macrocore / Hollow Stem Auger
<b>Client:</b>	Blades Holding Company Inc.	<b>Date started/completed:</b>	29-Nov-2010
<b>Location:</b>	5392 Rt 19, Amity, NY	<b>Ground surface elevation:</b>	1,371.24 ft AMSL
<b>Number:</b>	190500593.300	<b>Top of casing elevation:</b>	1,374.00 ft AMSL
<b>Field investigator:</b>	S. Reynolds-Smith	<b>Easting:</b>	1292840.77
<b>Contractor:</b>	Nothnagle Drilling	<b>Northing:</b>	813509.36

Sand Pack Interval: 3.80 - 16.00 ft BGS  
Screen Interval: 6.00 - 16.00 ft BGS  
Well Seal Interval: 2.00 - 3.80 ft BGS

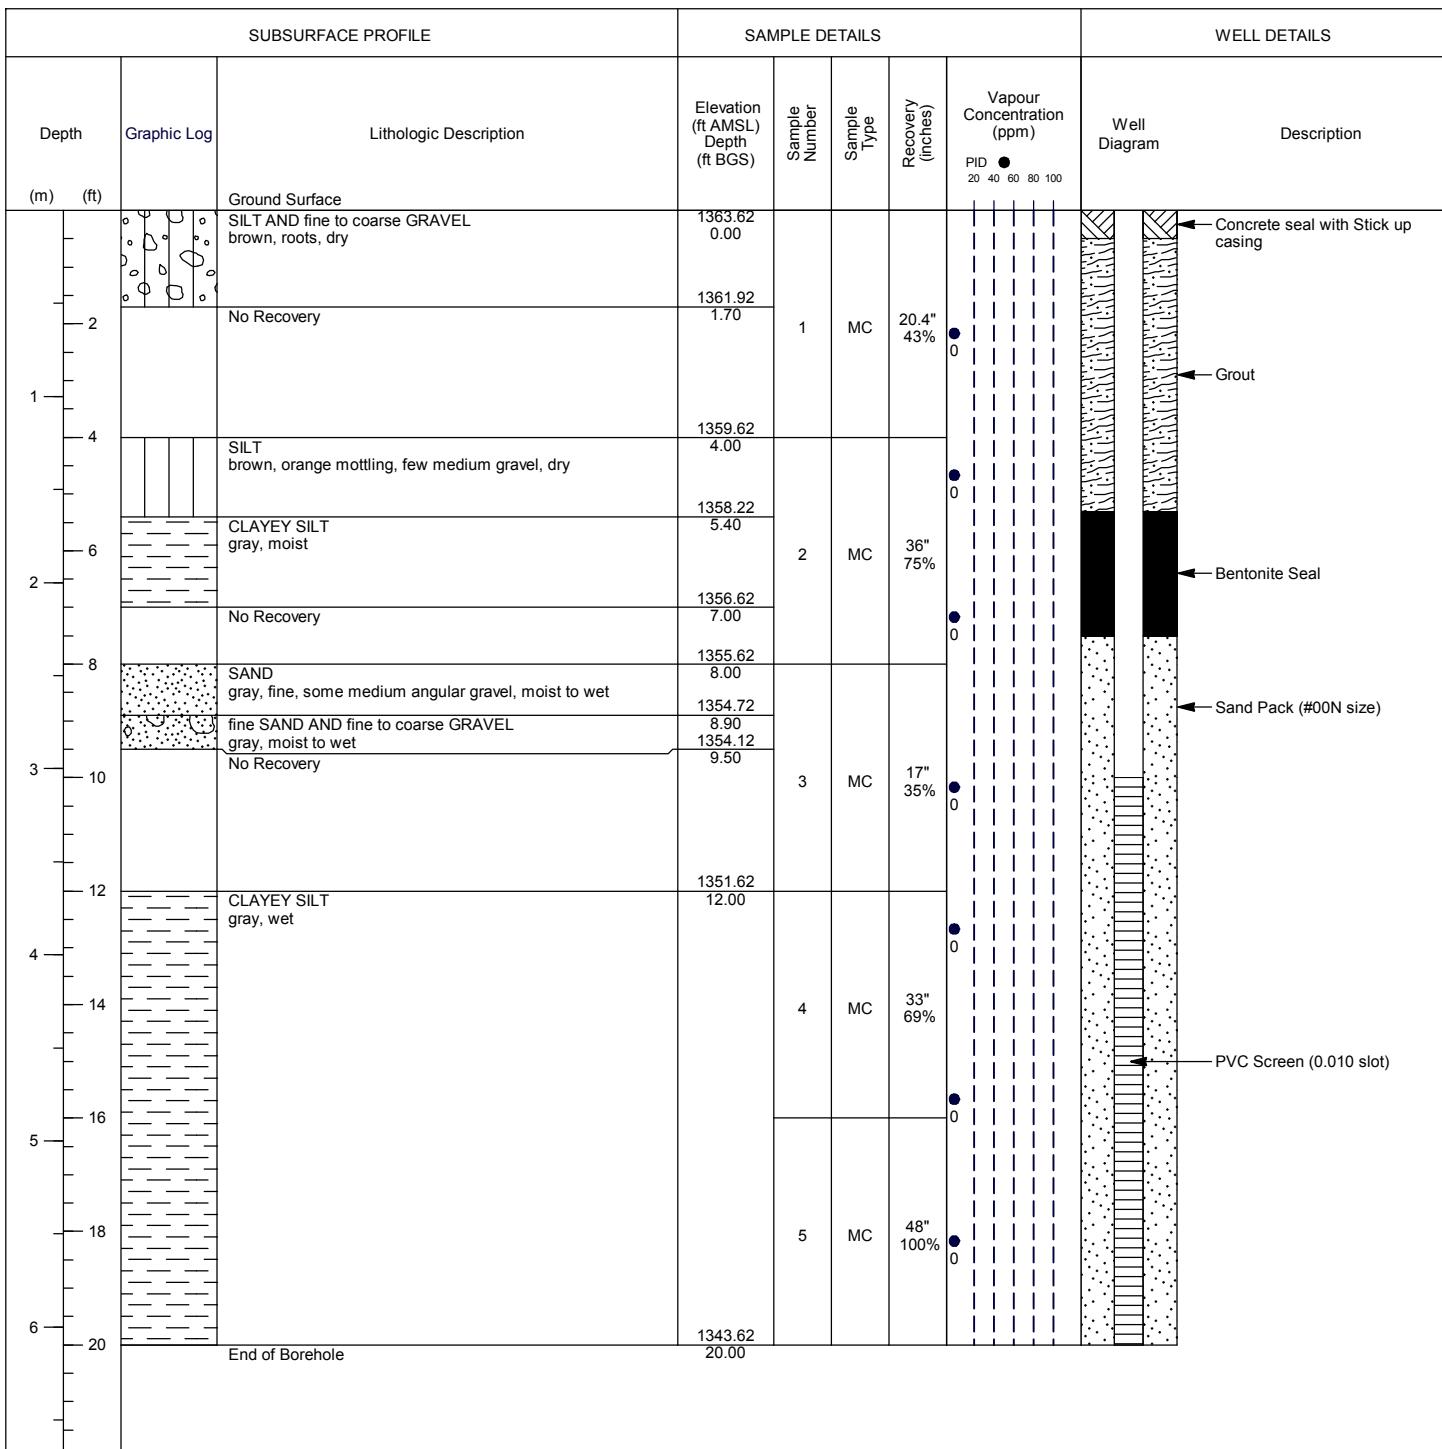
**Drilling method:** Macrocore / Hollow Stem Auger  
**Date started/completed:** 30-Nov-2010  
**Ground surface elevation:** 1,363.62 ft AMSL  
**Top of casing elevation:** 1,366.54 ft AMSL  
**Easting:** 1292987.42  
**Northing:** 814026.5

Sand Pack Interval: 7.50 - 20.00 ft BGS  
Screen Interval: 10.00 - 20.00 ft BGS  
Well Seal Interval: 5.30 - 7.50 ft BGS

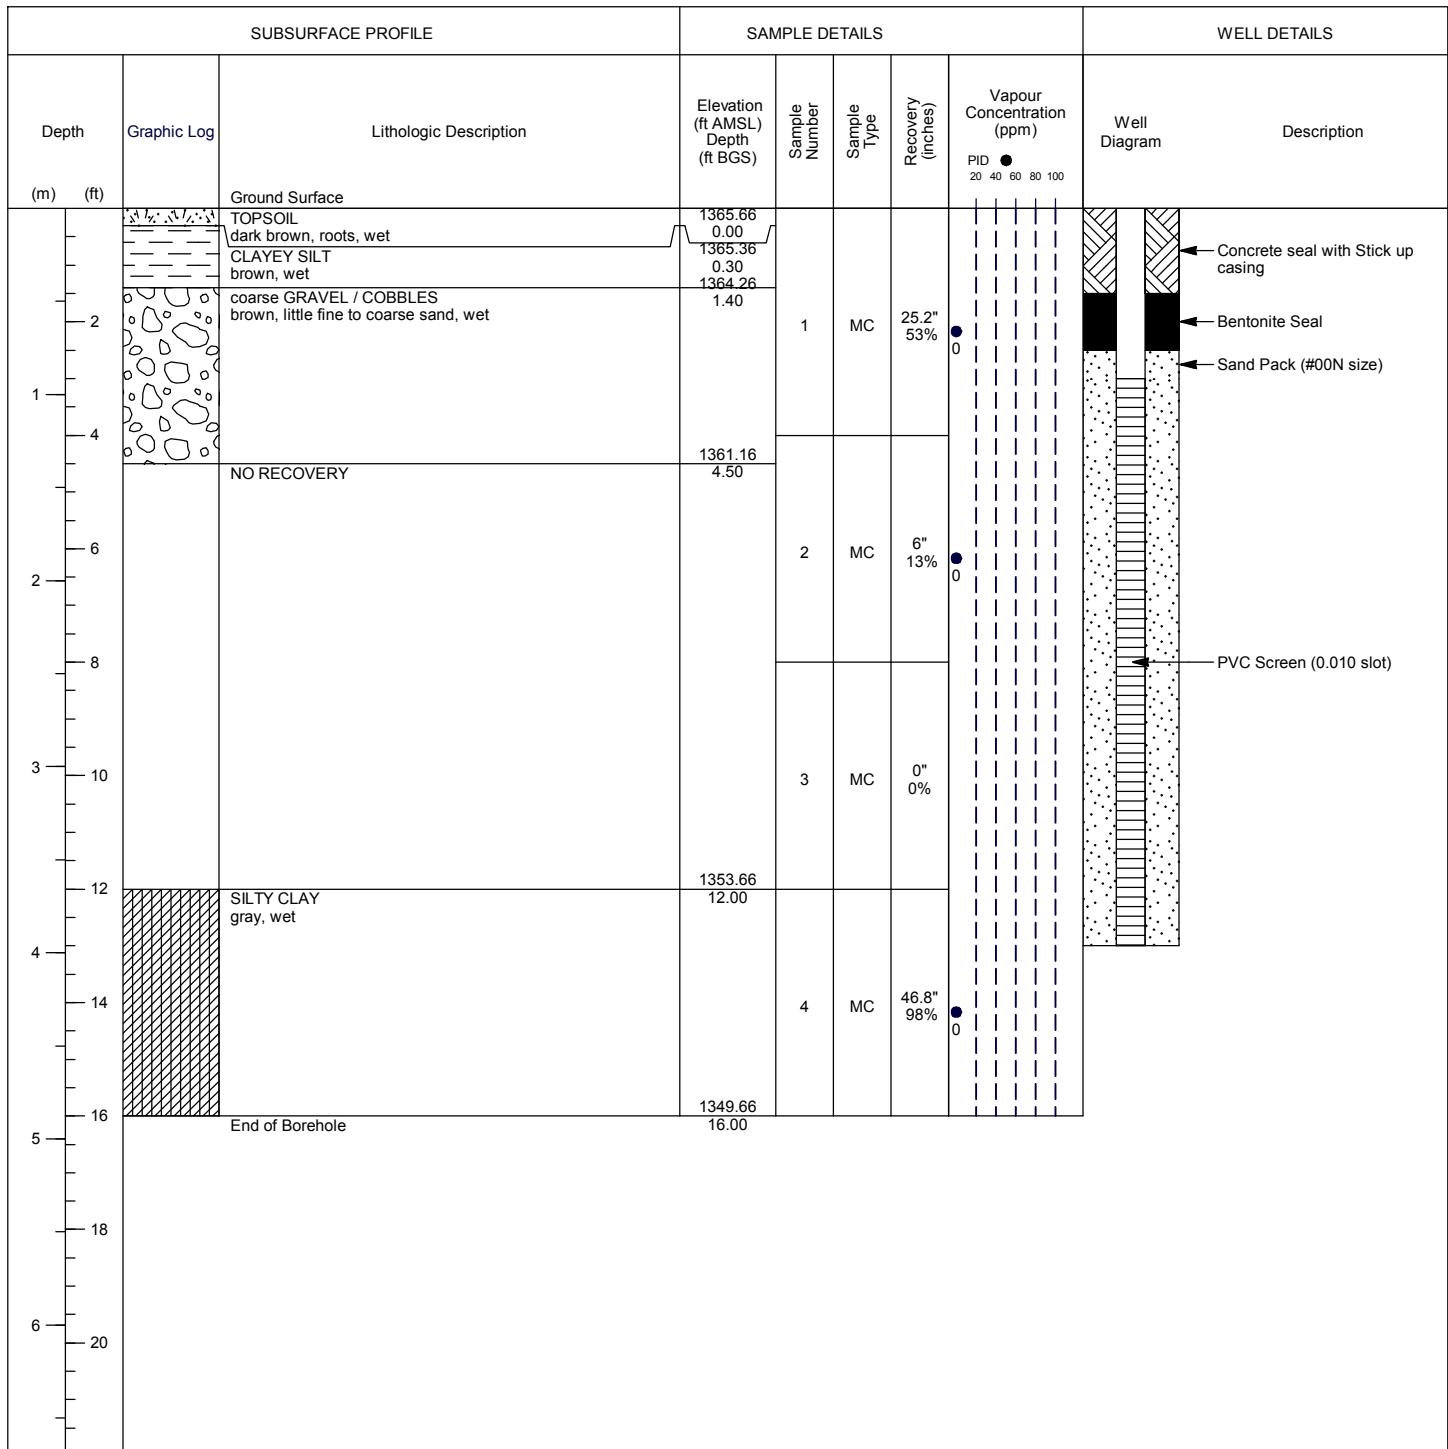
**Drilling method:** Macrocore / Hollow Stem Auger  
**Date started/completed:** 03-Dec-2010  
**Ground surface elevation:** 1,365.66 ft AMSL  
**Top of casing elevation:** 1,368.32 ft AMSL  
**Easting:** 1292524.37  
**Northing:** 814248.27

Sand Pack Interval: 2.50 - 13.00 ft BGS  
Screen Interval: 3.00 - 13.00 ft BGS  
Well Seal Interval: 1.50 - 2.50 ft BGS

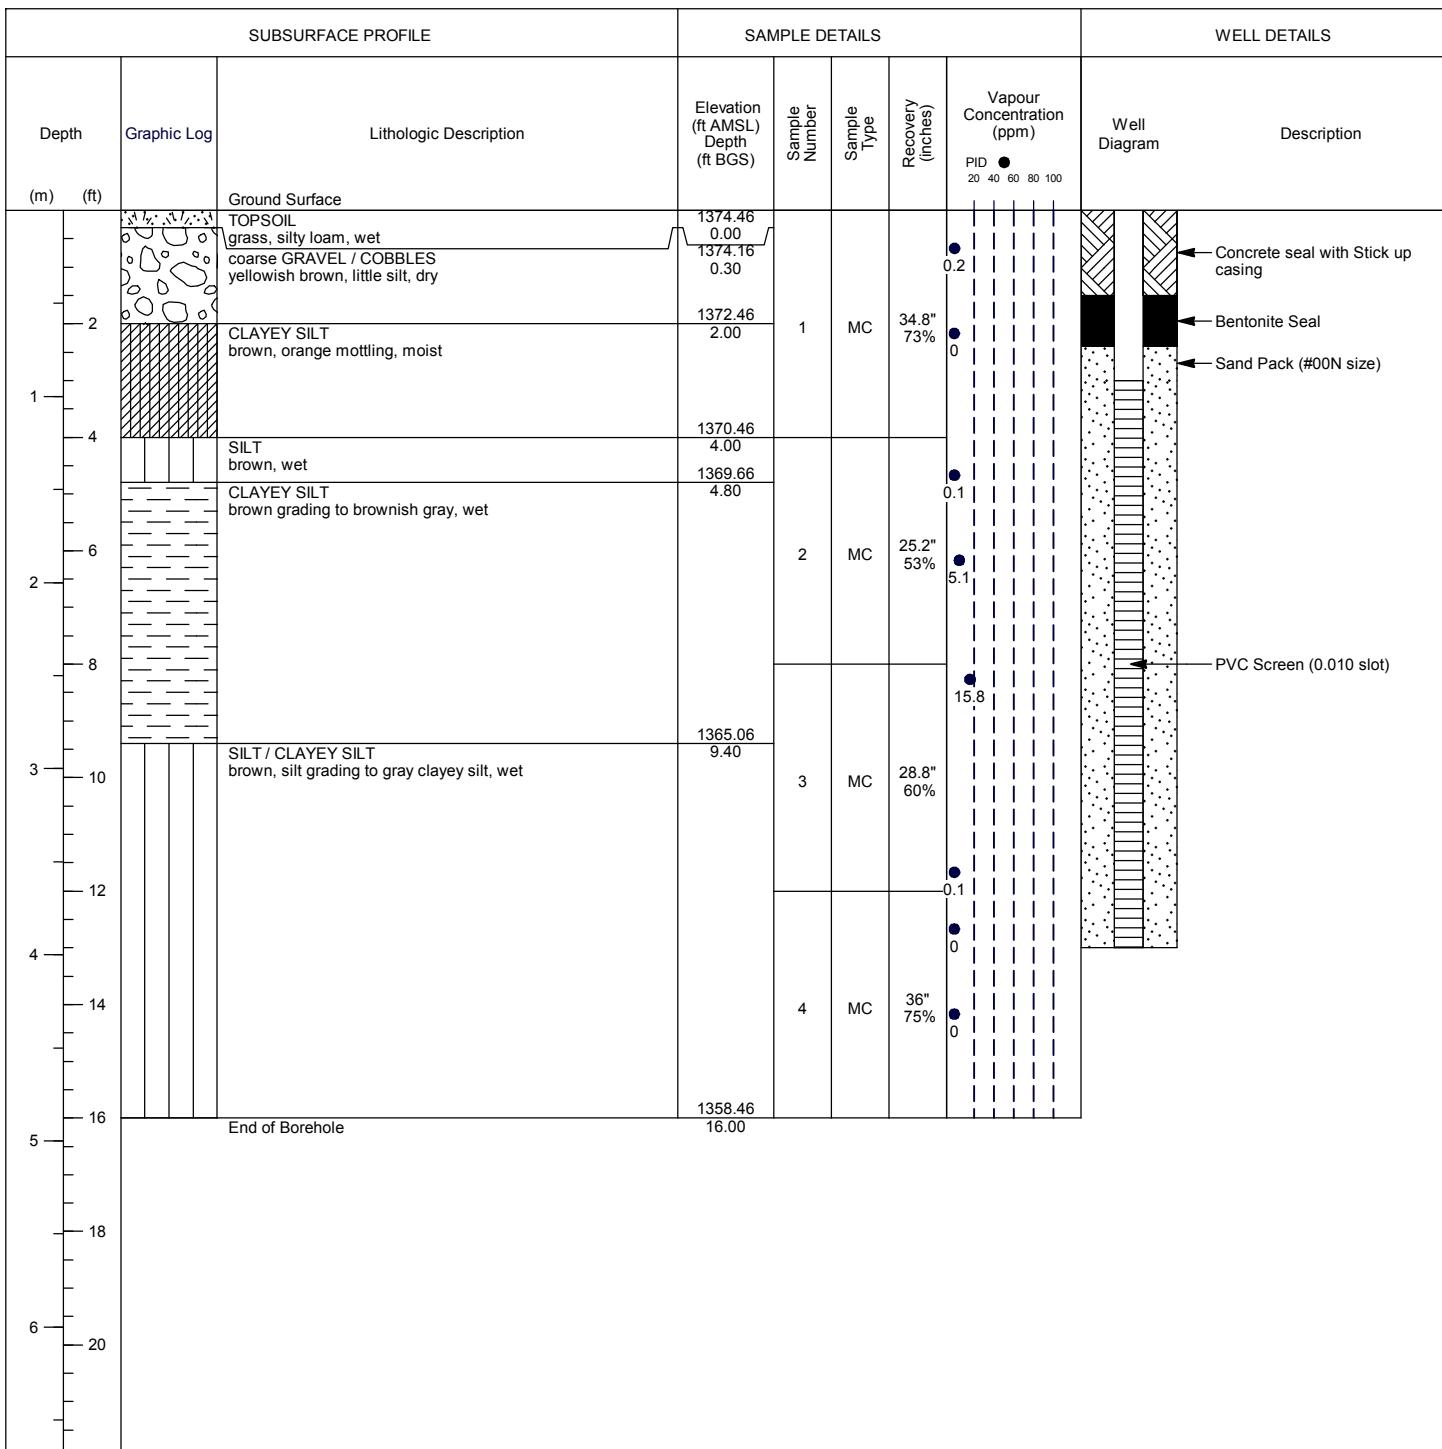
**Drilling method:** Macrocore / Hollow Stem Auger  
**Date started/completed:** 06-Dec-2010 / 07-Dec-2010  
**Ground surface elevation:** 1,374.46 ft AMSL  
**Top of casing elevation:** 1,377.59 ft AMSL  
**Easting:** 1292619.71  
**Northing:** 814024.92

Sand Pack Interval: 2.40 - 13.00 ft BGS  
Screen Interval: 3.00 - 13.00 ft BGS  
Well Seal Interval: 1.50 - 2.40 ft BGS

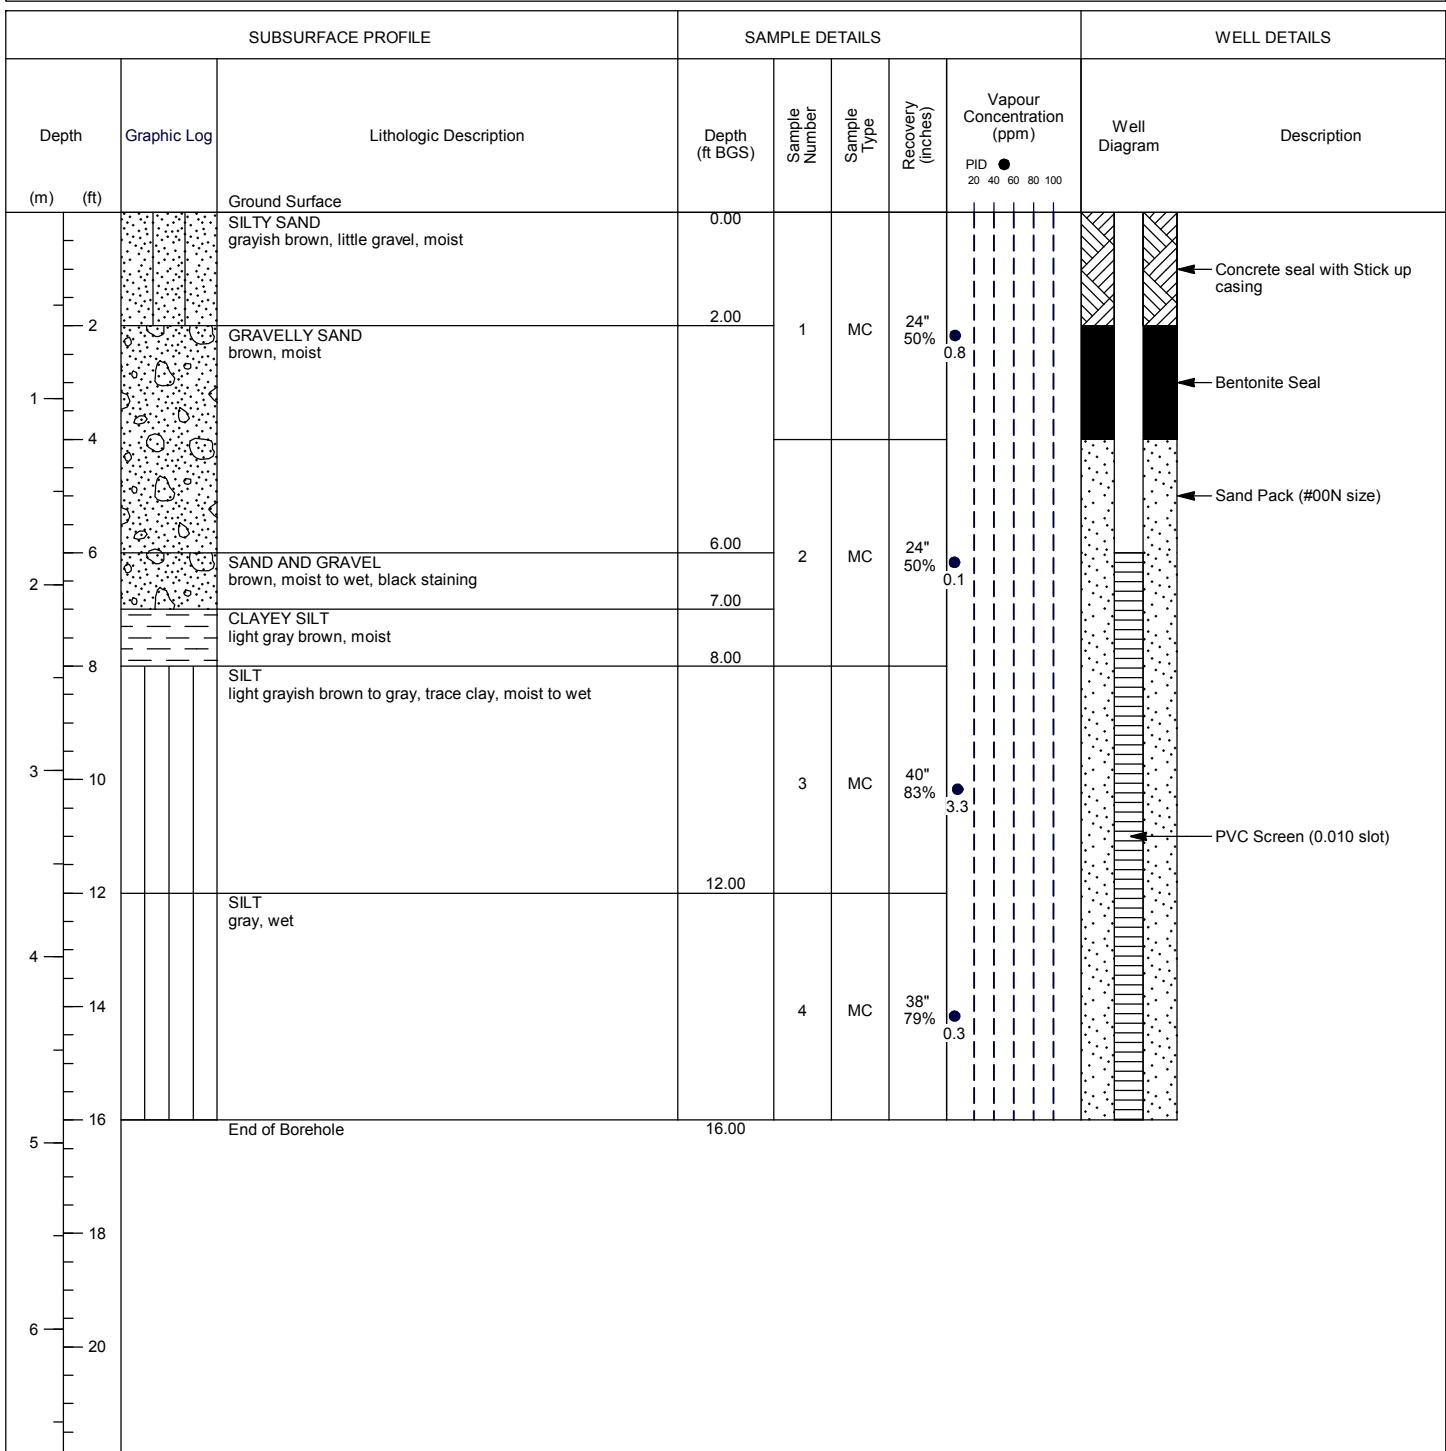
**Drilling method:** Macrocore / Hollow Stem Auger  
**Date started/completed:** 06-Dec-2010  
**Ground surface elevation:** n/a  
**Top of casing elevation:** n/a  
**Easting:** n/a  
**Northing:** n/a

Sand Pack Interval: 4.00 - 16.00 ft BGS  
Screen Interval: 6.00 - 16.00 ft BGS  
Well Seal Interval: 2.00 - 4.00 ft BGS

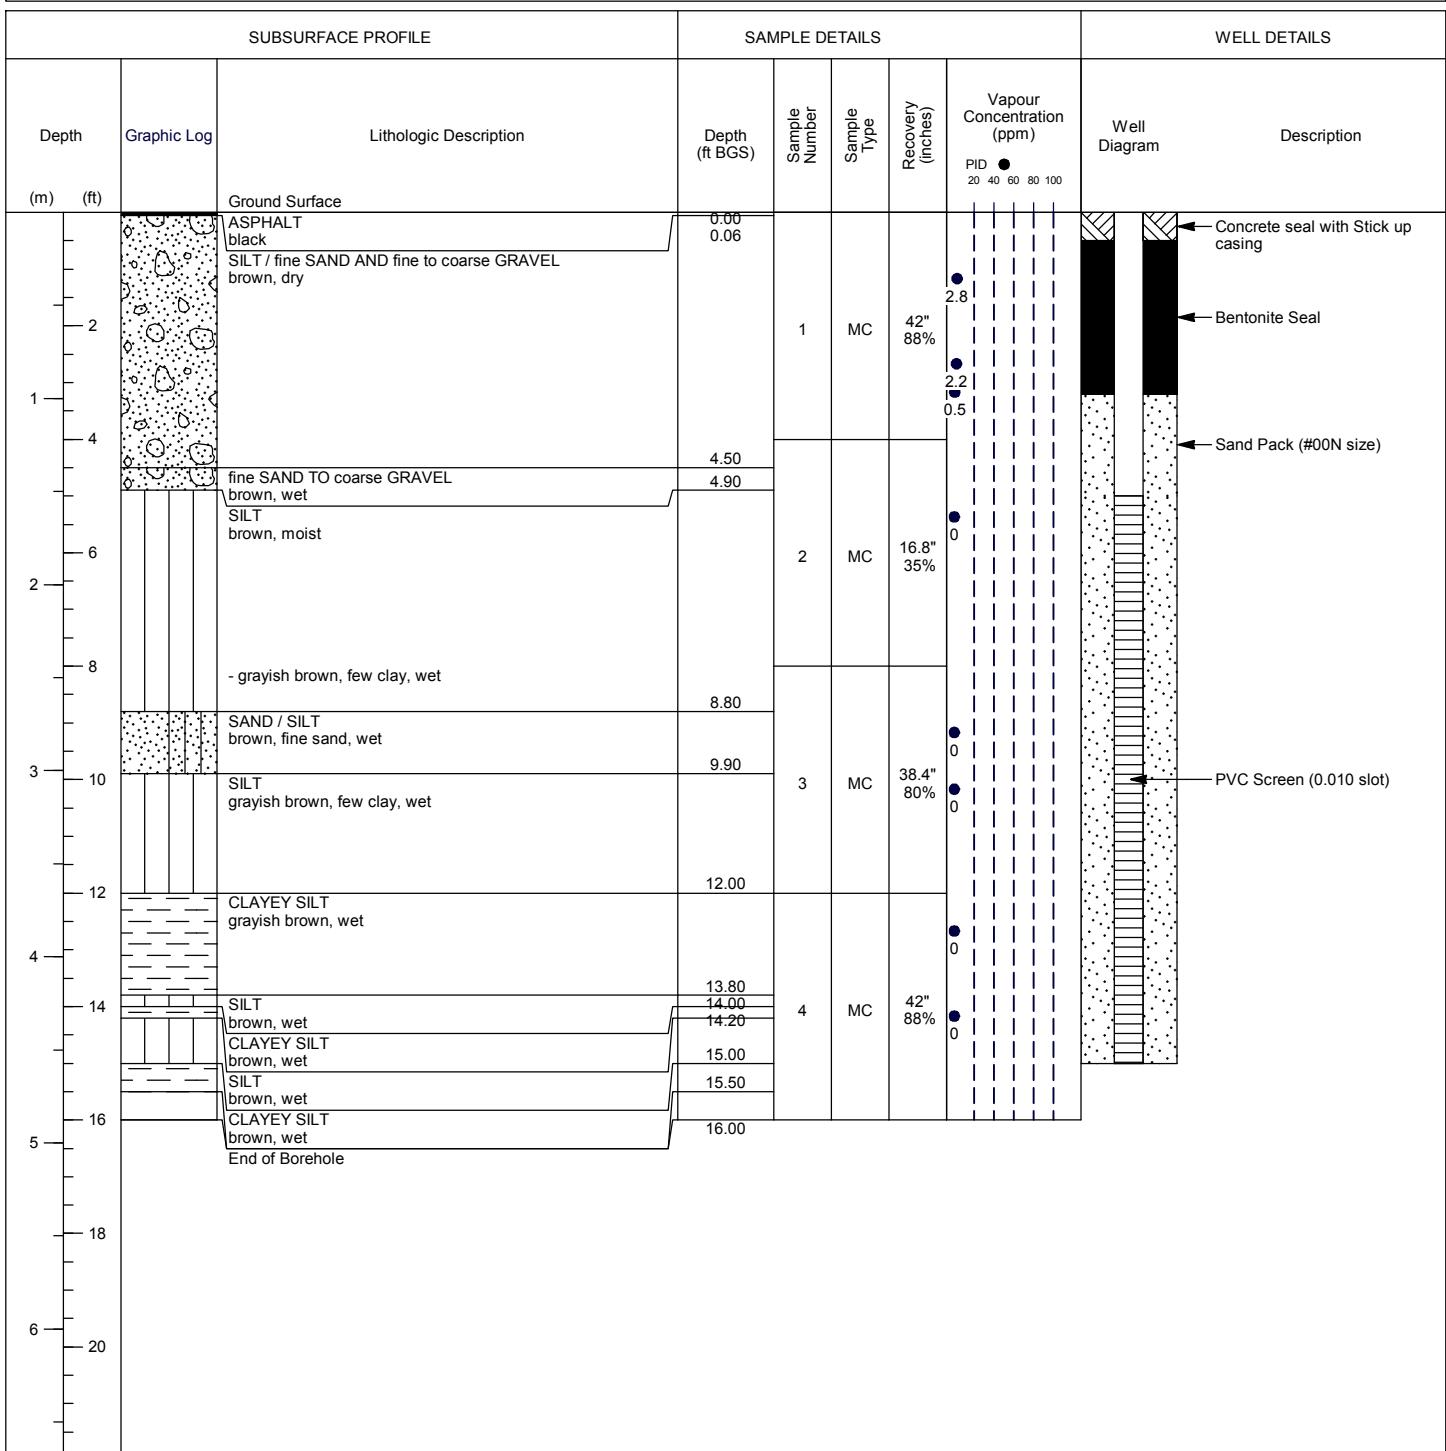
**Drilling method:** Macrocore / Hollow Stem Auger  
**Date started/completed:** 03-Feb-2011  
**Ground surface elevation:** n/a  
**Top of casing elevation:** n/a  
**Easting:** n/a  
**Northing:** n/a

Sand Pack Interval: 3.20 - 15.00 ft BGS  
Screen Interval: 5.00 - 15.00 ft BGS  
Well Seal Interval: 0.50 - 3.20 ft BGS

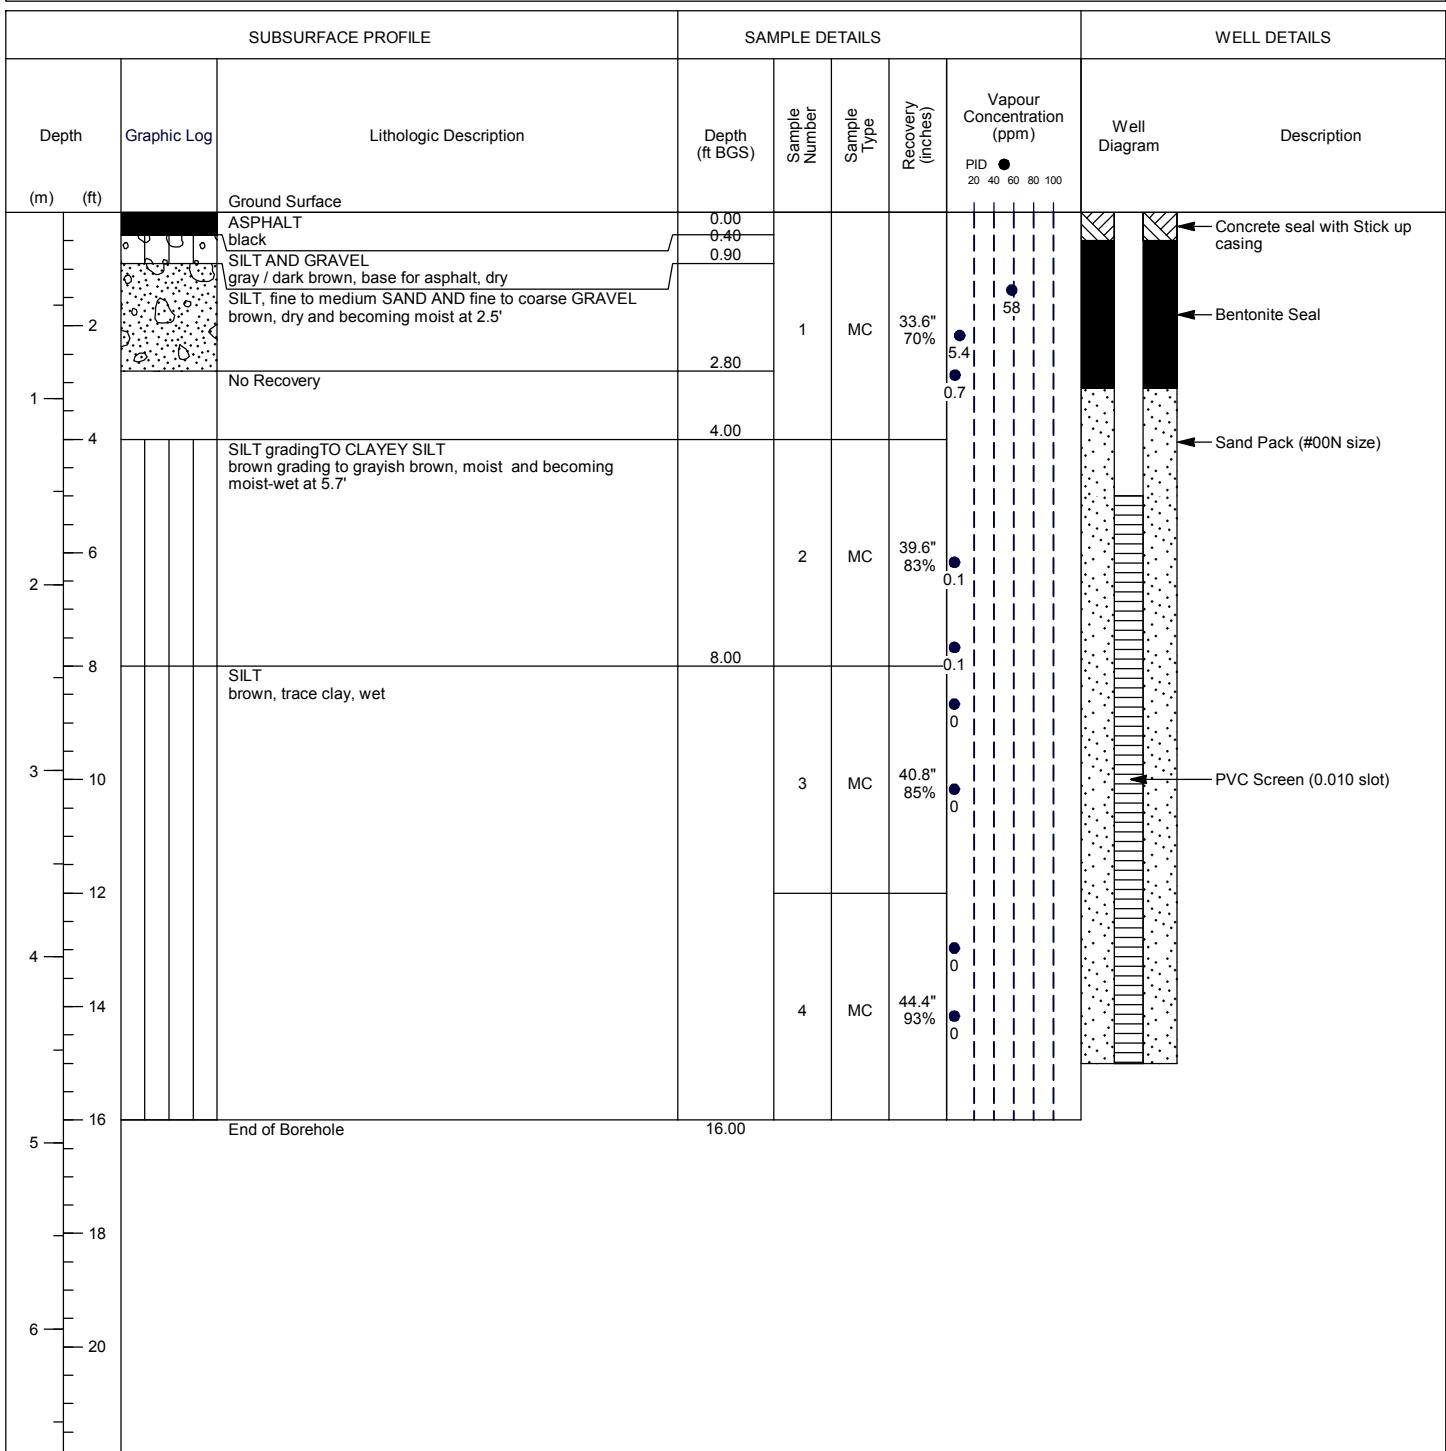
**Drilling method:** Macrocore / Hollow Stem Auger  
**Date started/completed:** 03-Feb-2011  
**Ground surface elevation:** n/a  
**Top of casing elevation:** n/a  
**Easting:** n/a  
**Northing:** n/a

Sand Pack Interval: 3.10 - 15.00 ft BGS  
Screen Interval: 5.00 - 15.00 ft BGS  
Well Seal Interval: 0.50 - 3.10 ft BGS

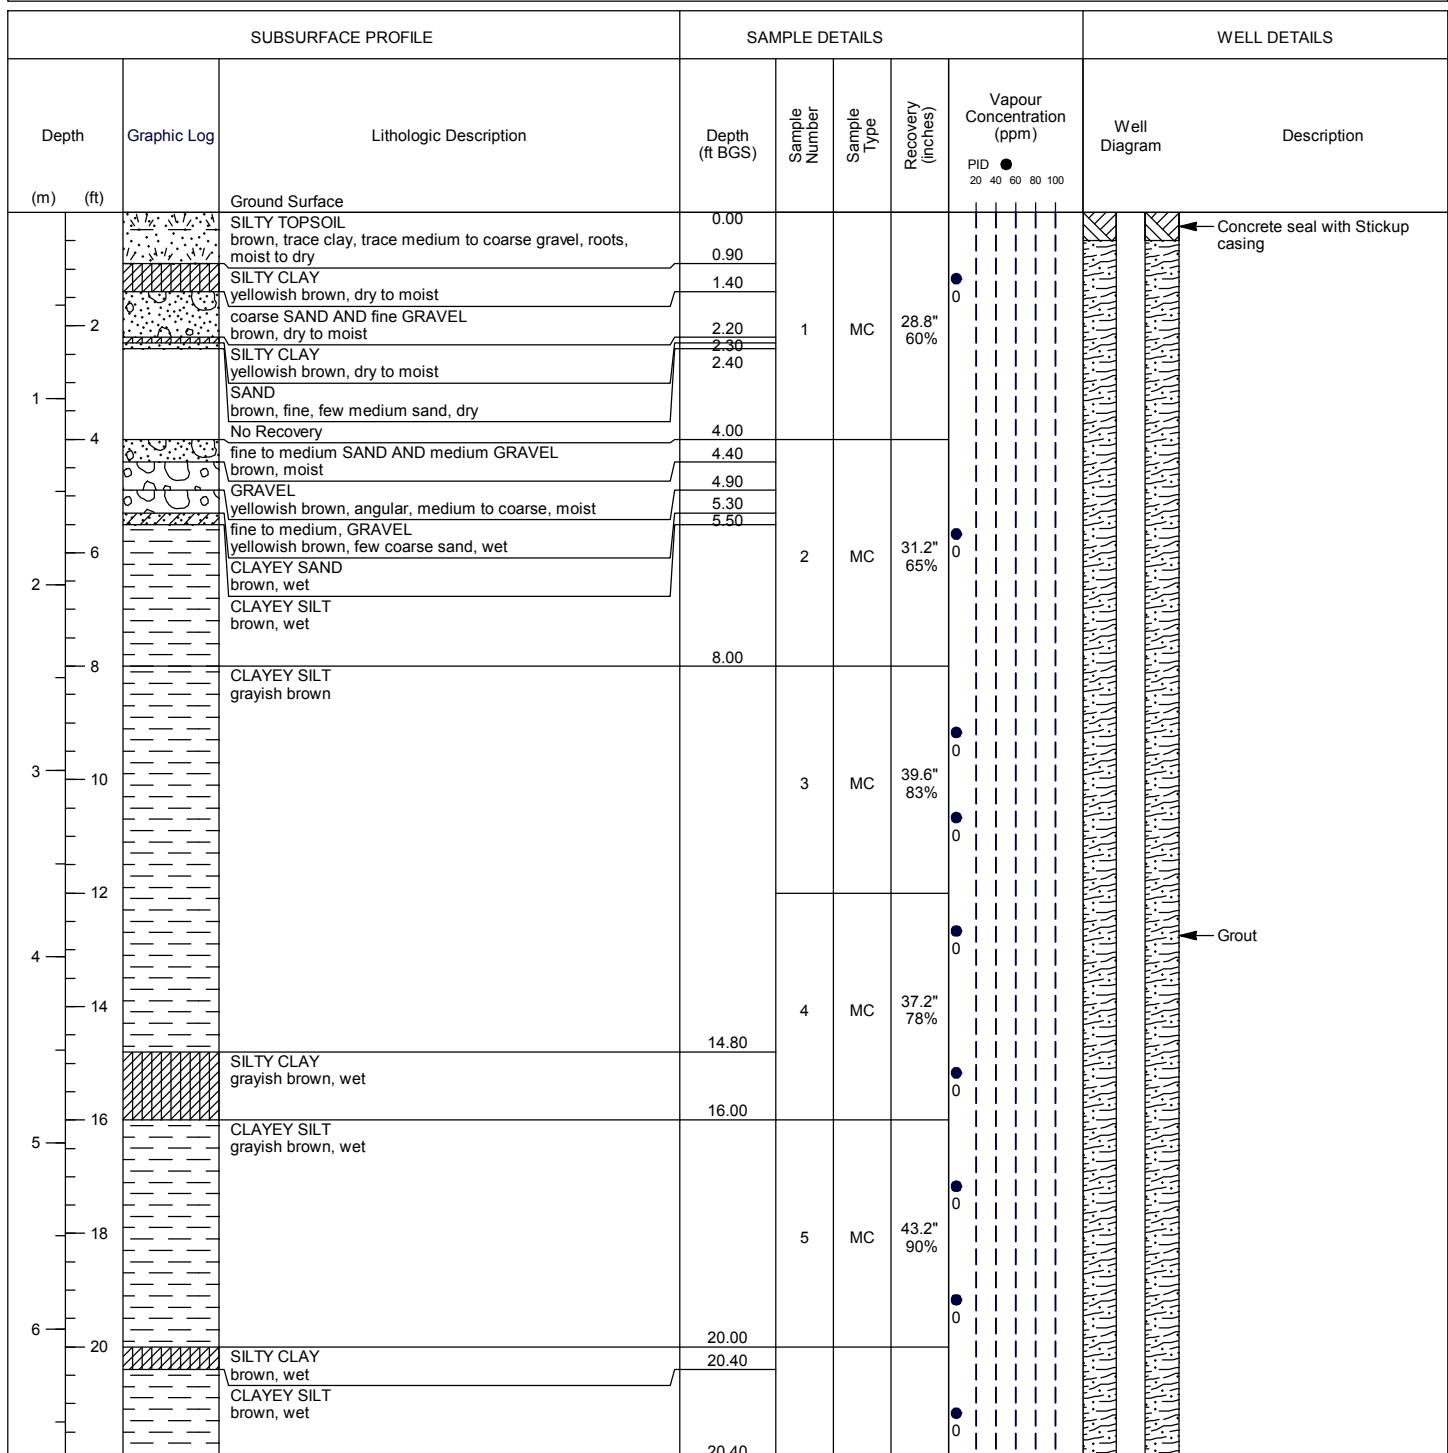
**Drilling method:** Macrocore / Hollow Stem Auger  
**Date started/completed:** 01-Feb-2011  
**Ground surface elevation:** n/a  
**Top of casing elevation:** n/a  
**Easting:** n/a  
**Northing:** n/a

Sand Pack Interval: 27.70 - 40.00 ft BGS  
Screen Interval: 30.00 - 40.00 ft BGS  
Well Seal Interval: 25.00 - 27.70 ft BGS
