**Contained-In Demonstration Work Plan  
Former Allegany Bitumens Belmont  
Asphalt Plant  
Brownfield Cleanup Program  
Site # C902019  
5392 State Route 19  
Amity, Allegany County, New York**

**RE: Contained-In Demonstration Work Plan  
Brownfield Cleanup Program Site # C902019  
Former Allegany Bitumens Belmont Asphalt Plant  
5392 State Route 19, Amity, New York**

**CONTAINED-IN DEMONSTRATION WORK PLAN  
FORMER ALLEGANY BITUMENS BELMONT ASPHALT PLANT****Table of Contents**

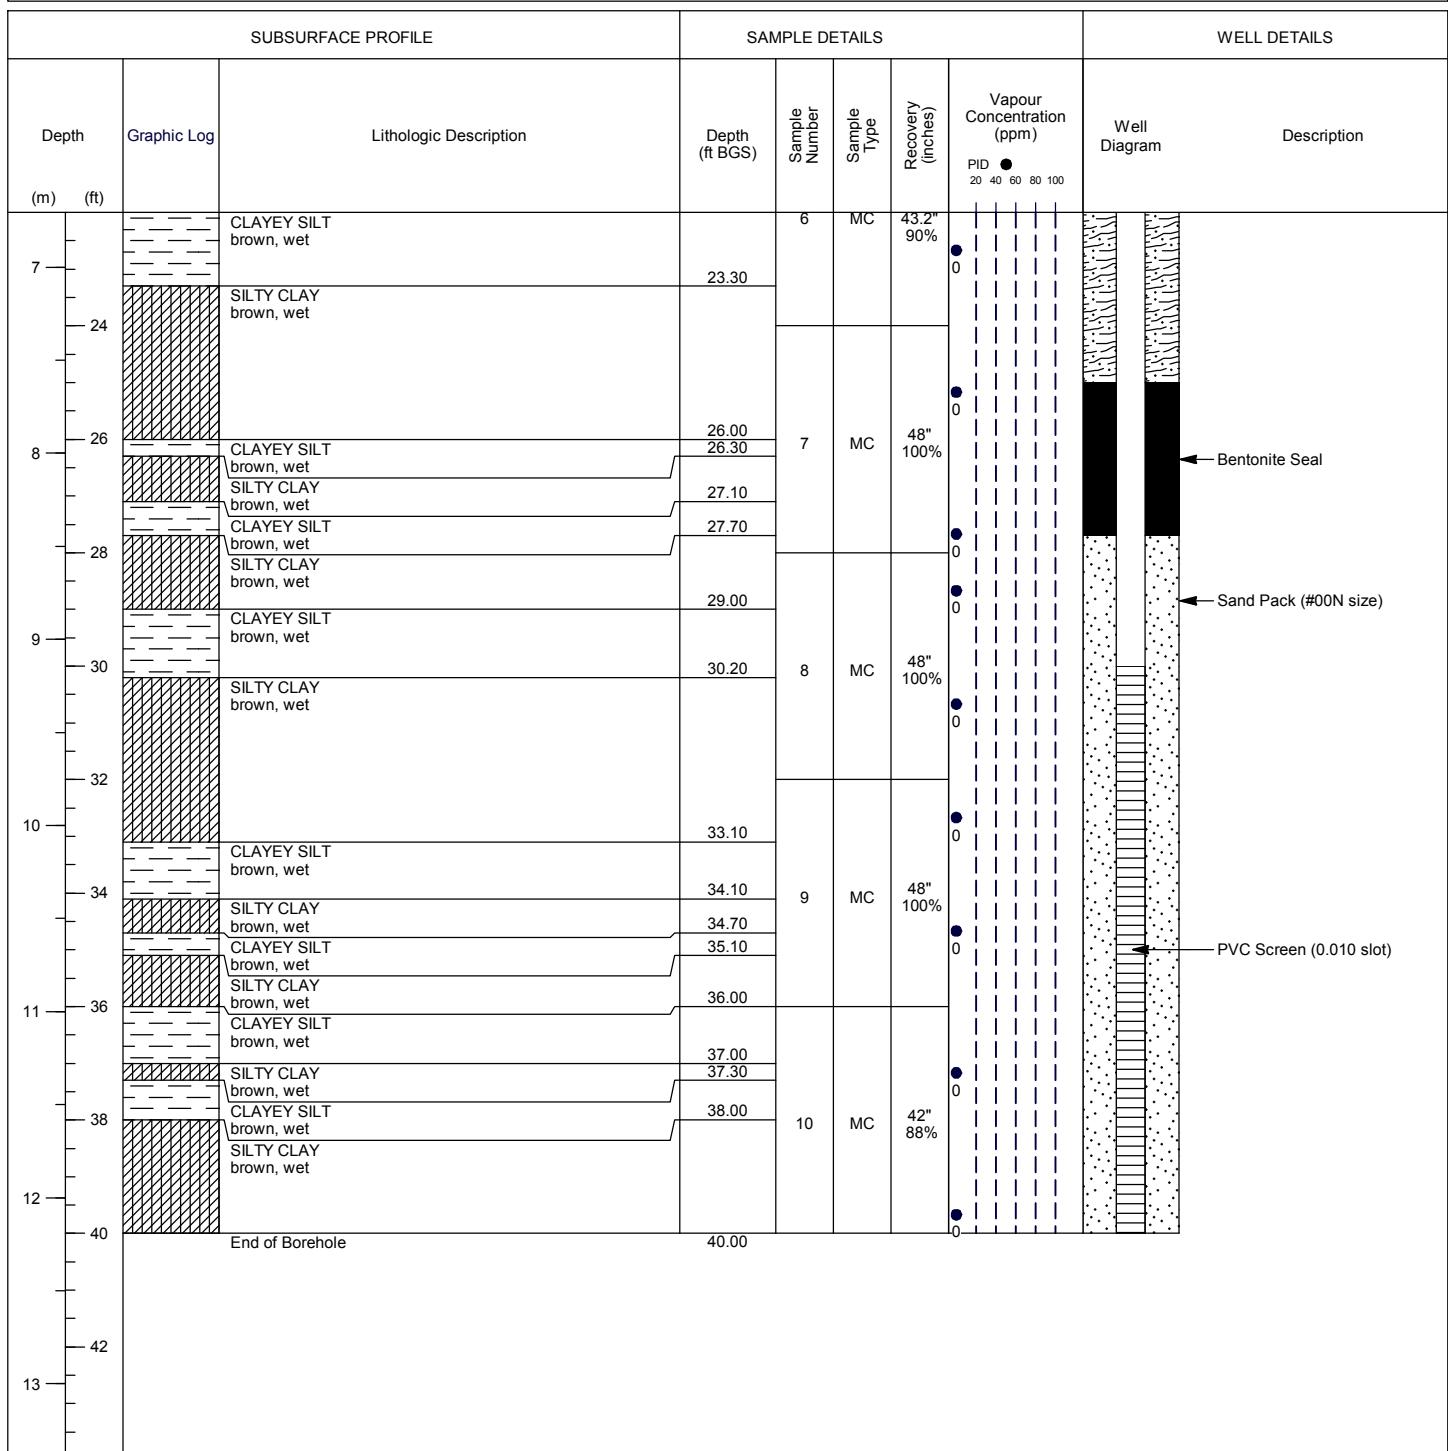
**Drilling method:** Macrocore / Hollow Stem Auger  
**Date started/completed:** 01-Feb-2011  
**Ground surface elevation:** n/a  
**Top of casing elevation:** n/a  
**Easting:** n/a  
**Northing:** n/a

Sand Pack Interval: 27.70 - 40.00 ft BGS  
Screen Interval: 30.00 - 40.00 ft BGS  
Well Seal Interval: 25.00 - 27.70 ft BGS
