# REMEDIAL INVESTIGATION REPORT/ REMEDIAL WORK PLAN

**1132 – 1146 Seneca Street Site  
Buffalo, New York 14240  
(BCP Site C915228)**

JULY 2010

**Malcolm Pirnie, Inc.**

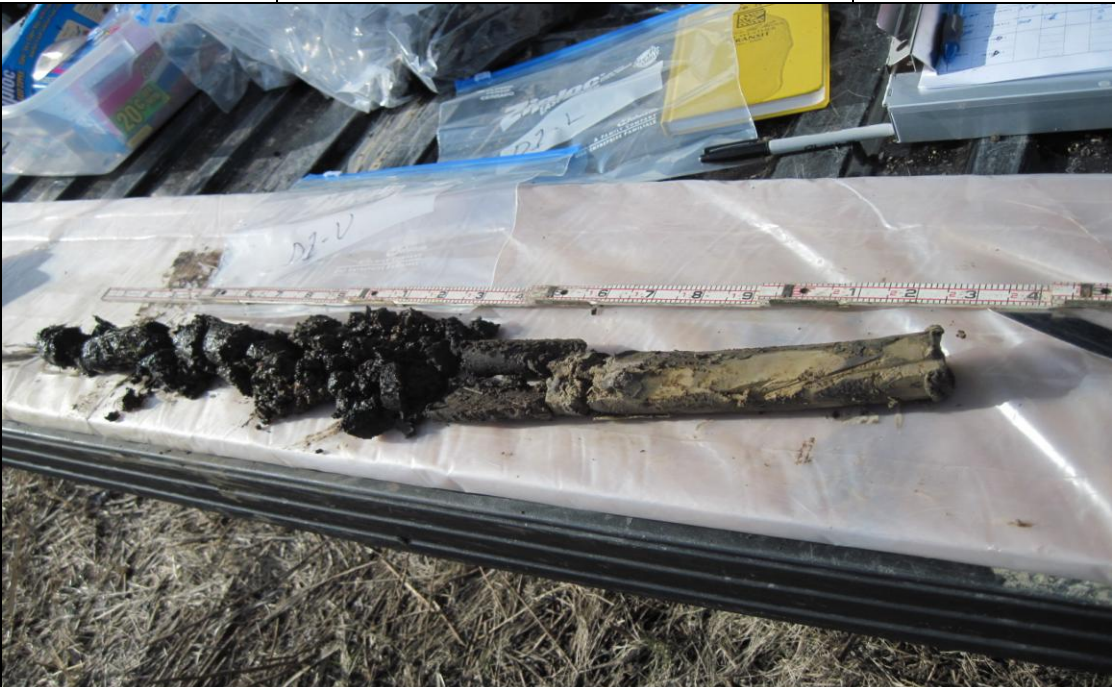
<b>Project:</b> 1132-1146 Seneca Street BCP Site		<b>Location:</b> Buffalo, NY	<b>Project No.</b> 6105-002
<b>Photo No.</b> 8	<b>Date:</b> 3/18/10

<b>Direction Photo Taken:</b> NA			
<b>Description:</b> Split spoon sample. Typical black colored soil/fill over native clay.

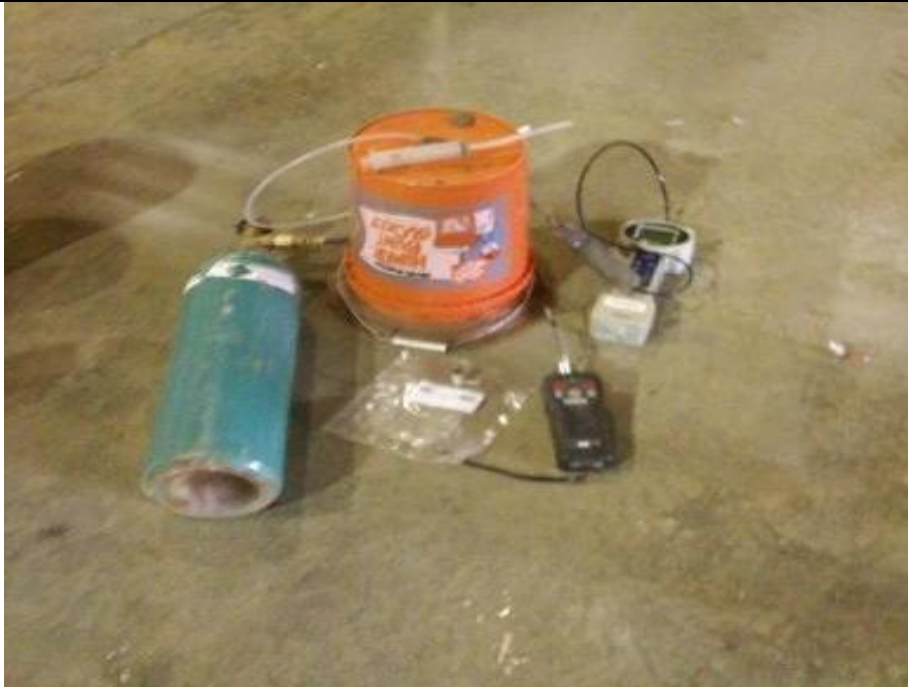
<b>Project:</b> 1132-1146 Seneca Street BCP Site		<b>Location:</b> Buffalo, NY	<b>Project No.</b> 6105-002
<b>Photo No.</b> 12	<b>Date:</b> 10/21/09

<b>Direction Photo Taken:</b>  NA			
<b>Description:</b>  Typical sub-slab soil vapor sampling- tracer test equipment and configuration.

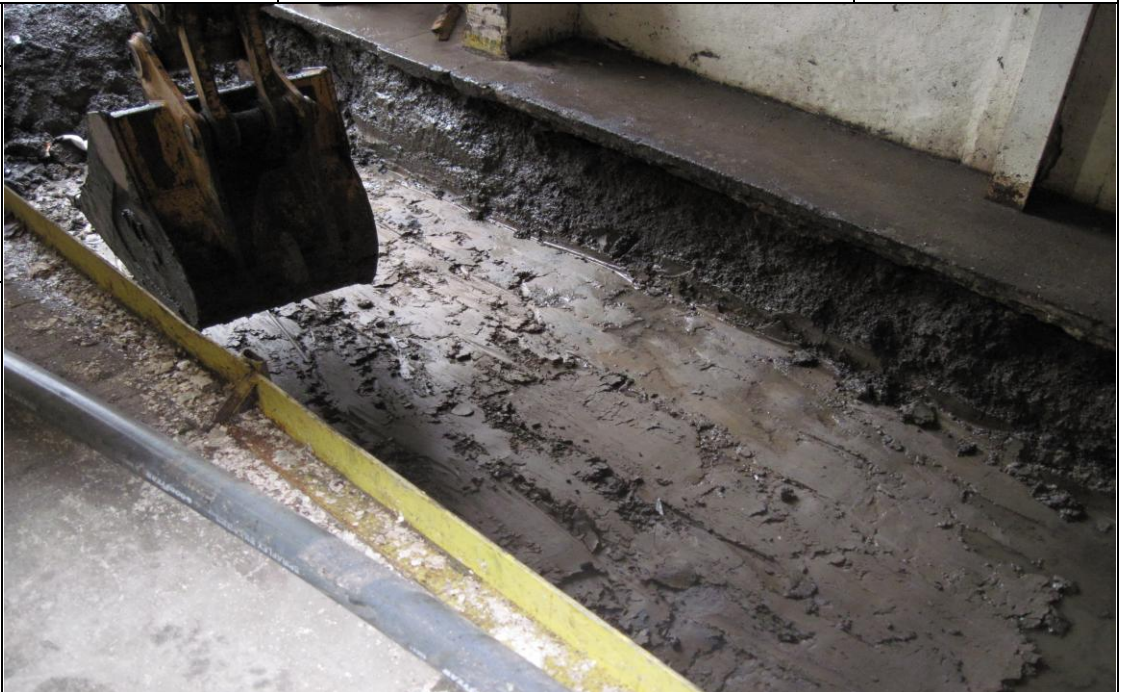
IRM excavation activities at 1132 loading dock. Note native clay at bottom of excavation.

At total of 73 tons of soil/fill and concrete were removed from the loading dock IRM area and disposed at Model City as hazardous waste. The remaining (51' x 3' x 3') of PCB-impacted soil/fill and overlying concrete slab will be removed during Site remediation.

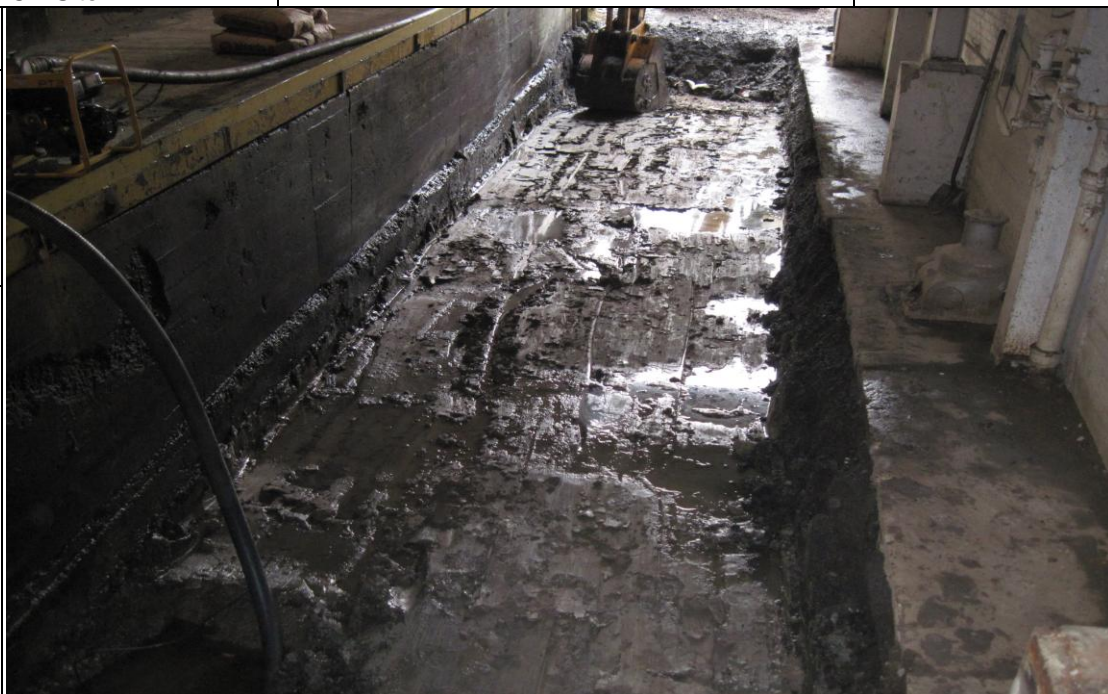
View of completed excavation at the 1132 loading dock IRM.

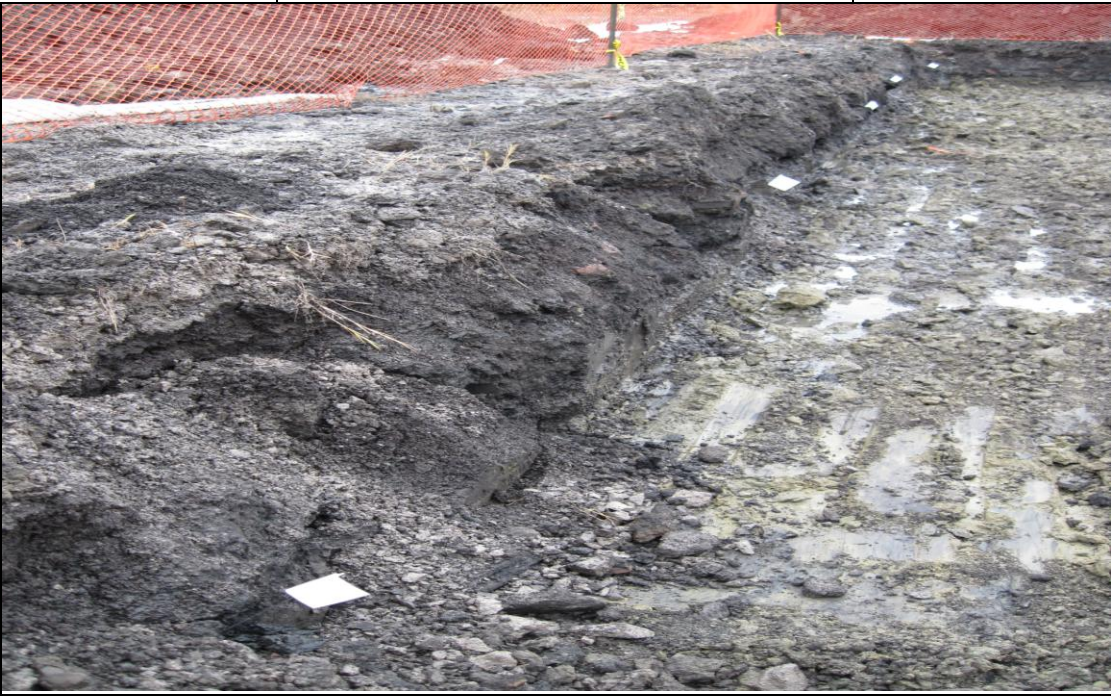
<b>Project:</b> 1132-1146 Seneca Street BCP Site		<b>Location:</b> Buffalo, NY	<b>Project No.</b> 6105-002
<b>Photo No.</b> 24	<b>Date:</b> 10/29/09

<b>Direction Photo Taken:</b> West/Northwest			
<b>Description:</b> Flags marking locations of composite sample points sampled from north wall of the 1132 North area IRM.

A total of 277 tons of PCB-impacted soil/fill from the north IRM excavation were removed from the Site and transported to the Tonawanda Landfill as non-hazardous waste via Ensol. Appendix C contains manifests for all materials transported and disposed off-Site from the two IRMs.

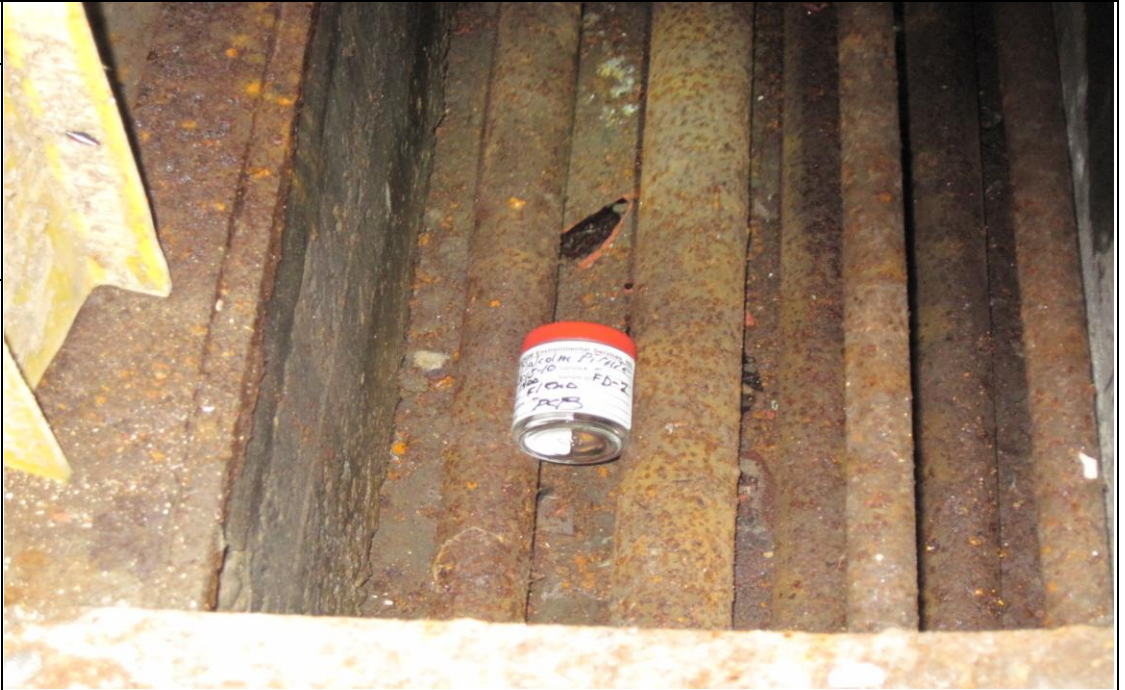
FD-2 sample collected of dirt/sediment beneath pipes

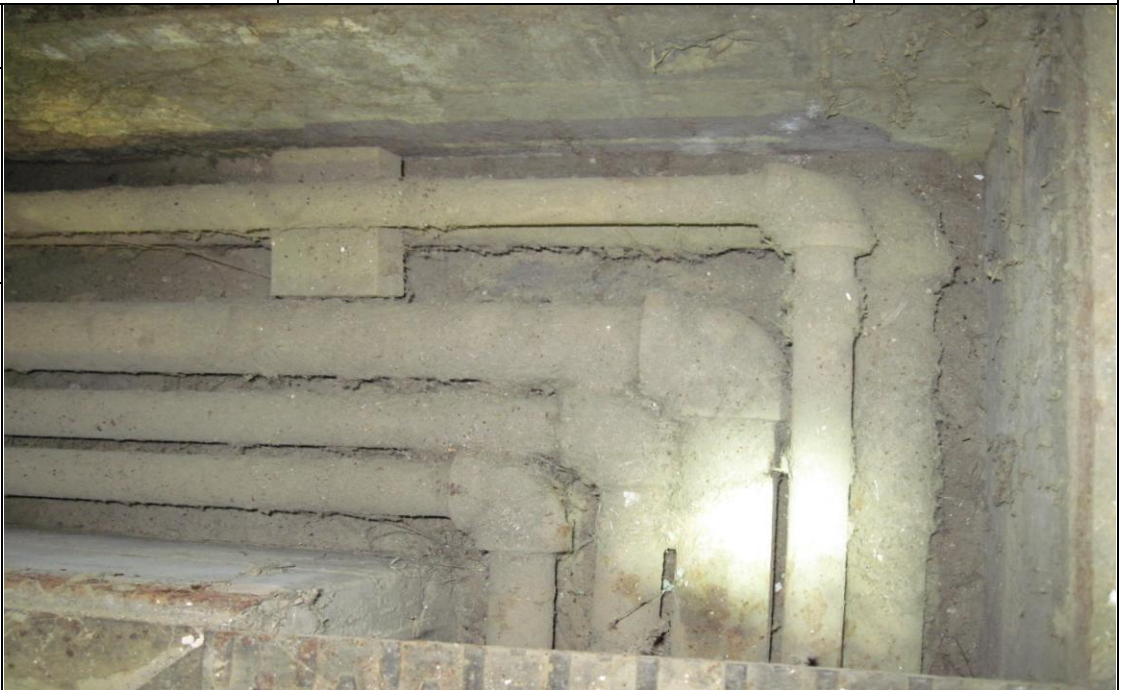
Location of FD-1, collected from beneath and west of all pipes.
