**Subject: Sub-Slab Vapor Evaluation - Former Scott Aviation Facility Area 1 BCP Site
NYSDEC Site Code No. C915233, Lancaster, New York**

Photograph Log

Client Name: Tyco International
Project No.: 60155991

Site Location: Former Scott Aviation Facility
Area - 1 BCP, Lancaster, New York

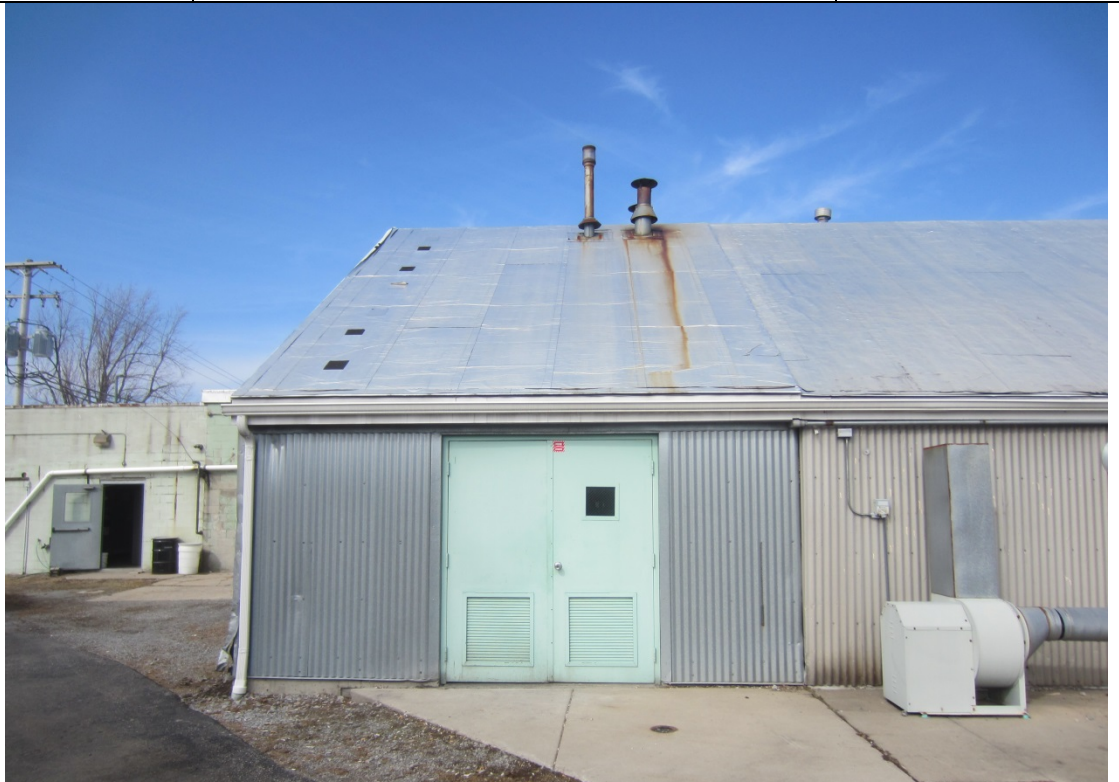
Photo No.
1

View of boiler room. Note boiler room (grey metal siding) is a separate building with its own foundation built next to the tan metal former Reliability Test room.

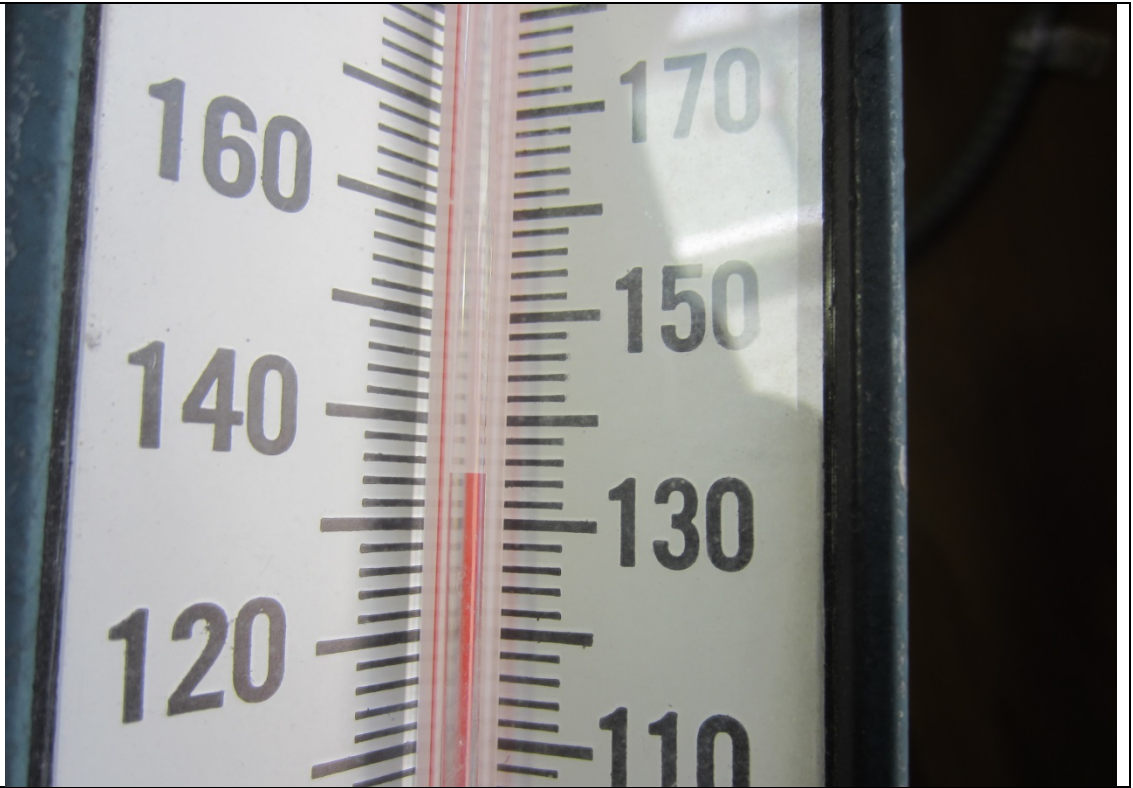
Photo No. 6	Date: 12/23/14
Direction Photo Taken: West	
Description: View of thermometer displaying average temperature inside the boiler room.

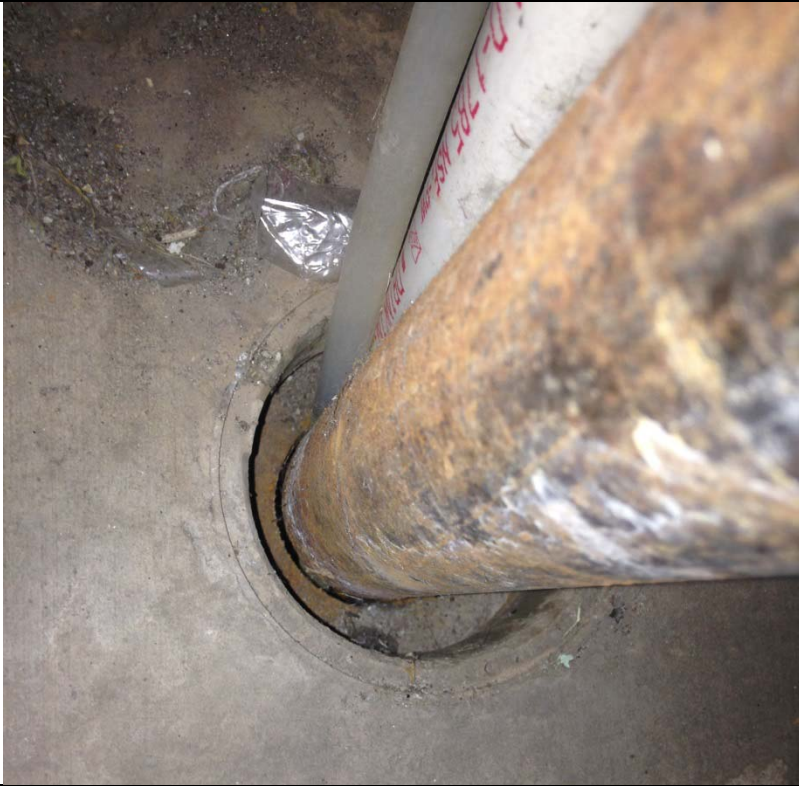
Photo No. 7	Date: 11/4/14
Direction Photo Taken: East	
Description: View of floor perforation (drain) prior to sealing.

During the scoping activity for installation of a sub-slab depressurization system associated with the Interim Remedial Measures Remedial Action Work Plan dated June 4, 2014, several foundation perforations (drains) were identified behind the boiler and associated machinery that were not noted during the original sampling effort. Also, several cracks in the concrete floor were observed which may have been conduits for sub-slab vapor to enter the boiler room. Prior to the December 24, 2014 sample collection, the floor cracks were patched and the foundation perforations were sealed.

On November 4, 2014, AECOM and NYSDEC inspected the concrete floor of the boiler room and sealed visible floor cracks with concrete caulking. In addition, the annulus between a drain line effluent and the associated floor penetration foundation perforations was sealed with expanding foam. Two other foundation perforations (drains) were observed and temporarily plugged with modelling clay just prior to the sampling event. The floor drains appeared to discharge to the bedding gravel beneath the concrete floor slab (refer to **Attachment 1** for a photographic log).

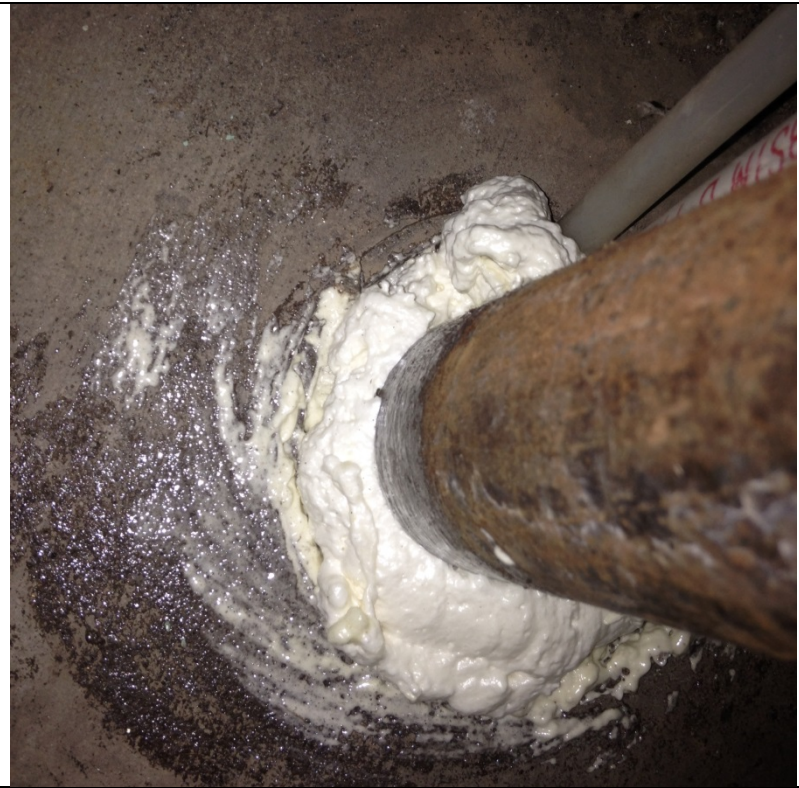
Photo No. 8	Date: 12/23/14
Direction Photo Taken: South	
Description: View of floor perforation (drain) after sealing.

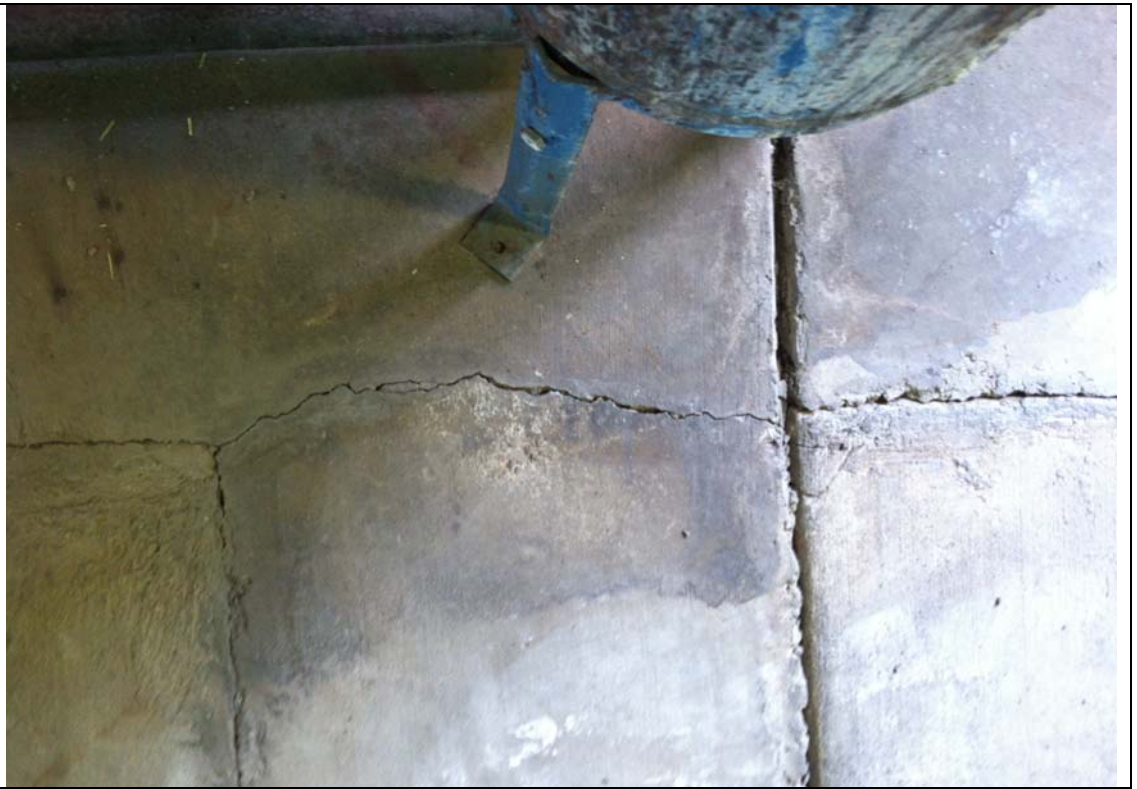
Photo No. 9	Date: 11/4/14
Direction Photo Taken: West	
Description: Example of floor crack and construction joints.

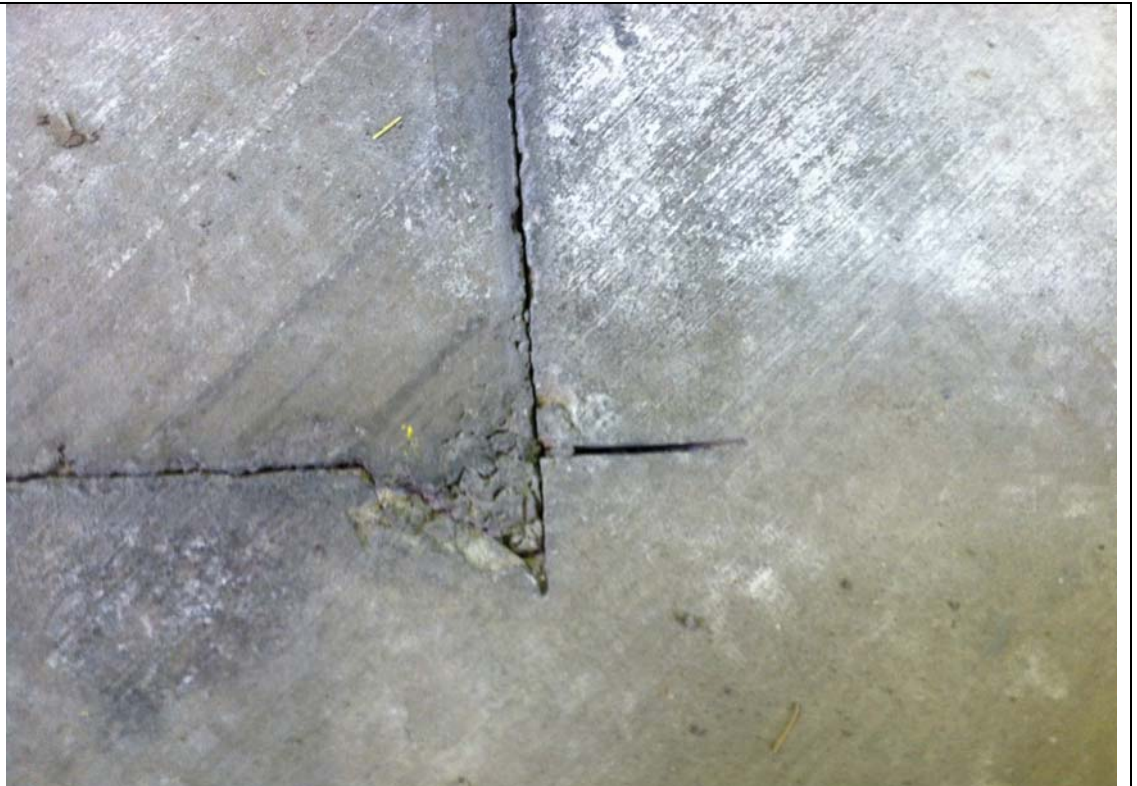
Photo No. 10	Date: 11/4/14
Direction Photo Taken: North	
Description: Example of saw cut.

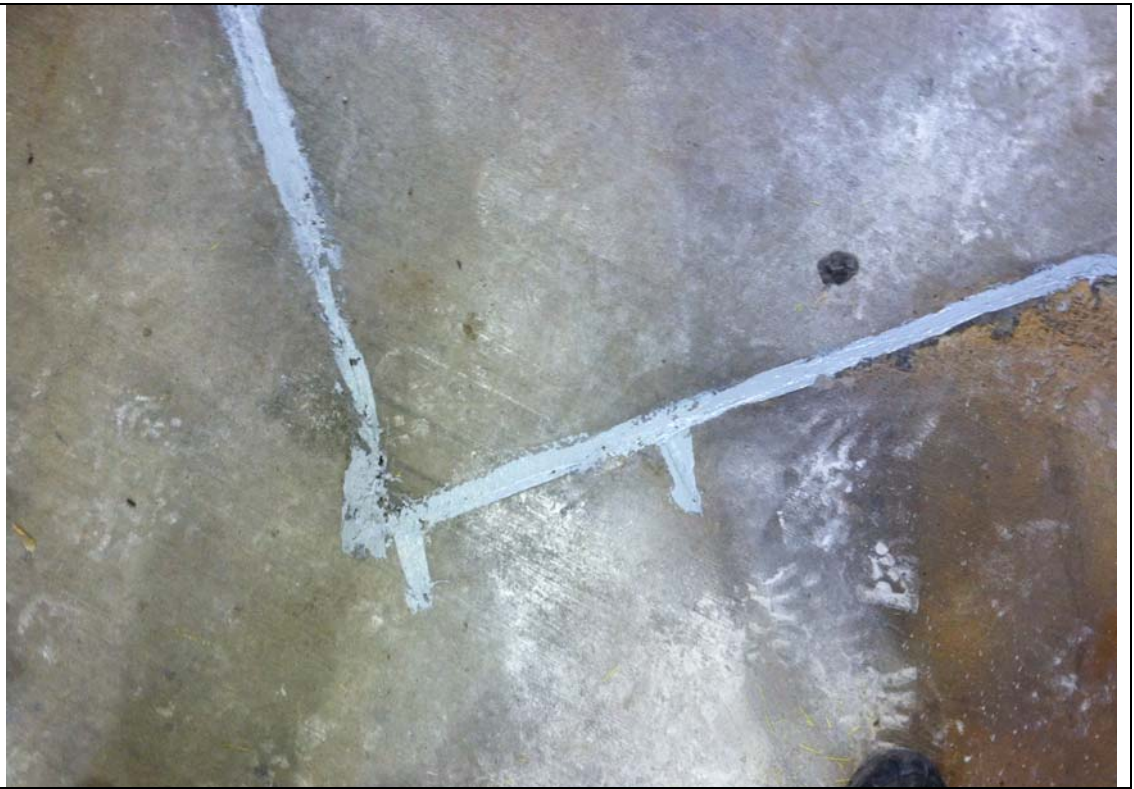
Photo No. 11	Date: 12/23/14
Direction Photo Taken: North	
Description: View of sealed floor cracks and saw cuts. Note the floor cracks/cuts were sealed on 11/4/14.

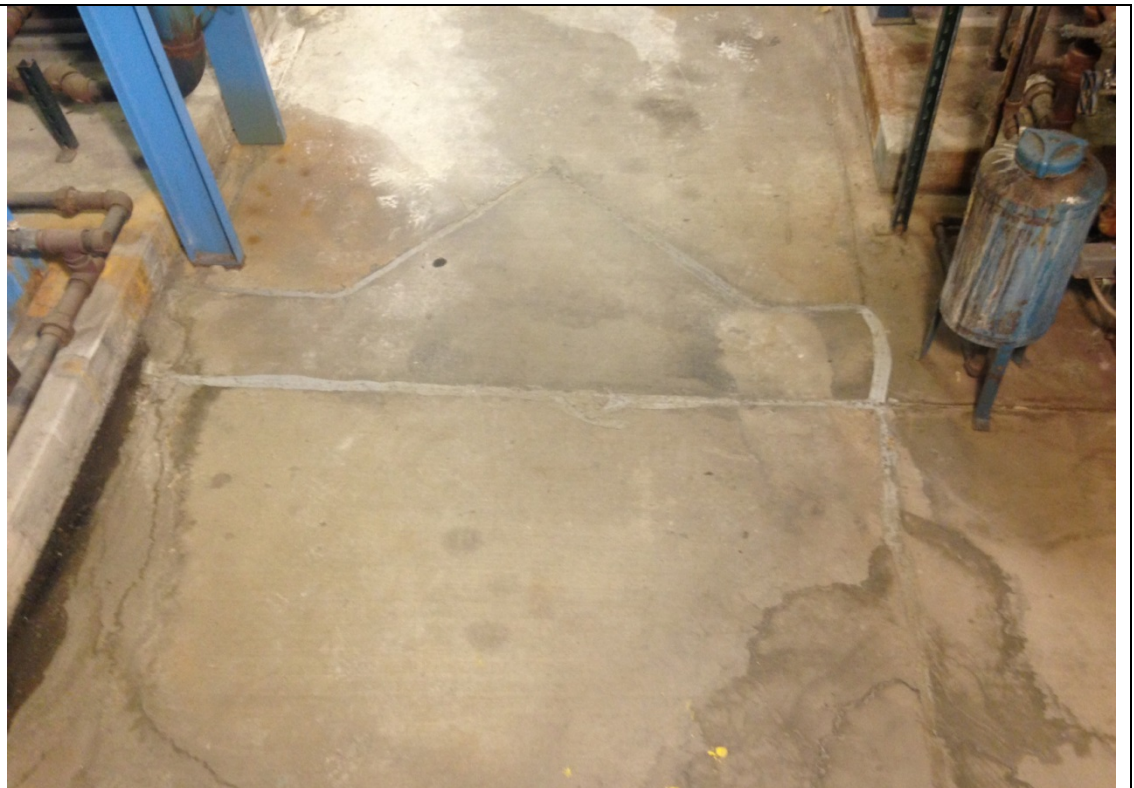
Photo No. 12	Date: 12/23/14
Direction Photo Taken: South	
Description: View of sealed floor cracks and saw cuts. Note the floor cracks/cuts were sealed on 11/4/14.

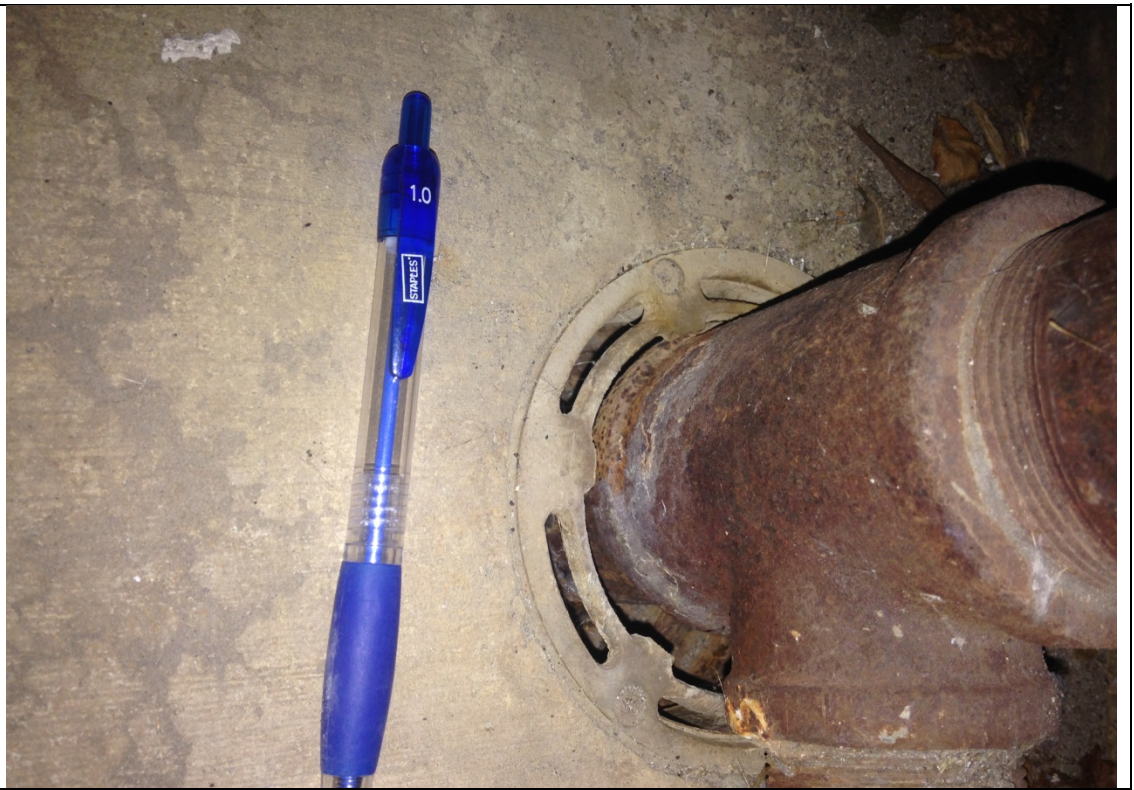
Photo No. 13	Date: 11/4/14
Direction Photo Taken: East	
Description: View of floor perforation (drain) prior to sealing.

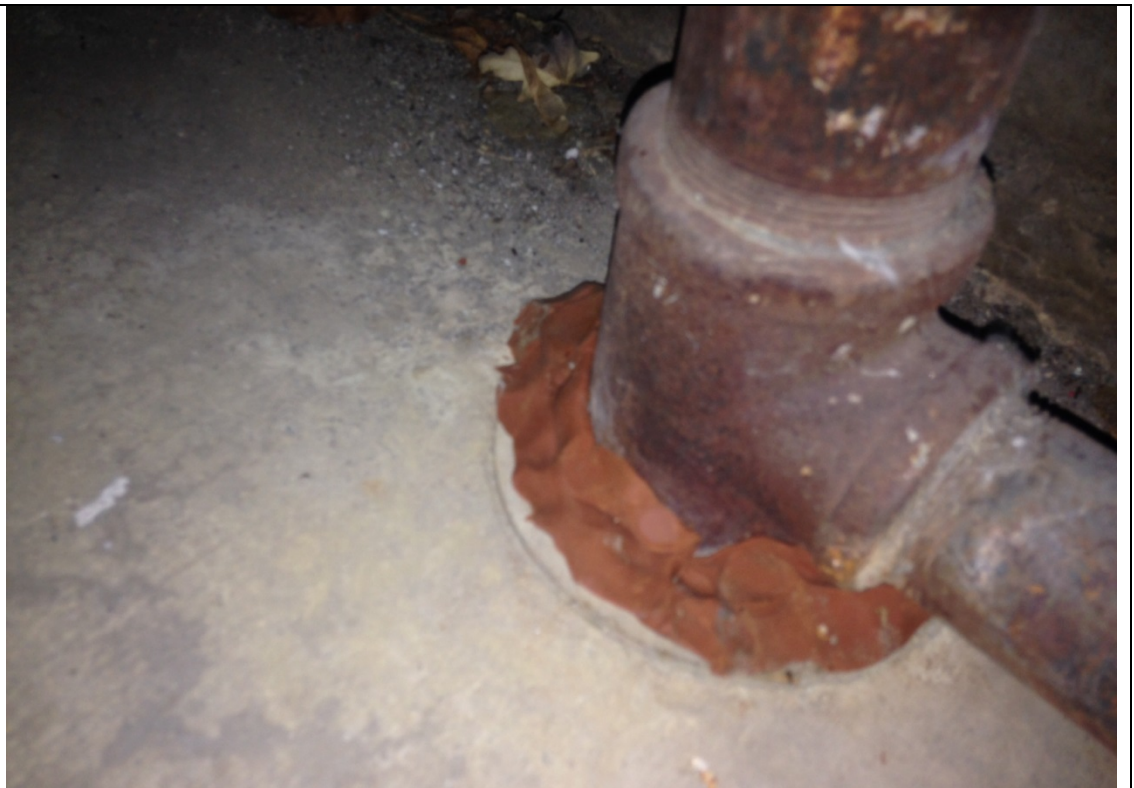
Photo No. 14	Date: 12/23/14
Direction Photo Taken: East	
Description: View of floor perforation (drain) sealed with modelling clay on 12/24/15.

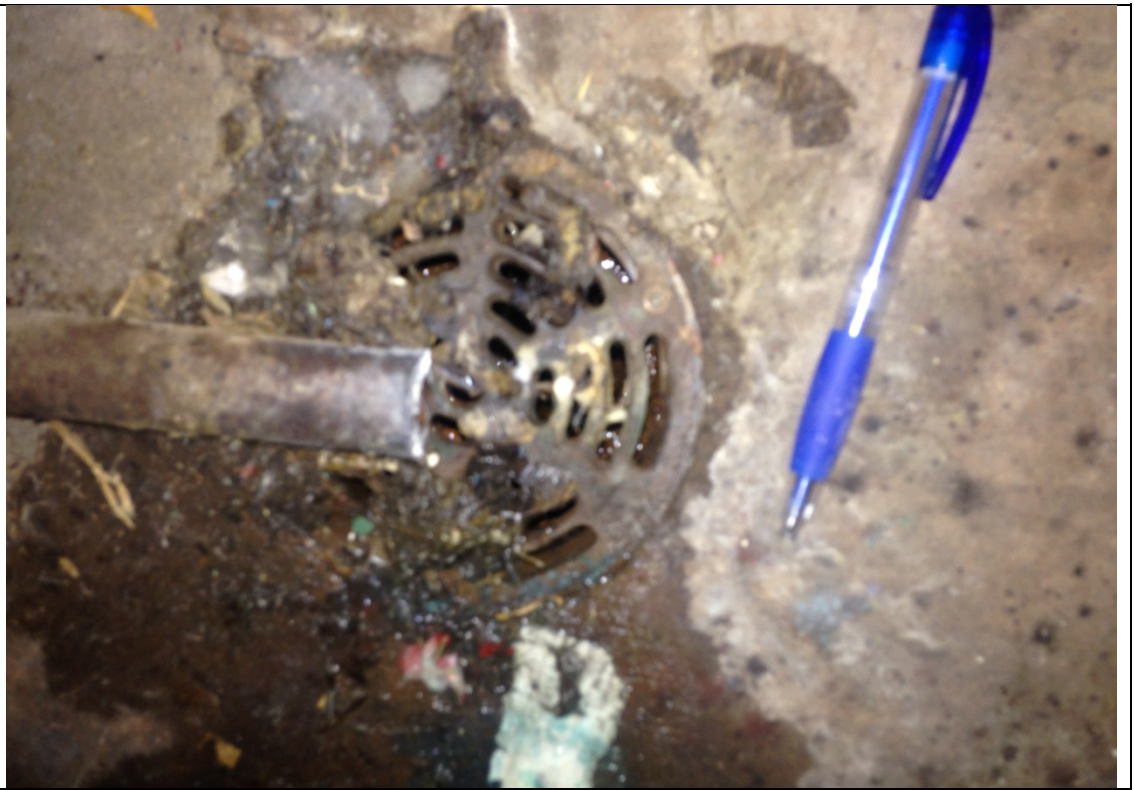
Photo No. 15	Date: 11/4/14
Direction Photo Taken: East	
Description: View of floor perforation (drain) prior to sealing.

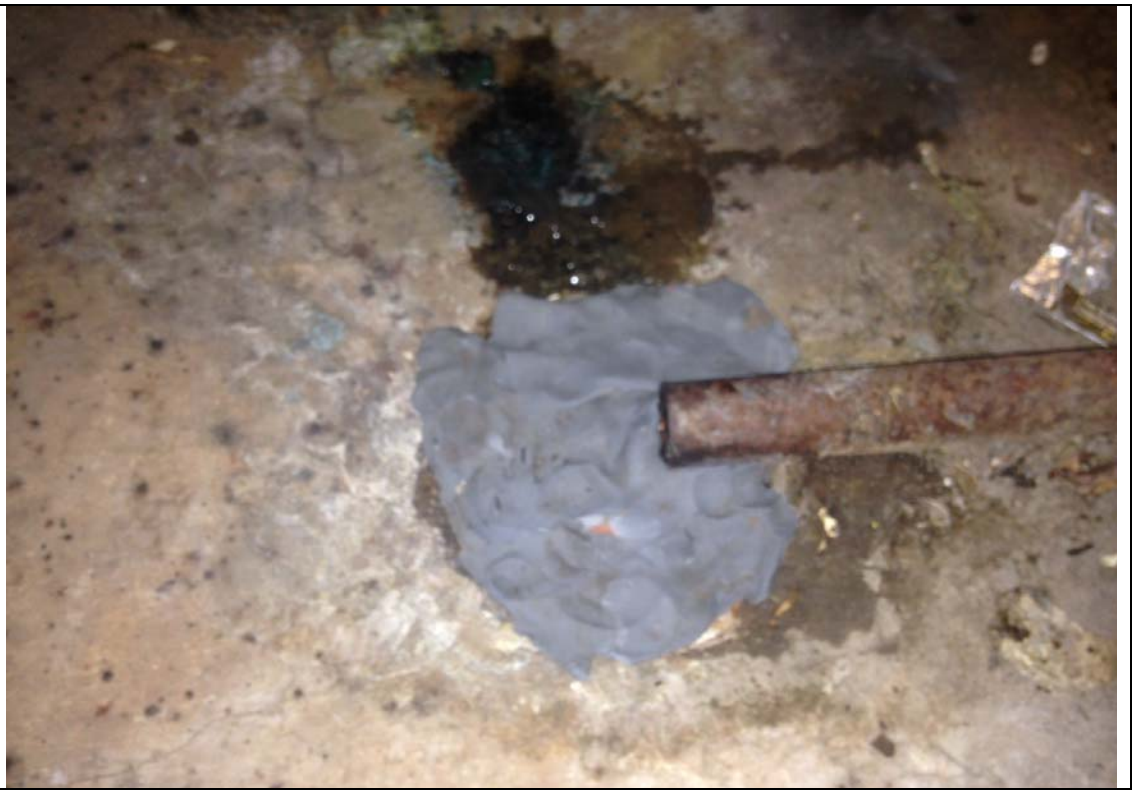
Photo No. 16	Date: 12/23/14
Direction Photo Taken: West	
Description: View of floor perforation (drain) sealed with modelling clay on 12/24/15.

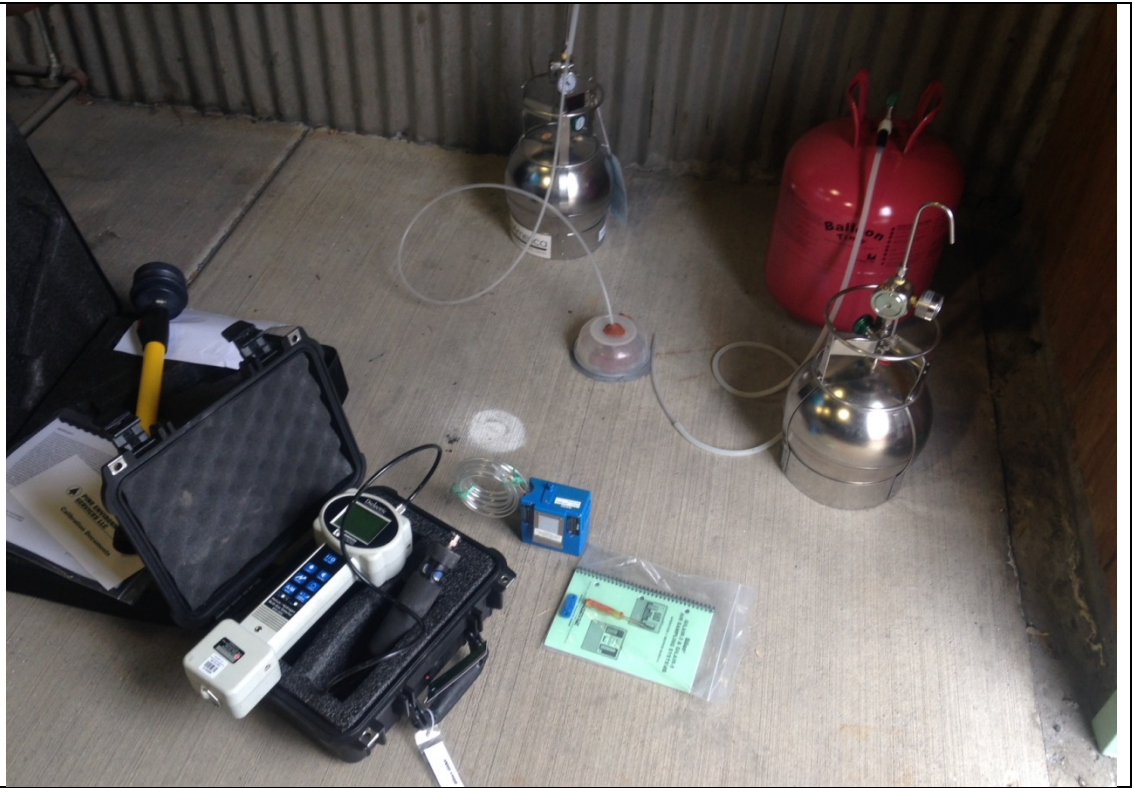
Photo No. 17	Date: 12/23/14
Direction Photo Taken: East	
Description: View of sub-slab vapor implant seal testing.

On December 23, 2014, prior to sample collection, a new seal consisting of non-toxic modelling clay was placed in the vapor Teflon tubing/floor annulus. A tracer gas (helium) shroud was placed over the sub-sample vapor sample location prior to sampling to ensure the ambient (indoor) air was not being pulled into the canister during sampling. This was accomplished by placing a clean, small plastic shroud over the probe location. An air-tight seal was placed on the ground surface around the edge of the shroud where it contacted the ground. Prior to purging or sampling activities, helium tracer gas was injected into the helium shroud using application methods described in the DOH's Guidance (Section 2.7.5). Prior to collection of the sub-slab vapor sample, the point was purged of approximately three implant volumes (i.e., volume of the sample tube and sand pack). A Dielectric Technologies Model MGD-2002 Multi-Gas Leak Locator and GilAir-3 sample pump were used to purge the implant while simultaneously screening helium concentrations in purged vapor; the purge flow rate did not exceed 0.2 liters per minute. Once the seal was determined to be satisfactory, a MultiRae Model PGM-7240 photoionization detector (PID) was used to screen the sub-slab vapor, indoor air, and the ambient (outdoor) air for VOCs (refer to **Attachment 3** for log sheets).

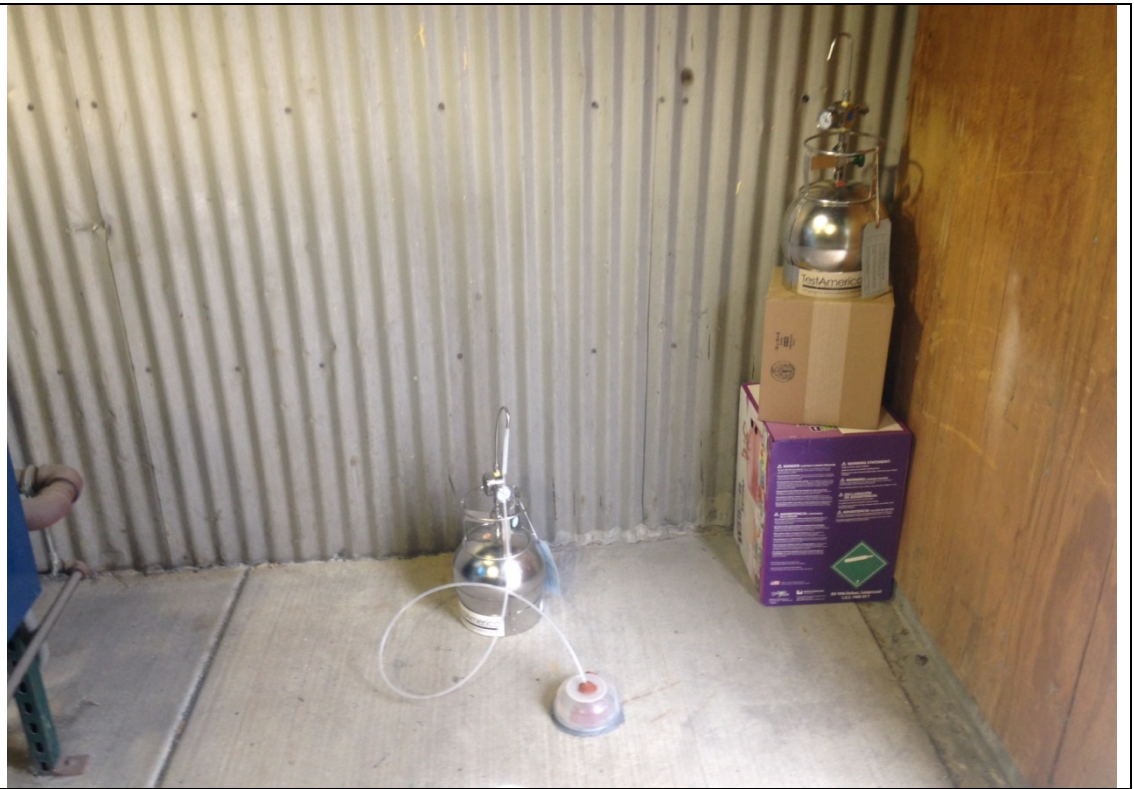
Photo No. 18	Date: 12/23/14
Direction Photo Taken: East	
Description: View of sub-slab and indoor air Summa canisters.

Sample collection was performed using a six-liter, stainless steel, Summa[®] canister, equipped with a 24-hour regulator. Sub-slab, indoor, and ambient (outdoor) air samples were collected concurrently; one field duplicate was also collected at the ambient (outdoor) air location for quality assurance purposes. The field geologist recorded the sample identification, canister and regulator

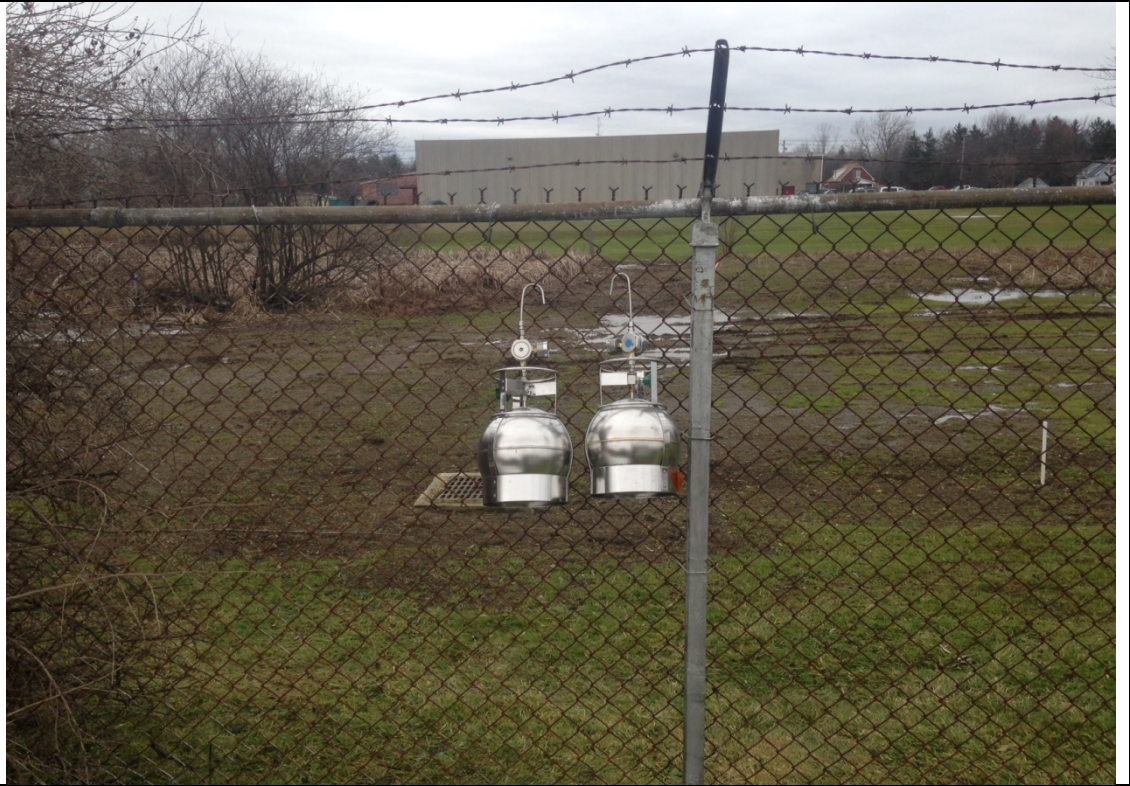
Photo No. 19	Date: 12/23/14
Direction Photo Taken: West	
Description: View of ambient air Summa canisters (duplicate sample being collected at this location). Note completed soil IRM restoration on west side of perimeter fence.

One ambient (outdoor) air sample was collected during the sub-slab and indoor air sampling activities. The ambient (outdoor) air sample was collected at the sample location chosen during the 2010 sampling event, approximately 100 feet upwind from the boiler room and approximately four feet above ground surface.

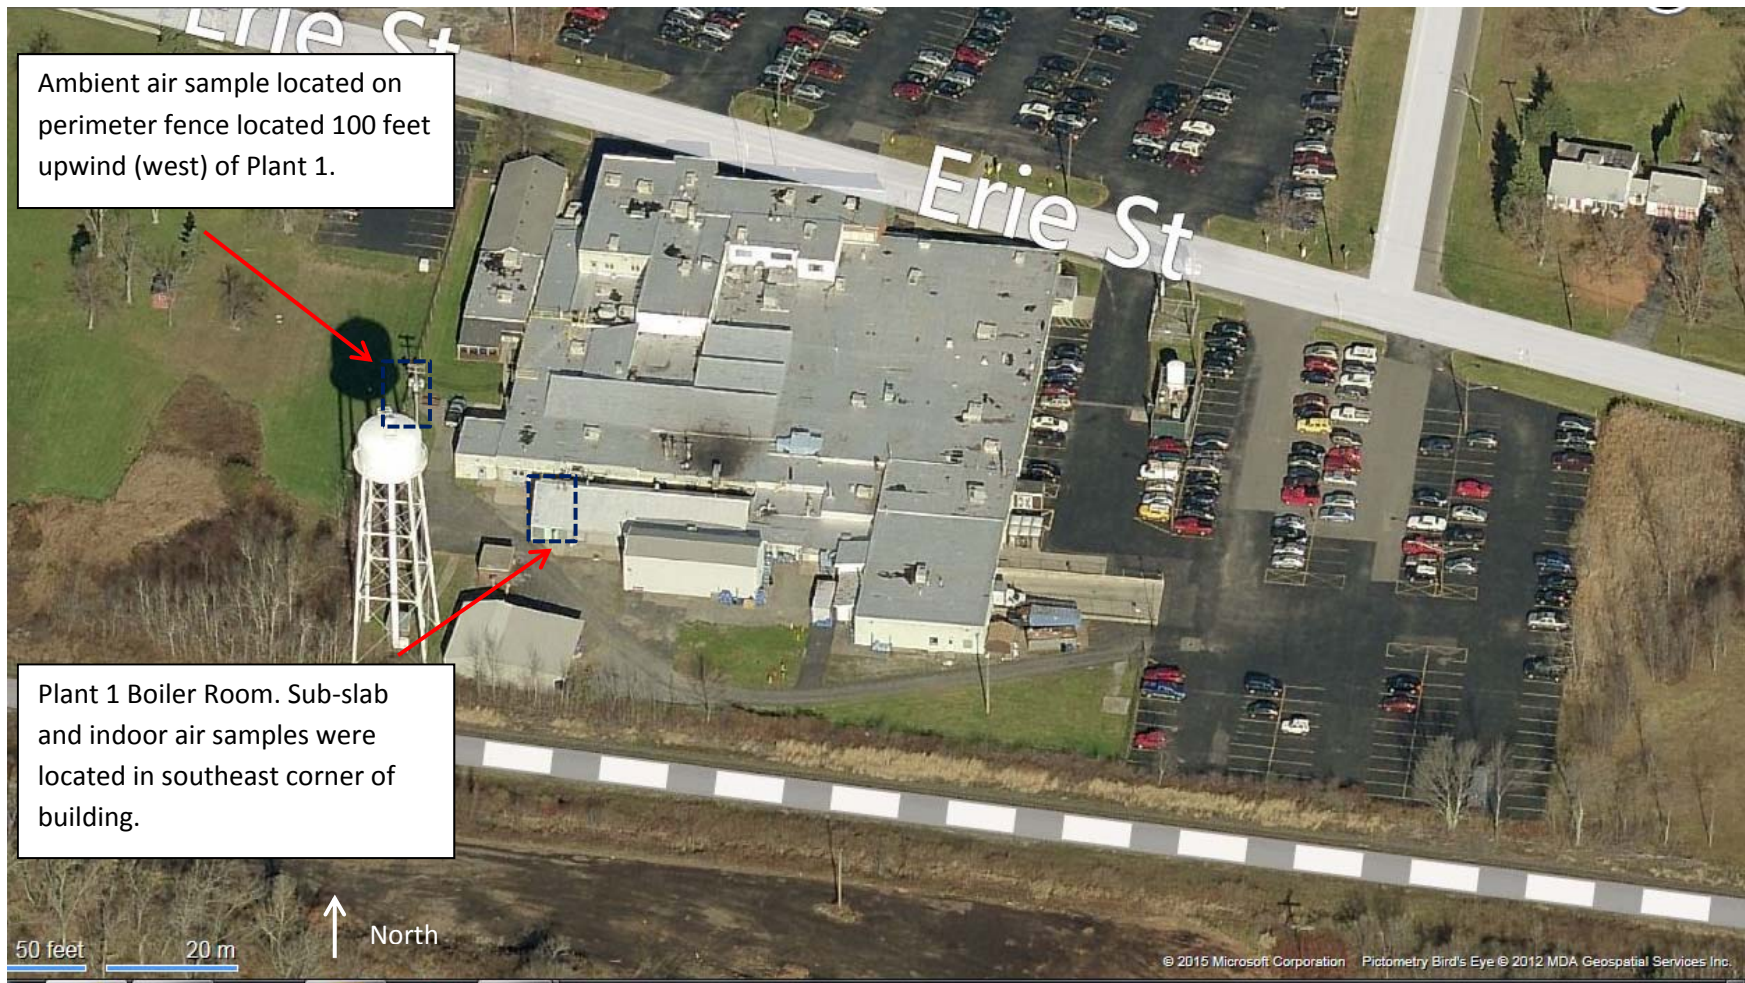
Section 12 – Outdoor Plot

Refer to attached figure
