Prepared for:
Prepared by:
AECOM
Buffalo, NY
60536398
June 2017

Periodic Review Report (December 29, 2015 through April 12, 2017)

Former Scott Aviation Facility (Area 1)
Lancaster, New York
NYSDEC Site Code No. C915233

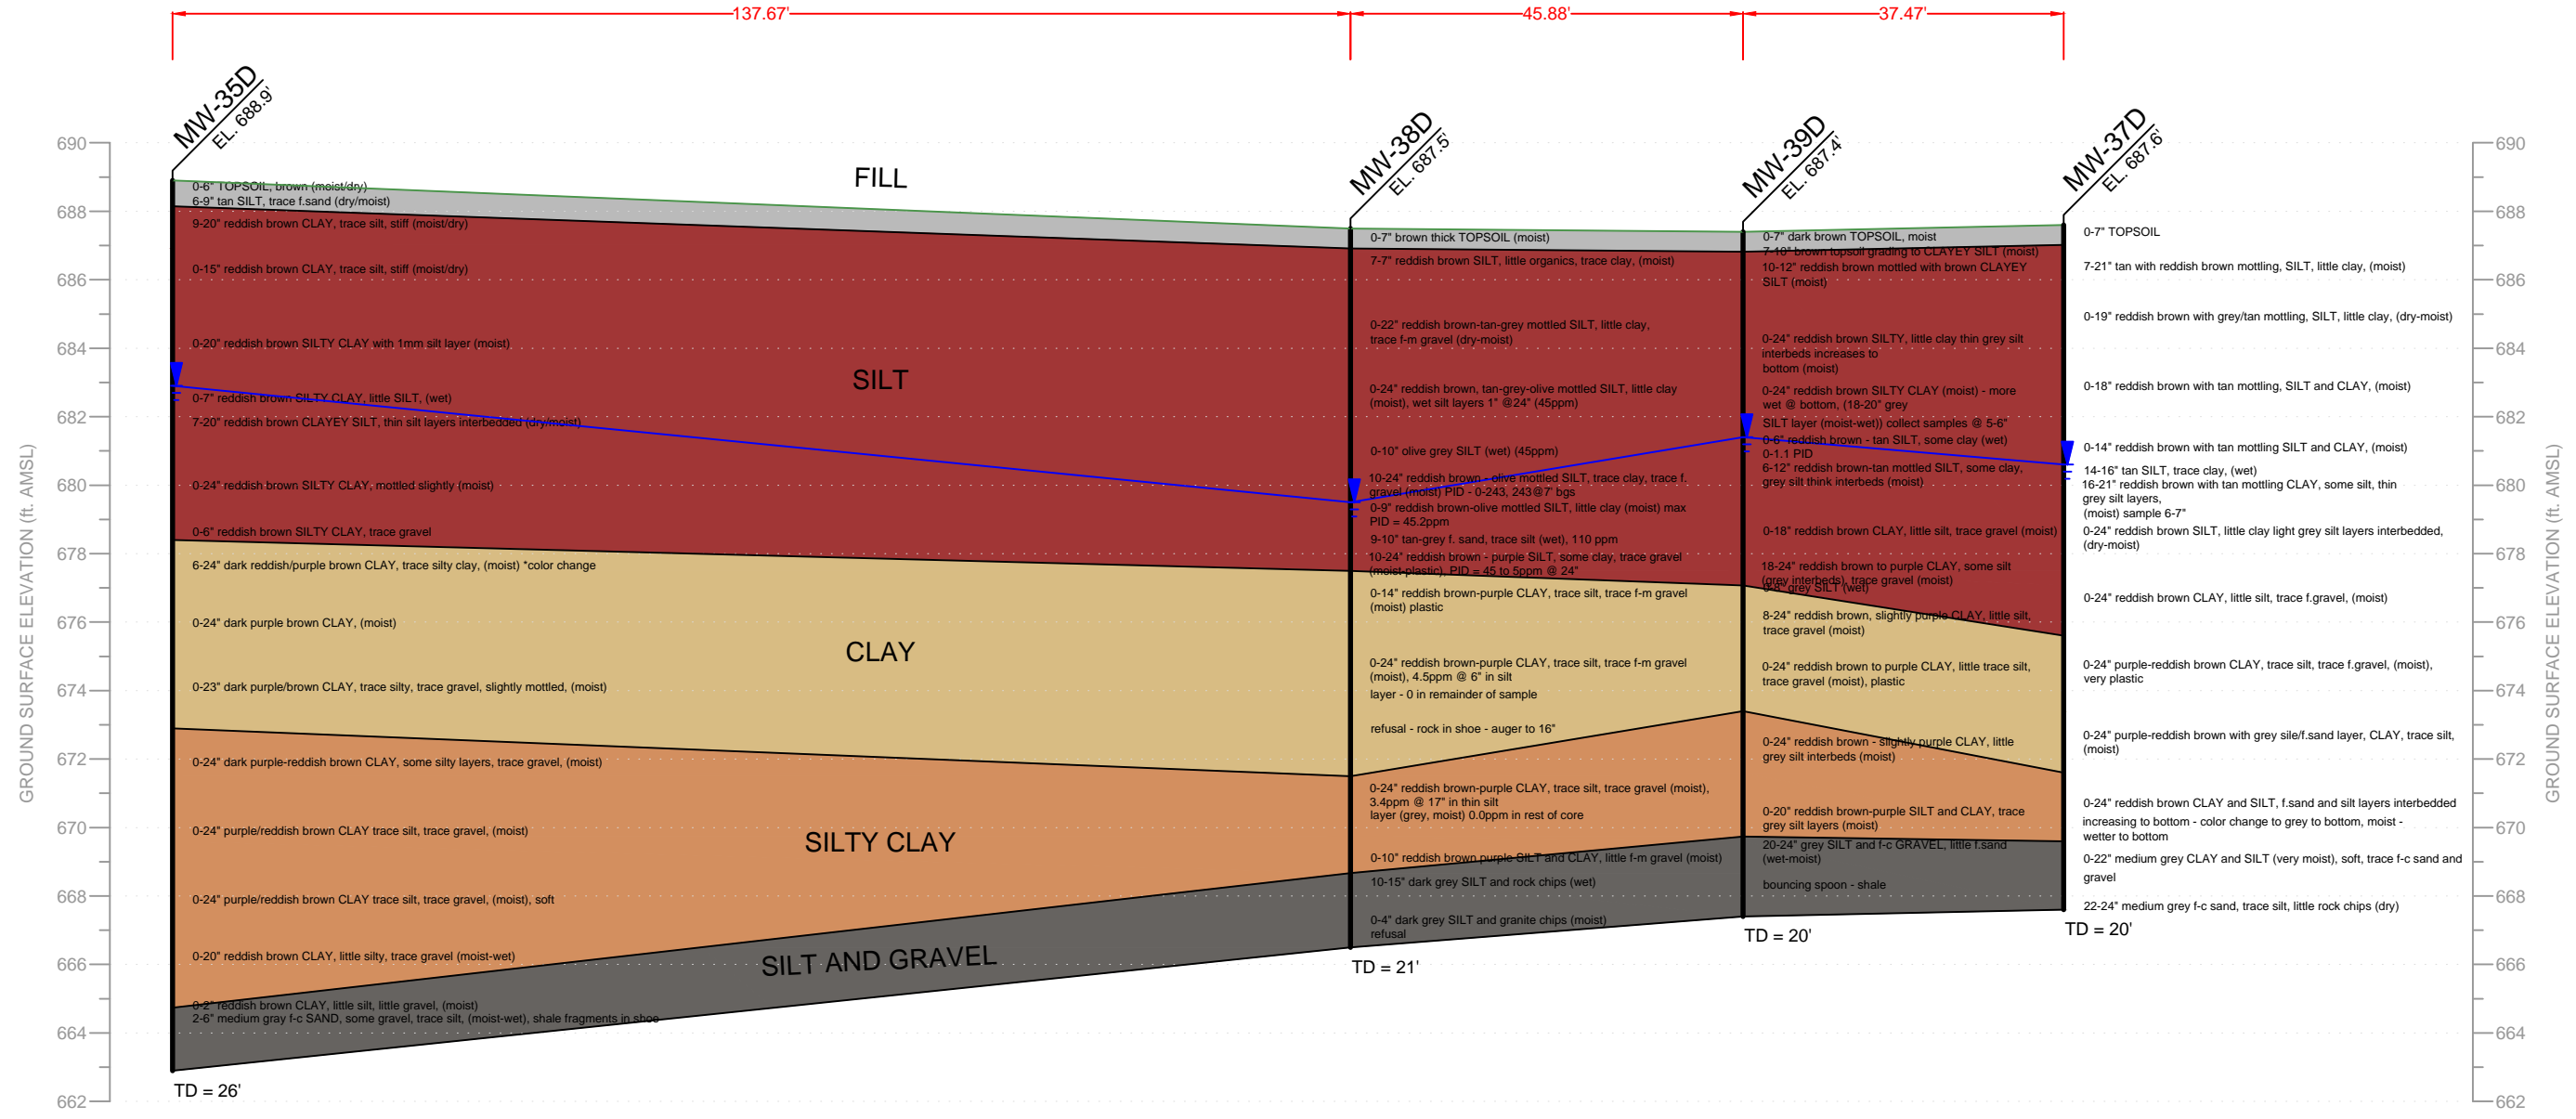
FIGURE 4
GEOLOGIC CROSS-SECTION

The native soils underlying the Site generally consist of interbedded silts and clays, with discontinuous sporadic fine sand lenses (shallow overburden). A thin coarse-grained layer of weathered shale is located above the bedrock (deep overburden). Overburden thickness ranges from 20 feet (ft) in the southern portion of the Site to 26 ft in the northern portion of the Site.

The average depth to bedrock is approximately 21 ft. Bedrock was observed to consist of black shale of the Marcellus Formation (Hamilton Group).

A transect for a geologic cross section with monitoring well and piezometer locations is shown on **Figure 3**, and the geologic cross-section is shown on **Figure 4**.
