Re: Post-Remedial Soil Vapor Intrusion (SVI) Sampling Report
December 1-2, 2020
295 Maryland Street Site (C915242), Buffalo, New York

SITE LOCATION AND VICINITY MAP
 SOIL VAPOR INTRUSION INVESTIGATION REPORT

295 MARYLAND STREET SITE
 BCP SITE NO. C915242
 BUFFALO, NEW YORK
 PREPARED FOR
 295 MARYLAND, LLC

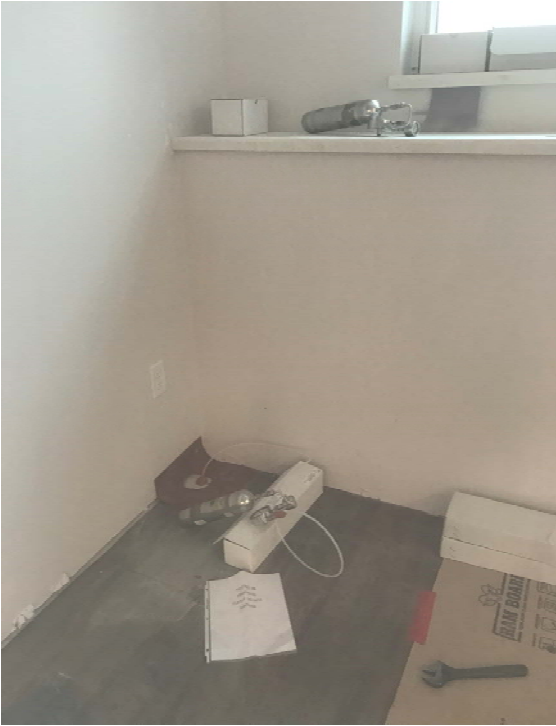
Client Name: 295 Maryland, LLC		Site Location: 295 Maryland Street Site	Project No.: 0222-020-002
Photo No. 1	Date 12/01/20

Direction Photo Taken: South			
Description: Sub-slab air sample port and air sampling canister (CW SS-1) and indoor ambient air sampling canister (CW IA-1). Basement.

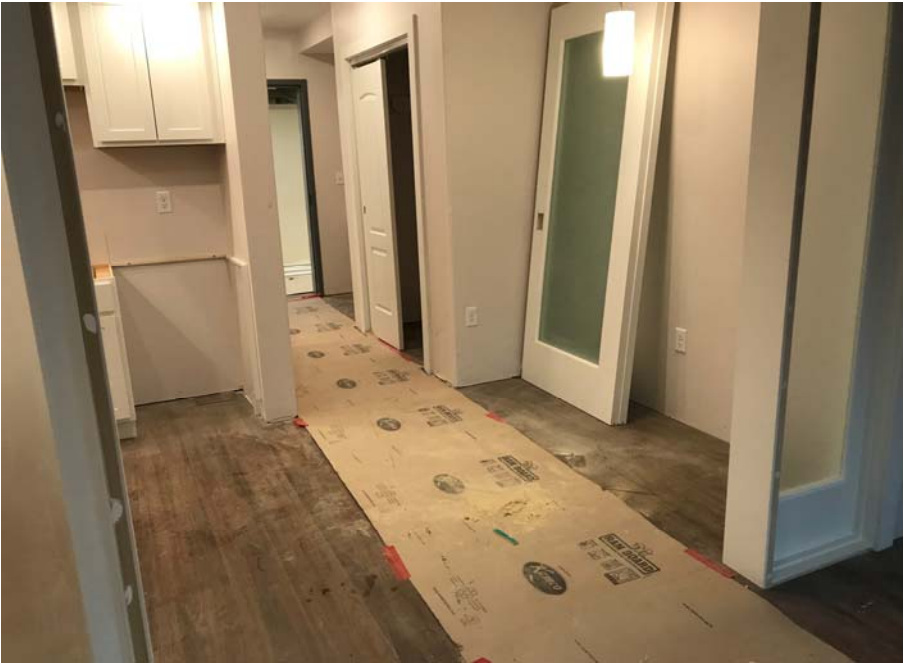
Photo No. 2	Date 12/01/20

Direction Photo Taken: Northeast		
Description: Basement apartment where sub-slab and indoor air samples were collected.

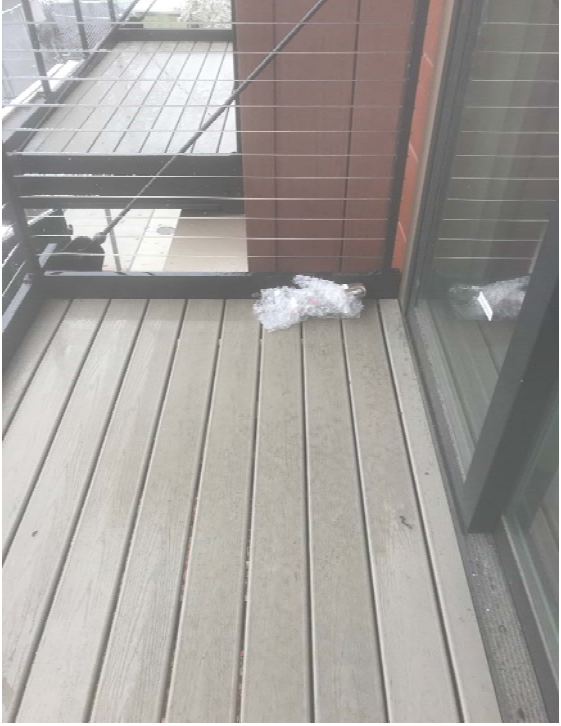
Client Name: 295 Maryland, LLC		Site Location: 295 Maryland Street Site	Project No.: 0222-020-002
Photo No. 3	Date 12/01/20

Direction Photo Taken: Southeast			
Description: Outdoor ambient air sampling canister (CW OA-1). Outside on second story patio.

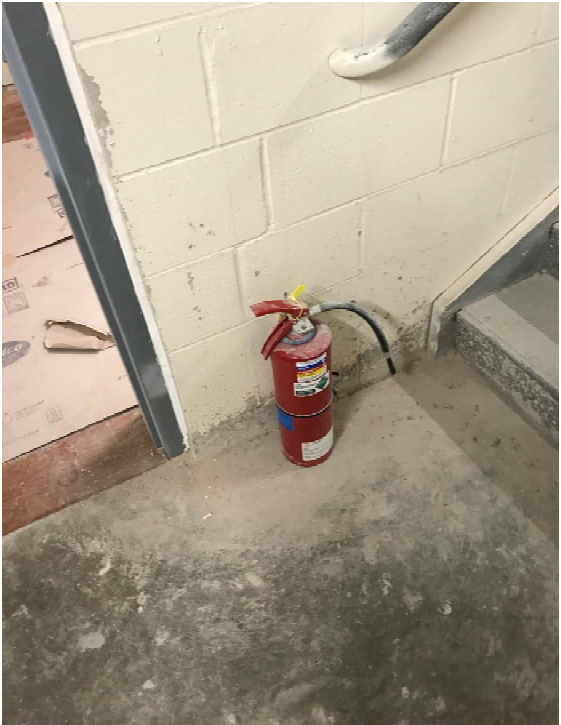
Photo No. 4	Date 12/01/20

Direction Photo Taken:		
Description: Chemical Inventory - Basement

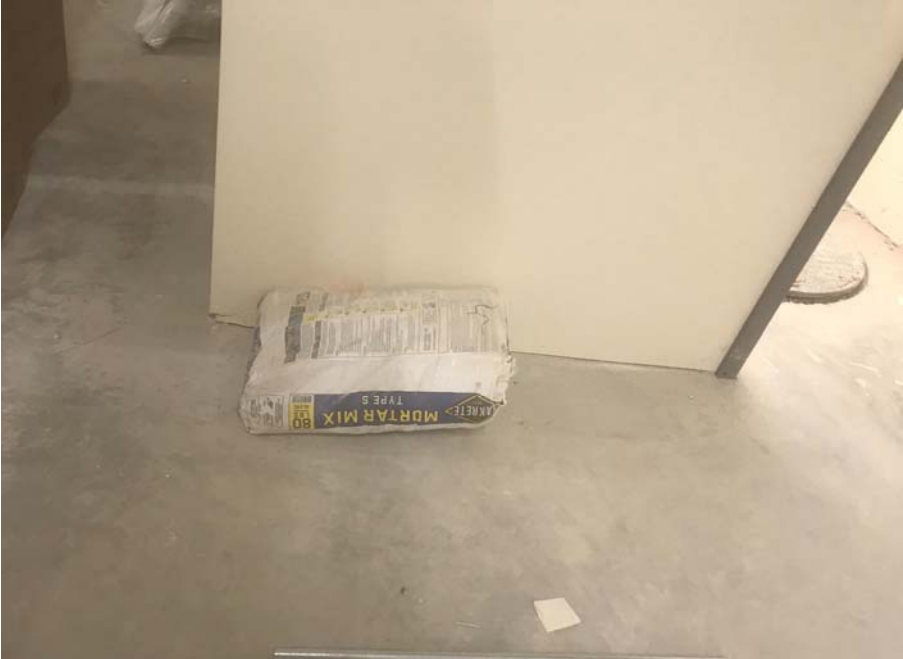
Client Name: 295 Maryland, LLC		Site Location: 295 Maryland Street Site	Project No.: 0222-020-002
Photo No. 5	Date 12/01/20

Direction Photo Taken:			
Description: Chemical Inventory - Basement

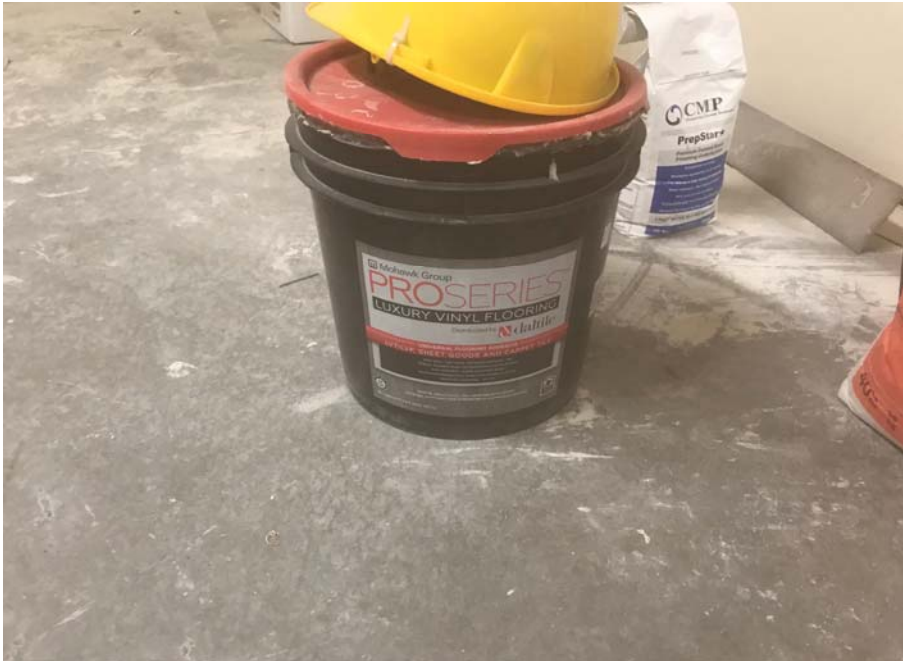
Photo No. 6	Date 12/01/20

Direction Photo Taken:		
Description: Chemical Inventory - Basement

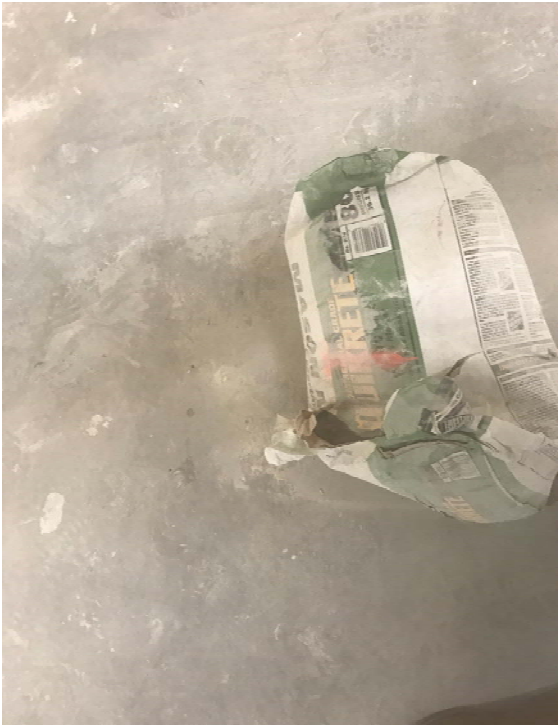
Photo No. 8	Date 12/01/20

Direction Photo Taken:		
Description: Chemical Inventory - Basement

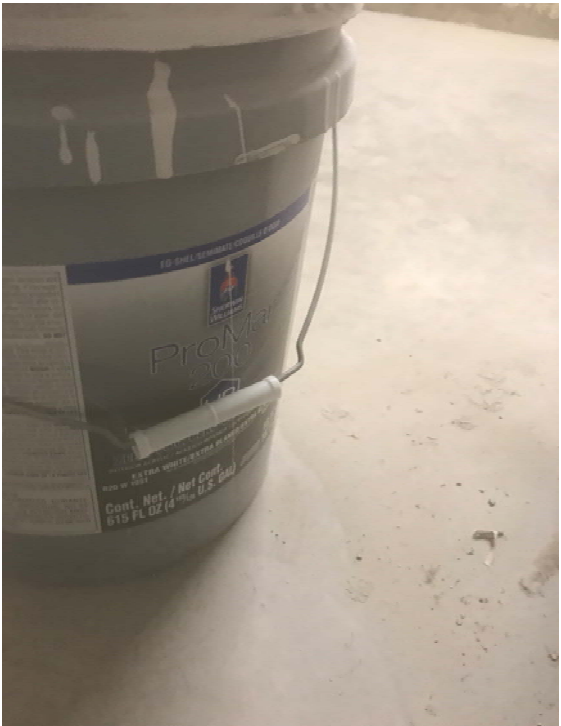
Client Name: 295 Maryland, LLC		Site Location: 295 Maryland Street Site	Project No.: 0222-020-002
Photo No. 9	Date 12/01/20

Direction Photo Taken:			
Description: Chemical Inventory - Basement

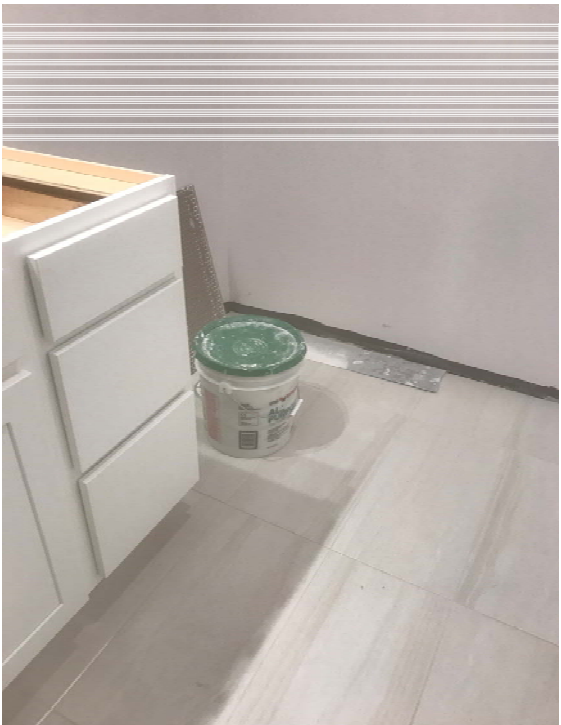
Photo No. 10	Date 12/01/20

Direction Photo Taken:		
Description: Chemical Inventory - Basement

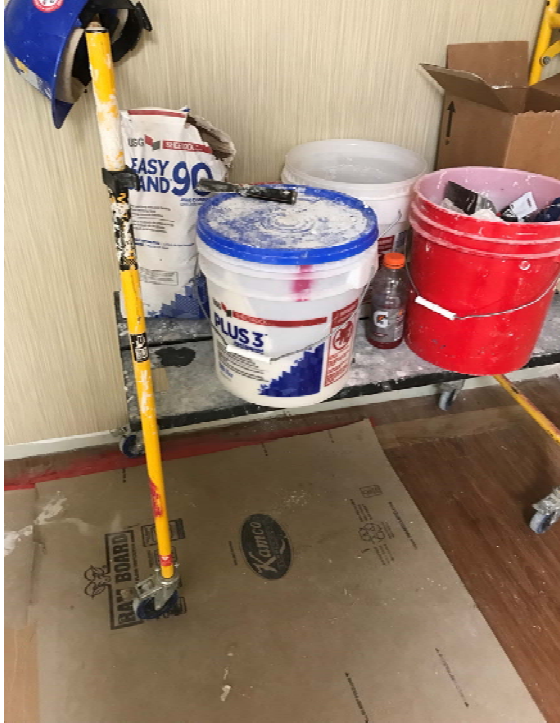
Client Name: 295 Maryland, LLC		Site Location: 295 Maryland Street Site	Project No.: 0222-020-002
Photo No. 11	Date 12/01/20

Direction Photo Taken:			
Description: Chemical Inventory - Basement

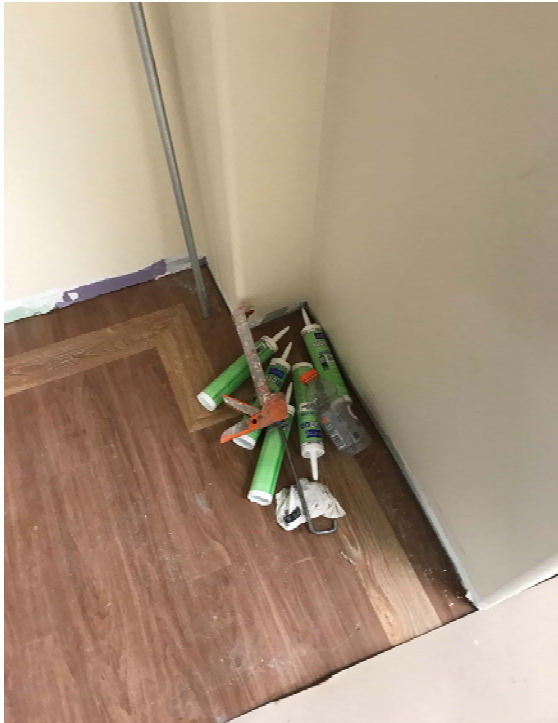
Photo No. 12	Date 12/01/20

Direction Photo Taken:		
Description: Chemical Inventory - Basement
