**31 TONAWANDA STREET SITE
AND
150 TONAWANDA STREET/FORMER CSX VACANT
RAIL PROPERTY
ERIE COUNTY, NEW YORK**

FINAL ENGINEERING REPORT

NYSDEC Site Number: C915299

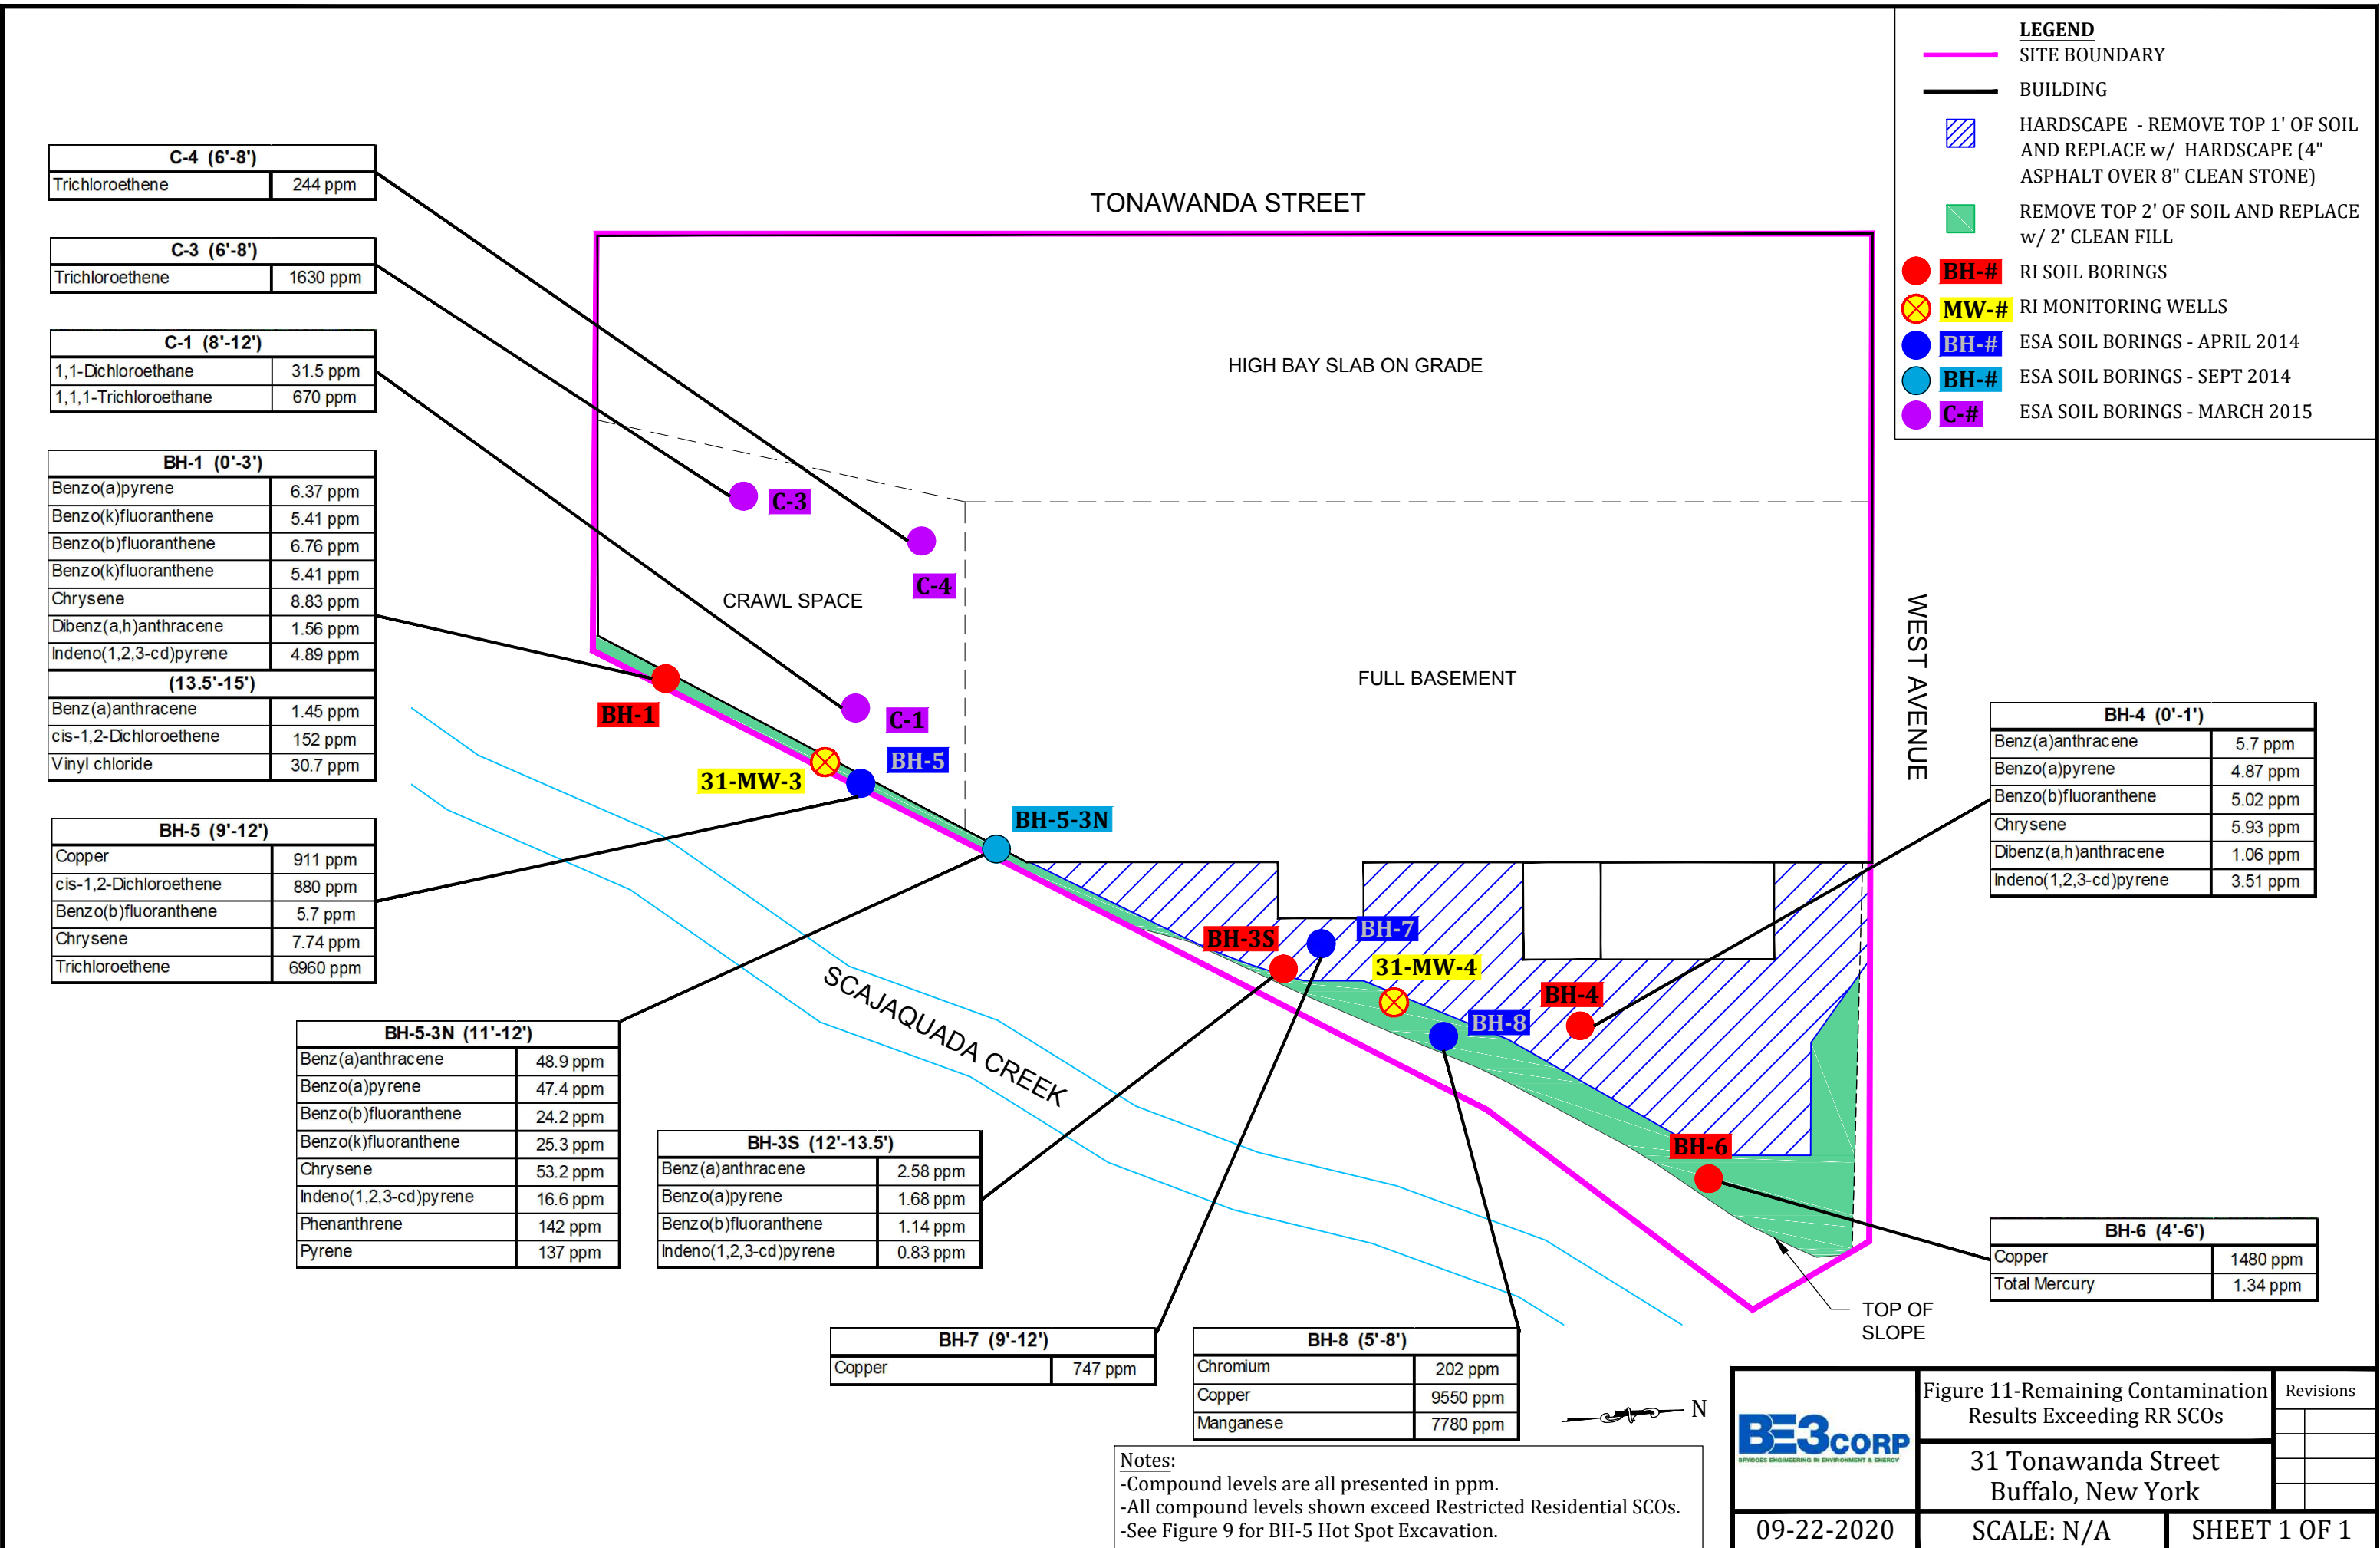
Figure 11-Remaining Contamination Results Exceeding RR SCOs	Revisions
	31 Tonawanda Street Buffalo, New York	
09-22-2020	SCALE: N/A	SHEET 1 OF 1

BH-4 (0'-1')	
Benzo(a)anthracene	5.7 ppm
Benzo(a)pyrene	4.87 ppm
Benzo(b)fluoranthene	5.02 ppm
Chrysene	5.93 ppm
Dibenz(a,h)anthracene	1.06 ppm
Indeno(1,2,3-cd)pyrene	3.51 ppm

BH-6 (4'-6')	
Copper	1480 ppm
Total Mercury	1.34 ppm

Notes:
 -Compound levels are all presented in ppm.
 -All compound levels shown exceed Restricted Residential SCOs.
 -See Figure 9 for BH-5 Hot Spot Excavation.
