DRAFT REMEDIAL INVESTIGATION - ALTERNATIVE ANALYSIS REPORT

BROWNFIELD CLEANUP PROGRAM

**For
MOD-PAC CORP.
1801 Elmwood, Buffalo 14207
BCP # C915314**

February 1, 2019

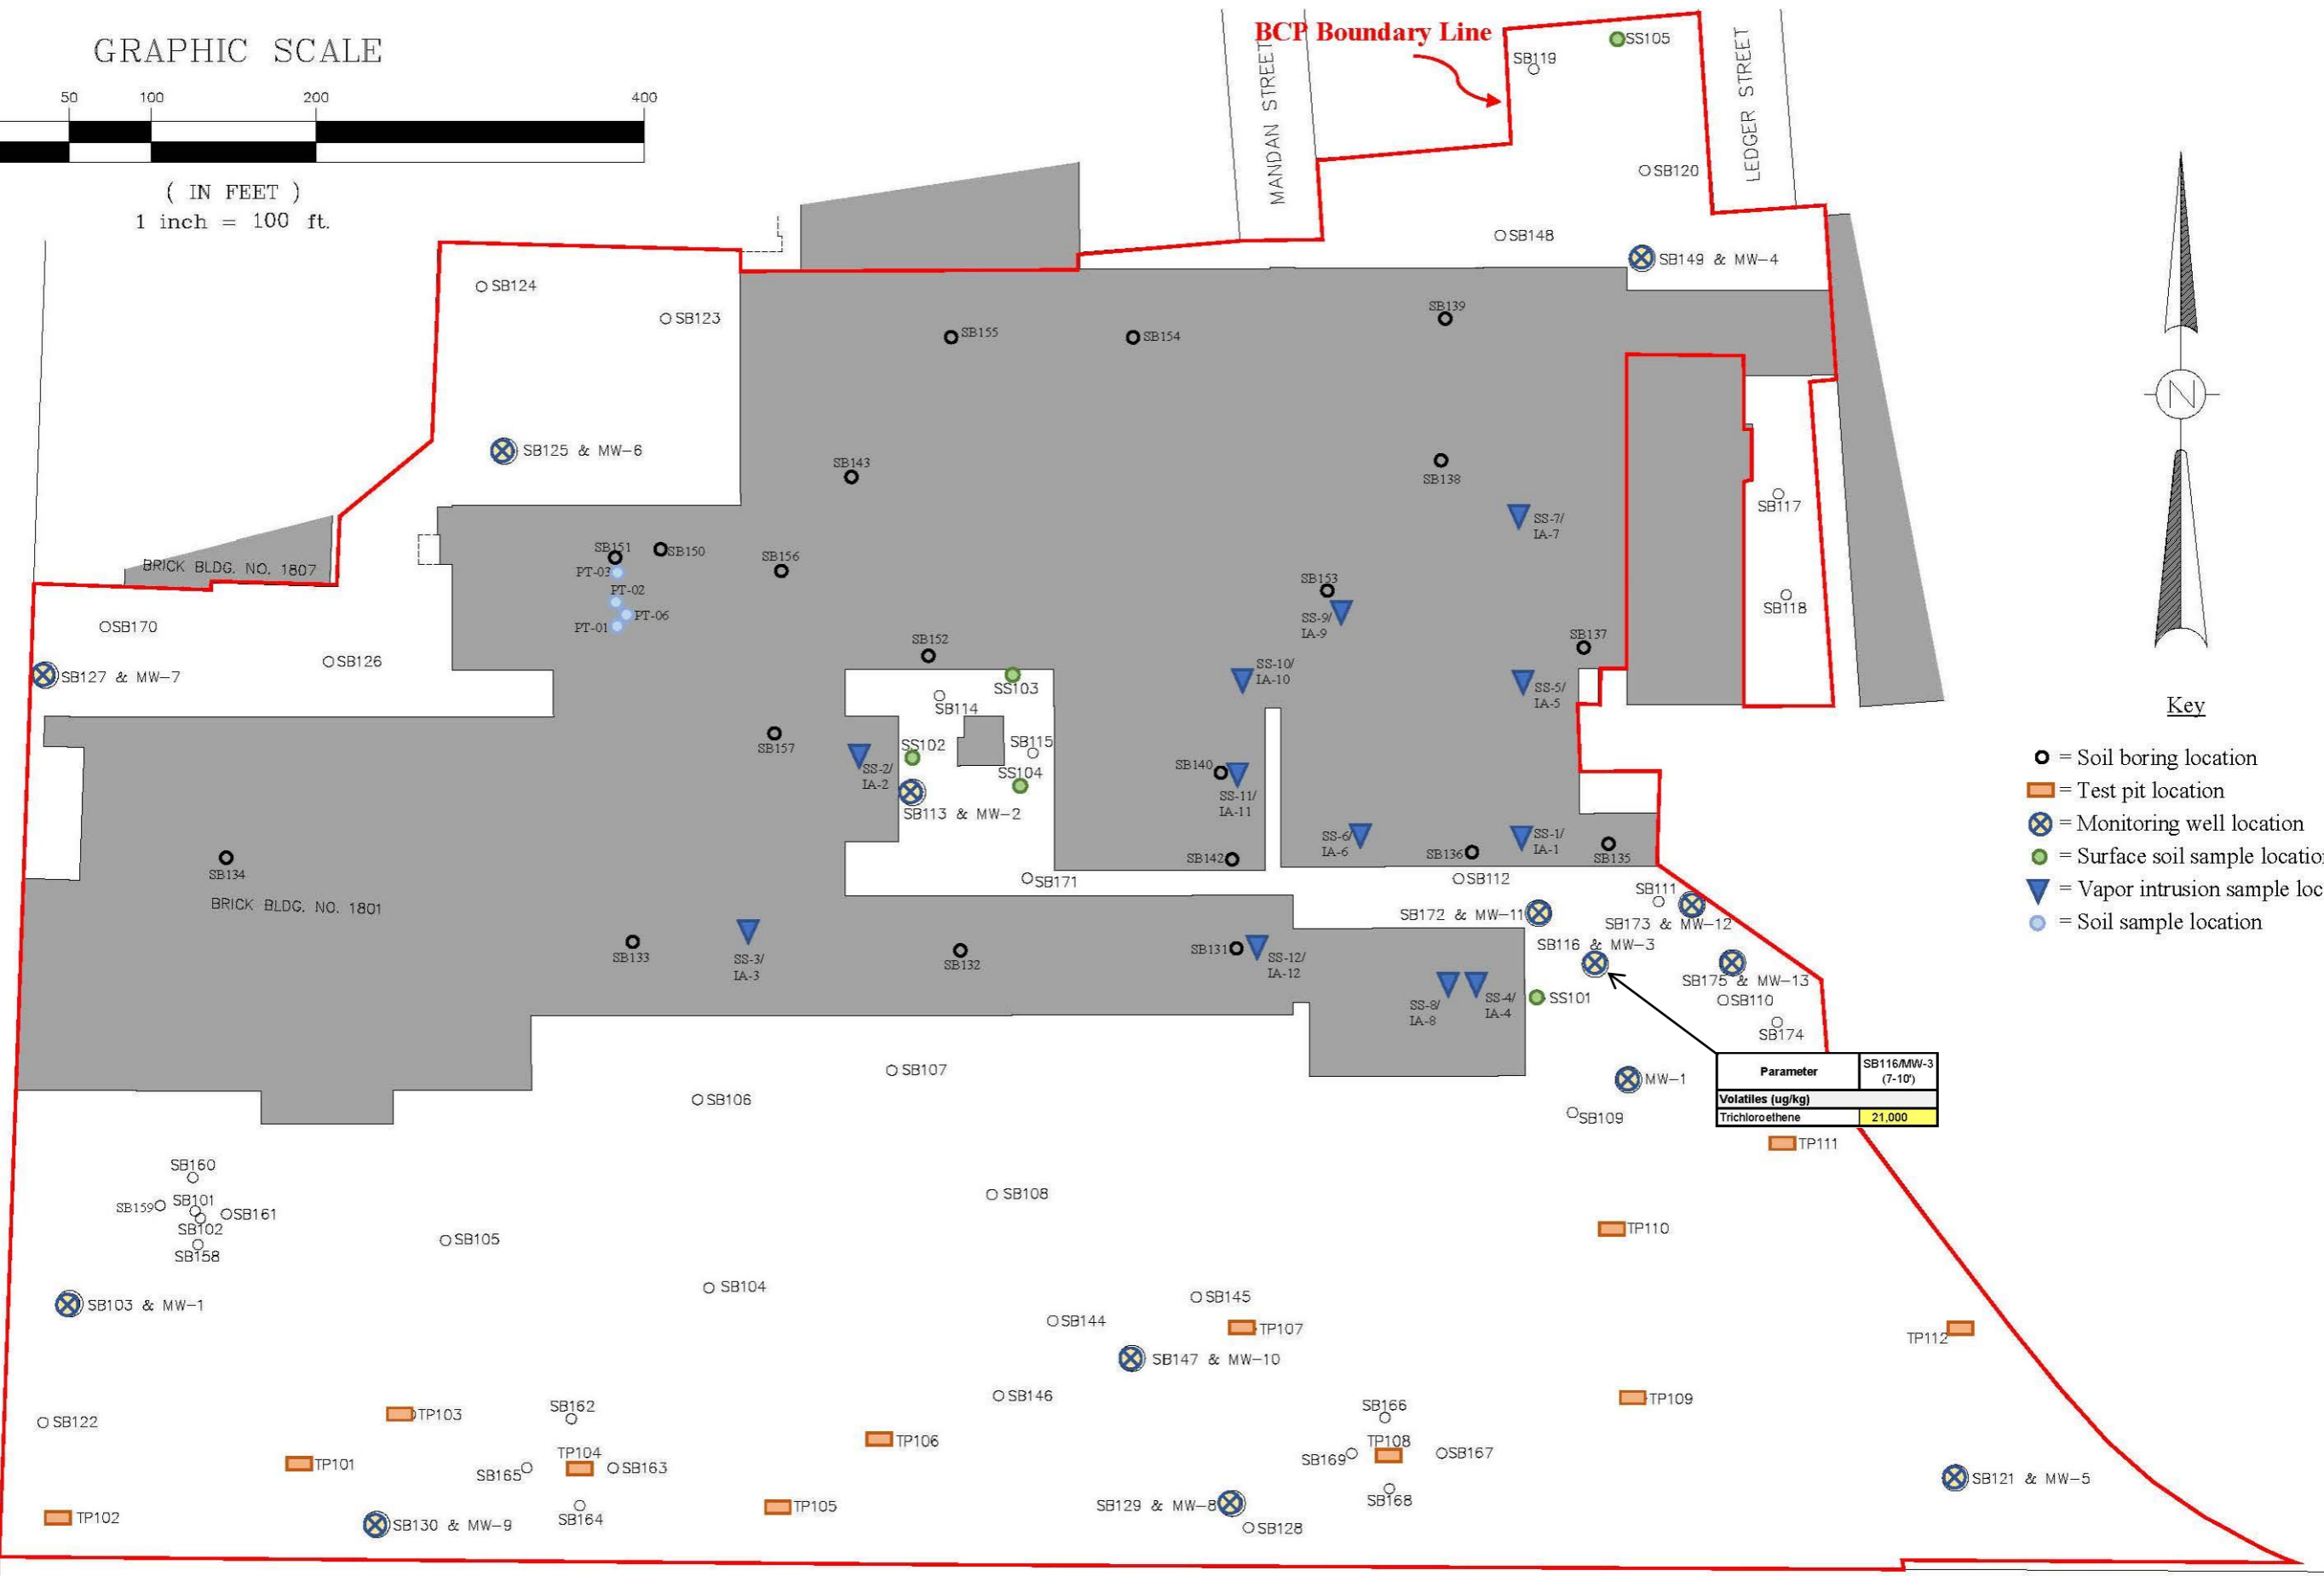
- = Soil boring location
- = Test pit location
- ⊗ = Monitoring well location
- = Surface soil sample location
- ▼ = Vapor intrusion sample location
- = Soil sample location

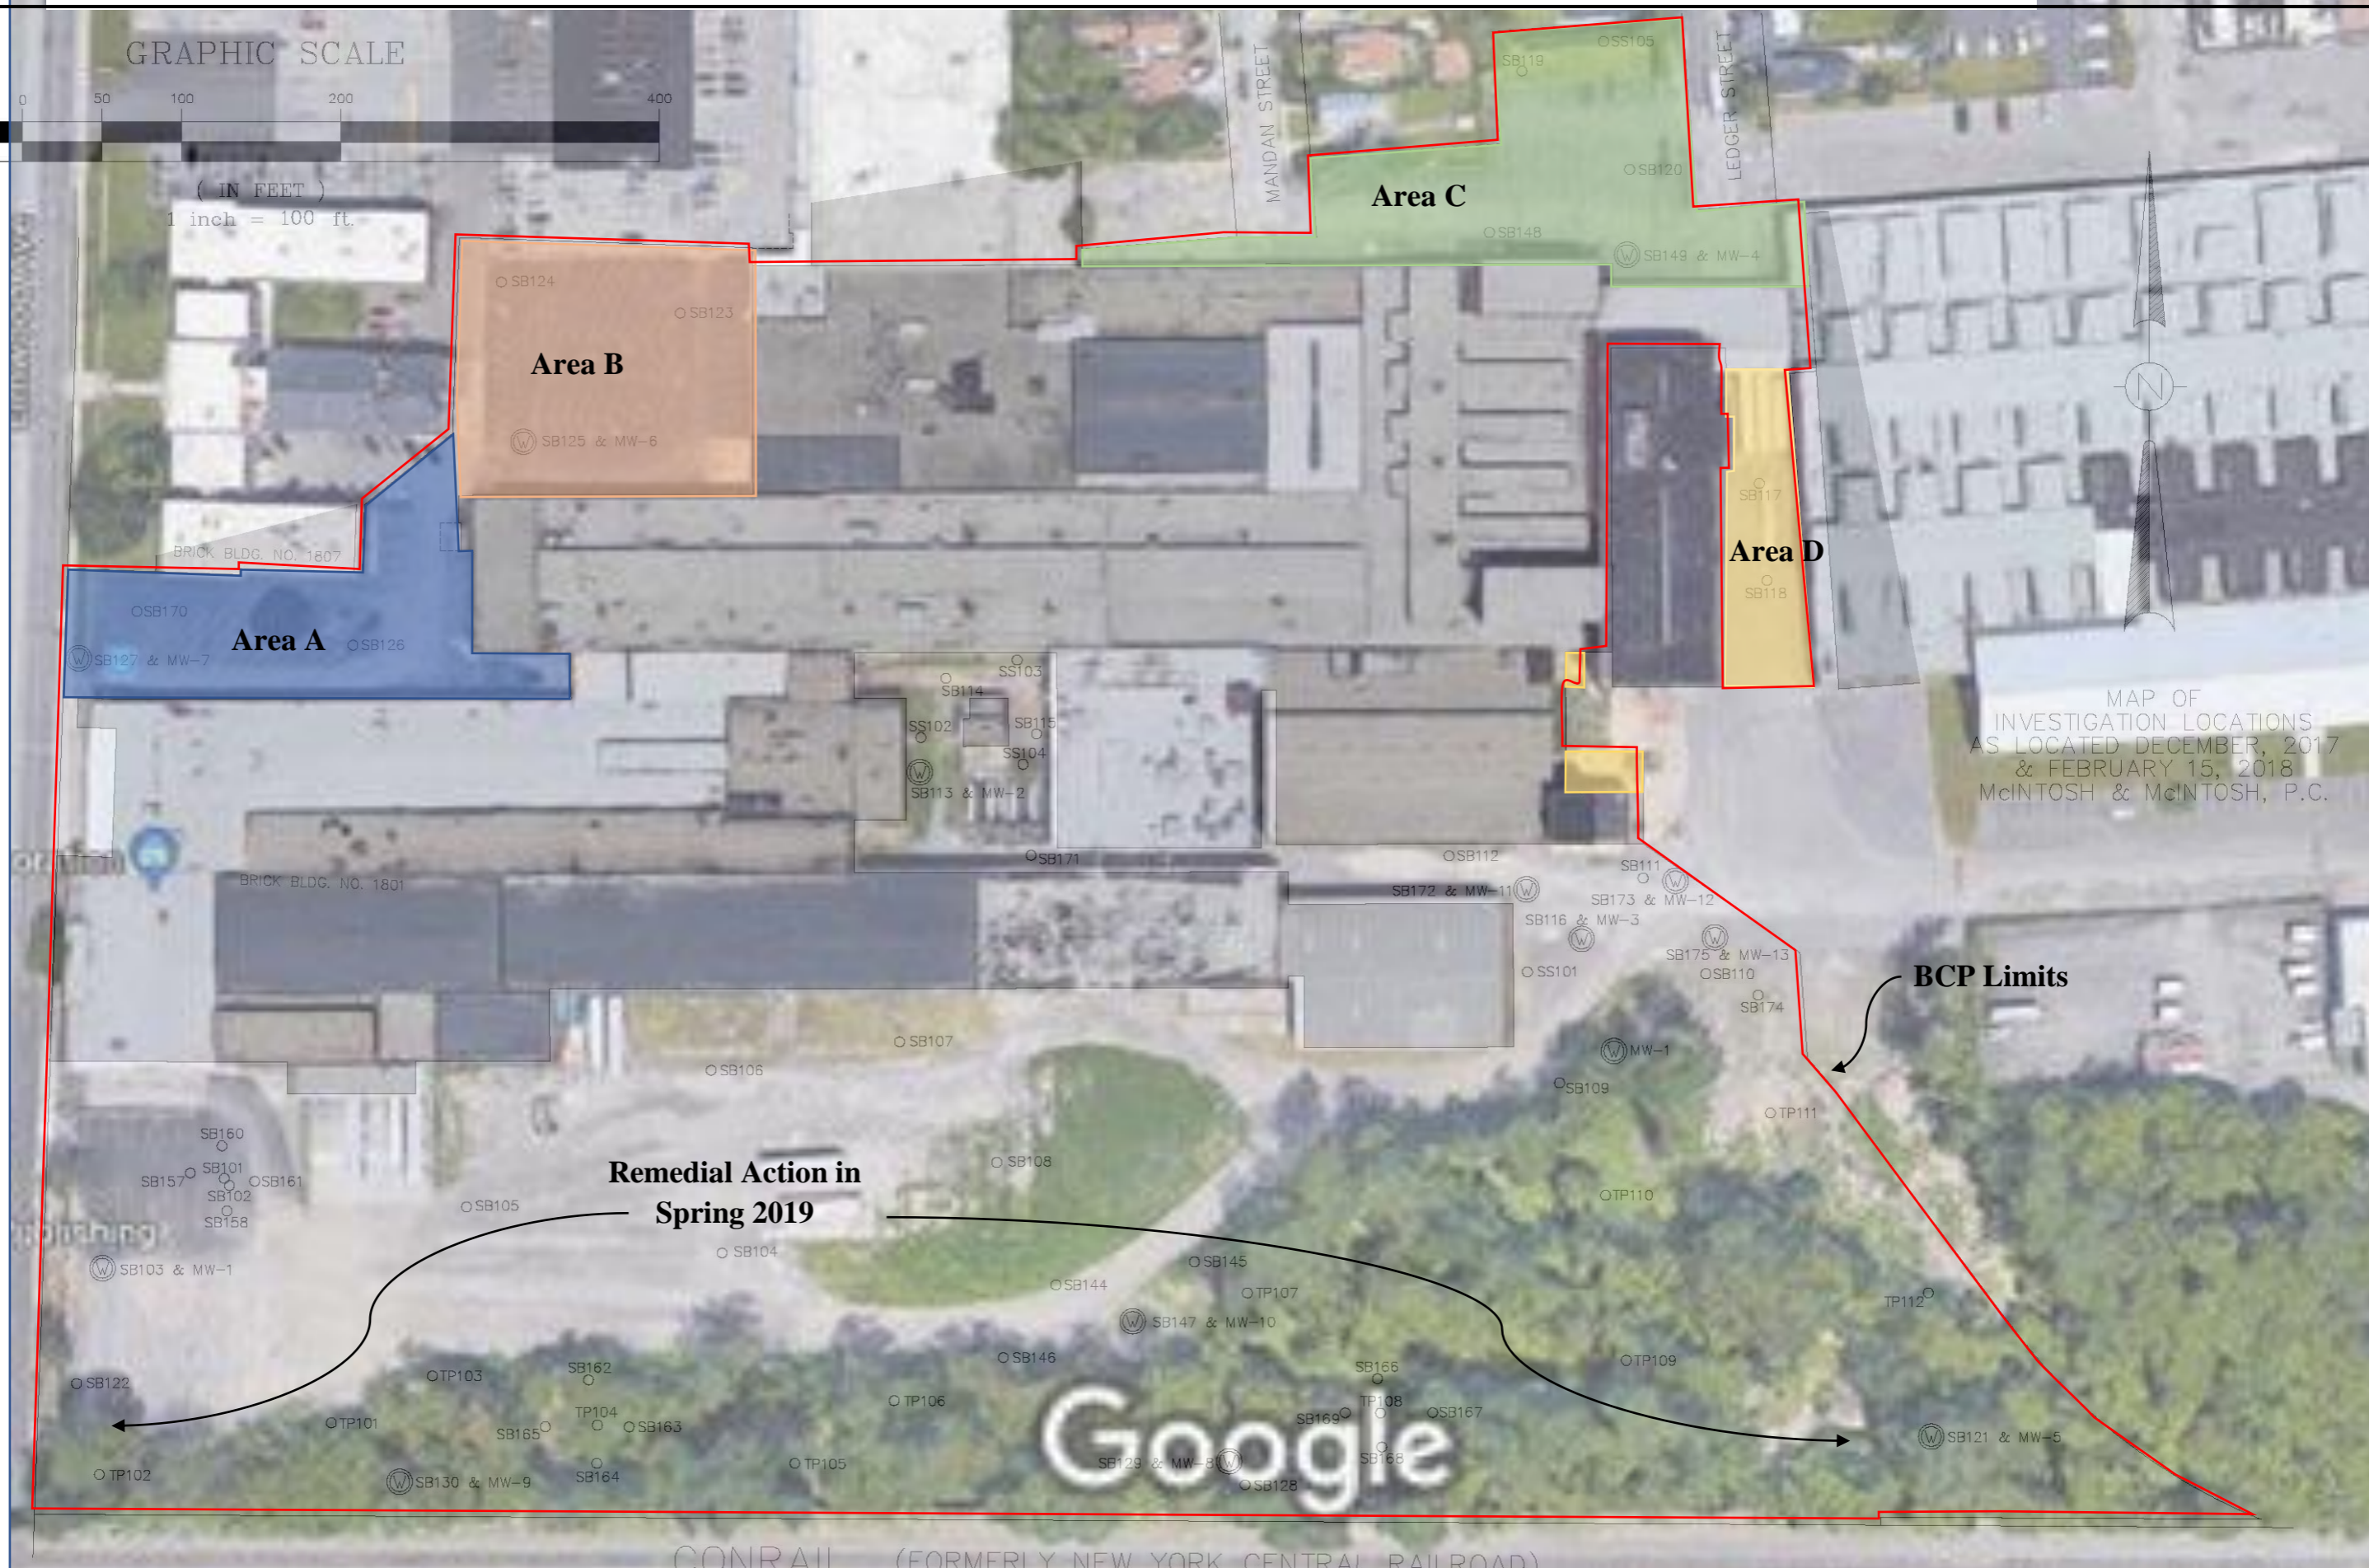
PROJECT: 18-103
FIGURE NO: 13

Remedial Action in Spring 2019

Many of the parking lot areas exhibit indications of wear, cracking, and were in need of improvements, and did not meet NYSDEC impermeable cover requirements. Four areas, identified as Area A to Area D were identified that needed some improvement or replacement, as shown on the attached Figure 13.

Due to current conditions of the various areas requiring upgrades in the cap system, geotechnical/civil design were completed to determine appropriate requirements to complete the pavement upgrades to allow the cap to meet its intended use. The geotechnical/civil evaluations included pavement cores to determine the ability for milling and resurfacing versus total full-depth replacement; as well as topographic survey to evaluate Site drainage as standing water is often present in many of the pavement areas.

The final pavement design for the cap remedy for each area was dependent on the geotechnical/civil investigation findings and topographic survey. Each area that was either milled, resurfaced and/or total full depth replacement, as required. Additionally, stormwater drainage was altered or upgraded as needed, based on the topography results.

Within Area A, a section of the parking lot had consistent settling, requiring filling and patching, with continued settling. In an effort to prevent the settling, and to improve stormwater drainage within this area, an exploratory test pit was completed to determine the source of the settlement. During test pit work, significant fill material was identified, which generally included foundry sand intermixed with brick, cinders, sand, gravel, and slag. Additionally, miscellaneous debris was also present including wire, electronic pieces, and an entire radiator. Old building walls as well as a former doorway, hallways and a concrete floor were found within the excavation. Due to the findings, the material was removed to provide proper drainage and prevent future settling.

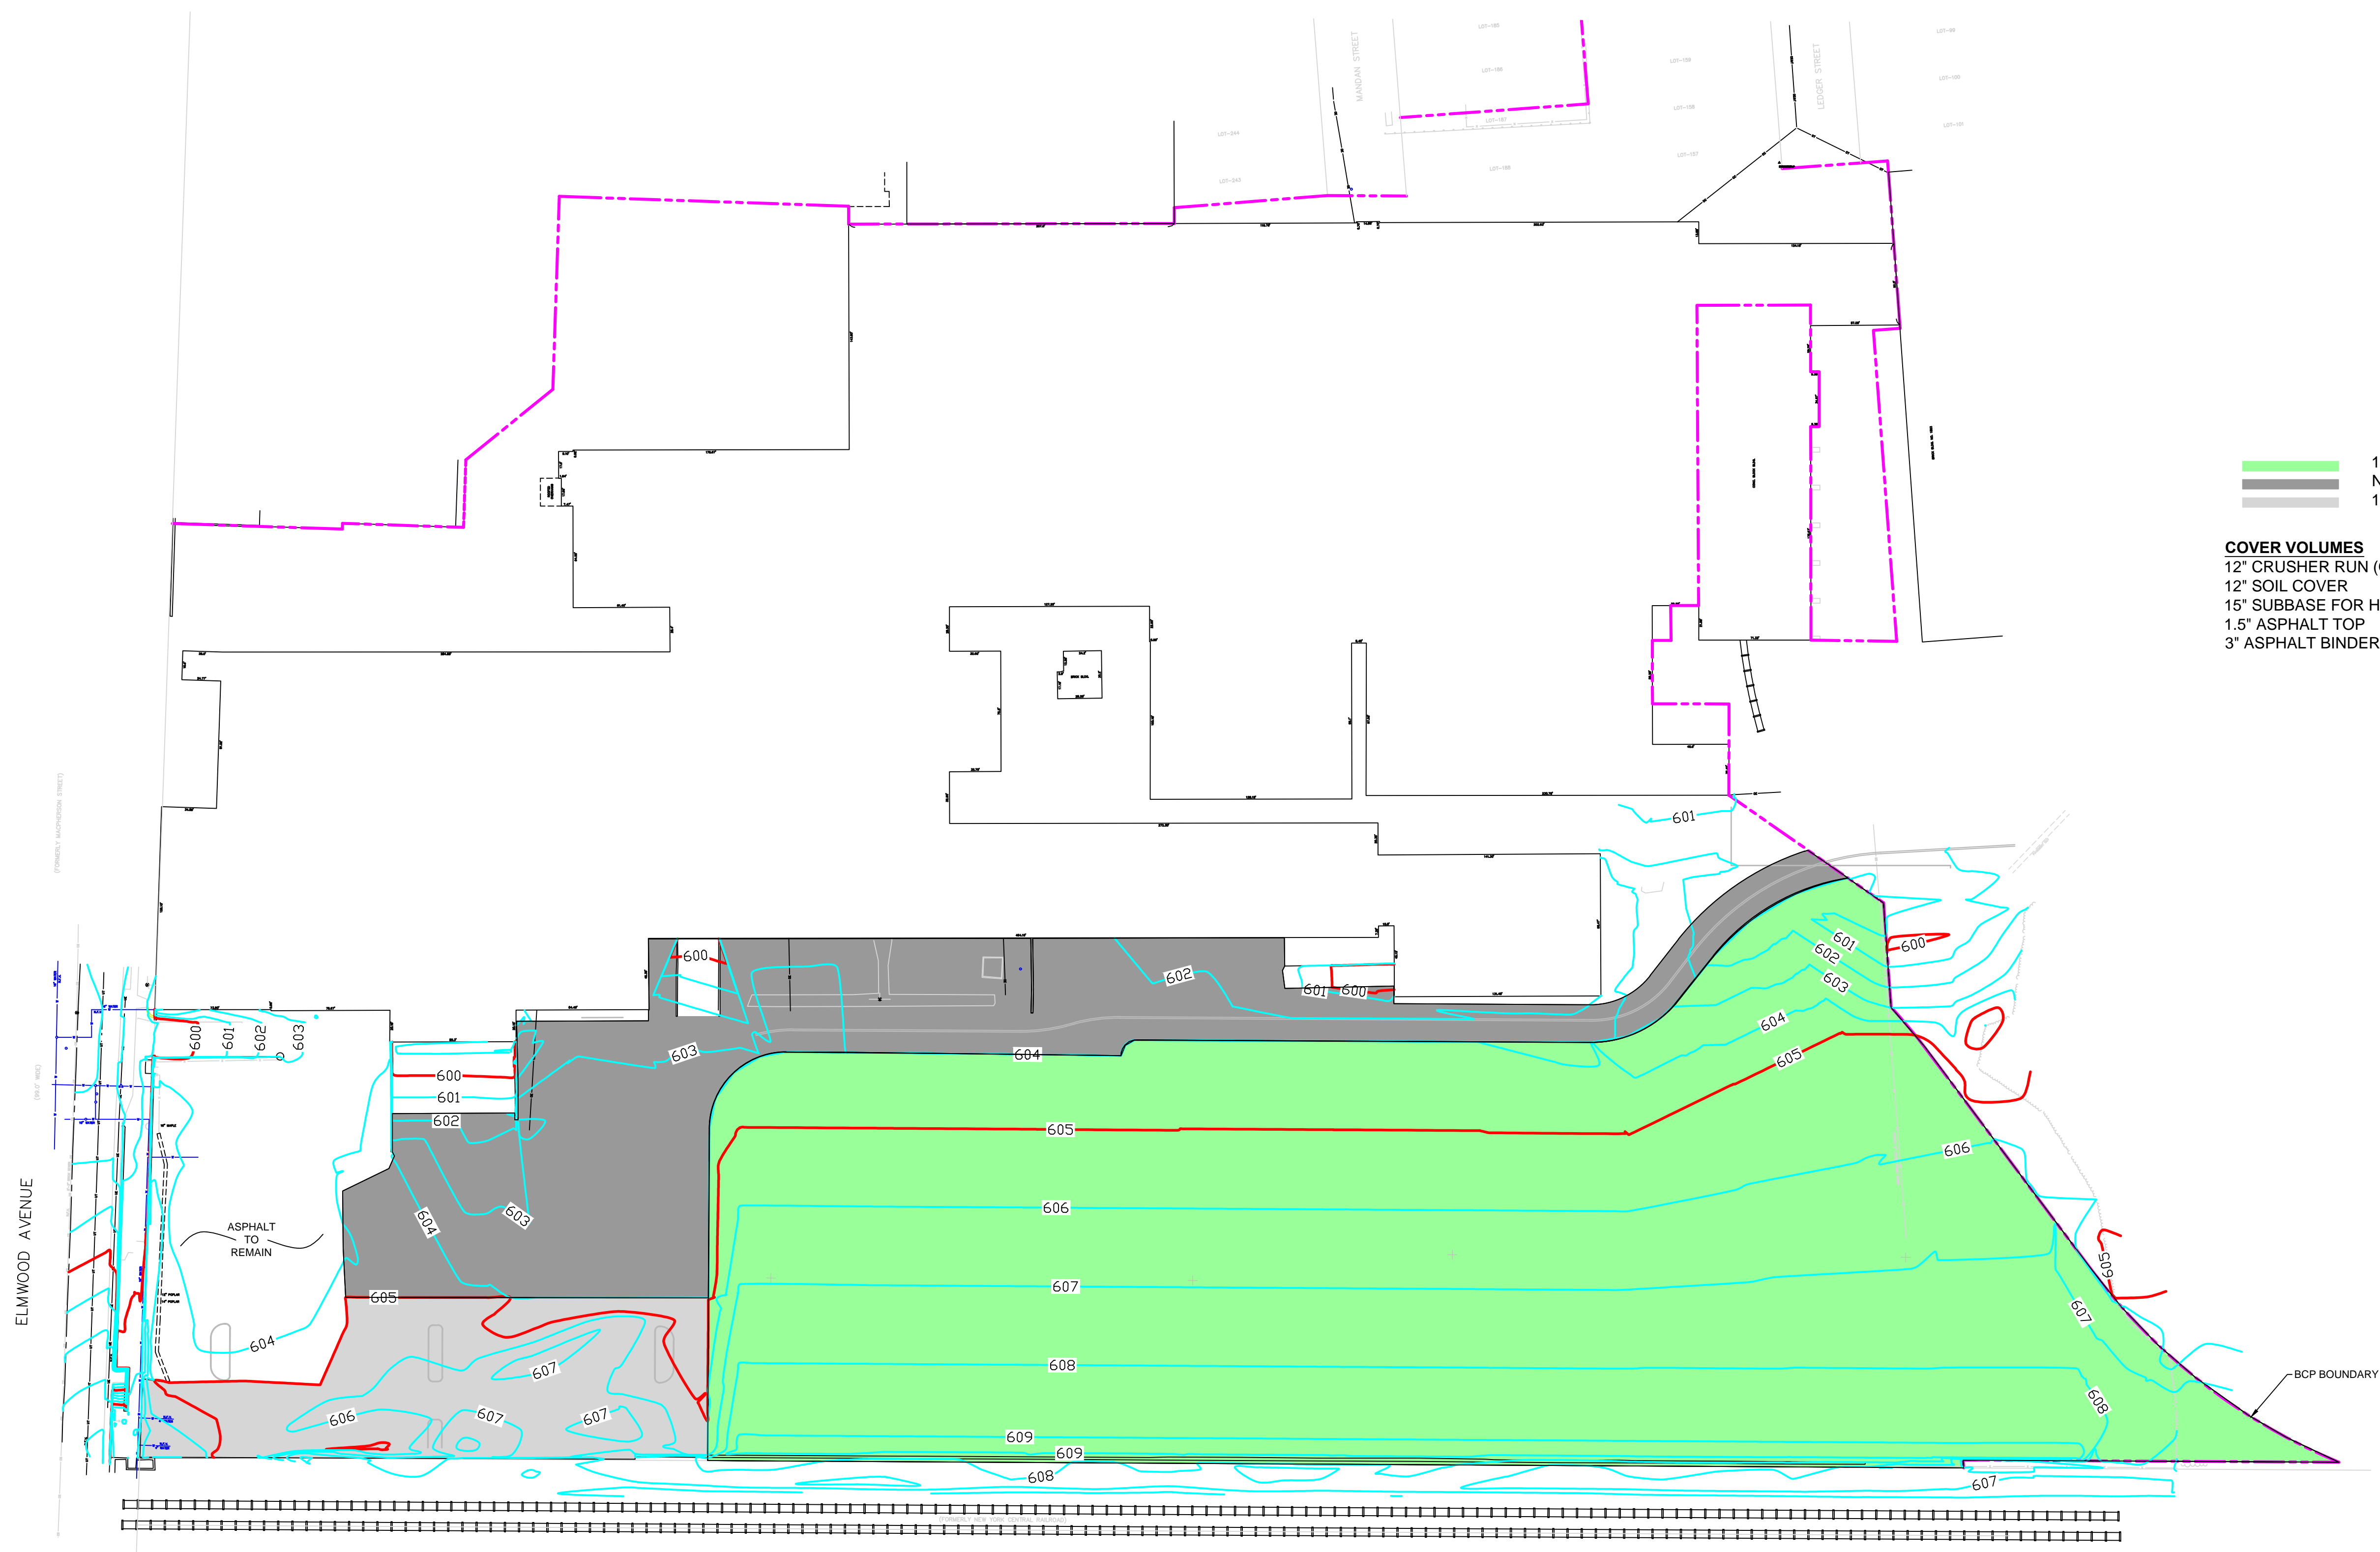
**OVERALL
 SITE PLAN**

12" SOIL COVER
	NEW HEAVY DUTY ASPHALT
	12" GRAVEL COVER

COVER VOLUMES	
12" CRUSHER RUN (GRAVEL COVER)	1,200 CY
12" SOIL COVER	8,900 CY
15" SUBBASE FOR HEAVY DUTY PAV'T	3,310 CY
1.5" ASPHALT TOP	330 CY
3" ASPHALT BINDER	662 CY

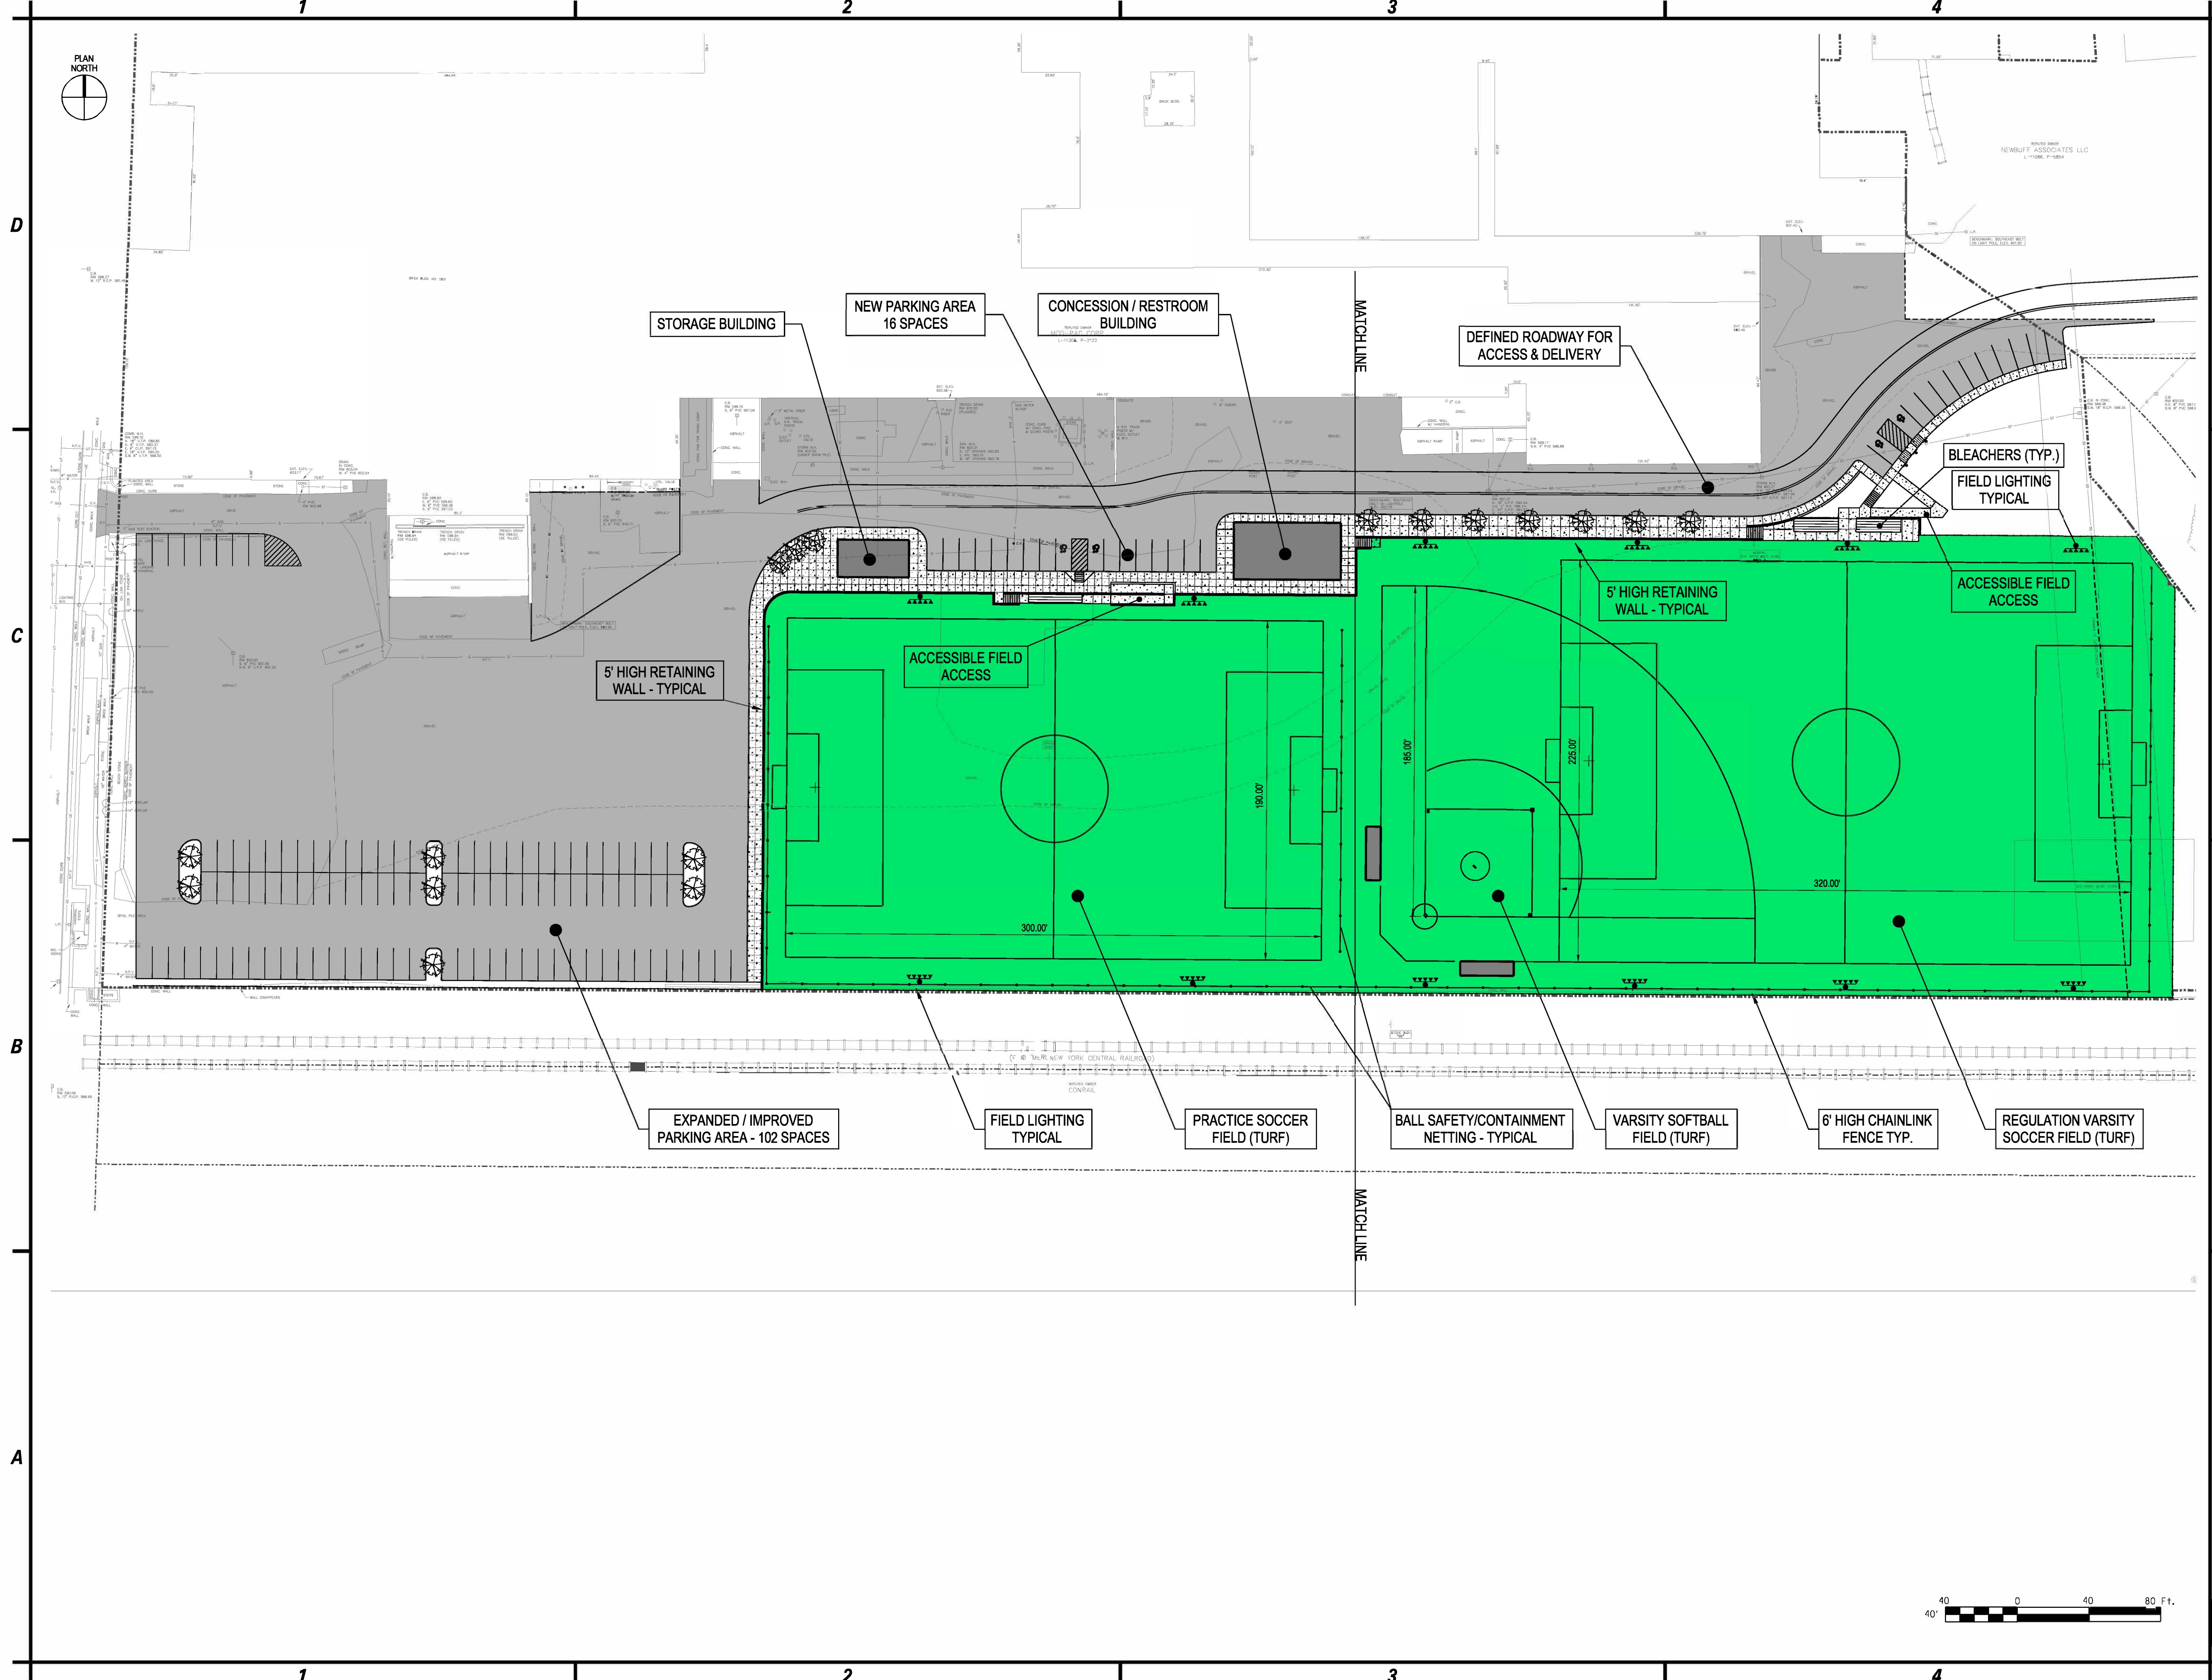
Figure 16B – Proposed Athletic Field Option

MOD-PAC CORP.
PROPOSED ATHLETIC FIELD OPTION
