RICHARD BUI ASSOCIATES
520 FAIR VISTA COURT
WEXFORD, PA 15090
724-934-8765 OFFICE
724-934-8768 FAX

1.0 Introduction

2.0 Environmental Site Assessment

The subject property is located at 750 East Ferry Street, Buffalo, New York, 14211. The subject site is located in Erie County, on the east side of the city of Buffalo, New York (See Figure I in Attachment I). According to information provided to RBA, the approximate coordinates for the subject property are 42 degrees 54 minutes' 58 seconds latitude, and 78 degrees 50 minutes' 25 seconds longitude.

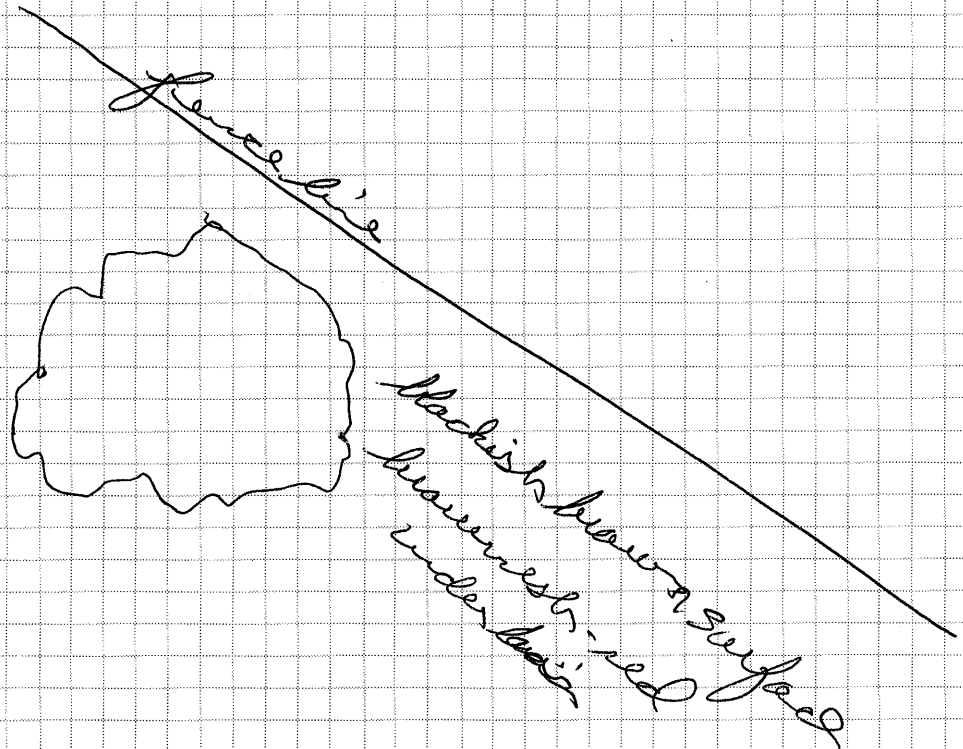
⑥ Large brownish-red spot w/ no
negation in the ^{north} east corner behind
Machine Shop -
080201-09 went ~ 6" to 8" down
deeper I go the larger the metal
shavings
~ 10' x 10'

The last area sampled was collected on the subject property in the northwestern corner between the back of the Fabrication building and the fence line. RJ Lee Group analyzed samples 080201-08 and 080201-09 for metals in bulk. The soil in this section of the plant is unconsolidated to consolidated material (reddish brown in color) with little to no vegetation. Sample 080201-08 was taken at a depth of approximately eight (8) to twelve (12) inches. The underlying material is an unconsolidated material (dark fine silt). The sample area of 080201-09 consisted of a top layer is unconsolidated (blackish silt) material which changes at a depth of approximately three (3) to four (4) inches to a consolidated material (brownish-red in color). The sample depth was approximately six (6) to eight (8) inches. The soil at the eight- (8) inch depth displayed various metal shavings. Photographs thirteen (13), five (5), and seven- (7) show that vegetation grows everywhere in this area except in the two noted sections. See Figure I – Plant Property-Buildings-Fences-R.R. Tracks – Hazardous Waste Storage Areas – Substations (Drawing No. L-640) for sample locations. See attach Laboratory report.

1. Stained area between the Main Floor Fabrication building and the Laboratory showed elevated Total Petroleum Hydrocarbons (TPH) levels by the air distillation tanks.
2. The two stained areas on the northeastern side of the Machine Shop Main Floor. Both of the stained areas is this location show elevated metal results
