**RE: Lime Pile Investigation Summary
90 Hopkins Street, City of Buffalo, New York
CHA Project No. 13258**

PIEZOMETER, BORING & TEST PIT
 LOCATION PLAN
 LIME PILE INVESTIGATION
 90 HOPKINS STREET
 BUFFALO, NEW YORK

Test Pit Logs

Attachment B
Photographic Log

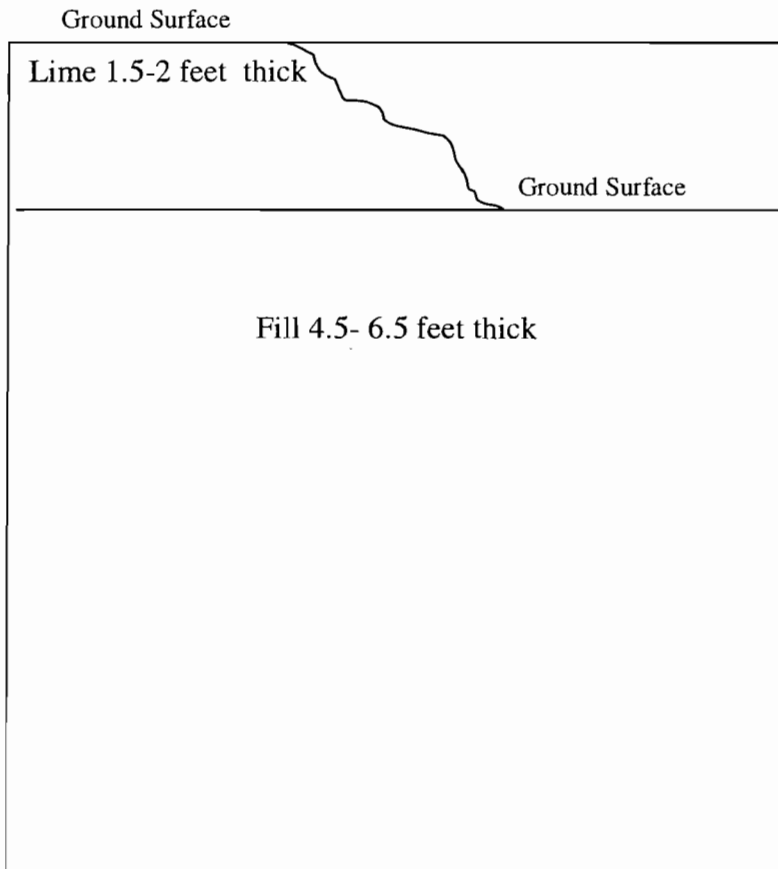
Test Pit No.: TP-1

-Lime only in west end of pit, at surface
