**Periodic Review Report**  
June 19, 2018 – June 19, 2021

**ShopRite Plaza**  
**Newburgh, New York**  
**Site #V00118-3**

**Alpha Geoscience**  
**679 Plank Road**  
**Clifton Park, New York 12065**

**September 24, 2021**

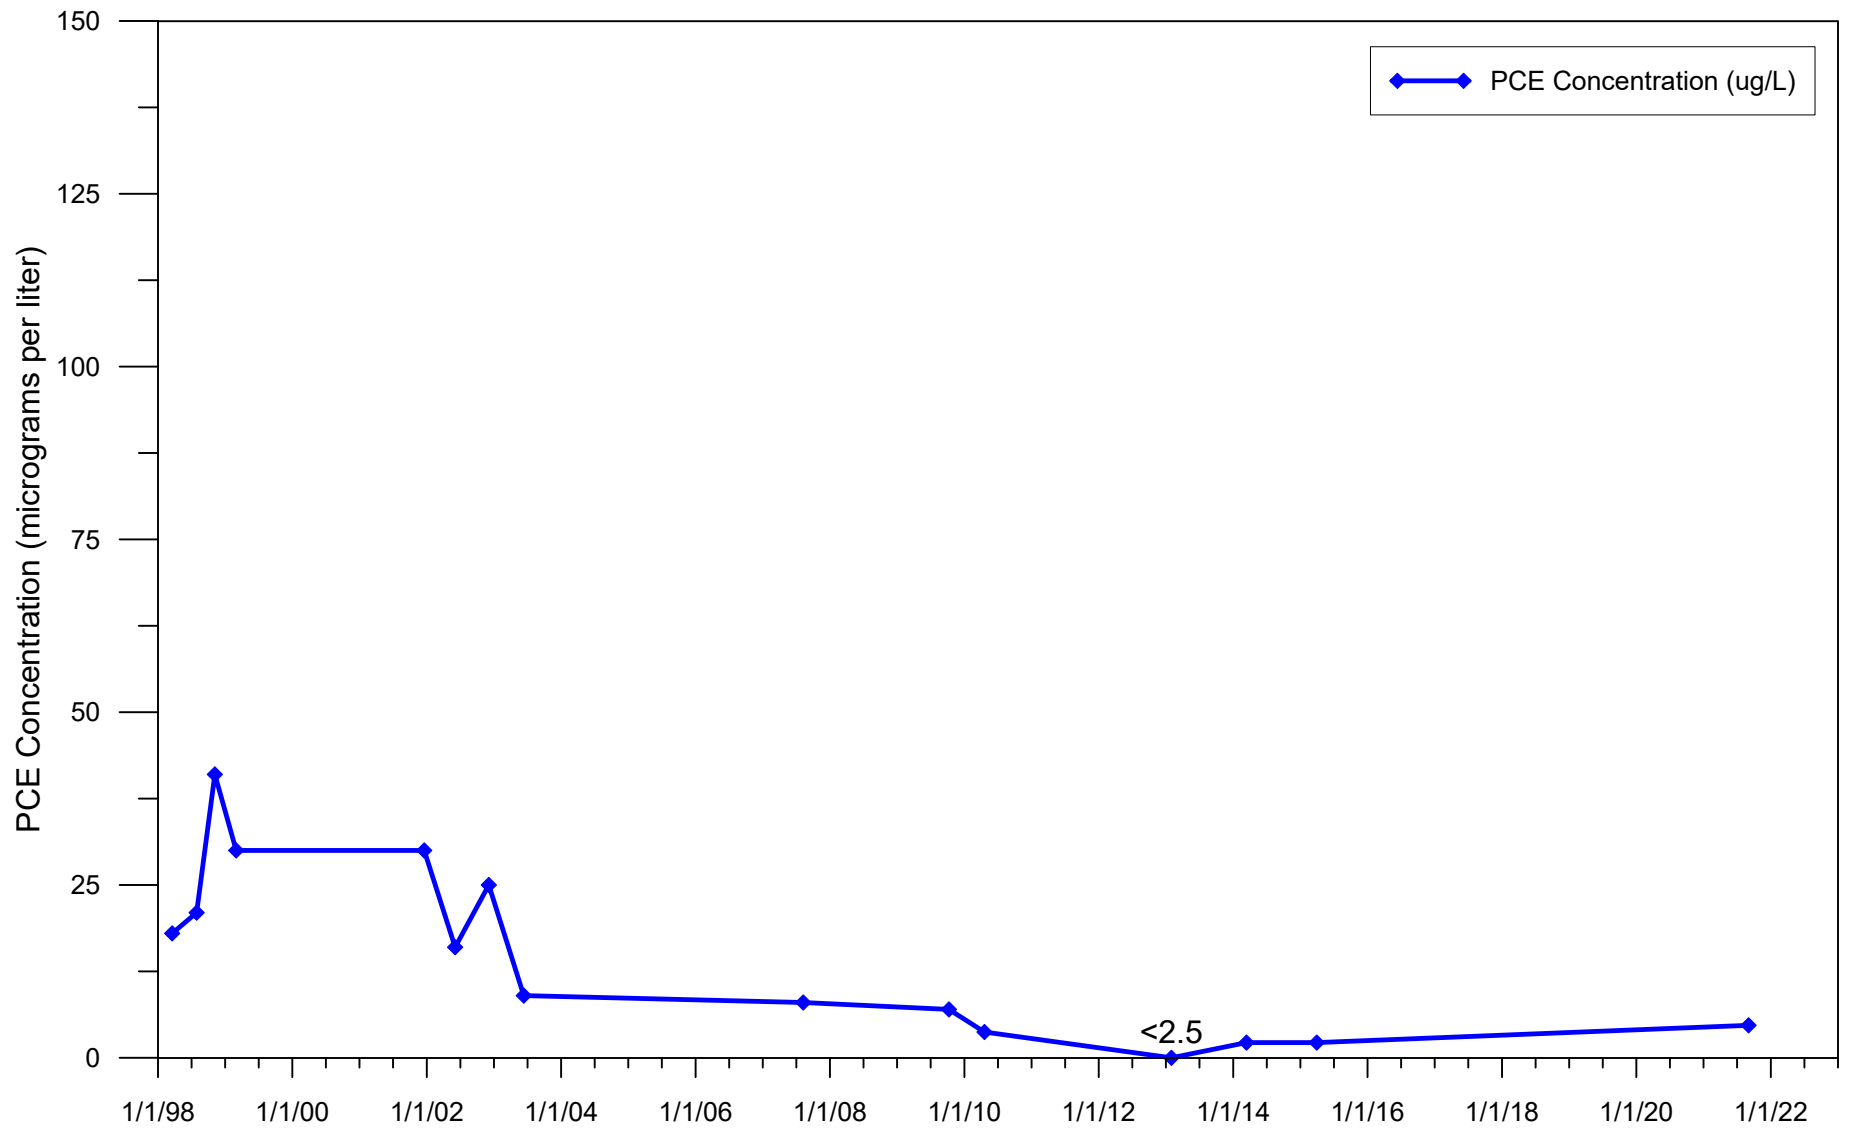
**FIGURE 3**  
 Monitoring Well MW-3  
 PCE Concentration

Notes:  
 -Analytical data are summarized on Table 2.  
 -PCE was not detected in January 2013 at a 2.5 ug/L reporting limit.

The historical analytical results are tabulated for wells MW-3, MW-5, MW-7, SB-1, and SB-3 and are presented on Tables 2 through 6, respectively. The laboratory analytical report for the ground water samples collected on September 2, 2021 is included in this report as Appendix B. Graphs prepared for wells MW-3, MW-5, MW-7, SB-1, and SB-3 showing the concentration of PCE in each well are presented as Figures 3 through 7, respectively. Review of the current and historic data indicates that the concentration of PCE in the ground water is relatively stable or decreasing since circa 2003. The highest concentrations of total VOCs have historically been detected in well MW-7. The highest concentration of total VOCs in well MW-7 was 1,921 ppb in November 1998. The current concentration of total VOCs in well MW-7 (209 ppb) is 89 percent lower than the historical high value.

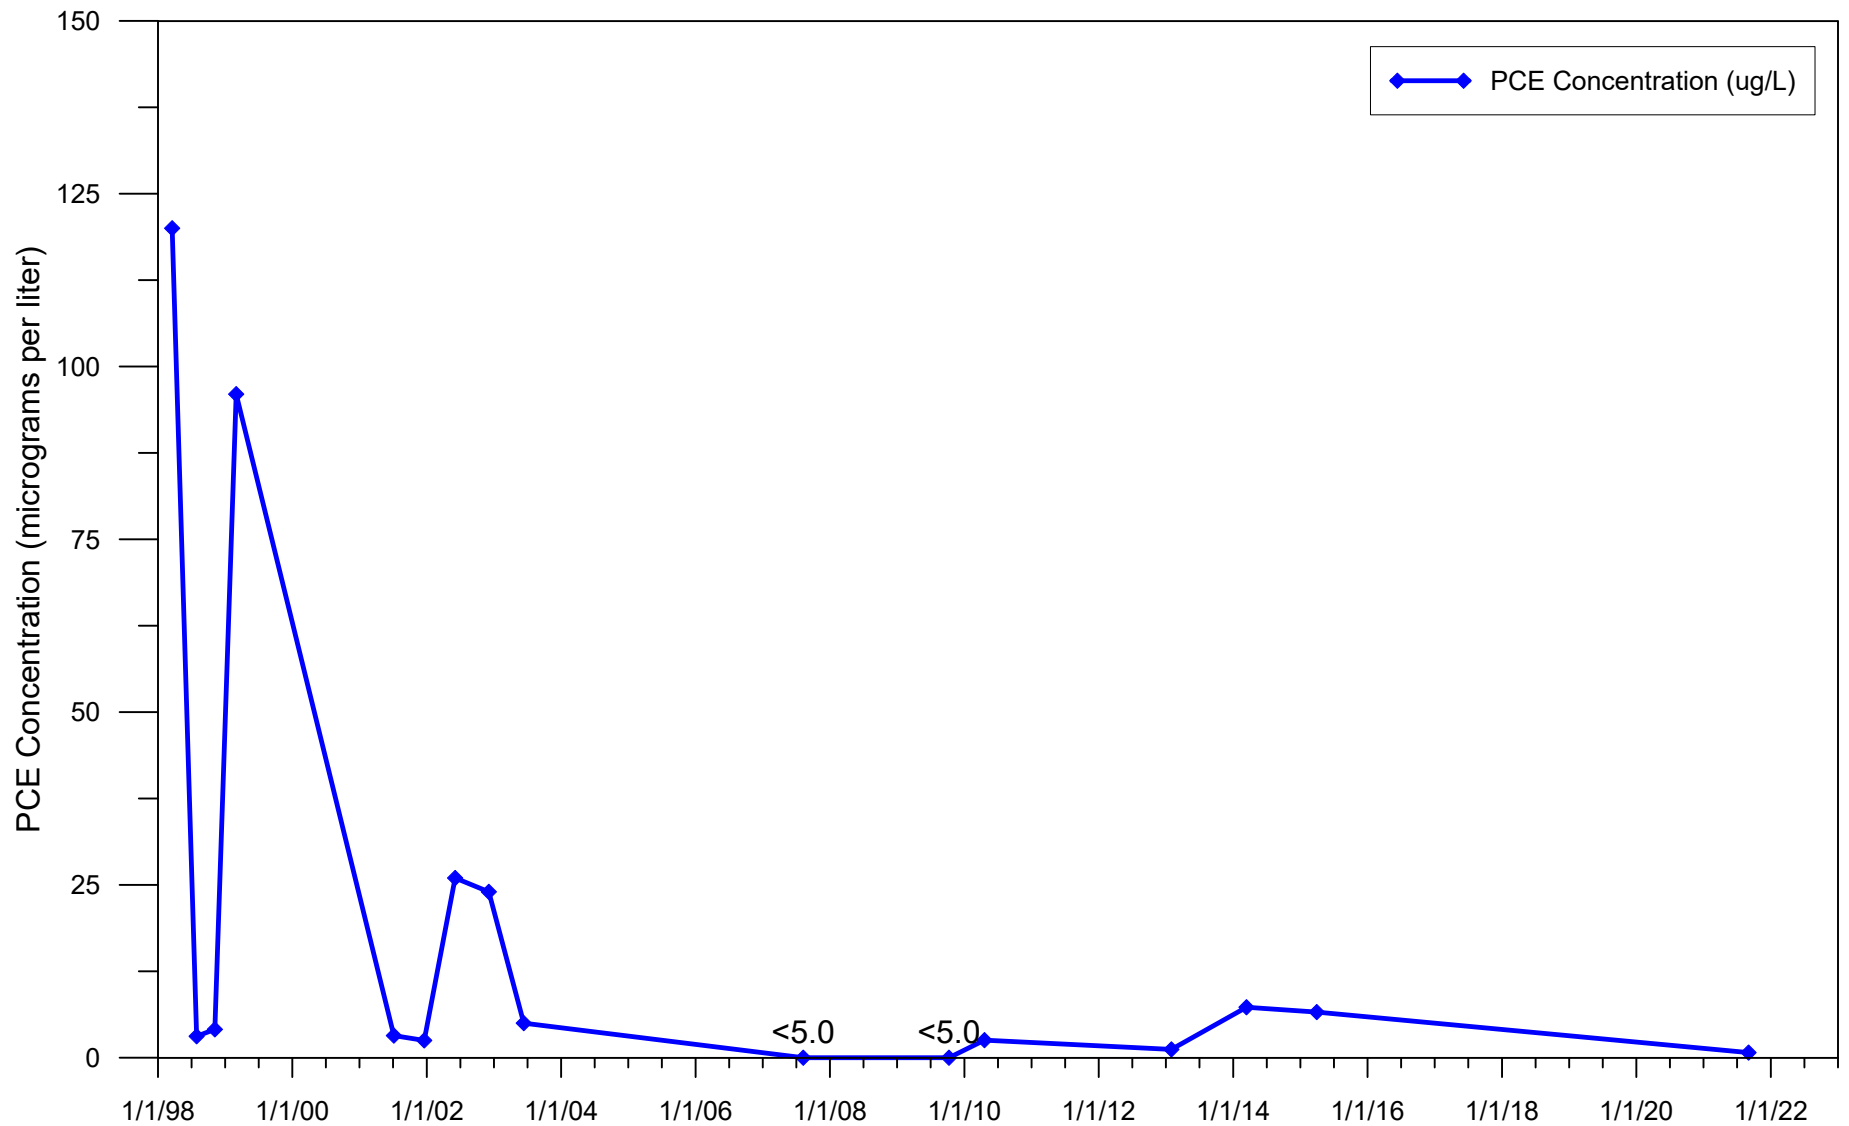
**FIGURE 4**  
Monitoring Well MW-5  
PCE Concentration

- Analytical data are summarized on Table 3.
- PCE was not detected in August 2007 and October 2009 at a 5.0 ug/L reporting limit.

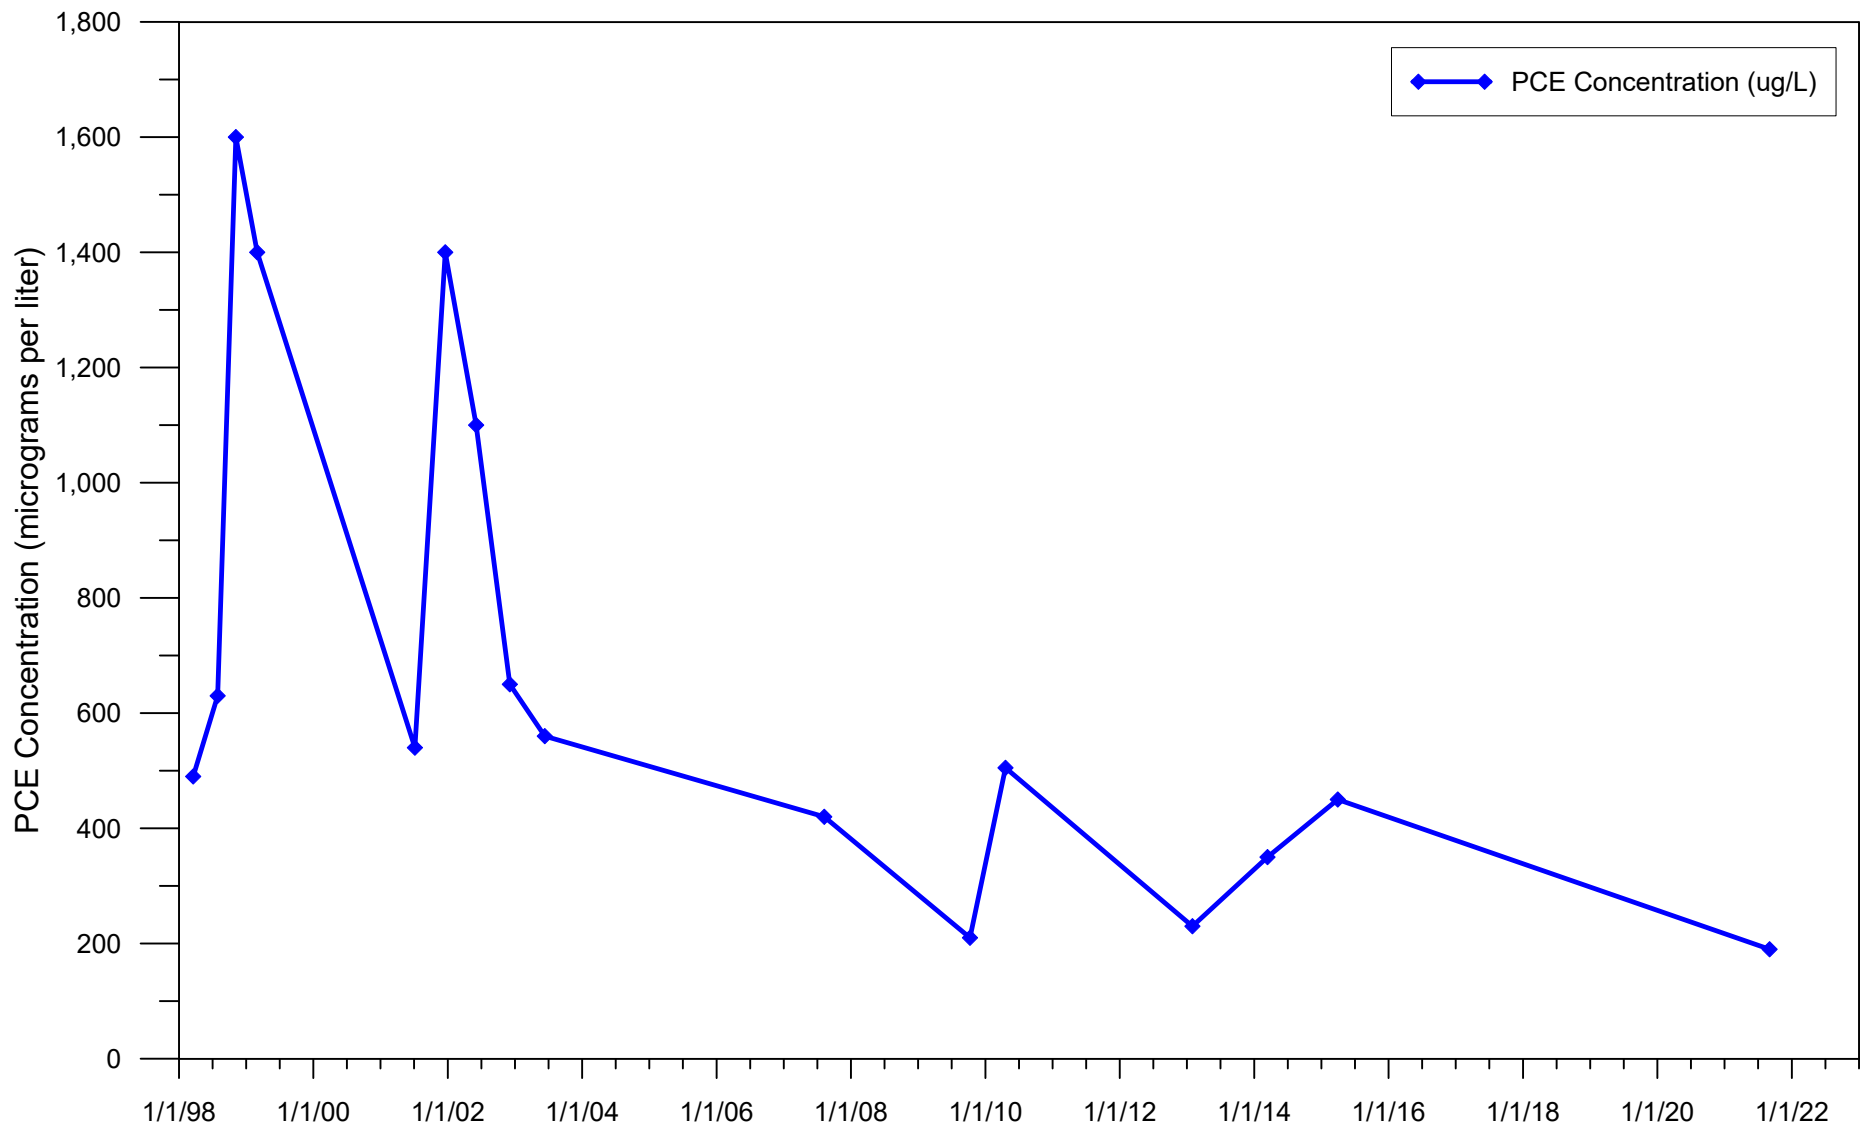
**FIGURE 5**  
Monitoring Well MW-7  
PCE Concentration

Notes:  
-Analytical data are summarized on Table 4.

The data for the samples collected on September 2, 2021 indicate that the highest concentration of PCE was detected in well MW-7 (190 ppb). The PCE concentration in the other wells was lower, ranging from 0.74 ppb in MW-5 to 16 ppb in SB-1. Compared with the previous round of sampling in March 2015, the September 2021 analytical results indicate slight increase (MW-3 and SB-3) or decrease (MW-5, MW-7, and SB-1) in PCE concentrations that are not considered significant variations and concentrations of PCE are within the range, or lower, than concentrations reported since 2002. The data from this sampling event suggest that the overall ground water quality at the site is stable or continues to improve.

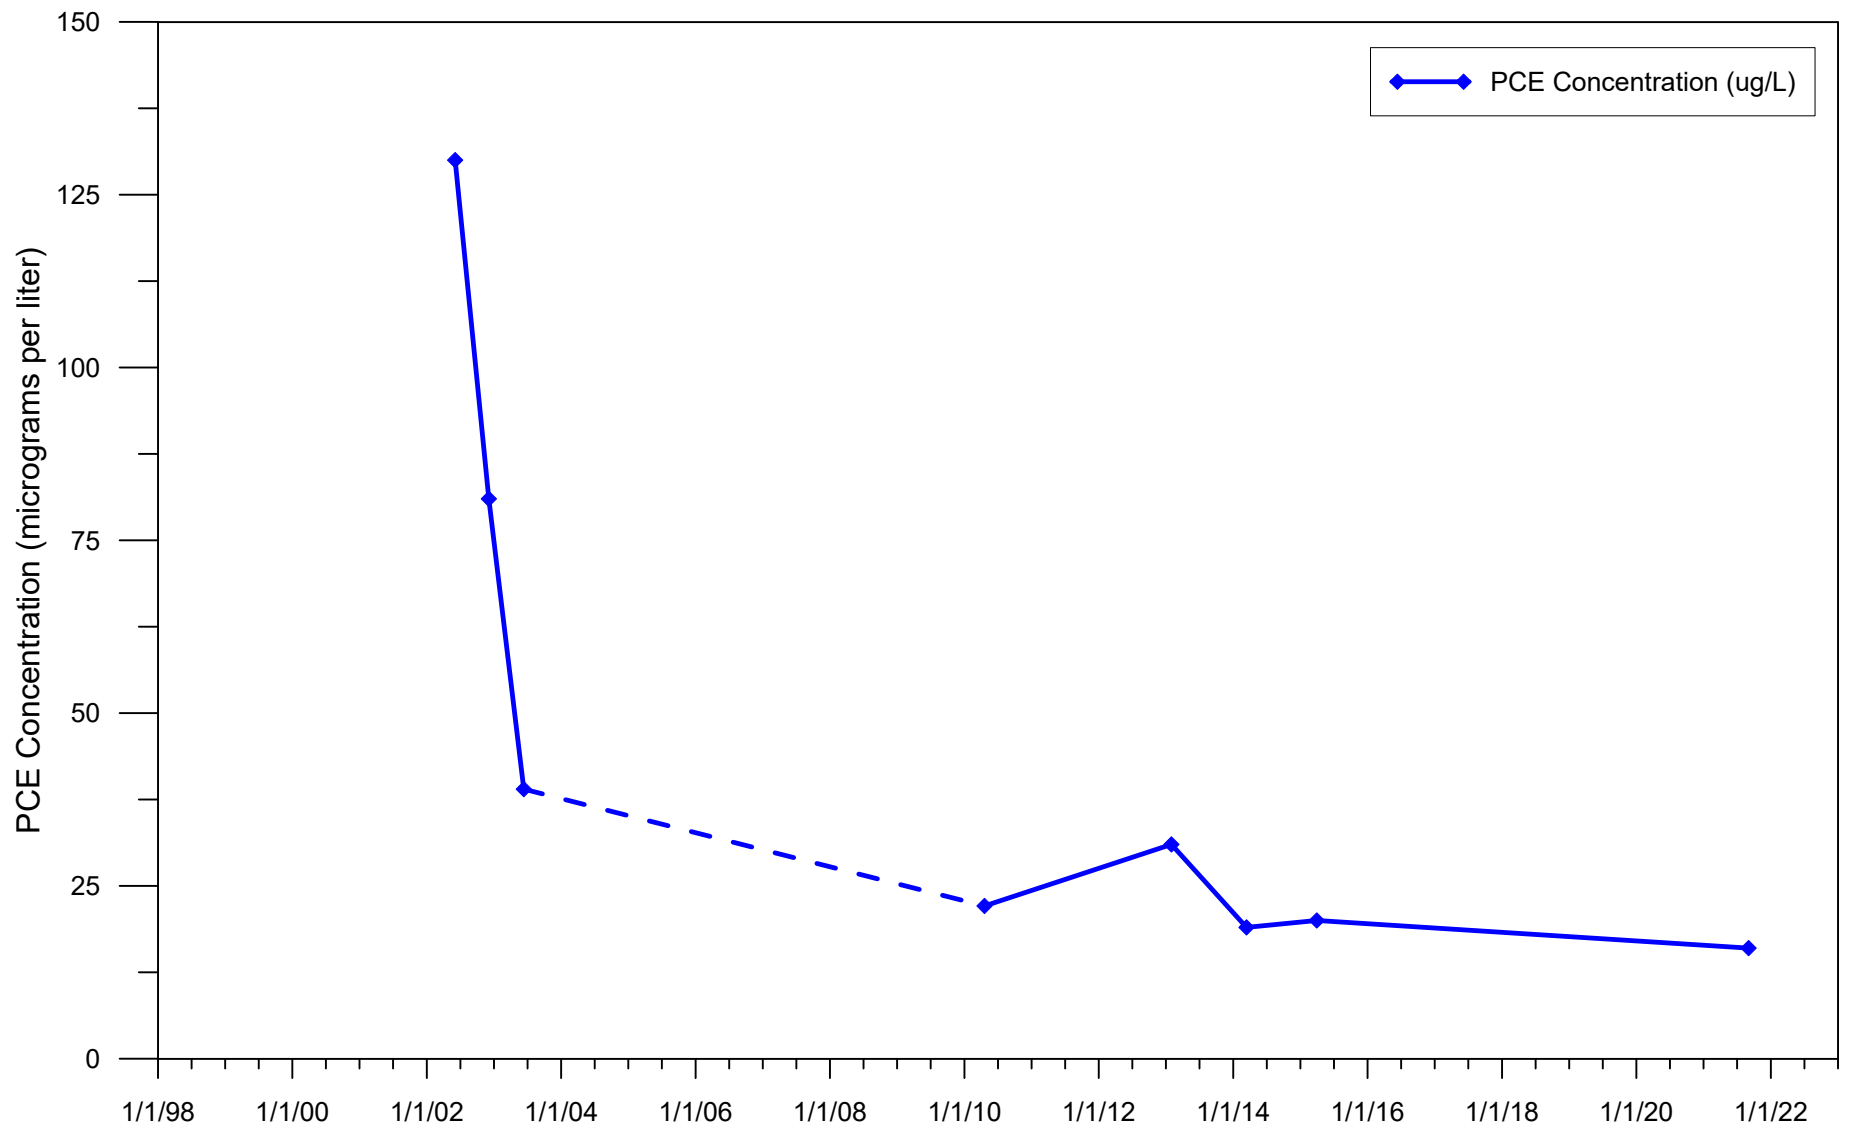
**FIGURE 6**  
Monitoring Well SB-1  
PCE Concentration

- Analytical data are summarized on Table 5.
- Well SB-1 was dry during the August 2007 and October 2009 sample events and no samples were collected.

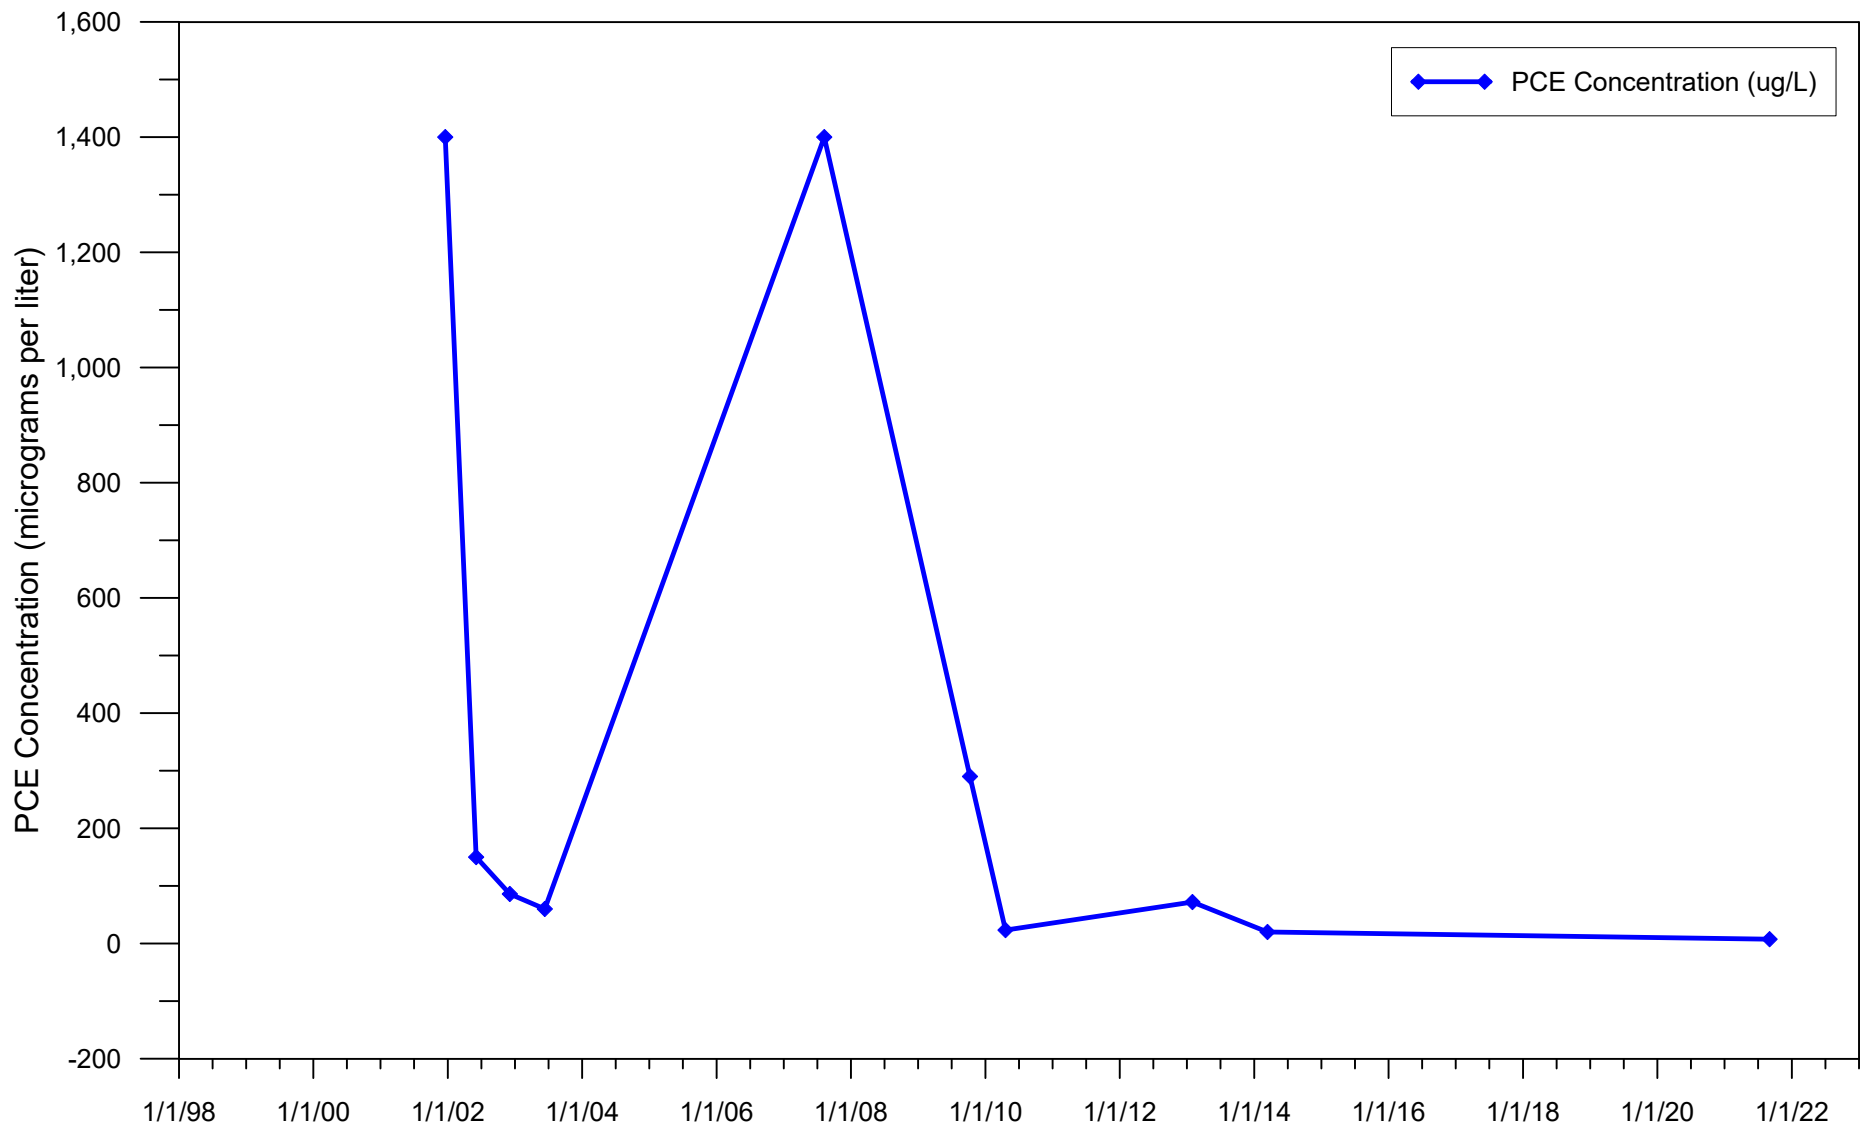
Notes:  
-Analytical data are summarized on Table 6.

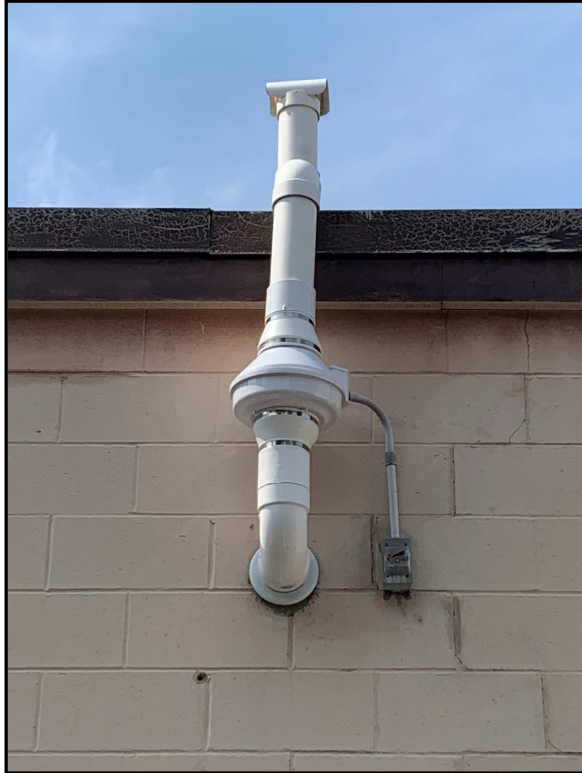
Item	Observation
System Fan	Fan operating with scraping noise, Fan Replaced with Fantech Model RN4-4
System Piping and Connections	No Deficiencies observed
Slab/System Interface Seals	No Deficiencies observed
Electrical Components	No Deficiencies observed
Pressure Gauges	No Deficiencies observed
Low Pressure Alarm	Not operating, missing transformer and cord. Replaced alarm.

New fan installed.

After replacing the system fan and low pressure alarm, Sub-system #3 (Hair Salon) is operating as designed.

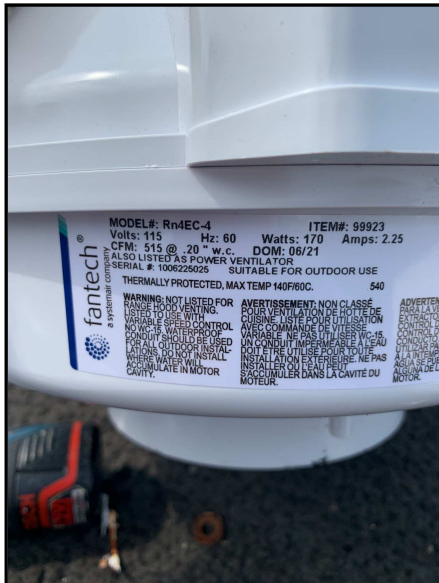
New fan nameplate.
