Re: Voluntary Cleanup Program
18-30 Whitestone Expressway, College Point, New York

REMEDIATION REPORT
1830 WHITESTONE EXPRESSWAY
WHITESTONE, QUEENS, NEW YORK

**18-30 WHITESTONE
EXPRESSWAY**
Queens, New York
Test Pit Excavation

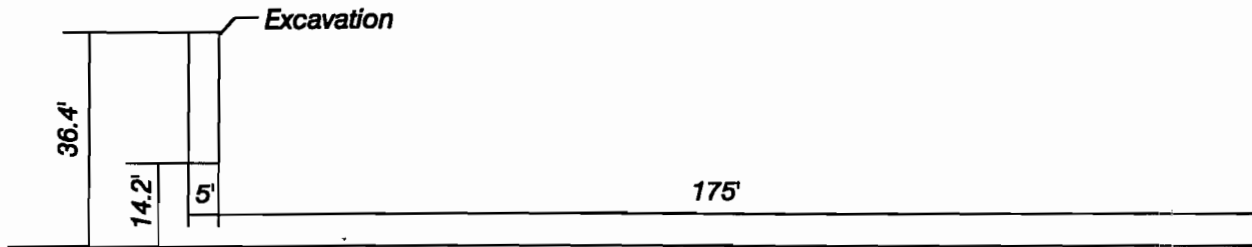
1

Because it was now dark, excavation work could not continue and work was suspended pending the results of laboratory analyses of the end point samples. The dimensions and location of the excavation were measured and recorded (see Figure 1). Since the site is unfenced and could not be properly secured from trespassers, the excavation was temporarily backfilled with clean surface soil from elsewhere on the site.

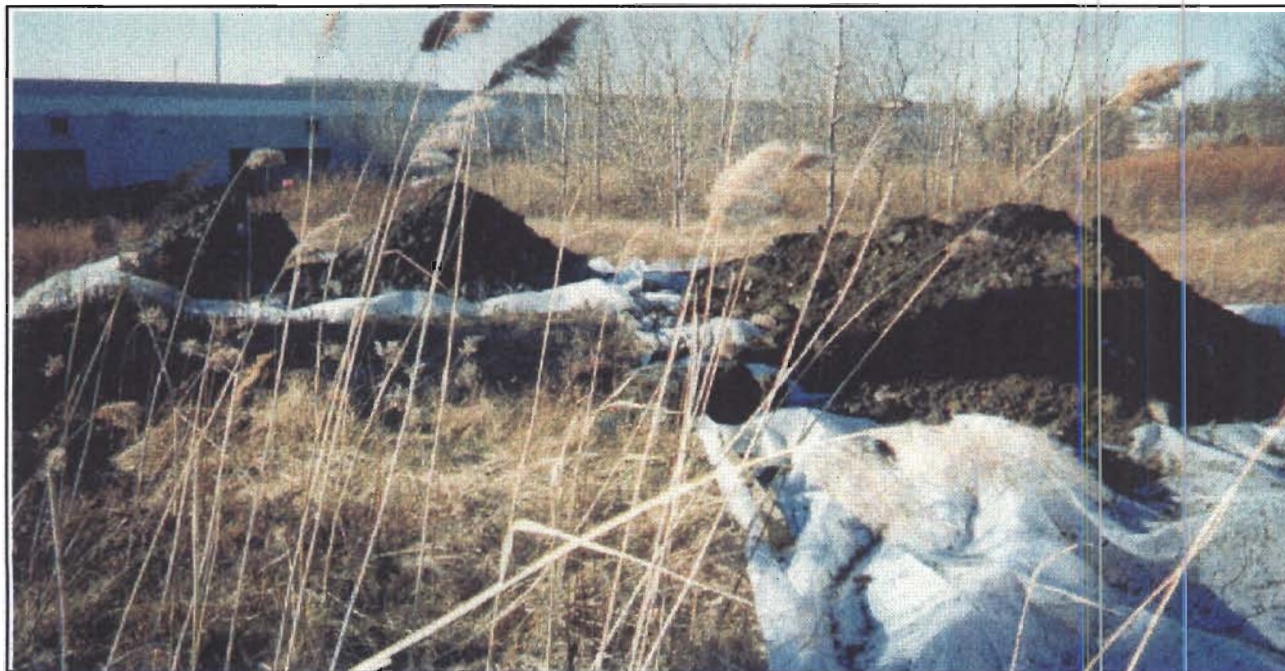
Photograph 1. Initial soil stockpiles

0-3' stockpiled just S of pit
3'-6' stockpiled on plastic just
N of pit. 6'-9' on plastic N of pit

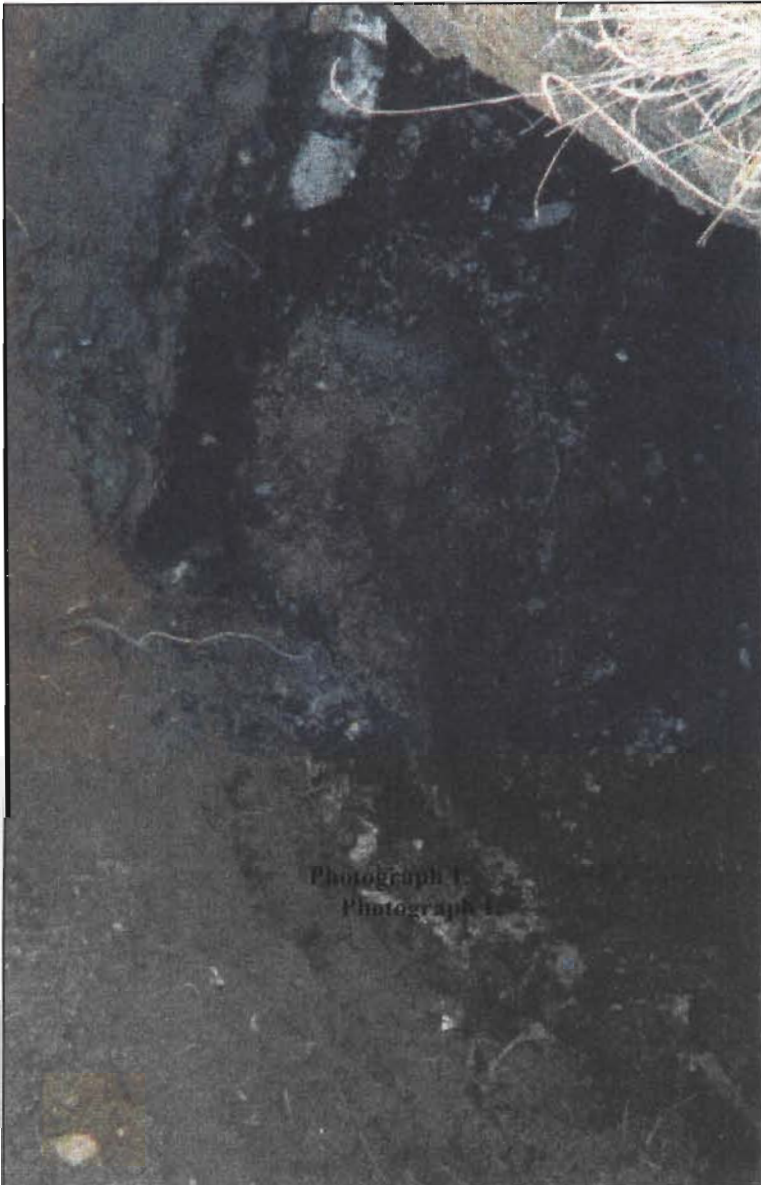
Photograph 2. Excavation in progress.

Based on the screening results, it was decided to extend the test pit deeper. The pit was excavated to a depth of 12 feet, with the 9 to 12 foot soil being placed in a separate stockpile. Six samples were collected for screening: two composites from the 9 to 12 foot stockpile, and samples from the bottom of the pit and from the four sides at the 9 to 12 foot level. The screening analyses again showed low levels of PCBs (less than 5 parts per million) in all samples except for one of the composites from the 9 to 12 stockpile, which fell in the 10 to 50 parts per million range, and the sample from the north wall of the excavation, which indicated over 50 parts per million.

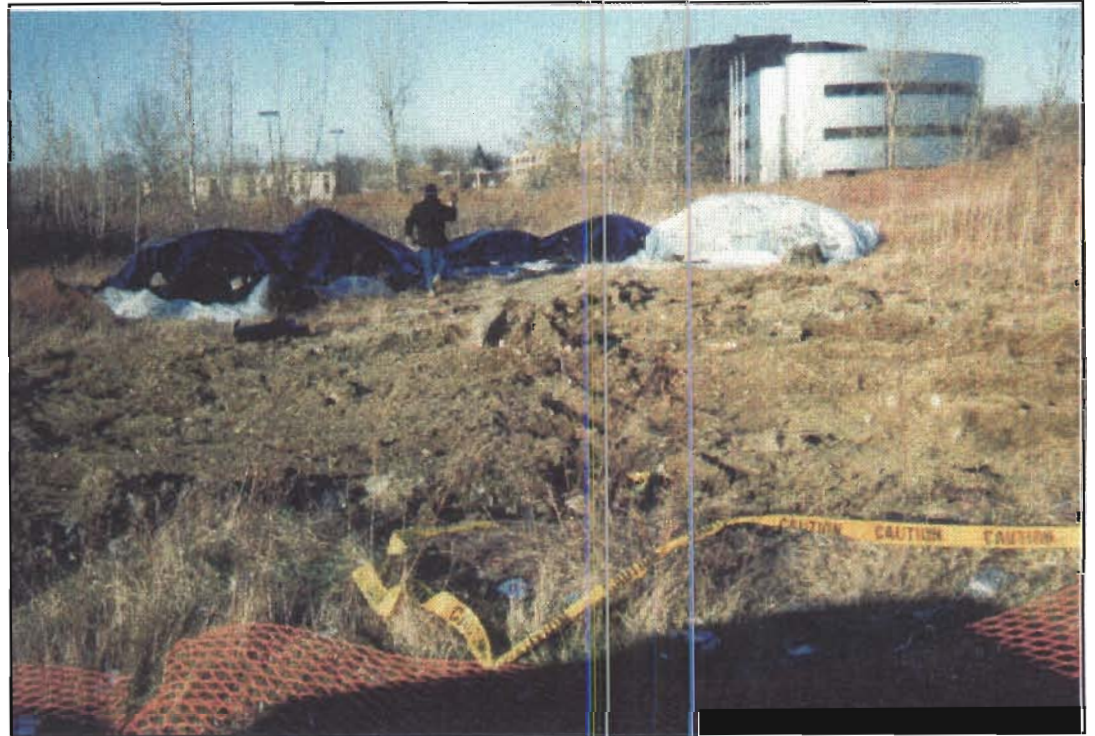
Photograph 3. Stockpiles covered with plastic pending removal.

The stockpiles were securely covered with 6-mil plastic sheeting. Piles were sized to be manageable, coverable, and fit in available areas. Plastic covering was sized and lapped to completely enclose the stockpiled soils. Plastic covering was applied and secured to protect the soils from wind and weather, and were shaped and secured to drain runoff. The soil stockpiles and plastic covering were maintained in good condition until the soil was removed from the site.
