10 March 2011

RE: Monthly Progress Report – February 2011
Greif, Inc. Facility – Tonawanda, New York
NYSDEC VCP Number V00334-9

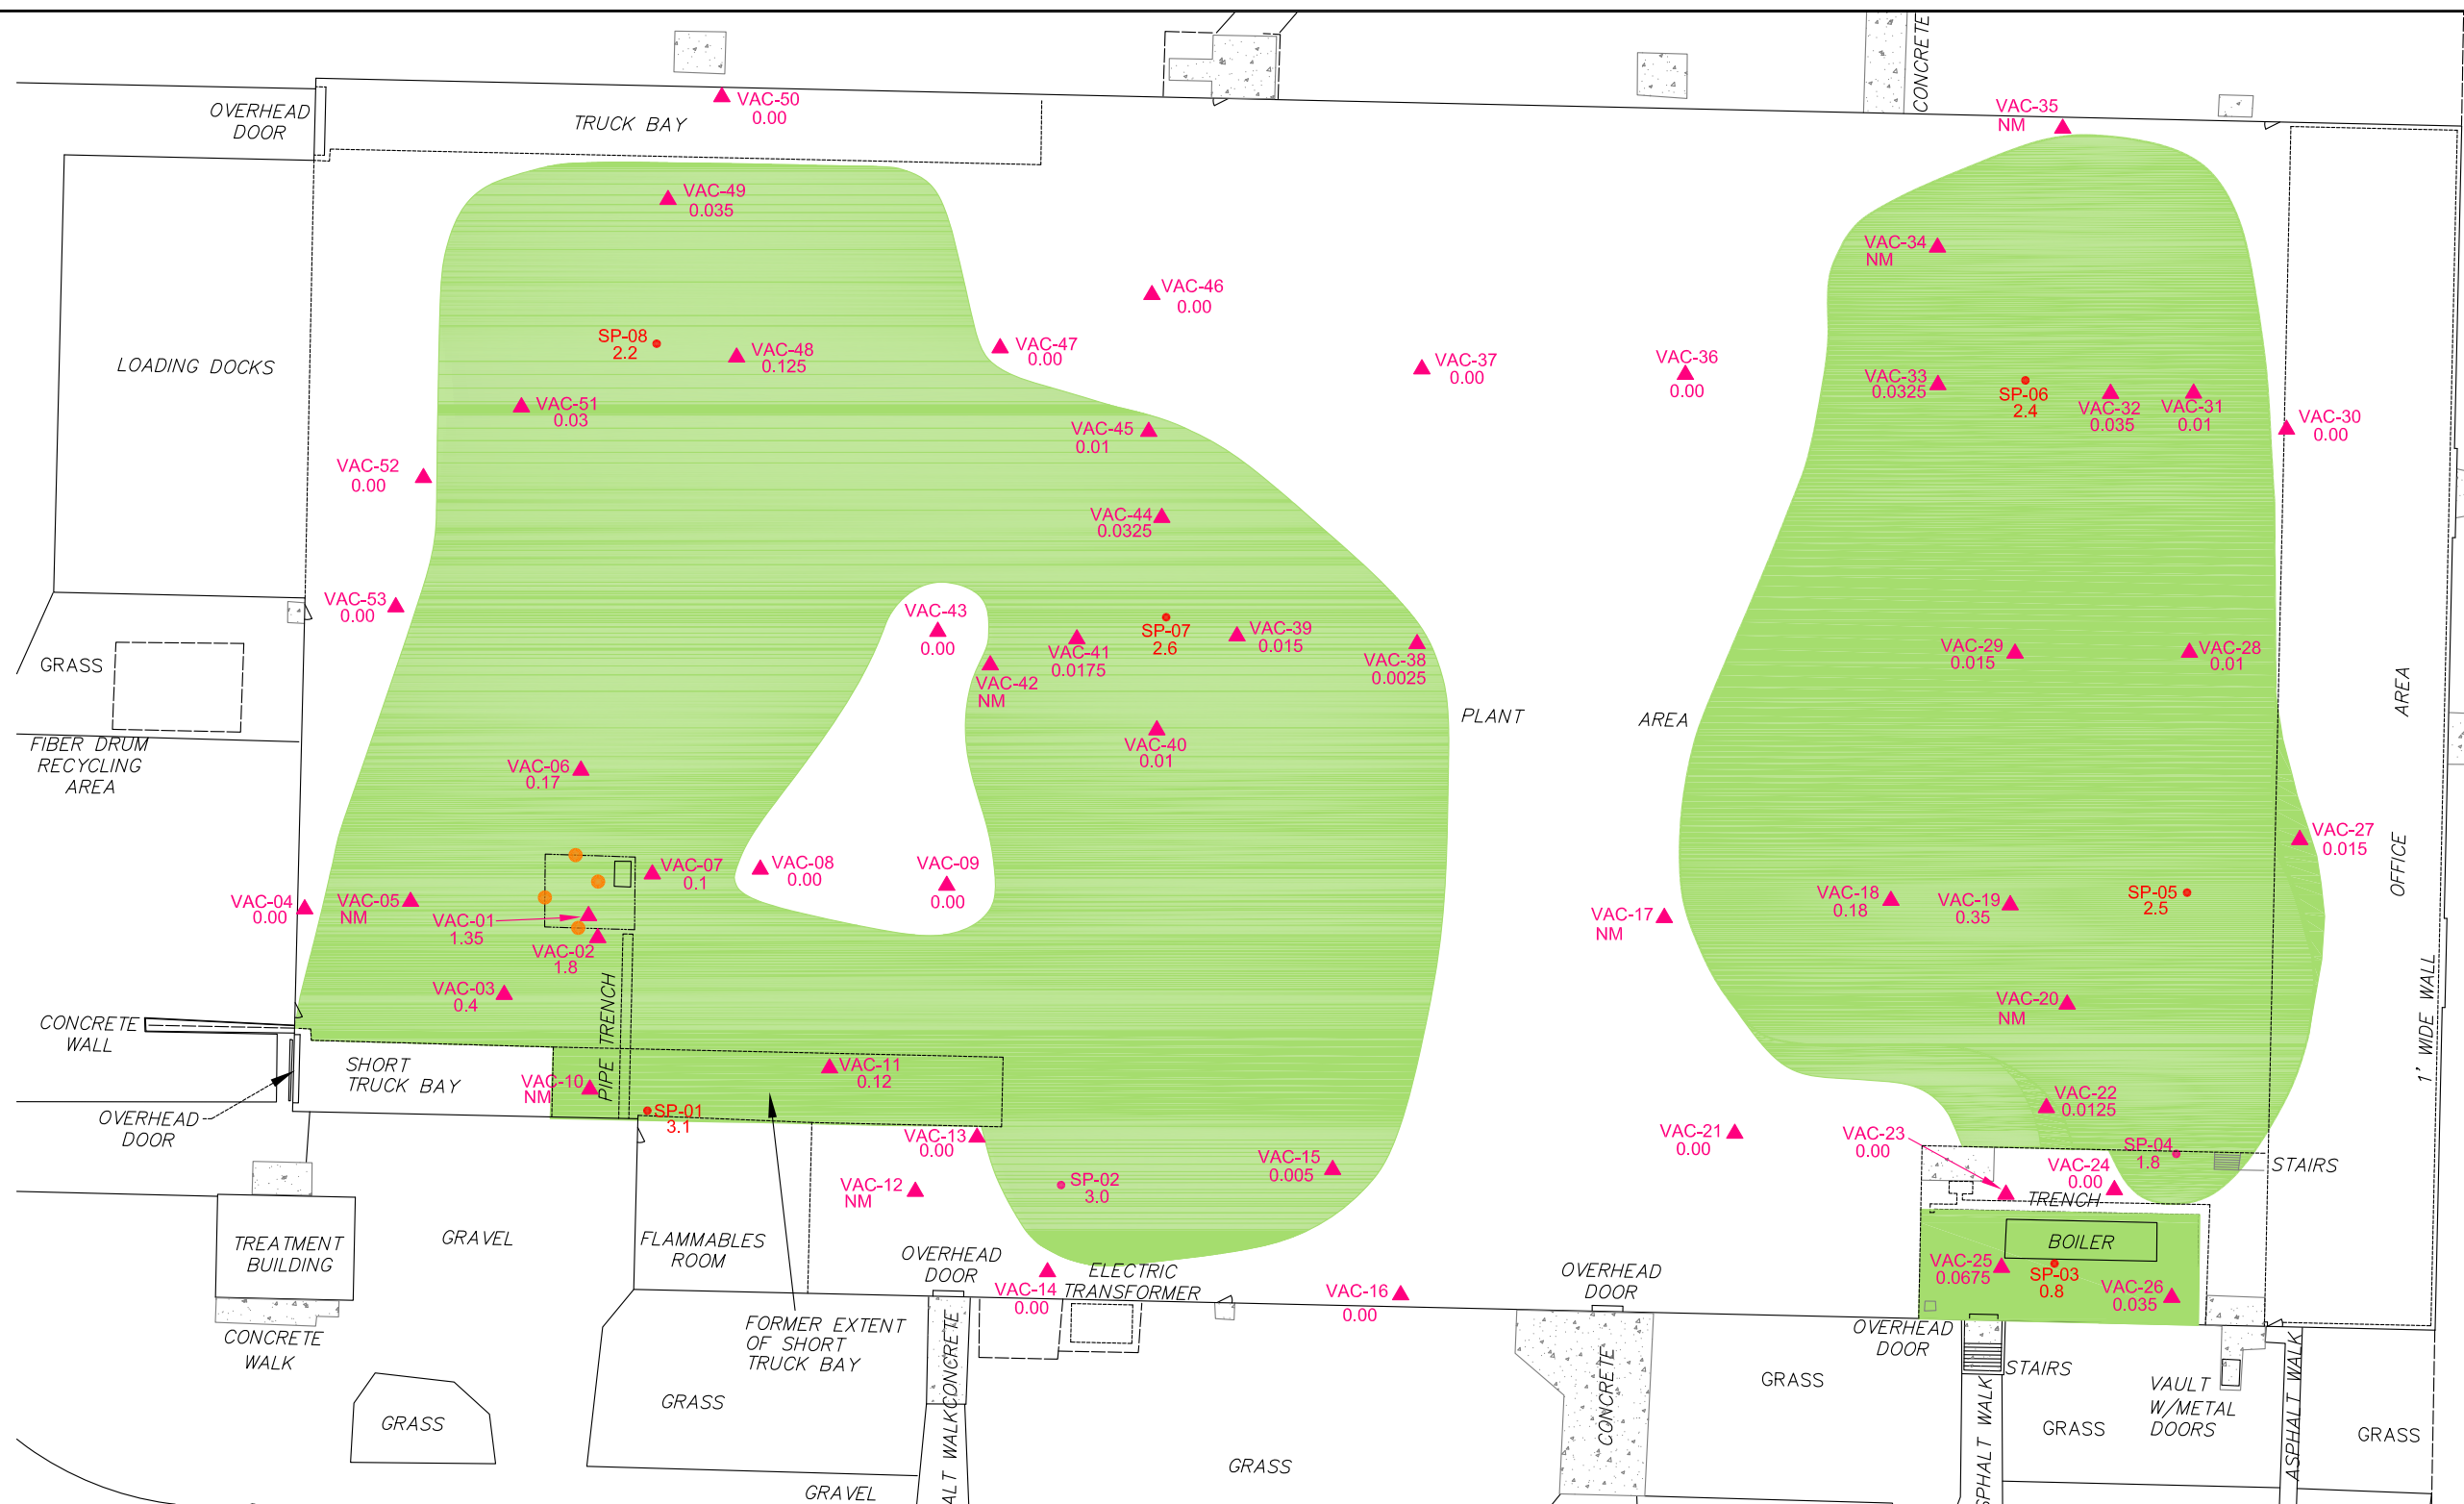
TITLE SUBSURFACE VACUUM DISTRIBUTION 21 FEBRUARY 2011 GREIF FACILITY-TONAWANDA, NEW YORK			
PREPARED FOR SONOCO PRODUCTS COMPANY			
Environmental Resources Management	SCALE GRAPHIC	FIGURE 2	
DRAWN: EMF	JOB NO.: 0112477.01	FILE NAME: 0129254-01-001	DATE 07-Mar-2011

- Performed routine operations and maintenance (O&M) on the Pilot Sub-Slab Depressurization (SSD) system and dense, non-aqueous phase liquid (DNAPL) recovery equipment. Collected and recorded relevant data. Data collected included liquid level measurements in selected Site wells and monitoring points (Table 1), vacuum readings in vacuum monitoring points (Table 2), and treatment system operational data (Table 3). The locations of wells and other monitoring points are presented in Figure 1. A map showing the estimated distribution of vacuum in the sub-slab at the facility on 21 February 2011 is presented in Figure 2.

During the 21 February 2011 site visit, additional water accumulation was observed in the system piping associated with suction point locations SP-05 through SP-08. Decreased and fluctuating vacuum readings similar to those during the December 2010 and January 2011 O&M site visits were also observed. To address this issue, ERM briefly isolated the blower vacuum to

discreet sections of the SSD system piping. ERM removed approximately 17-gallons of water from pipes PG-104 and PG-101 using focused blower vacuum to pull water into the system knockout pot. Subsequent to the water removal, fluctuation in vacuum readings at suction points SP-05 through SP-08 ceased and vacuum reading returned to normal values generally consistent with pervious month's readings.
