**REMEDIAL ACTION PLAN
166 CENTRAL AVENUE
ILION, NEW YORK**

**CHA PROJECT NO. 6201.14.04
NYSDEC SPILL NO. 97-014-02**

JUNE 1997

**CLOUGH, HARBOUR & ASSOCIATES LLP
*ENGINEERS, SURVEYORS, PLANNERS
& LANDSCAPE ARCHITECTS*
109 SOUTH WARREN STREET, SUITE 1300
SYRACUSE, NEW YORK
13202**

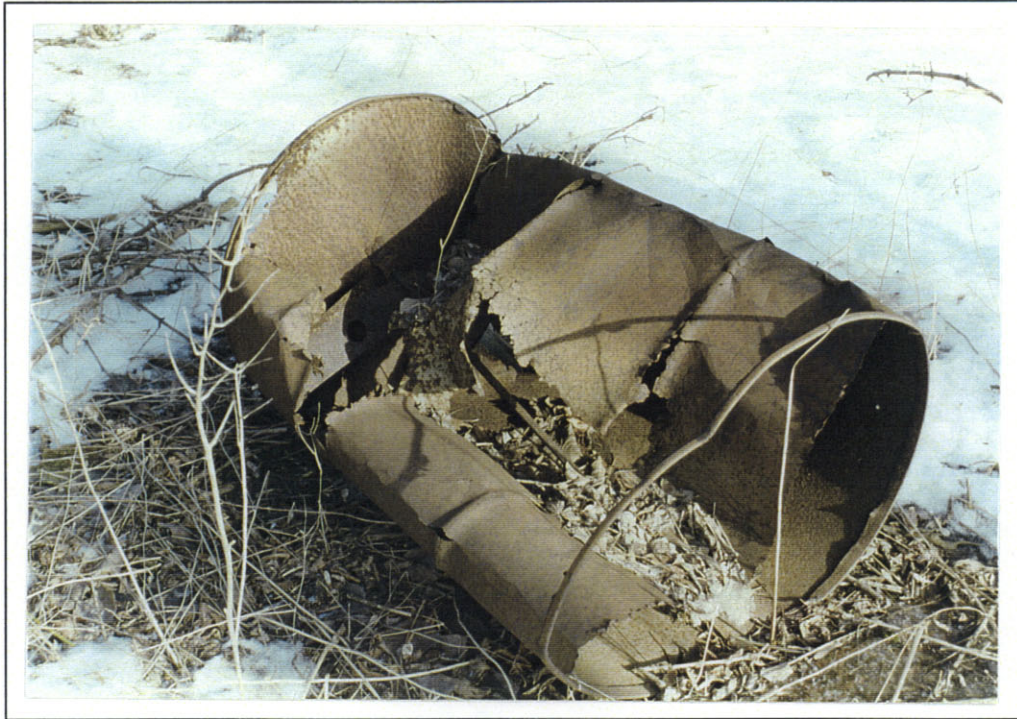
Photograph 5. Heavily rusted and empty drum located to eastern edge of subject site.

There were three 55 gallon drums observed on the subject site. Two were heavily rusted, broken into several pieces and empty. A third drum to the southeast of the property was heavily rusted but intact. At the time of the site inspection this intact drum was frozen in place and it could not be determined if it contained any material.

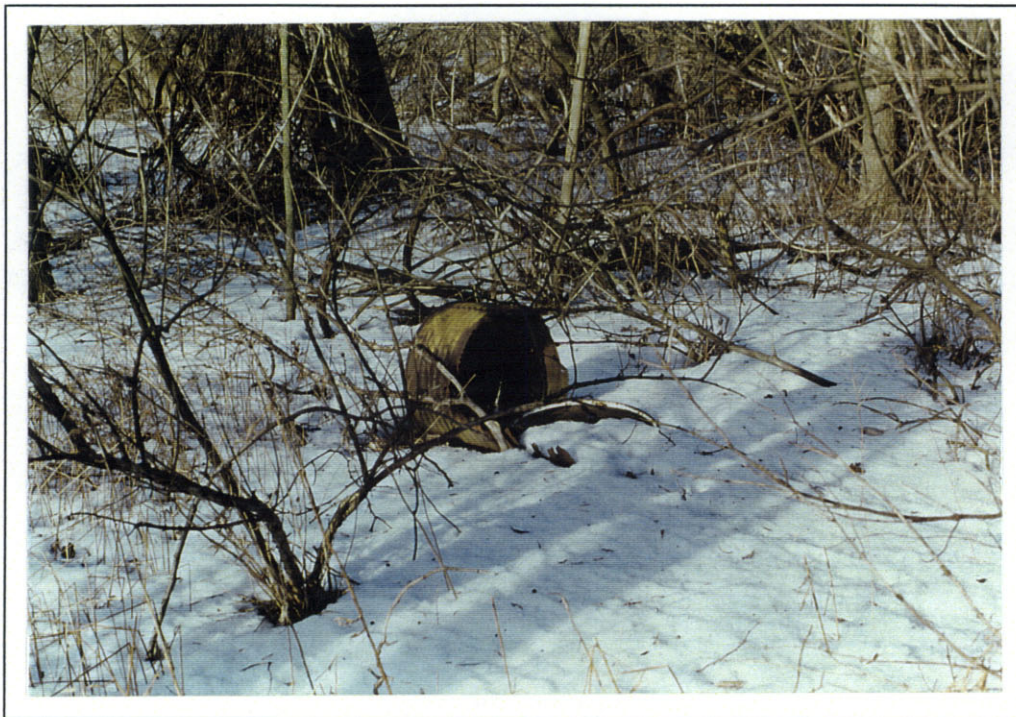
Photograph 6. Piece of rusted drum to southeastern edge of subject site.

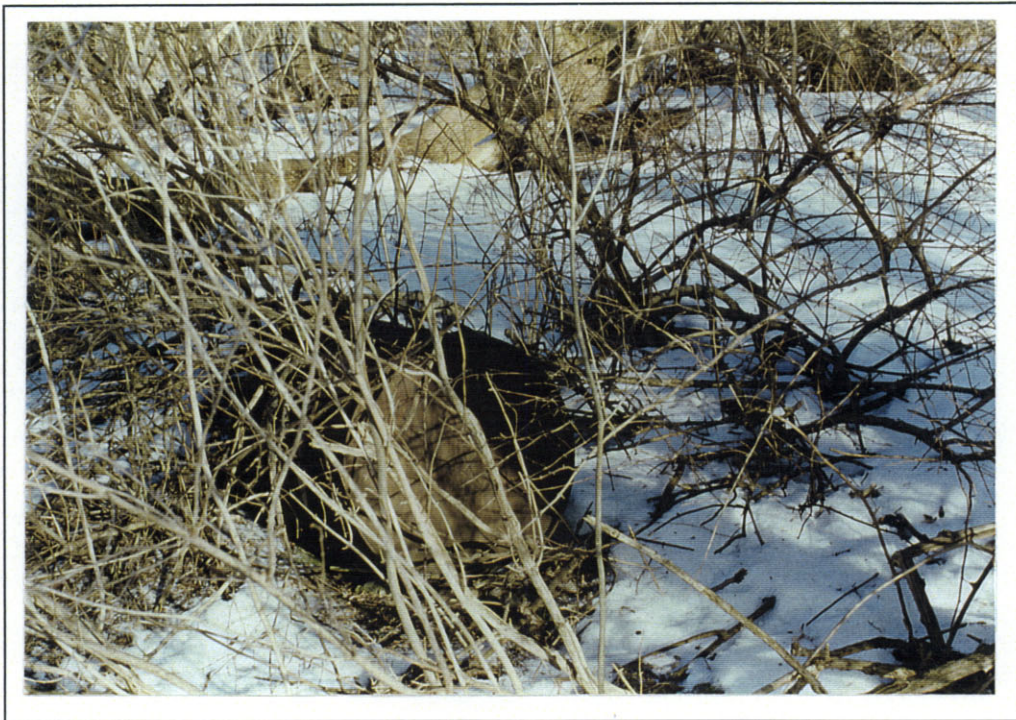
Photograph 7. Heavily rusted and intact drum located to southeastern edge of subject site.
