Site Characterization Work Plan

Site Investigations

Ballston Spa Non-Owned Former MGP Site
130 Milton Avenue
Ballston Spa, New York

May 2004

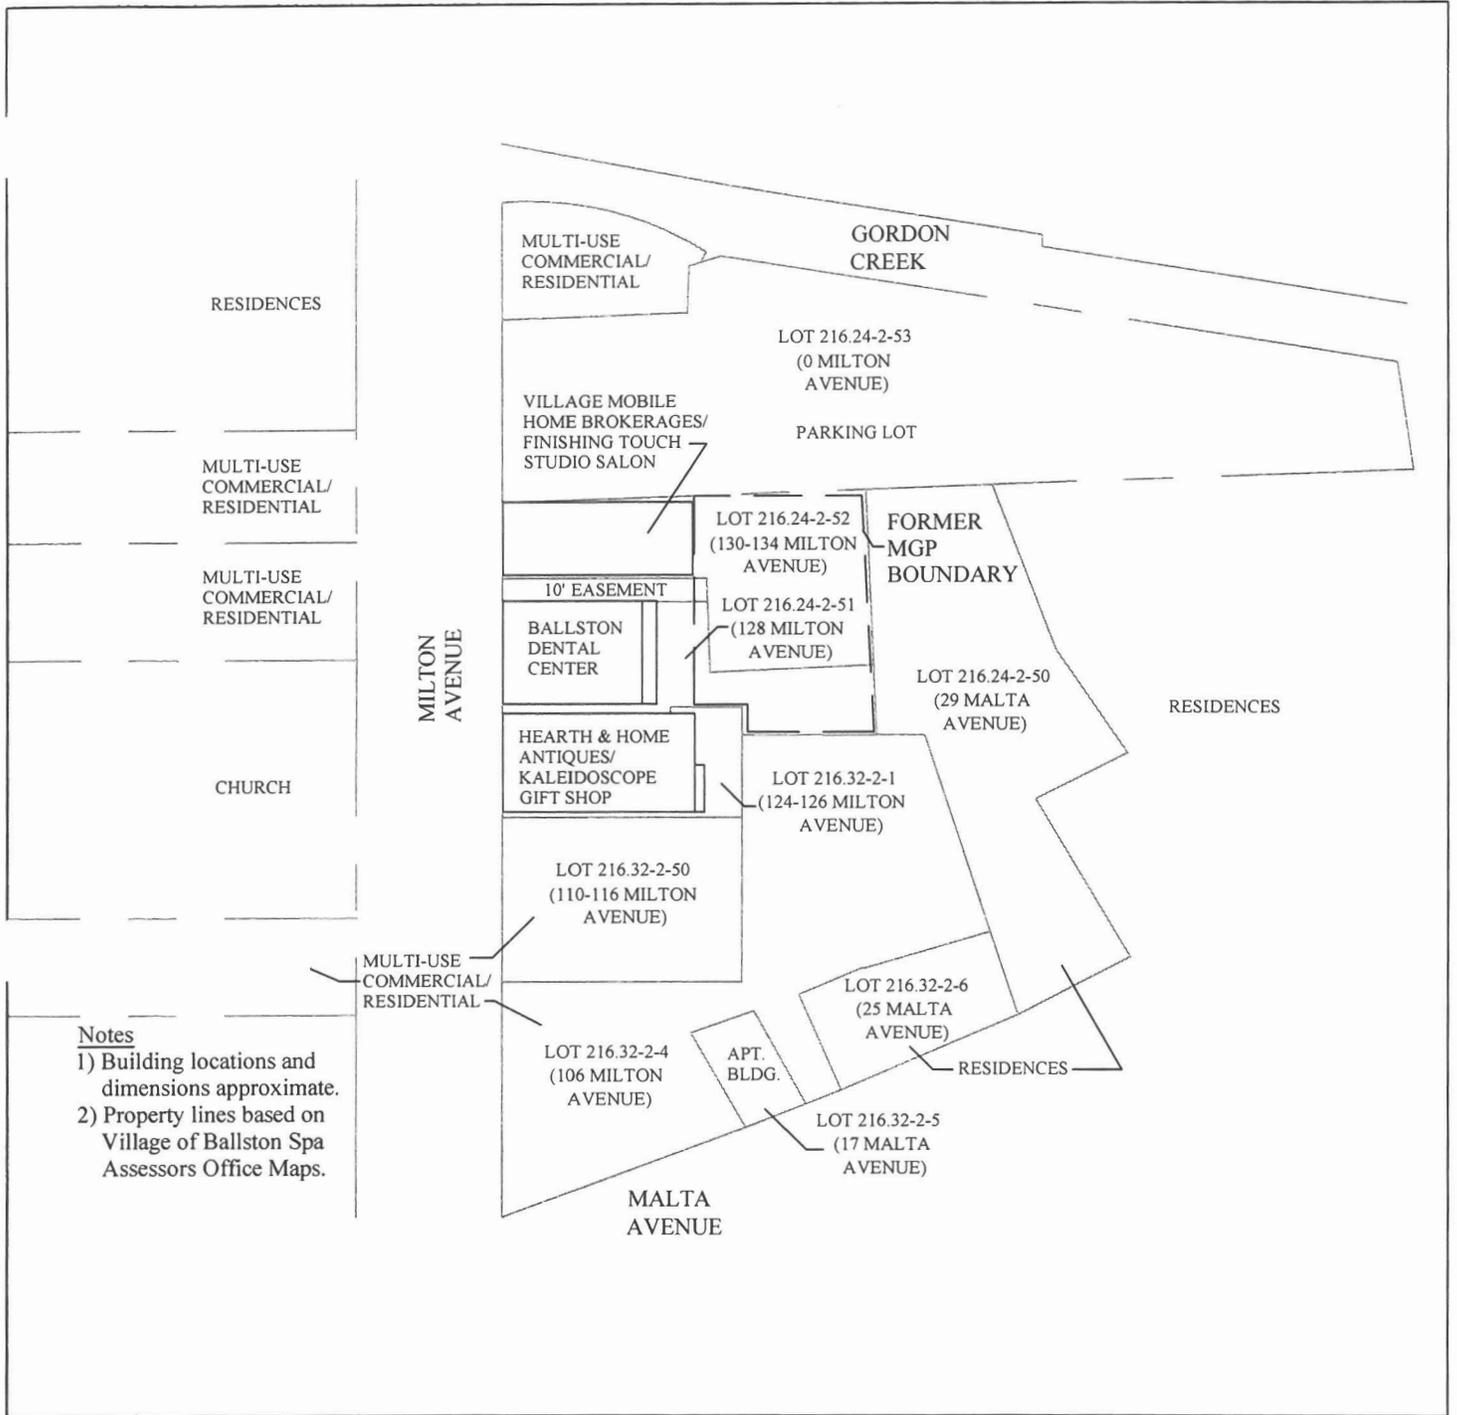
<p>Environmental Engineering Consulting Services Inc.</p>	<p align="center">SITE LAYOUT MAP Ballston Spa Non-Owned Former MGP Site 130 Milton Avenue Ballston Spa, New York</p>	<p align="center">FIGURE</p> <p align="center">2</p>
--	--	--

- 1) Building locations and dimensions approximate.
- 2) Property lines based on Village of Ballston Spa Assessors Office Maps.
- 3) Former building locations and dimensions approximate.
Structures from 1904 Sanborn Map.
