**ANNUAL SITE MANAGEMENT REPORT
FROM APRIL 2013 TO MARCH 2014
METROPOLITAN AVENUE CAMPUS (Q686)
92-34 METROPOLITAN AVENUE
FOREST HILLS, NY
VCP AGREEMENT # V-00500-2**

Date of Issue: April 14, 2014

Cardno ATC Project No. 015.19125.1819

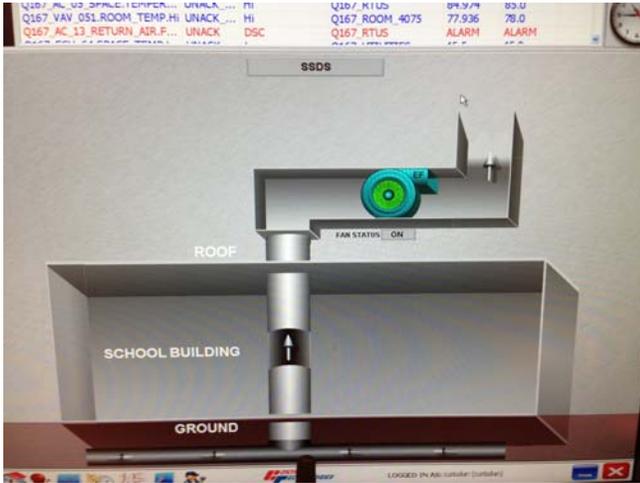
Photo 1: View of the BMS indicating SSDS operation.

1. The SSDS fan unit and indicator lights were operational;
2. Rust or other debris in the vicinity of the post, sleeve and discharge cap at the SSDS stack vent were not observed;
3. Rust or other debris in the vicinity of the inline filter was not observed; and
4. All gauges were observed to be functioning.

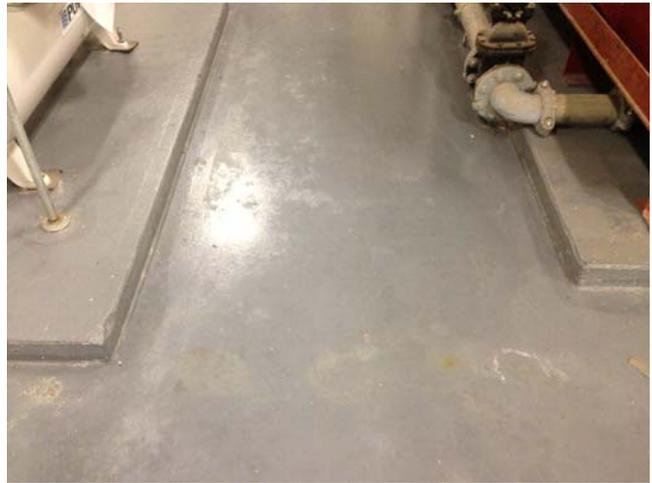
Photo 2: View of typical bare concrete floor in Room 0005.

ATC inspected the accessible areas of the basement floors and walls. ATC did not observe any visible concrete cracks penetrating into the basement floor during the annual inspection. ATC also inspected the elevator pits and cracks were not observed. ATC's observation of the basement concrete floors was limited due to architectural finishes such as ceramic floor tiles, vinyl floor tiles, wood flooring and miscellaneous equipment and furniture.

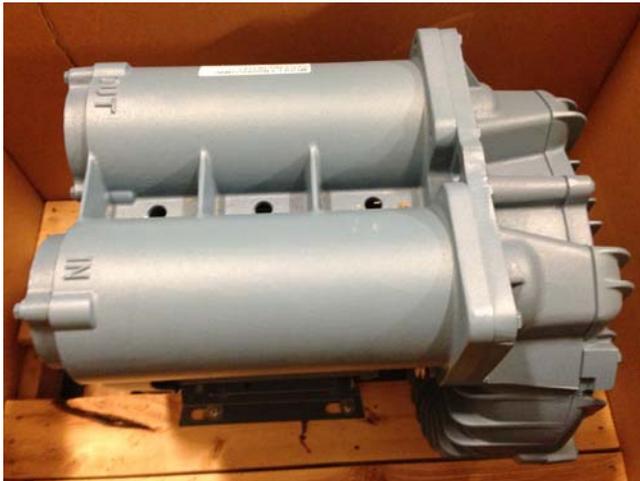
Photo 3: View of spare SSDS fan motor in Room 0005.

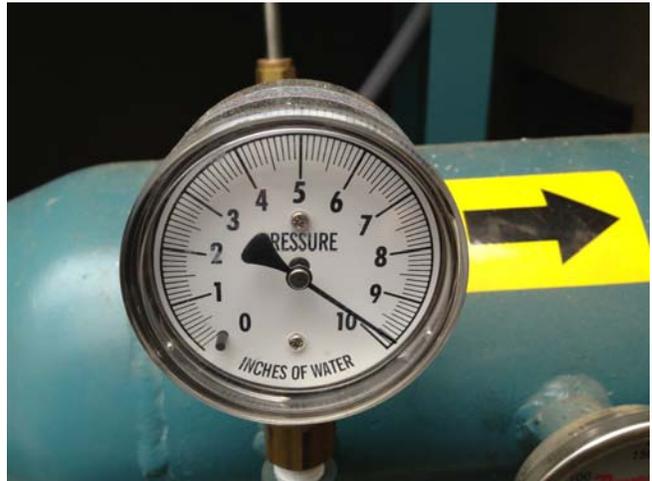
Photo 4: View of SSDS vacuum gage.

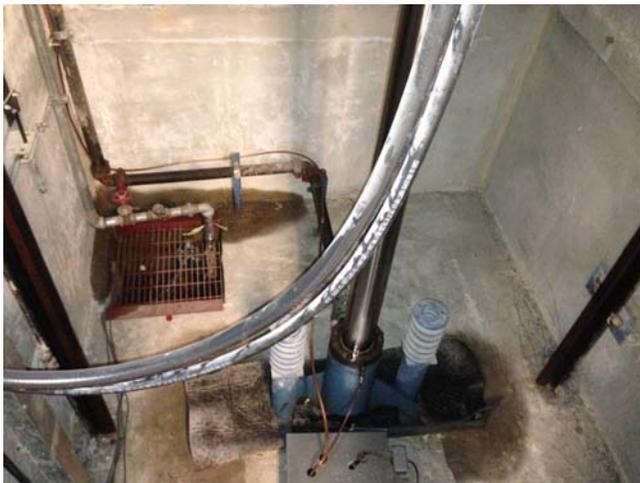
Photo 5: View of elevator pit.

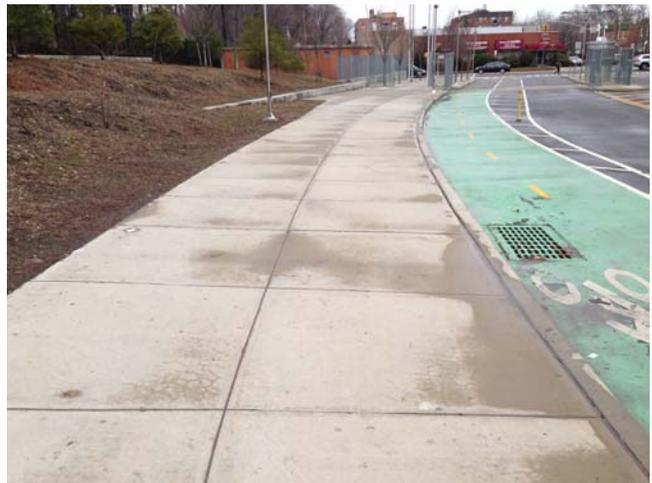
ATC inspected the composite cover system around the perimeter of the property including the paved and unpaved areas. ATC observed hairline cracks on the roadway, sidewalk, tennis court and playground; however these cracks do not compromise the cover system. ATC advised the custodial staff to repair or seal the hairline cracks to original condition to prevent further deterioration. There was no evidence of pavement removal. No structures have been constructed on the unpaved areas. There were no signs of soil washing or erosion. There were no signs of intrusive activities such as drilling, digging, trenching, grading or excavating. ATC also inspected the artificial turf and observed no apparent holes, cracks or deterioration. All exterior cover systems were intact.

Photo 6: View of typical concrete sidewalk, vegetation cover, and roadway.

1. Continue documenting all operation and maintenance activities on ECs;
2. Conduct preventative maintenance and document accordingly;
3. Repair or seal the exterior hairline cracks to prevent further deterioration; and
4. Monthly and Severe Condition inspections should be conducted and inspection logs should be completed by the custodial staff.
