**Remedial Action
Photograph Log
Central Avenue – Peekskill
July 7-9, 2004**

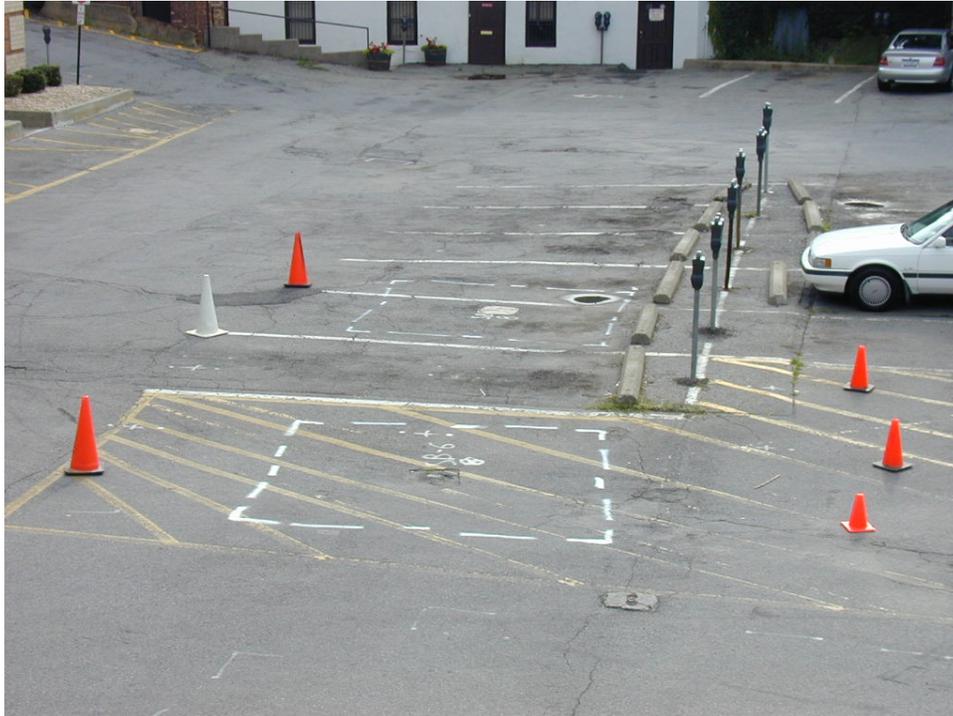
Photo 1 - View of the excavation area looking towards the east. The square areas outlined in white dashed lines show the initial areas to be excavated surrounding SB-6 (foreground) and SB-8 (background).

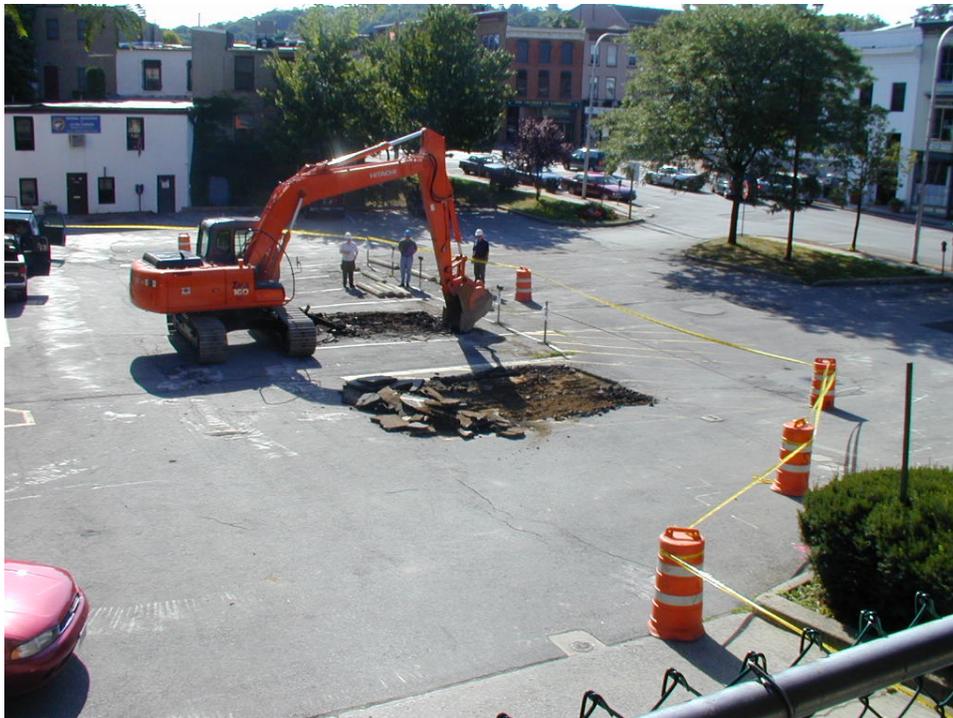
Photo 2 - View of excavation area looking southeast. The asphalt has been removed from the two excavation areas. The pedestrian walkway to the stairs into the garage can be seen on the right side of the photo.

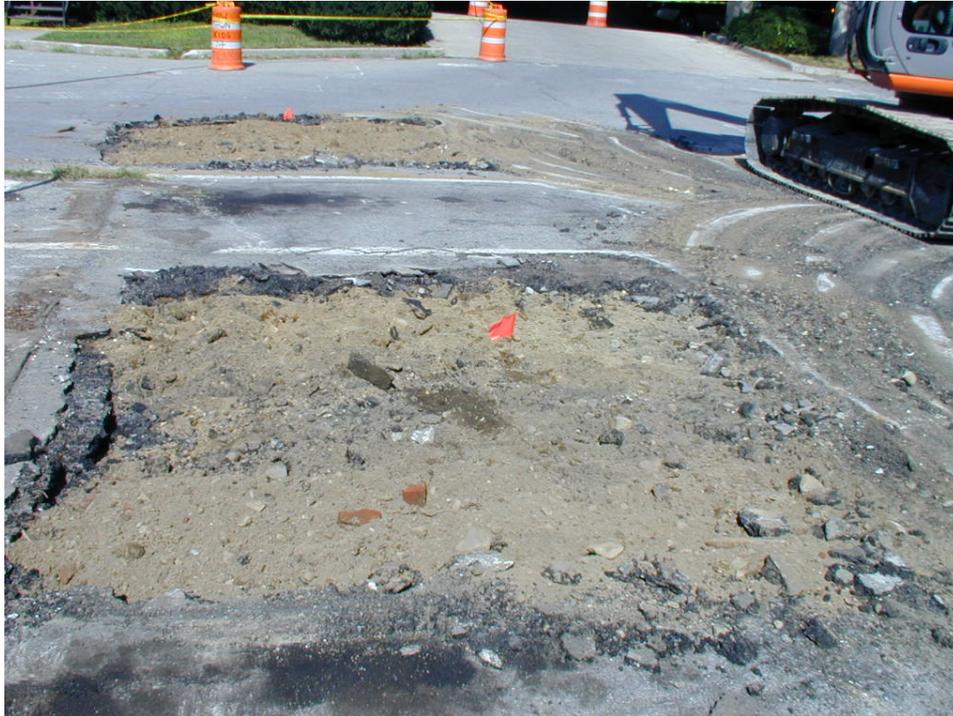
Photo 3 - View of the parking lot looking west showing the soil immediately beneath the asphalt in the excavation areas around soil boring SB-8 (background) and SB-6 (foreground). The red flags show the locations of the soil borings.

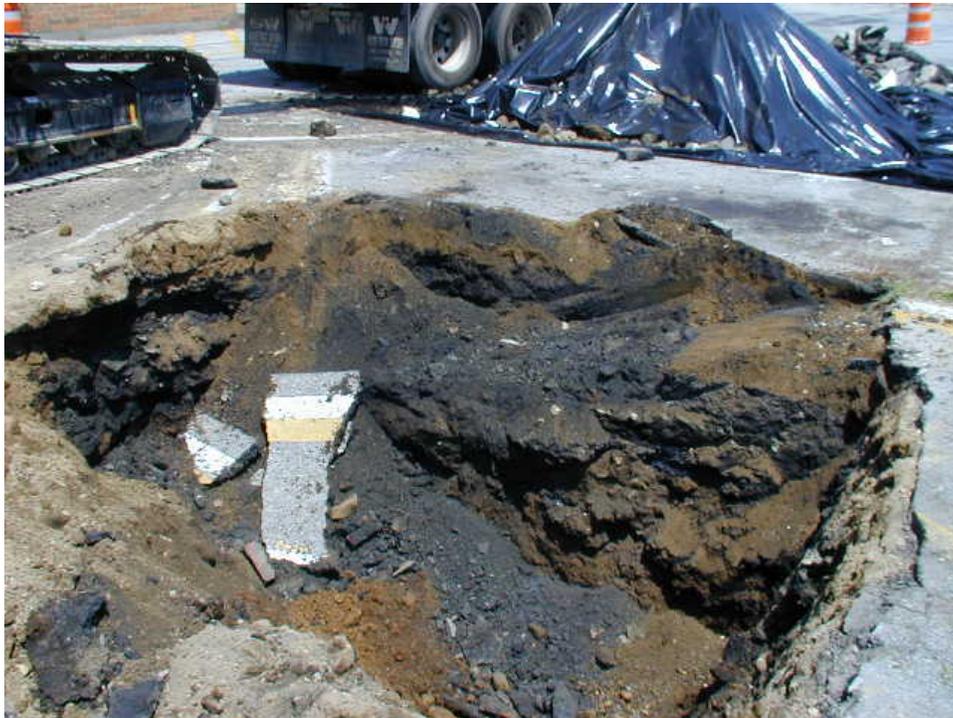
Photo 4 - View of the east wall of the excavation at SB-6 on the first day of excavation, showing impacted soils in the sidewall.

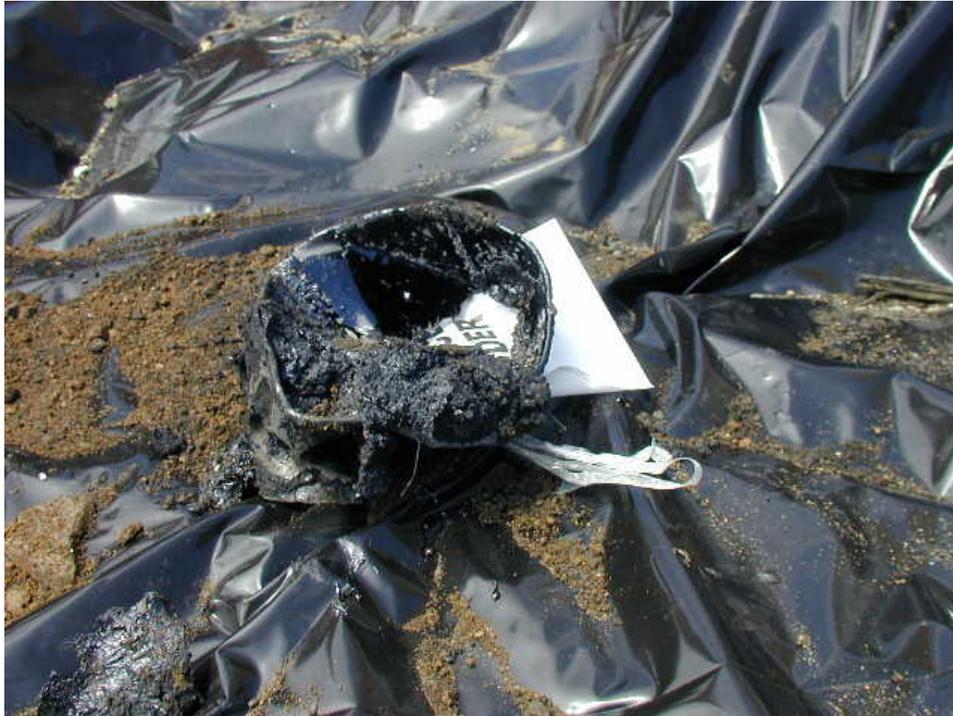
Photo 5 - Bucket containing tar-like material removed from the excavation.

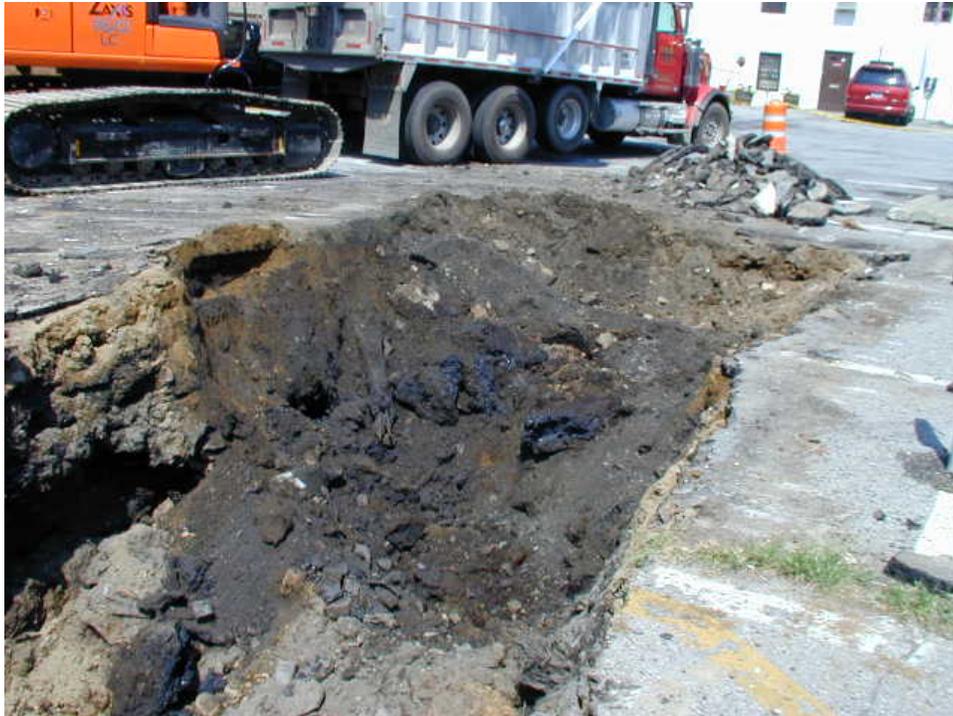
Photo 6 - Excavations SB-6 and SB-8 combined to form a single excavation.

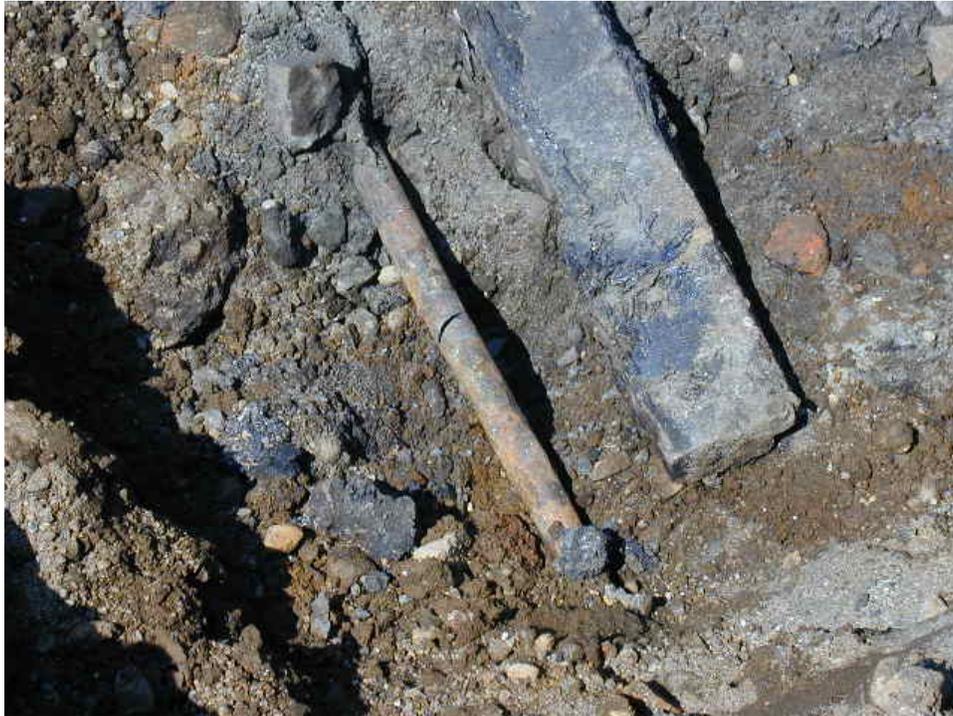
Photo 7 - A two-inch diameter iron pipe uncovered along west wall of excavation. Soils surrounding this pipe in the northwest portion of the excavation exhibited a petroleum-like odor.

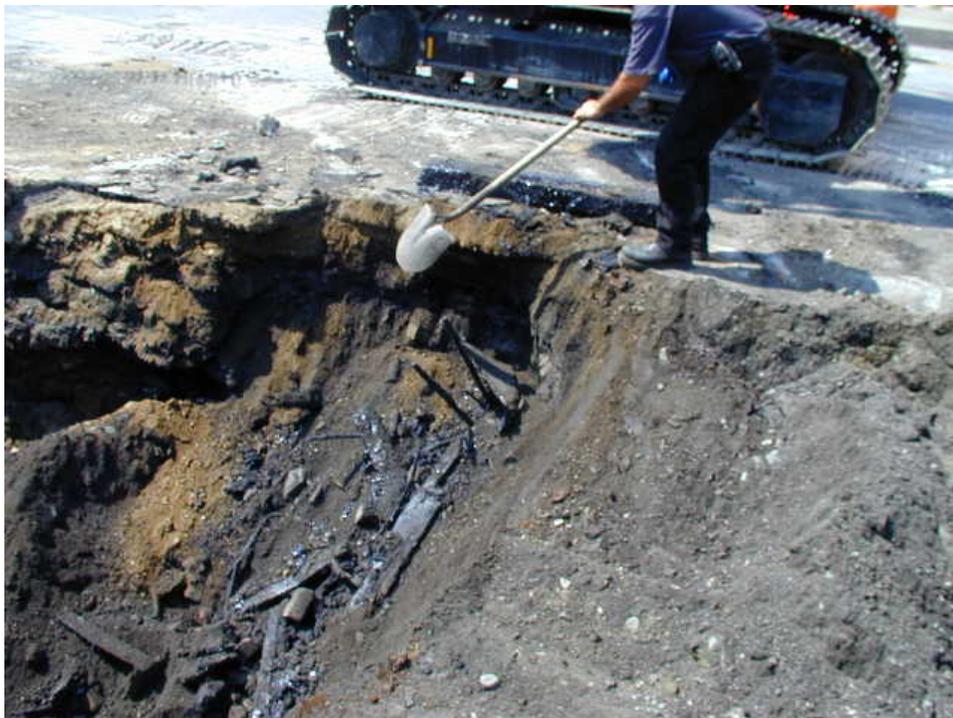
Photo 8 - Remains of one-foot by one-foot square wooden plank structure found in the center of the excavation.

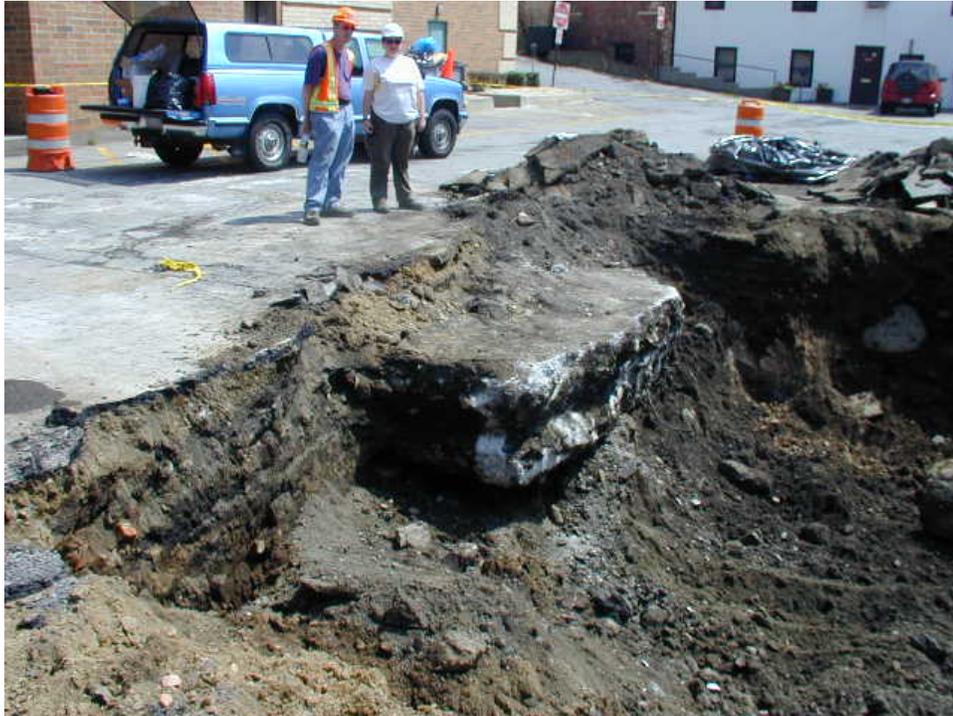
Photo 9 - View looking to the northeast showing the concrete slab along the north wall of the excavation. Note that removal of the affected soils required expansion of the initial excavations to create one excavation.

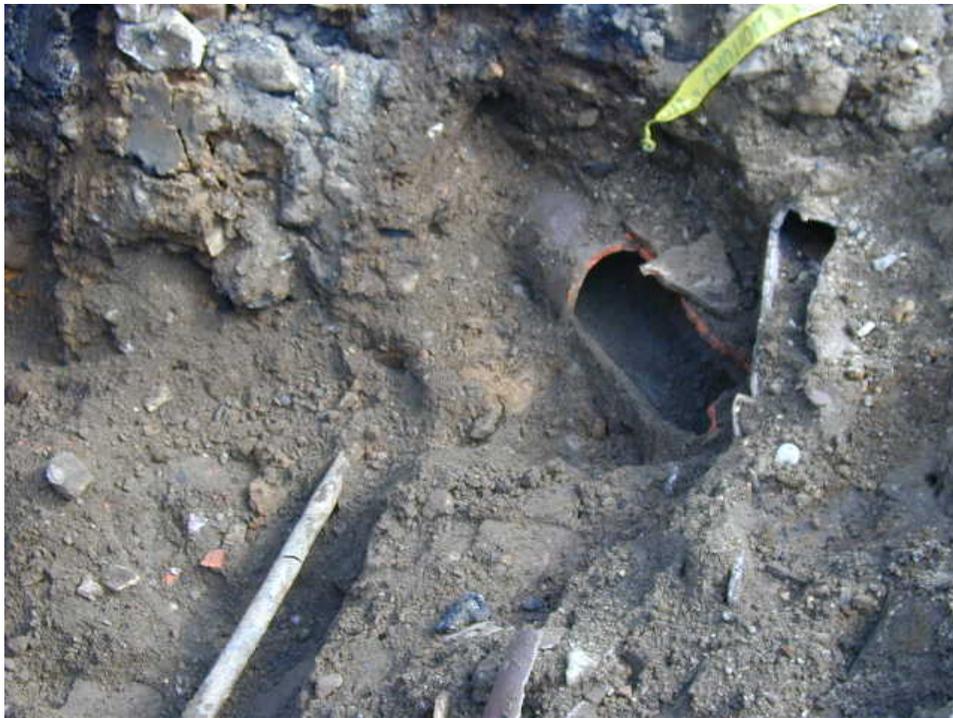
Photo 10 - Clay pipes uncovered beneath the southwest corner of the excavation.

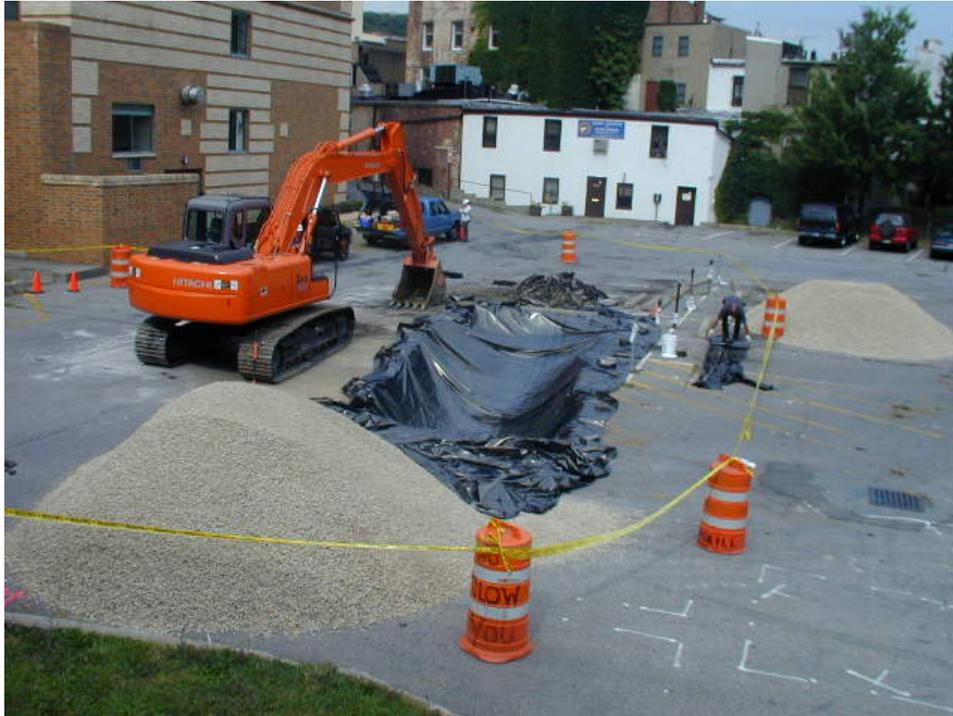
Photo 11 - Excavation secured for the night with plastic to prevent the release of odors. Backfill material (NYSDOT Item #4 stone) is shown stockpiled adjacent to the excavation for later use.

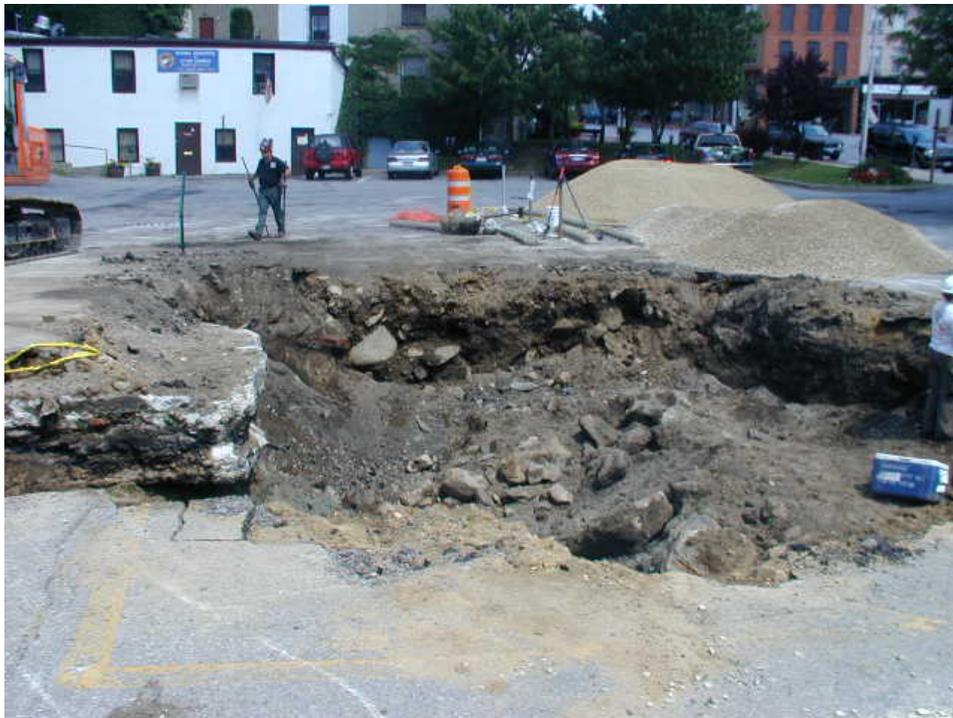
Photo 12 - View to east showing the maximum extent of excavation. Note the concrete slab at the left side of the photo.

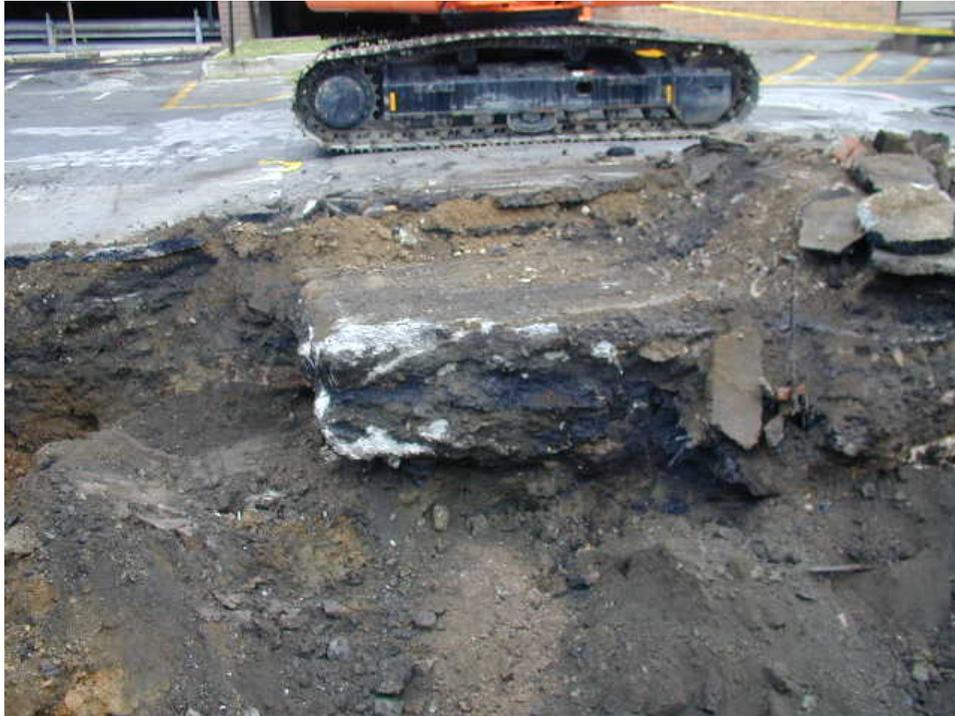
Photo 13 - View of north wall showing buried concrete slab.

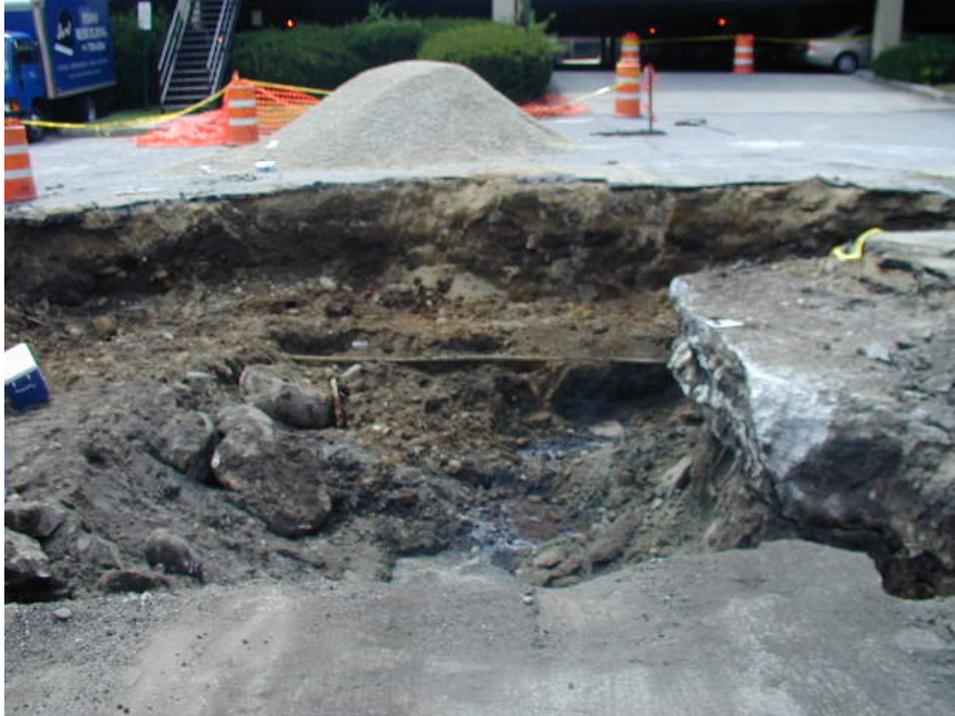
Photo 14 - View to west of final extent of excavation.
