**Re: 1061 North Broadway – City of Yonkers
Site Number V00687
Site Management Periodic Review Report & IC/EC Certification
October 24, 2016 – February 24, 2018**

SITE MANAGEMENT PERIODIC REVIEW REPORT 1

1061 (1060) NORTH BROADWAY, YONKERS, NEW YORK 10701

NYS DEC SITE NUMBER V00687

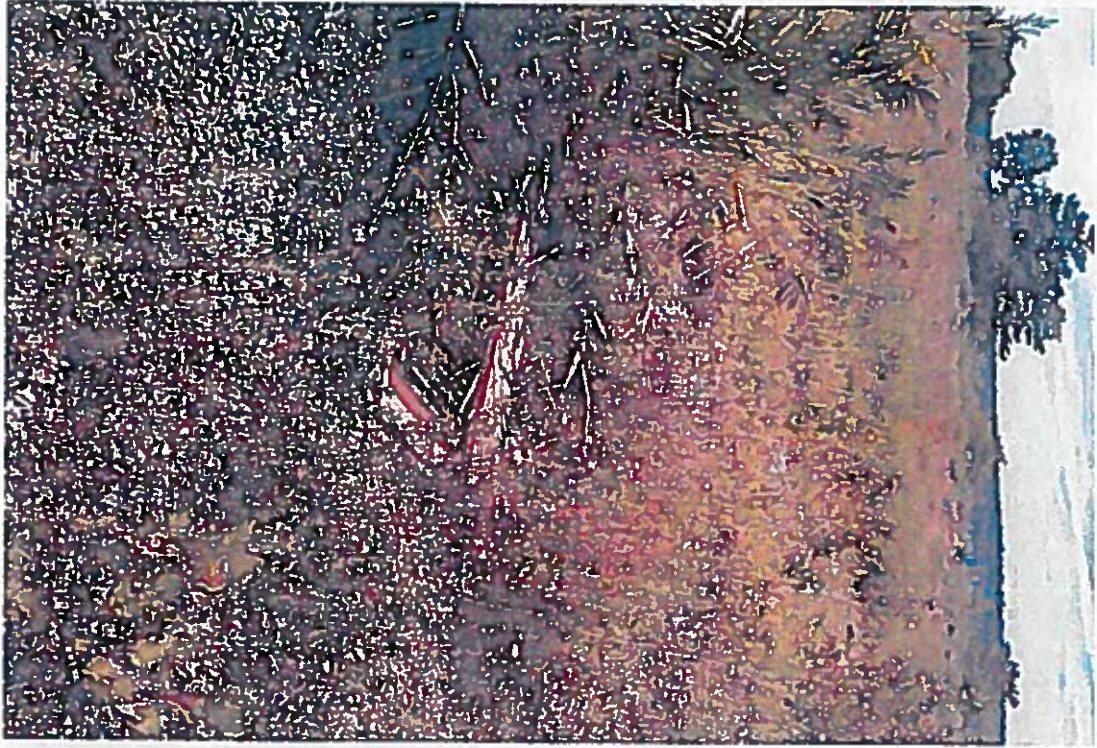
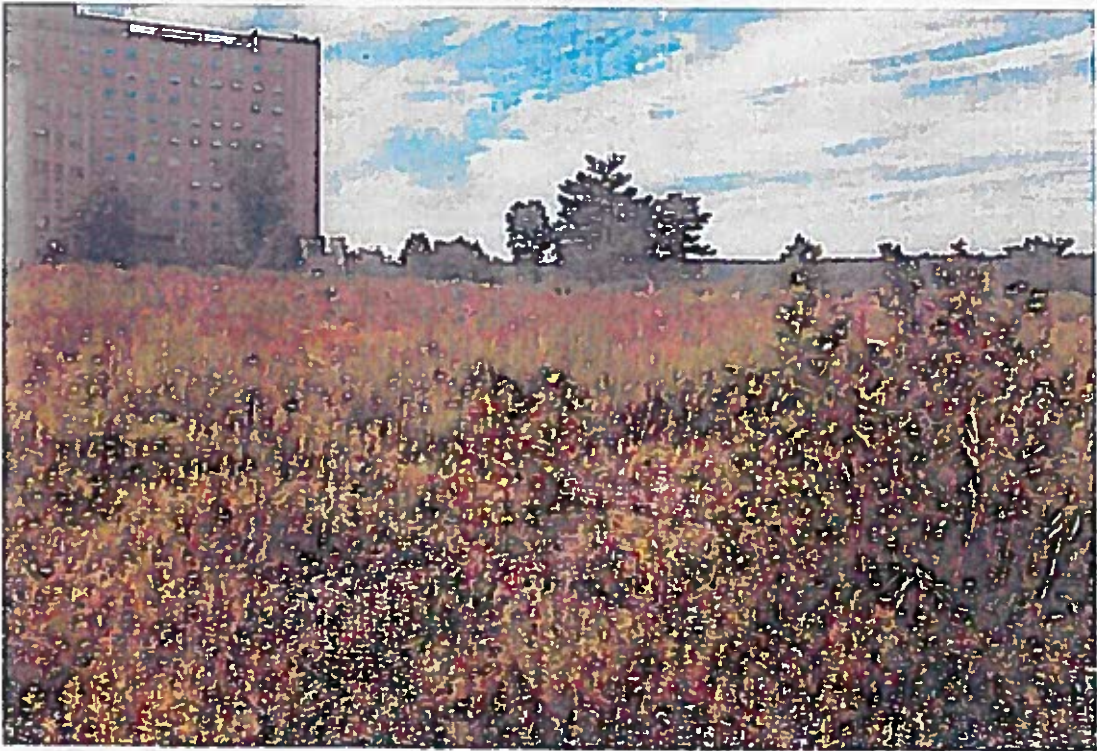
THE SITE WAS FOUND TO BE FULLY SECURED. ALL FENCING IS INTACT AND ENTRANCE GATE IS LOCKED. NO SIGNS OF PREVIOUS ENTRY WERE NOTICED. DRAINAGE SYSTEMS WERE FUNCTIONAL. ALL AREAS WERE FOUND TO BE UNDISTURBED.
