Croton Hydrilla Control Project

FIVE-YEAR MANAGEMENT PLAN

NOVEMBER 30, 2018

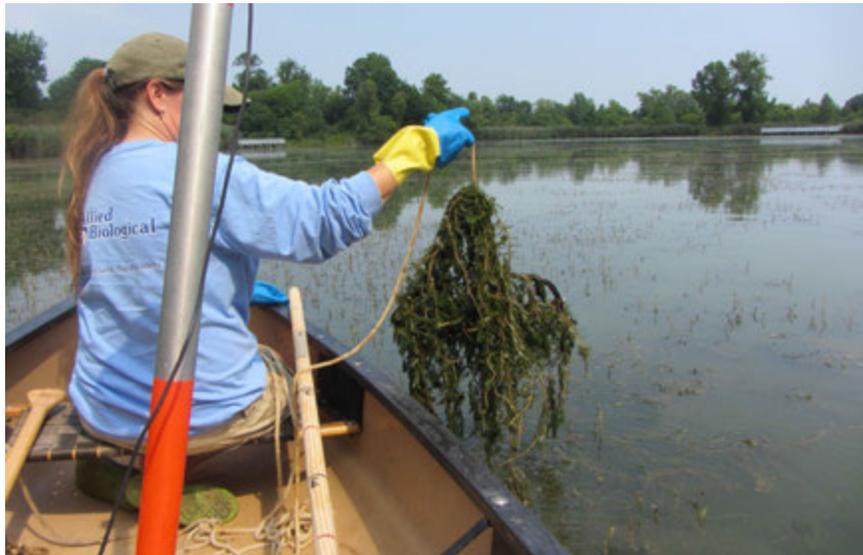
Aquatic plant sample collection using rake toss method
(Photo: Chris Doyle, SOLitude Lake Management)

The contractor will conduct the aquatic plant survey of the entire Croton River (from New Croton Reservoir Dam to Croton Bay using rake toss protocols and DEC-approved remote survey methods and a pre-determined GPS survey grid based on the 2016 aquatic plant survey (Doyle 2016a). The area of the Croton River below the New Croton Reservoir Dam and above the Black Rock Park area can be difficult to access and may require remote sensing methods to assess. Outside of this area, a double-sided rake head will be tossed 10 feet from the intersect points on the grid and pulled in toward the boat or shore. Two tosses will be made at each intersection. The surveyor will identify and record the plant species found on the rake and estimate the percentage of each plant species in the sample. When identification is questionable, voucher specimens will be collected for verification by local botany experts identified by DEC. GPS point locations (survey grids) will remain the same throughout the length of the project. The protocol for this procedure is outlined in Doyle 2015 and 2016a.
