FOREST PRESERVE DETAILED PROJECT WORK PLAN

Project # WP 277

<u>Region</u> 5	<u>Project Title</u> Sampson Bog Outlet Bridge Replacement
--------------------	---

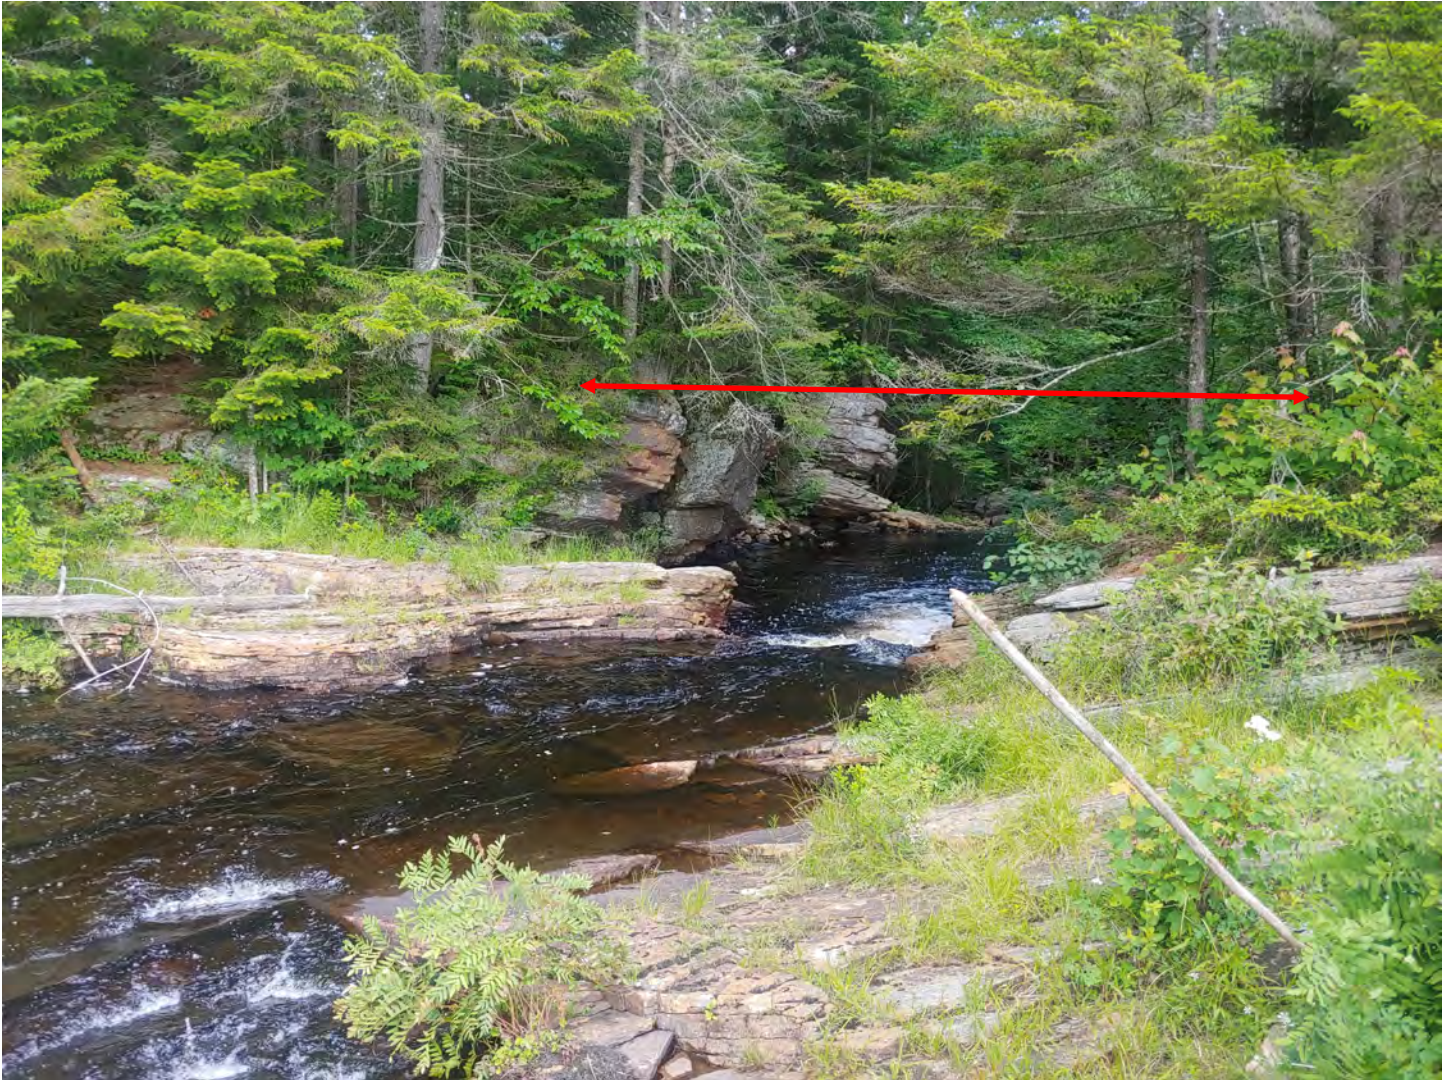
Photo 1: Side view of the Sampson Bog Outlet Crossing in low water. View looking west toward the crossing. Previous bridge was built on top of the flat rocks which was exposed and vulnerable to high water flow and passing debris. The intended bridge replacement will utilize a natural shelf on the adjacent ledge rock to gain height allowing the bridge to be placed well above high water to avoid future washouts.

The previous bridge was built on the flat where the stream channel narrows. Although it was cribbed up, the entire structure was exposed and vulnerable to high water events. The replacement bridge will be built above the crossing utilizing a natural rock shelf on adjacent ledge rock at the southern approach. The bridge sill at this location will be anchored into the side wall using friction fit

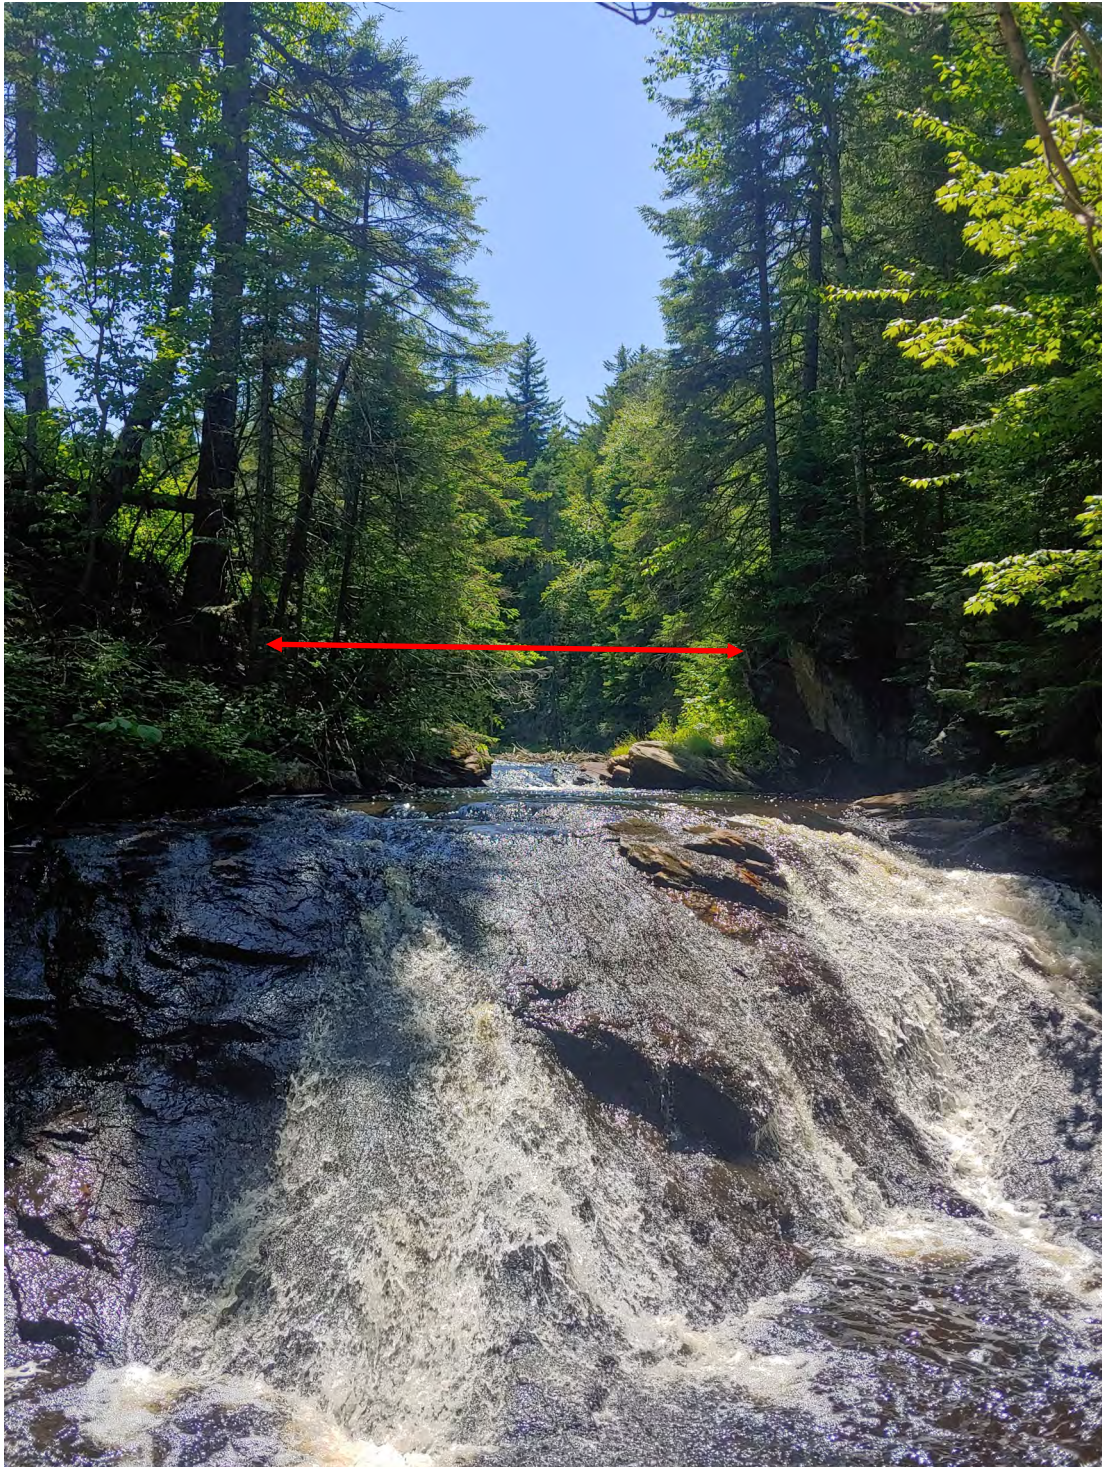
Photo 2: View of project site from downstream looking east towards the crossing. The northern bridge abutment will be dug into the side hill pictured on the left. Southern abutment will be built into a natural shelf on the ledge rock on the right.

anchor bolts drilled into the rock. The northern sill will be dug into the side bank on the opposite hillside. Two native log stringers 30 foot in length will be spiked into the sills and hand hewed on top to provide a flat and stable surface. Due to the increased height, log railings will be installed for safety.
