NYS DEPARTMENT OF ENVIRONMENTAL CONSERVATION
Application for General Permit GP-0-19-003 Authorization
Pursuant to Environmental Conservation Law Article 70

Sandy Island Beach State Park High Water Emergency

Project Description

<p style="font-size: small;">Drawing Copyright © 2019</p> <p style="font-size: x-small;">III Winners Circle, PO Box 5269 Albany, NY 12205-0269 518.453.4500 · www.chacompanies.com</p>	<p>TYPICAL SECTION – DESIGN DETAIL</p> <p>SANDY ISLAND BEACH STATE PARK LAKESHORE STABILIZATION MODIFICATIONS PULASKI, NEW YORK</p>	<p>PROJECT NO. 36273</p>
	<p>DATE: 06/2019</p>	
	<p>FIGURE 2</p>

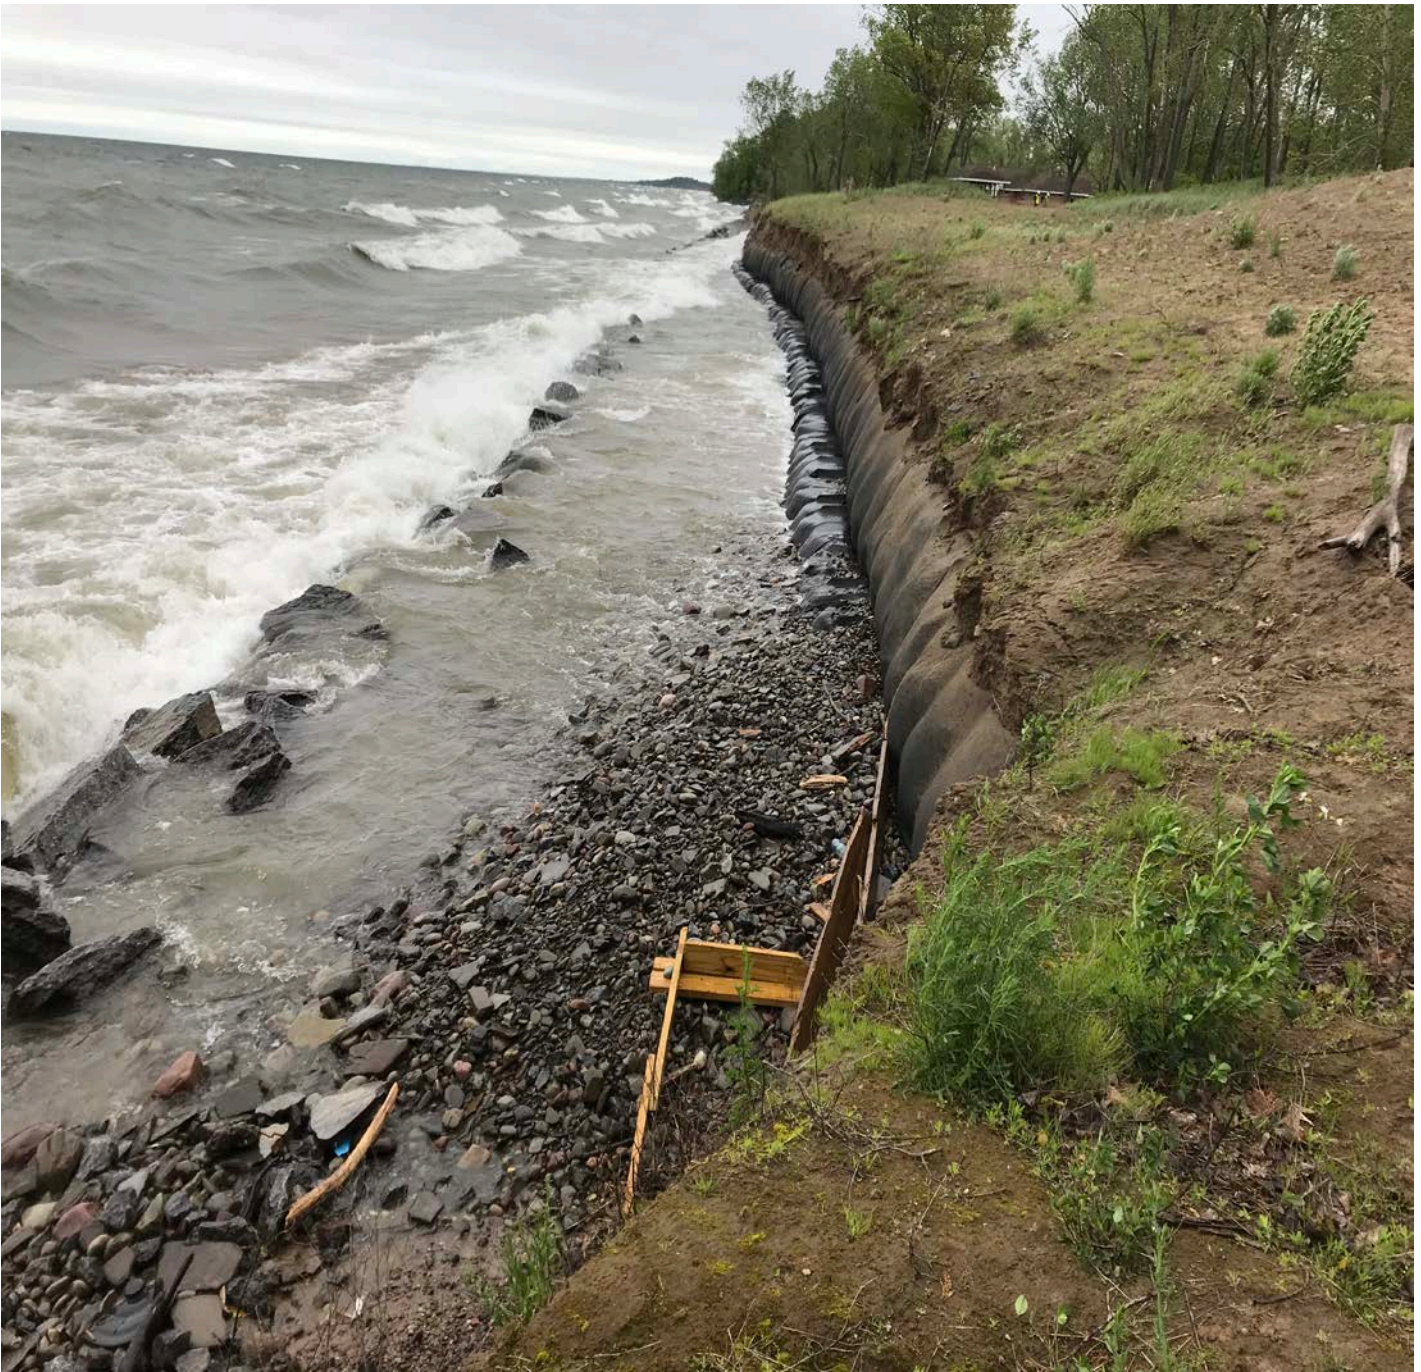
Photo 1. Existing Conditions: Sand placed during the 2017 construction to protect this natural dune structure has been affected by more recent high water levels, and has exposed trap bags. If these trap bags fail, the entire dune will be in jeopardy.

The proposed repair that Parks is advocating for is the placement of large stone rip-rap placed between the existing large stone placed along the lake shoreline in 2017 and the top of the now exposed sand bags, also installed in 2017 (see Photo 1). We are proposing to install the large rock on a 1:2 slope to fill this gap and help dissipate the wave energy and be a more resilient solution to the recurring erosion problem along the dune (See CHA Design Details).

The design from 2017 included a heavy stone breakwater installed at the Ordinary High Water Mark (OHW), with large trap bags filled to hold the dune. Sand was trucked in and placed over the trap bags to restore the original dune grades. Since installation, all placed sand has eroded away, leaving the trap bags exposed. There is concern for the longevity of these bags left to the elements; debris washing up on shore and ice scour during winter months. Therefore, leaving the site “as is” is deemed unacceptable. Restoring the dune “in kind” with sand is also seen as unacceptable. Replenishing the dune with sand after high waters will not address the problem as it will continue to wash out the embankment. This approach is unsustainable and at too high a cost. A more permanent revetment is needed to protect the dune and road behind.

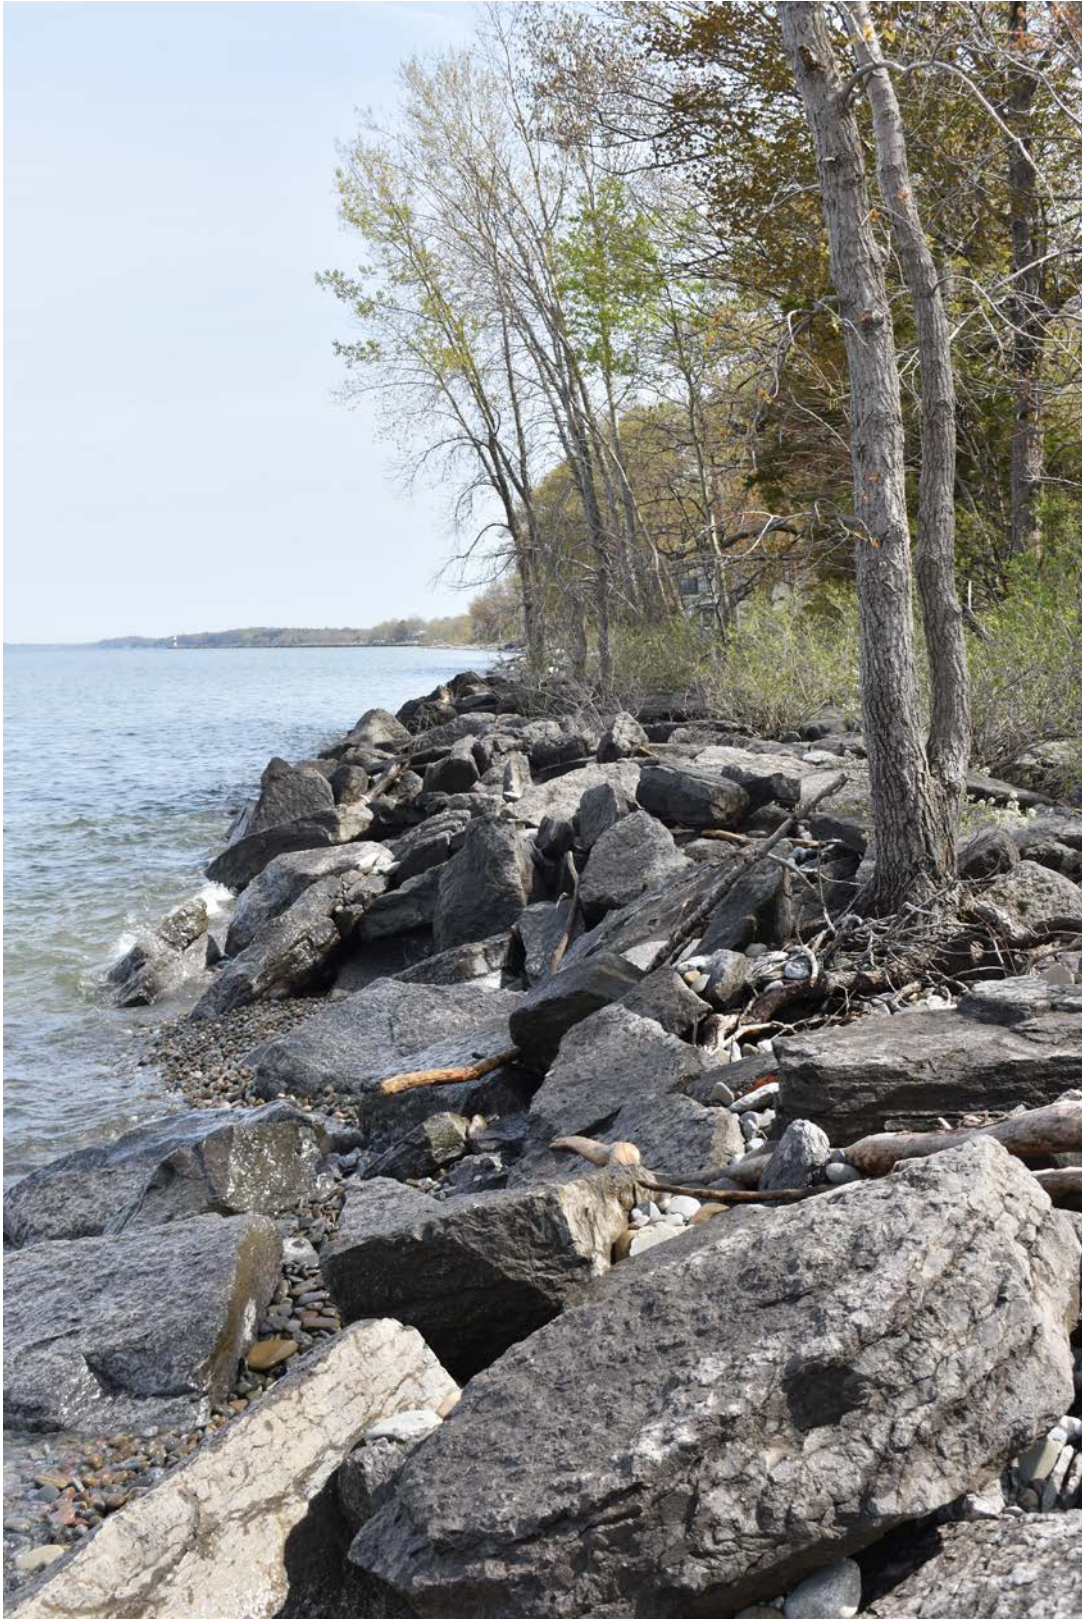
Photo 2. Shoreline protection along the banks of Selkirk Shores State Park in the 1960's and 1970's

The existing large stone rip-rap (2017) was also installed above the OHW level so it was, and is, out of the jurisdiction of the Army Corp (“No permit needed” – Phone conversation with Mikhail Boutsko, June 19, 2019). Parks’ proposed solution would allow all of the new repair work to occur above the OHW level. Final design drawings have been received from CHA, and Parks now awaits OGS to authorize mobilizing equipment and manpower to the site, however this is the proposed solution that Parks will be encouraging. Parks has used this method of shoreline protection along the banks of Selkirk Shores State Park in the 1960’s and 1970’s and it has proven to be a long-term solution which has not been damaged by the more recent high lake water levels. (see Photo 2)

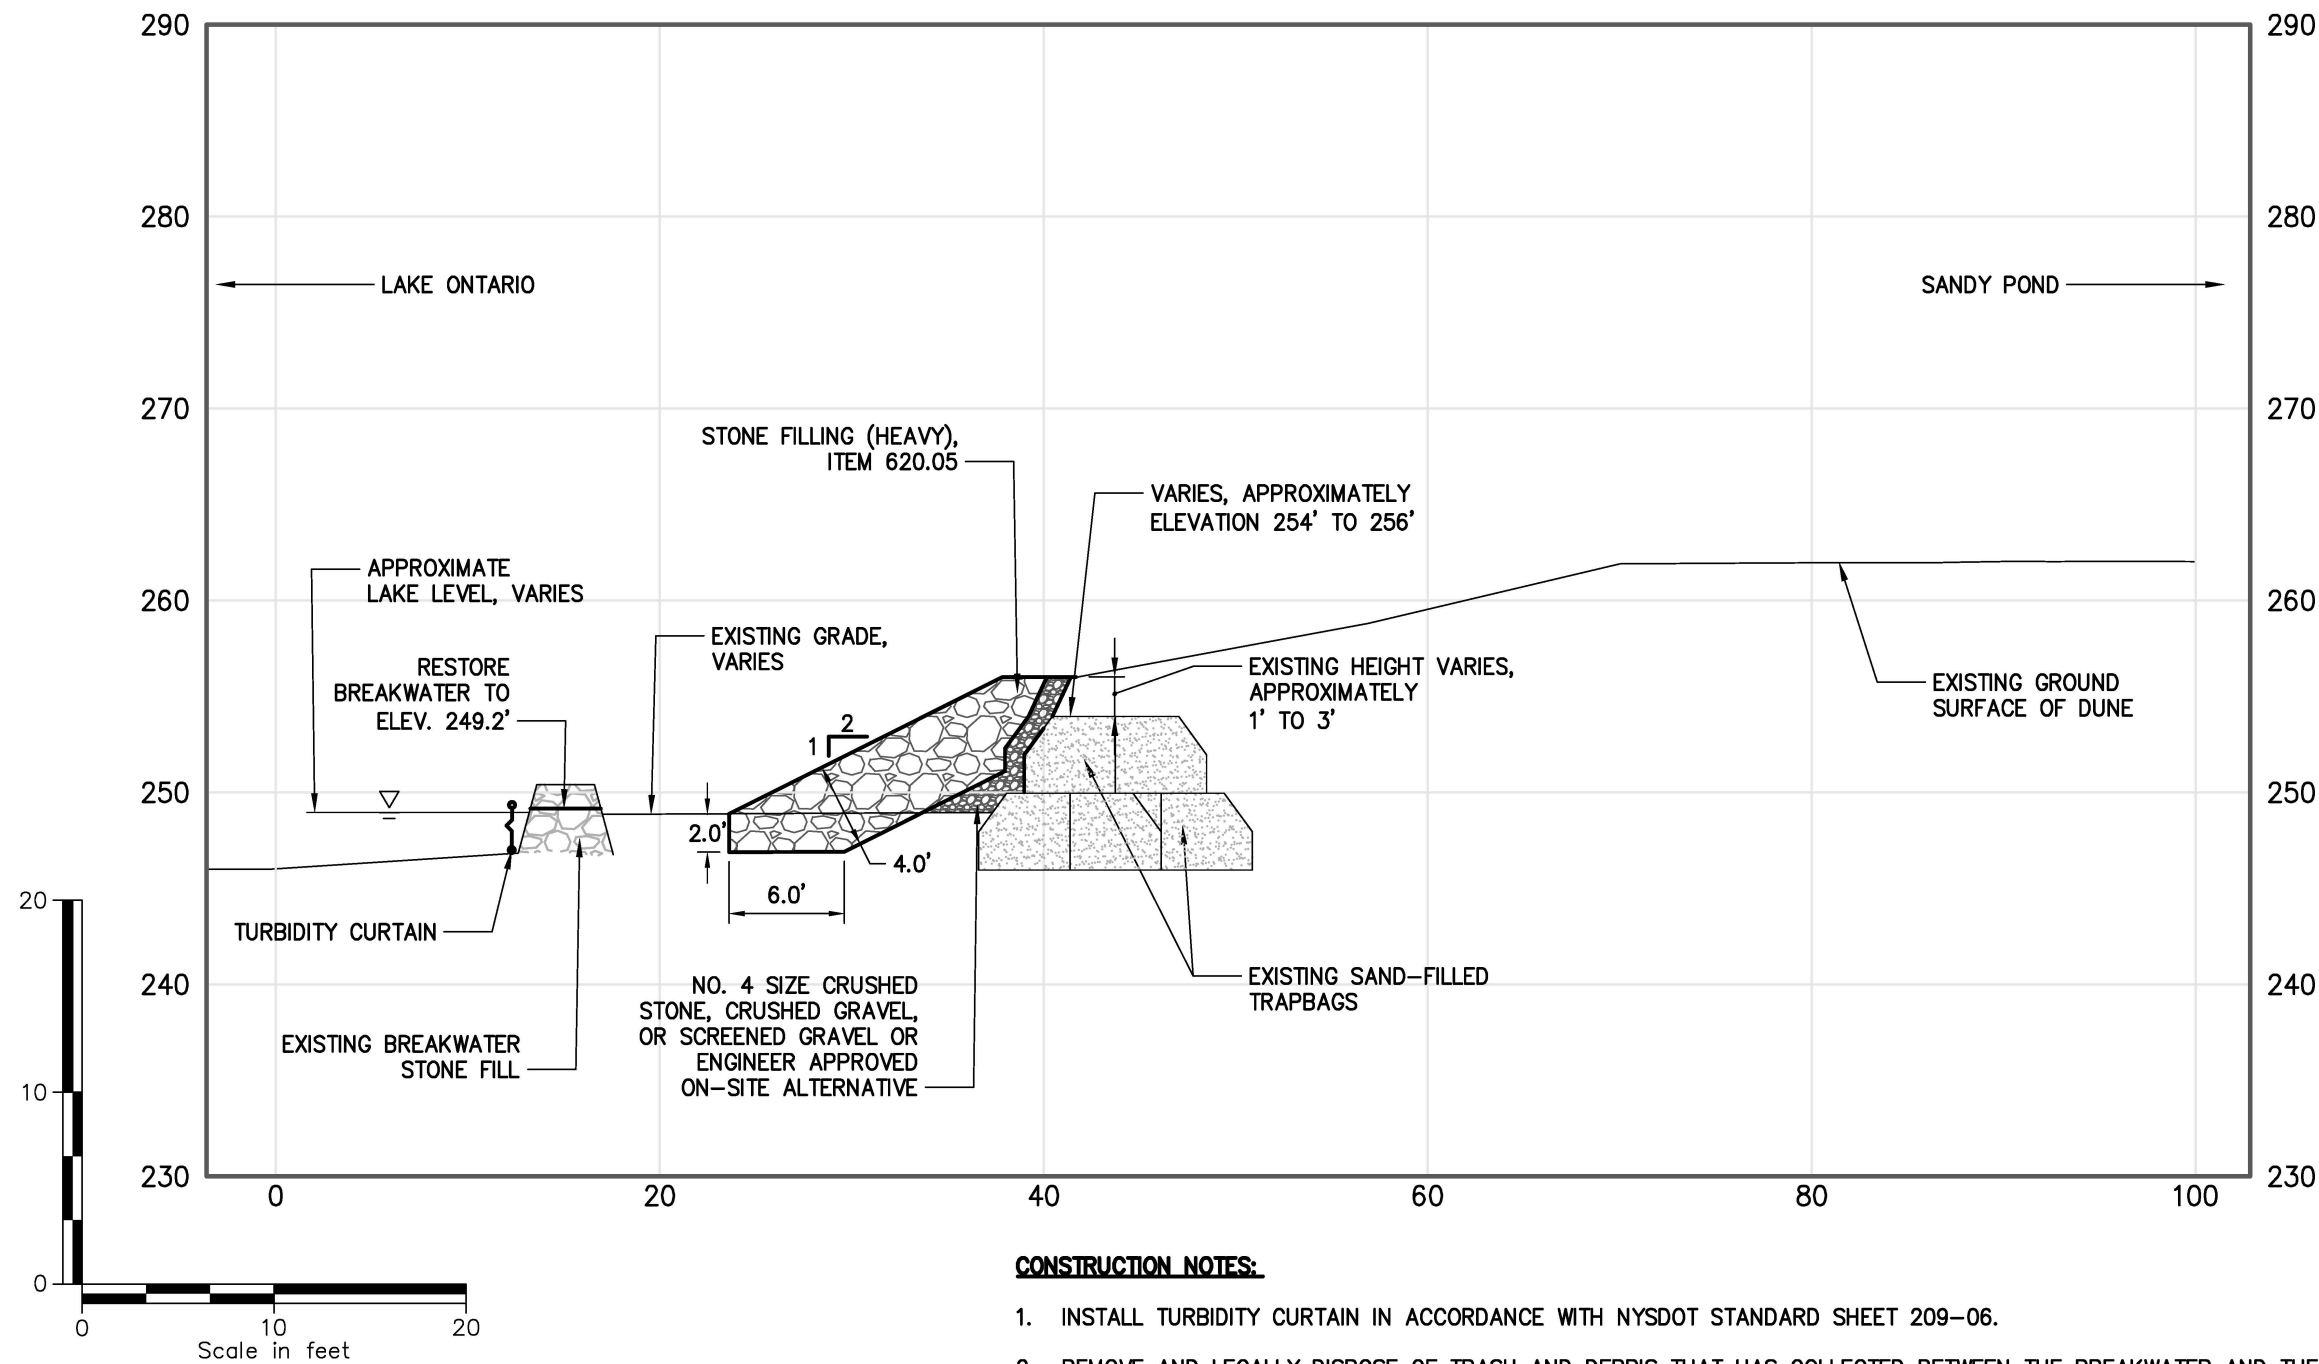
1. INSTALL TURBIDITY CURTAIN IN ACCORDANCE WITH NYS DOT STANDARD SHEET 209-06.
2. REMOVE AND LEGALLY DISPOSE OF TRASH AND DEBRIS THAT HAS COLLECTED BETWEEN THE BREAKWATER AND THE TRAPBAGS.
3. RESTORE BREAKWATER TO A ELEVATION 249.2 FT.
4. PROTECT TRAPBAGS BY INSTALLING A LAYER OF NO. 4 SIZE CRUSHED STONE, CRUSHED GRAVEL, OR SCREENED GRAVEL OR ENGINEER APPROVED ON-SITE ALTERNATIVE AS SHOWN ON THE DETAIL.
5. INSTALL NYS DOT ITEM 620.05 HEAVY STONE FILL TO A MINIMUM ELEVATION 256.00 FT. HEAVY STONE FILL TO BE INSTALLED IN A MINIMUM OF 2 LAYERS.
6. CLEAN SAND FILL TO BE PLACED TO MATCH THE CONTOURS ON DUNE, AS DIRECTED BY THE ON-SITE ENGINEER.
7. DUNE RESTORATION AND PLANTINGS TO BE PERFORMED BY OTHERS.
