**Conewango Creek Trout Stream Survey**  
Scott Cornett, Region Nine Fisheries

2/15/2024

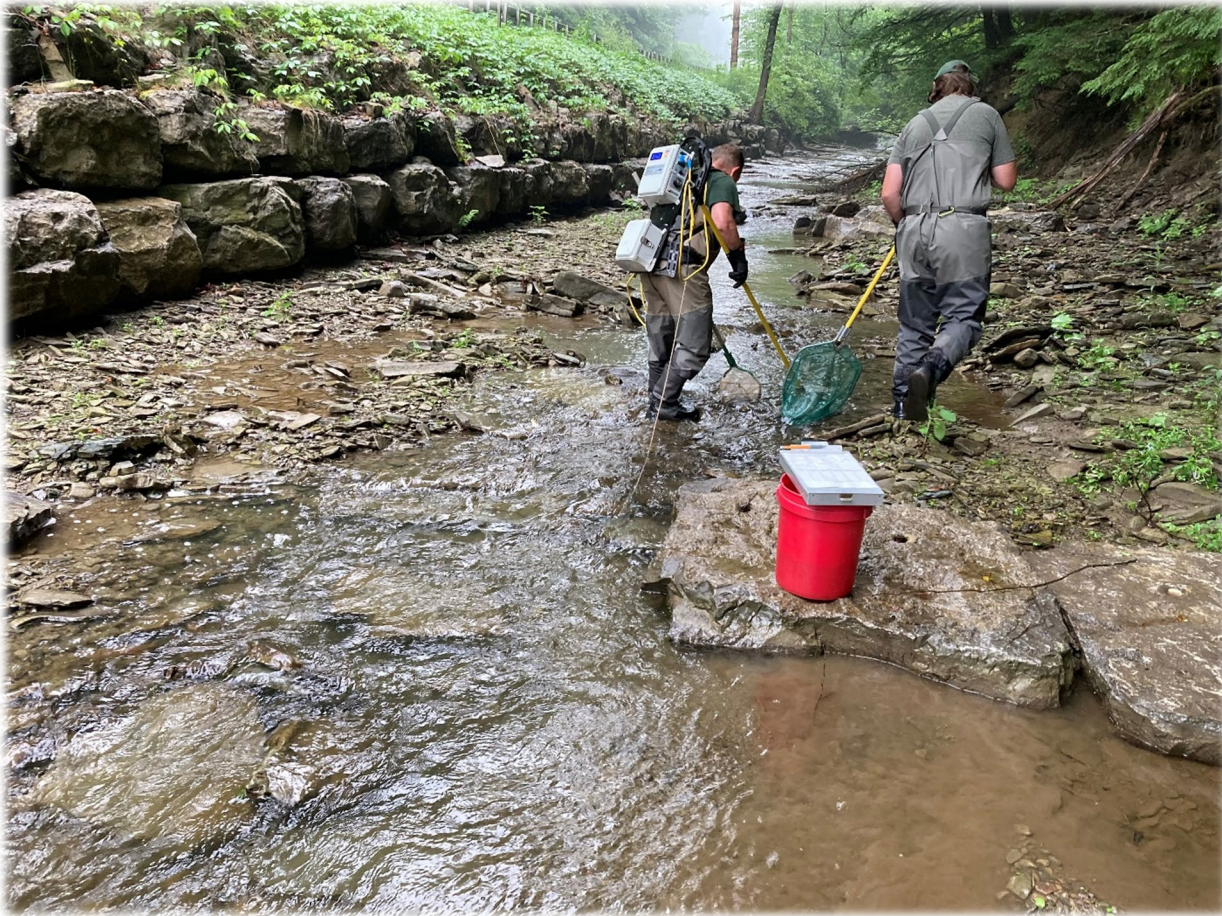
*Figure 1. Electrofishing on Conewango Creek in habitat enhancement section. Stream barb in the foreground.*

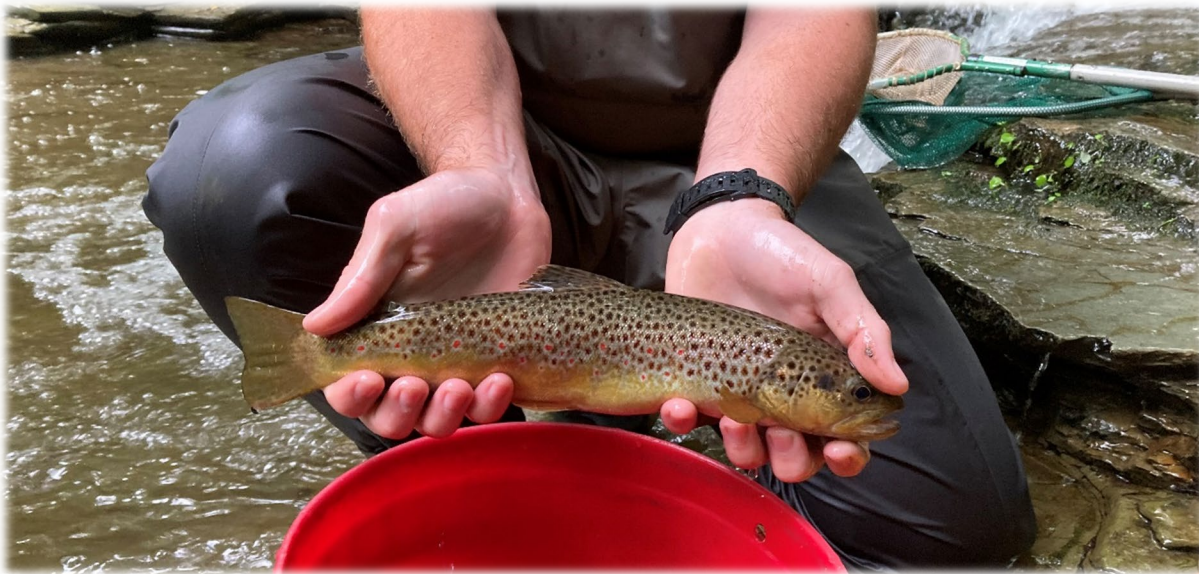
*Figure 2. Wild brown trout captured in Conewango Creek June 28, 2023.*

In the 2023 survey, a 700-foot stream section was sampled of which approximately 350 feet were located in the enhanced habitat project. A total of 20 adult wild brown trout were captured ranging from 5.2-14.2 inches (Figure 2). Two other fish species—mottled sculpin and creek chub—were also observed. Most of the adult trout were captured upstream of the habitat enhancement section where deeper pools in the bedrock provided adequate shelter. No young-of-year (YOY) were captured in this year's survey. In our 500-foot-long site done in 2020, we captured 17 adult wild brown trout and 36 YOY brown trout. Most young-of-year trout that year were captured in the gravel/cobble riffle section of the sampling site where the 2019 DPW work, and 2020 habitat enhancement work were done. Due to a lack of "before work" photos where the DPW work was done, we cannot say how much different the adult and juvenile trout habitat was in this section of stream in 2023 than it was prior to the 2019 DPW and 2020 habitat enhancement project. In 2023, the abundance of adult wild brown trout found in the upper section of our site was consistent with what we found in the 2001 and 2020 surveys. It should be noted that the area where habitat enhancement was done had bedrock very near the surface of the streambed, which limited the ability of the stream to dig deeper pools and form better adult trout habitat.
