# RECORD OF DECISION
# NIMO Glens Falls - Mohican Street
# Former MGP Site
# Operable Unit No. 1
# MGP Site and Canal

**Glens Falls (C), Warren County, New York**
**Site No. 5-57-016**

March 2003

Division of Environmental Remediation
New York State Department of Environmental Conservation

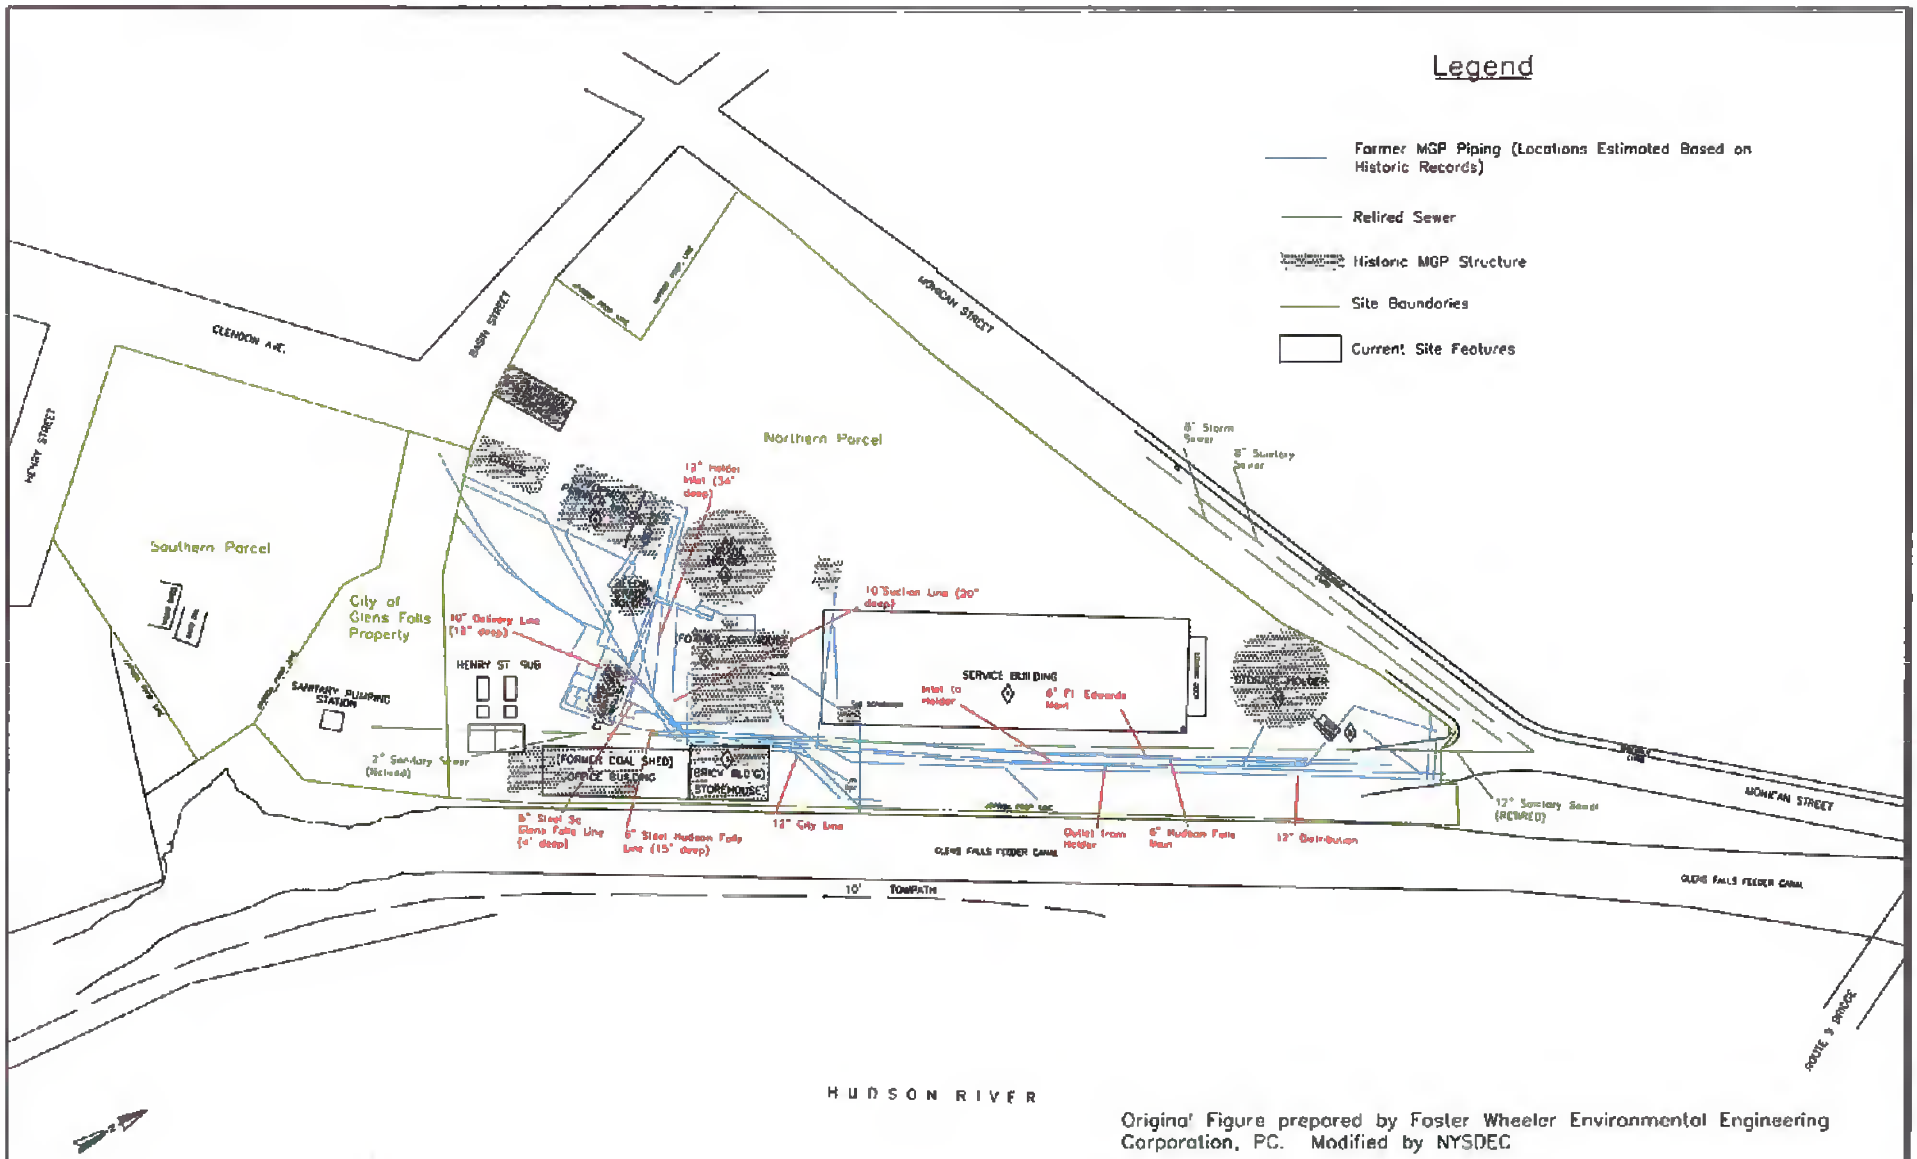
FIGURE 2

The PSA and RI activities identified four unconsolidated units located beneath the site (in descending order); fill, fine/medium/coarse sand and silt, sandy silt/silty sand, and a silty clay. These units are consistent with the glacial fluvial deposits found in this region. Limestone bedrock underlies the unconsolidated units at the site, at depths ranging from approximately 8.5 to 29 feet below ground surface. Site features and boring locations are shown on Figures 2 and 3. Cross sections of the site geology are included as Figures 4 and 5.

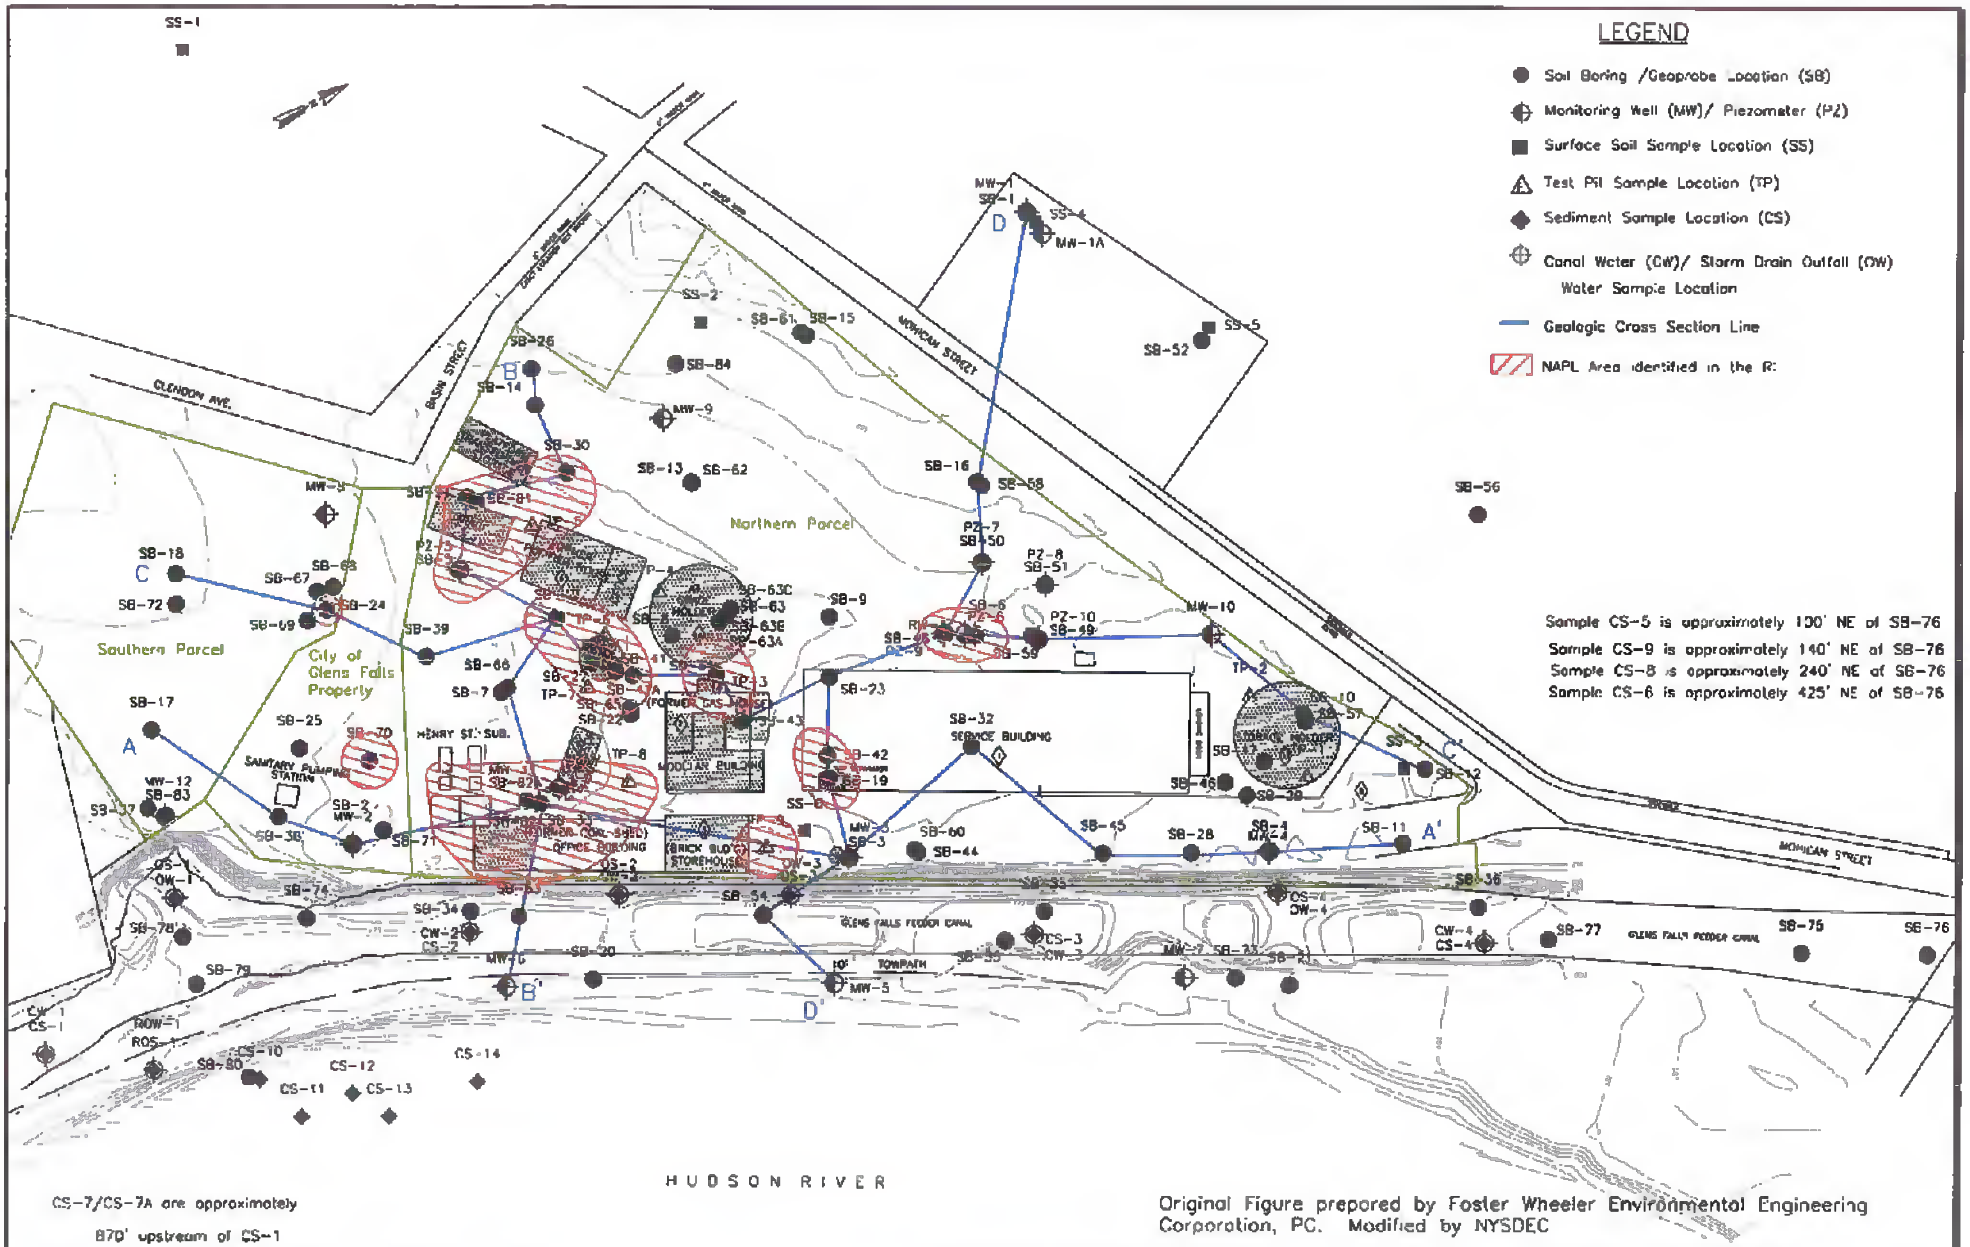
FIGURE 3

Please refer to Figures 3, 4, and 5 for cross sections from the SRI Report that illustrate the subsurface conditions at the site, and subsurface BTEX and PAH contamination in relation to the former MGP structures. Please refer to Figure 7 for the areas identified as, "source areas."

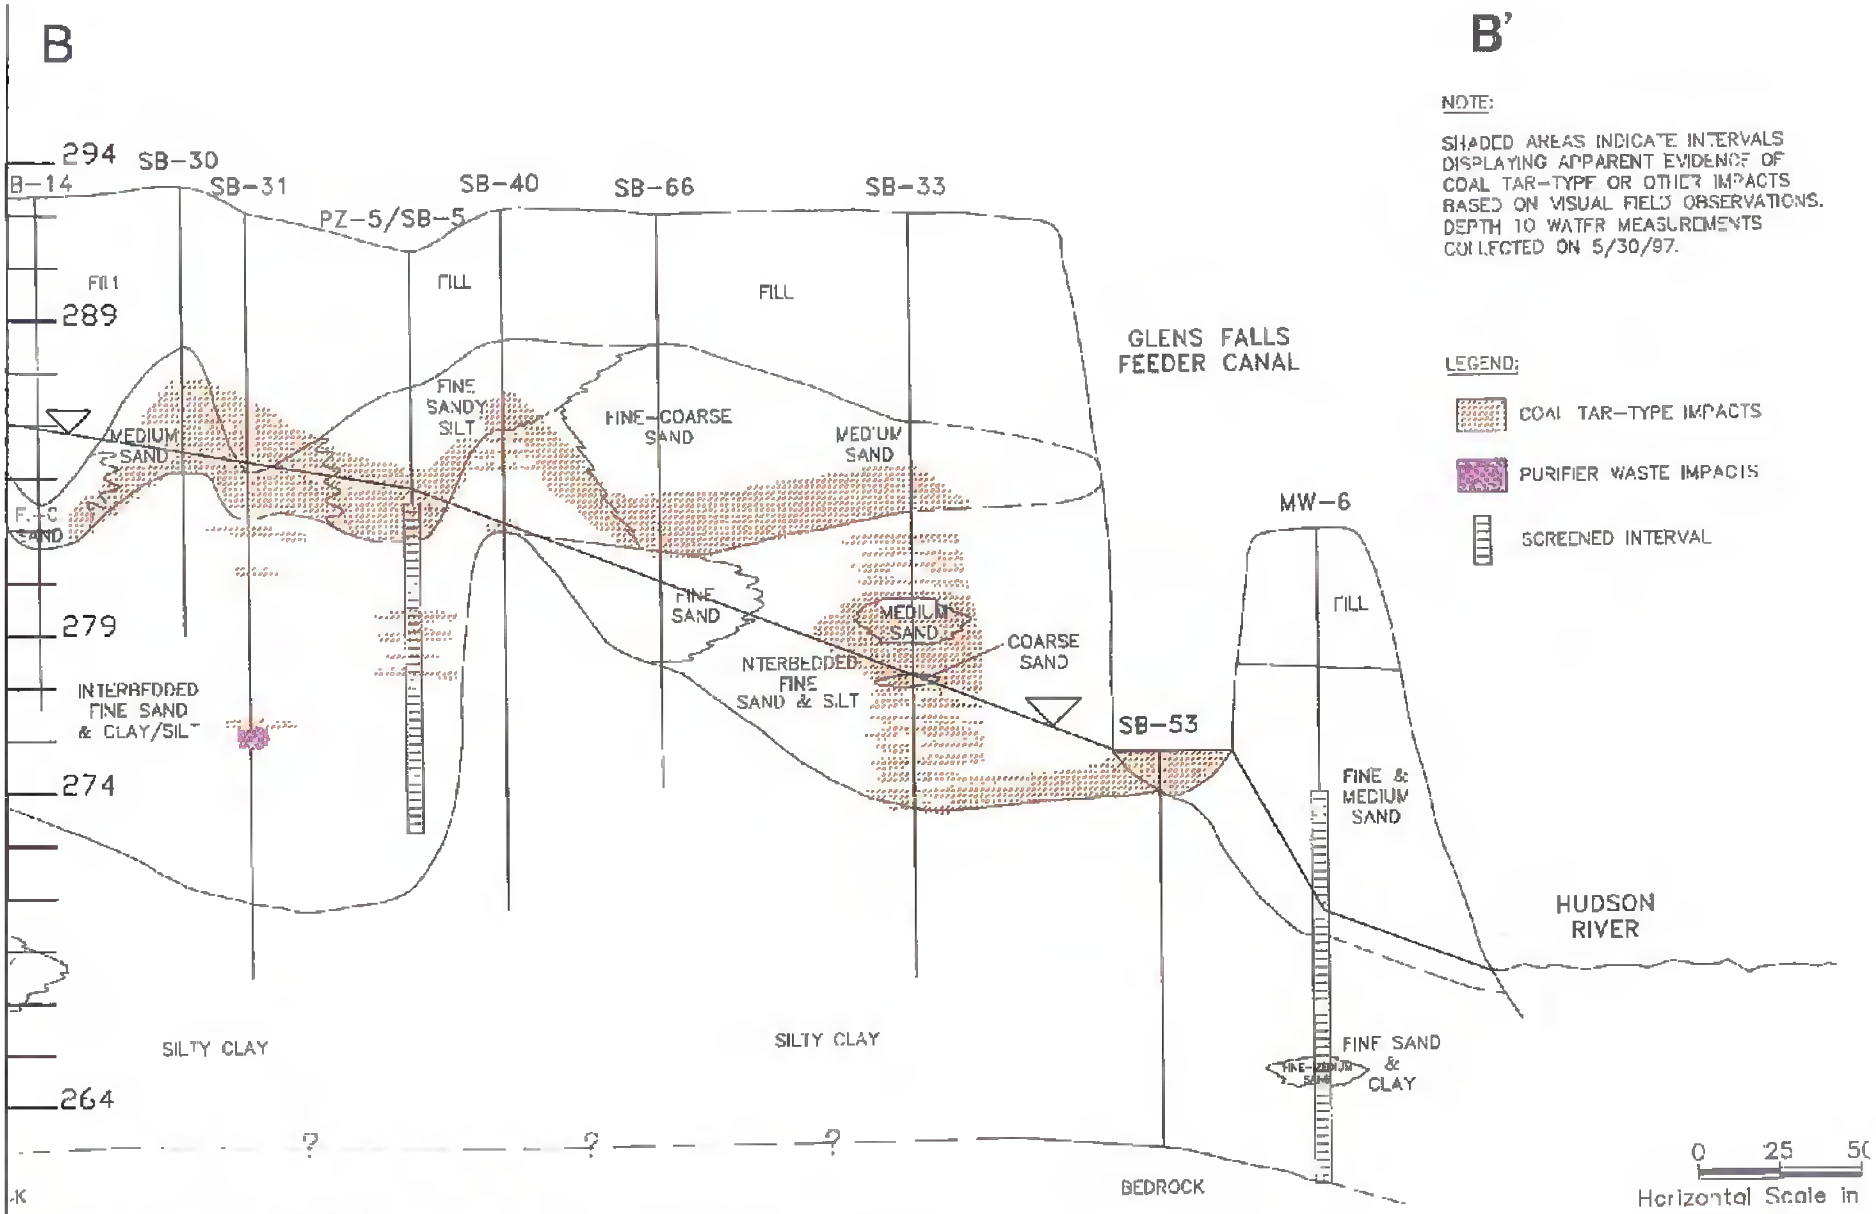
FIGURE 4

The impacts were visually observed to be heaviest in close proximity to several of the former plant structures, i.e. the below grade holder. The impacts were also observed to preferentially occur in the more permeable, coarser grained sand/silt layer.

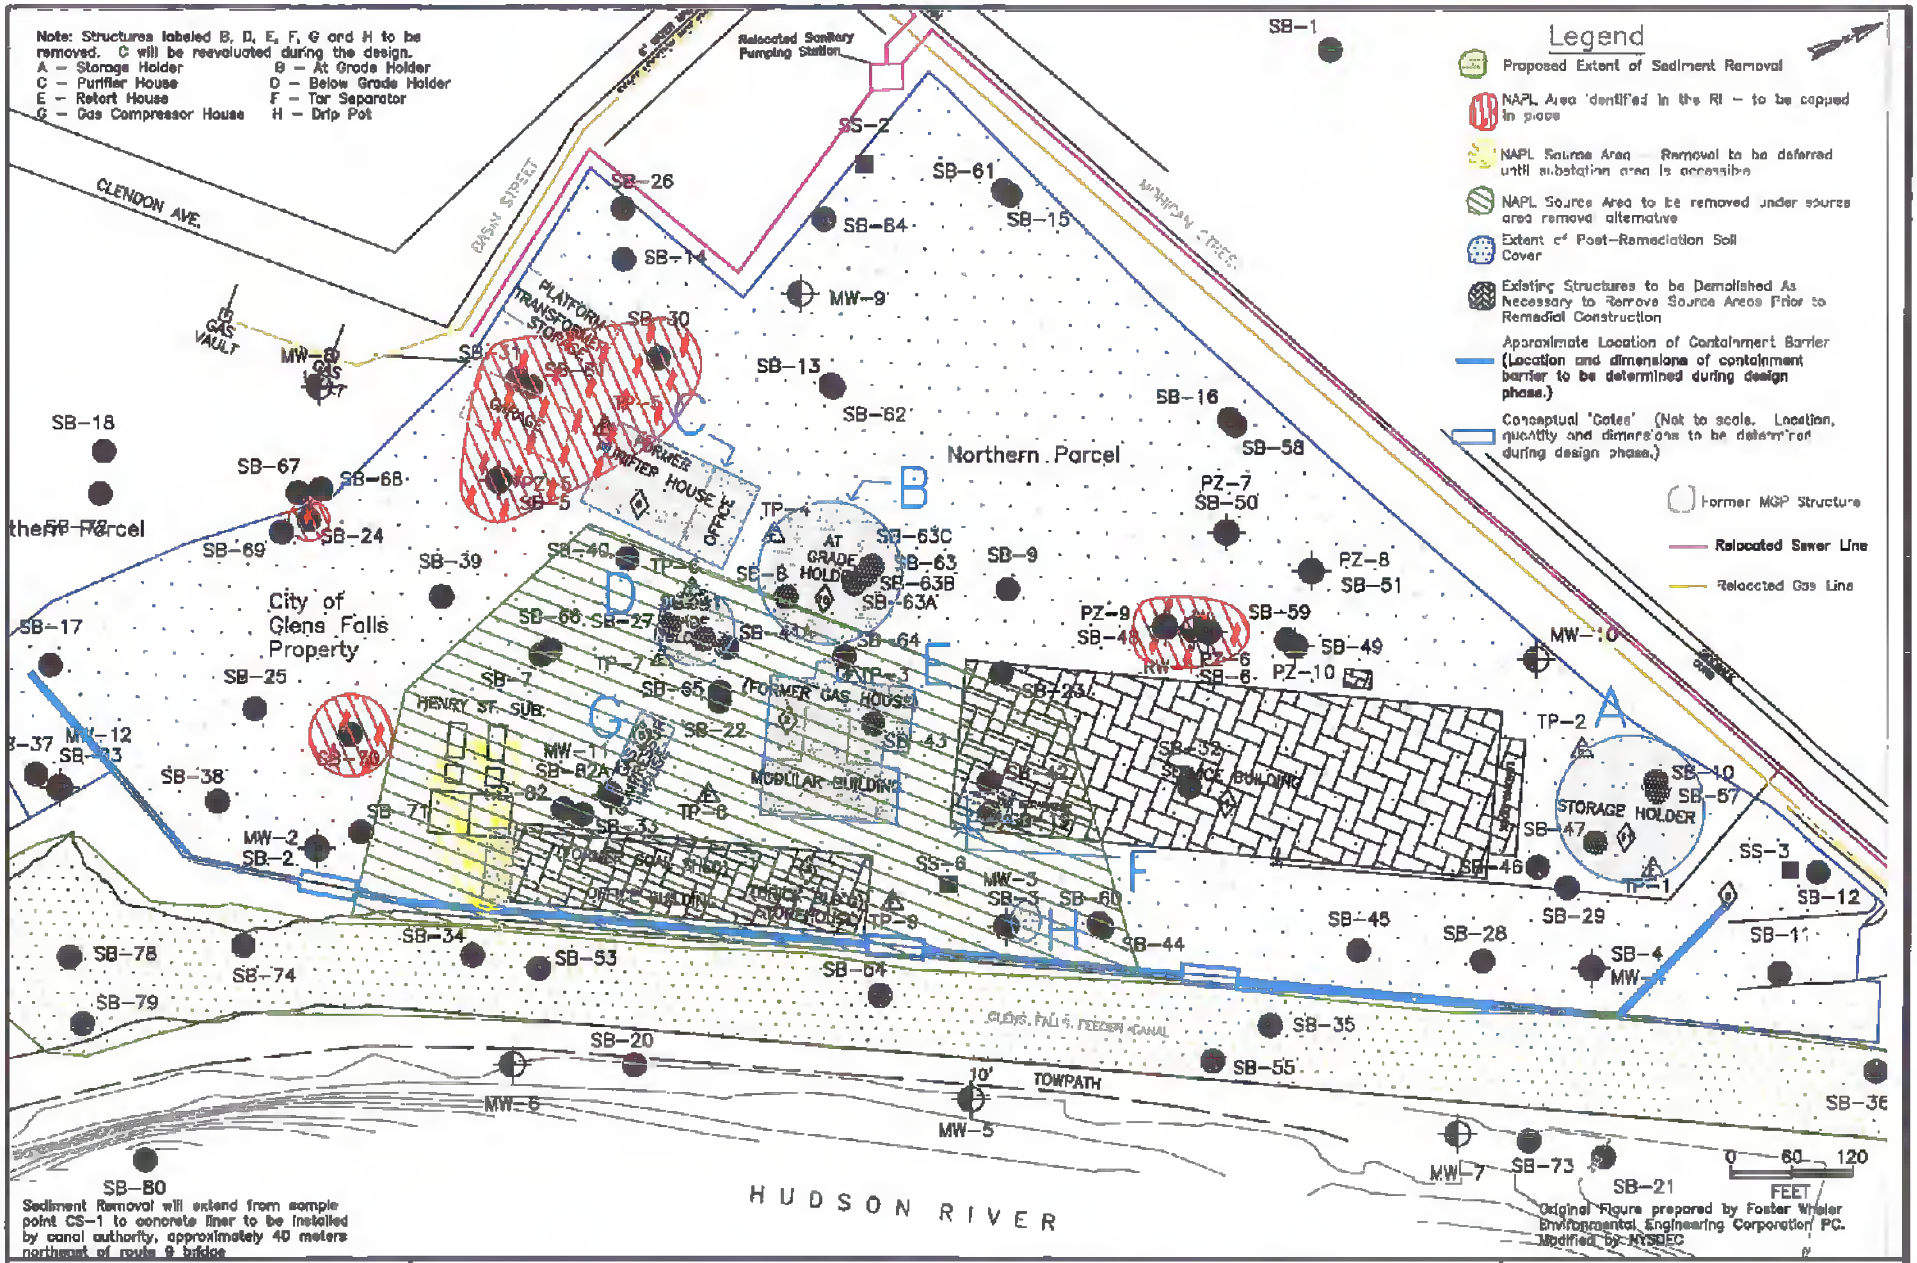
FIGURE 7

The source of much of the BTEX and PAH contamination found on site is the tar or NAPL which is found both in and around the various subsurface structures, or is migrating through the subsurface at the site. Analysis of the NAPL reveals that it contains BTEX and PAHs several orders of magnitude greater than the SCGs for these compounds. The NAPL was found to saturate the unconsolidated deposits and/or exist in scattered, discontinuous globules. Either of these conditions generally coincides with high BTEX and PAH concentrations in soils and typically results in significant contamination to the groundwater as well. Areas with a substantial volume of contaminants have been termed "source areas" and are defined as the locations at the site of former MGP structures and/or those areas of soil which contain significant volumes of coal tar waste or which are saturated with visually observed separate phase product (NAPL). Soils exhibiting odors, staining and/or sheens are not necessarily included in the definition of "source areas". At the site, these "source areas" appear to be directly associated with several of the former plant structures, some of which remain on site below the current ground surface. These "source areas", identified on Figure 7, are all located in the northern parcel of the site.

The NAPL source areas to be excavated under this alternative have been delineated based on available data and are shown on Figure 7. It is estimated that the in situ volume of source areas to be excavated and disposed/treated off site ranges from approximately 2,500 to 16,200 cubic yards (cy). Including this volume, it is estimated that up to 27,000 cy of material may be excavated to effect this alternative. This range of volumes is due to variability of waste material deposits observed on the site, which generally are found from 6 to 11 feet below ground surface, and the expected variability of subsurface conditions and abandoned MGP structure conditions often encountered at former MGP sites. Excavations would be dewatered, as necessary, to complete the removal.

2. Source area materials will be removed and transported off-site for thermal treatment and/or other appropriate disposal. Source areas are defined as the locations at the site of former MGP structures and/or those areas of soil which contain significant volumes of coal tar waste or which are saturated with visually observed separate phase product (NAPL). Soils exhibiting odors, staining and/or sheens will not be considered for removal as source areas. The proposed limits of this source area excavation, including the removal of several subsurface MGP structures that remain on site, is represented in Figure 7. The precise limits, depths and volume of the excavations will be defined in the remedial design. The estimated in situ volume of source areas to be excavated from within the polygon and disposed/treated off site ranges from approximately 2,500 to 16,200 cubic yards (cy). This volume includes any excavation associated with structures B and C, however the upper limit could increase if additional source area soils are identified in the polygon area. To access source area materials, it is estimated that approximately 27,000 cy of material may have to be excavated for this remedy. Soils not defined as source areas, excavated as part of this remedial effort may be reused as deep backfill, per criteria to be defined in the remedial design. Additional imported backfill will be needed to restore the site to final grade.

3. The tar separator, relief holder, at grade holder, retort house foundation, gas compressor house foundation, and other minor subsurface structures will be removed, as represented in Figure 7. Any NAPL source area soils adjoining these structures will also be removed. Deep excavations required to remove source area soils associated with these structures, as defined in #2 above, will continue to depths below the water table. Shoring, dewatering, and possibly sheet piling will be required to stabilize the deep excavations. The soils removed from below the water table will be dewatered and the water will be treated prior to discharge. The removal of all major piping associated with contaminated structures is also included. Piping encountered elsewhere during implementation of other aspects of the remedy may be cut, free drained, and capped, as determined appropriate by the final design.
