Flood Damage Reduction Segment / System Inspection Report

Name of Segment: **South Binghamton – NYSDEC Segment** (Susquehanna River & Park Creek)

Corps of Engineers Inspector: Alfred Zarnoski, P.E. ; William Wynn — Date of Inspection: 9/15/2008

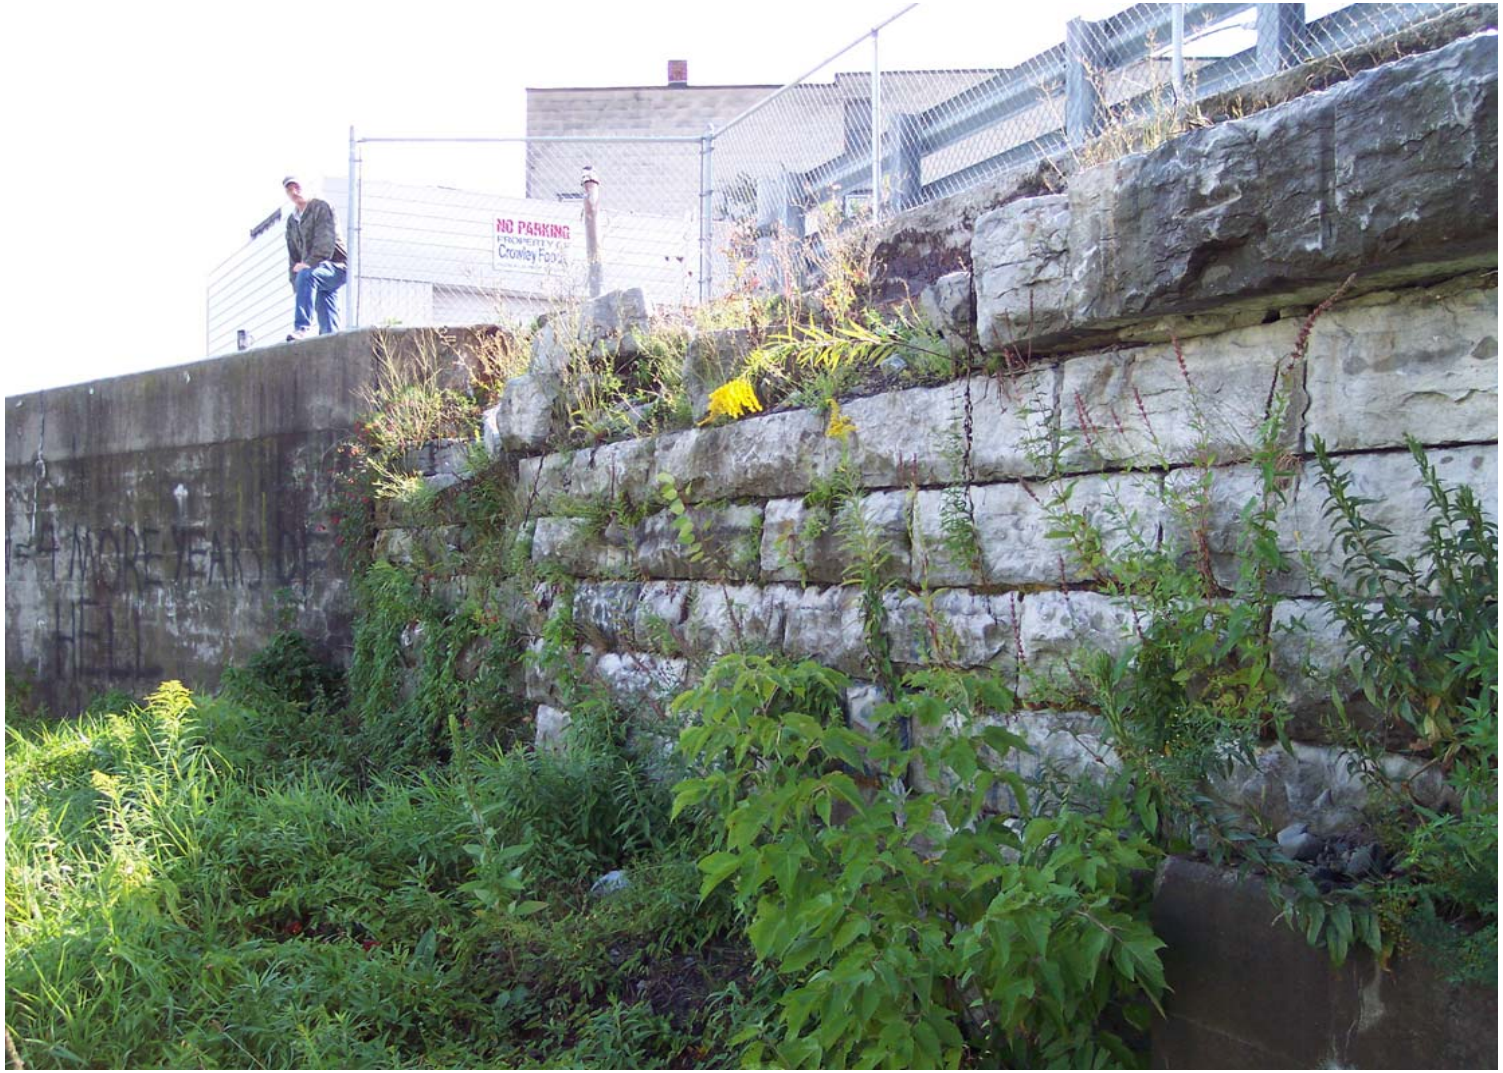
Inspect ID: BNGS_2008_a_0001 **Name:** Floodwall **Caption:** Former abutement area of the old Rock Bottom Bridge. To be replaced with new floodwall upon approval of recently submitted permit.
