EVALUATION OF HYDROGEOLOGIC CONDITIONS AND PREPARATION OF A PROPOSED GROUND-WATER MONITORING PROGRAM OSWEGO VALLEY LANDFILL OSWEGO COUNTY, NEW YORK

August 1984

Geraghty & Miller, Inc.
Ground-Water Consultants
6800 Jericho Turnpike
Syosset, New York 11040

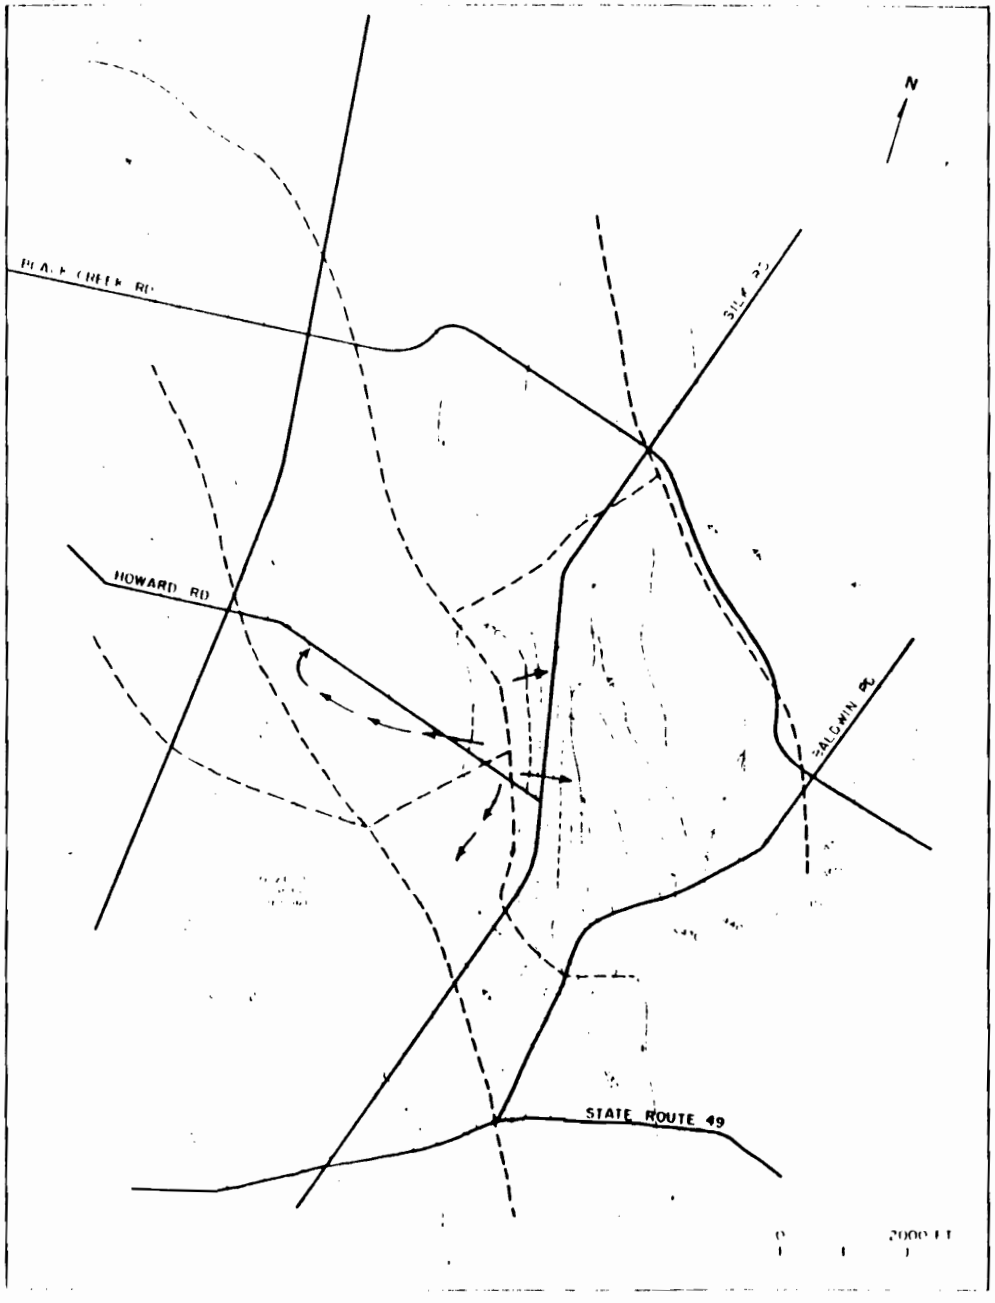
FIGURE 5 - MAP SHOWING WATER-TABLE AQUIFER AND GROUNDWATER DIVIDES, BASED ON USGS TOPOGRAPHIC MAPS

water. This is illustrated by the regional water-table map shown in Figure 5, which was constructed from stream elevations on USGS topographic maps.

Water levels from test wells and residential wells completed in the water-table aquifer were measured in June 1984. These data (Table 4) show a general drop in the water table of about 1/2 to 3 feet. This slight decrease did not appreciably change the water-table configuration shown in Figure 5, since the water-table contour interval selected for this figure was 10 feet.

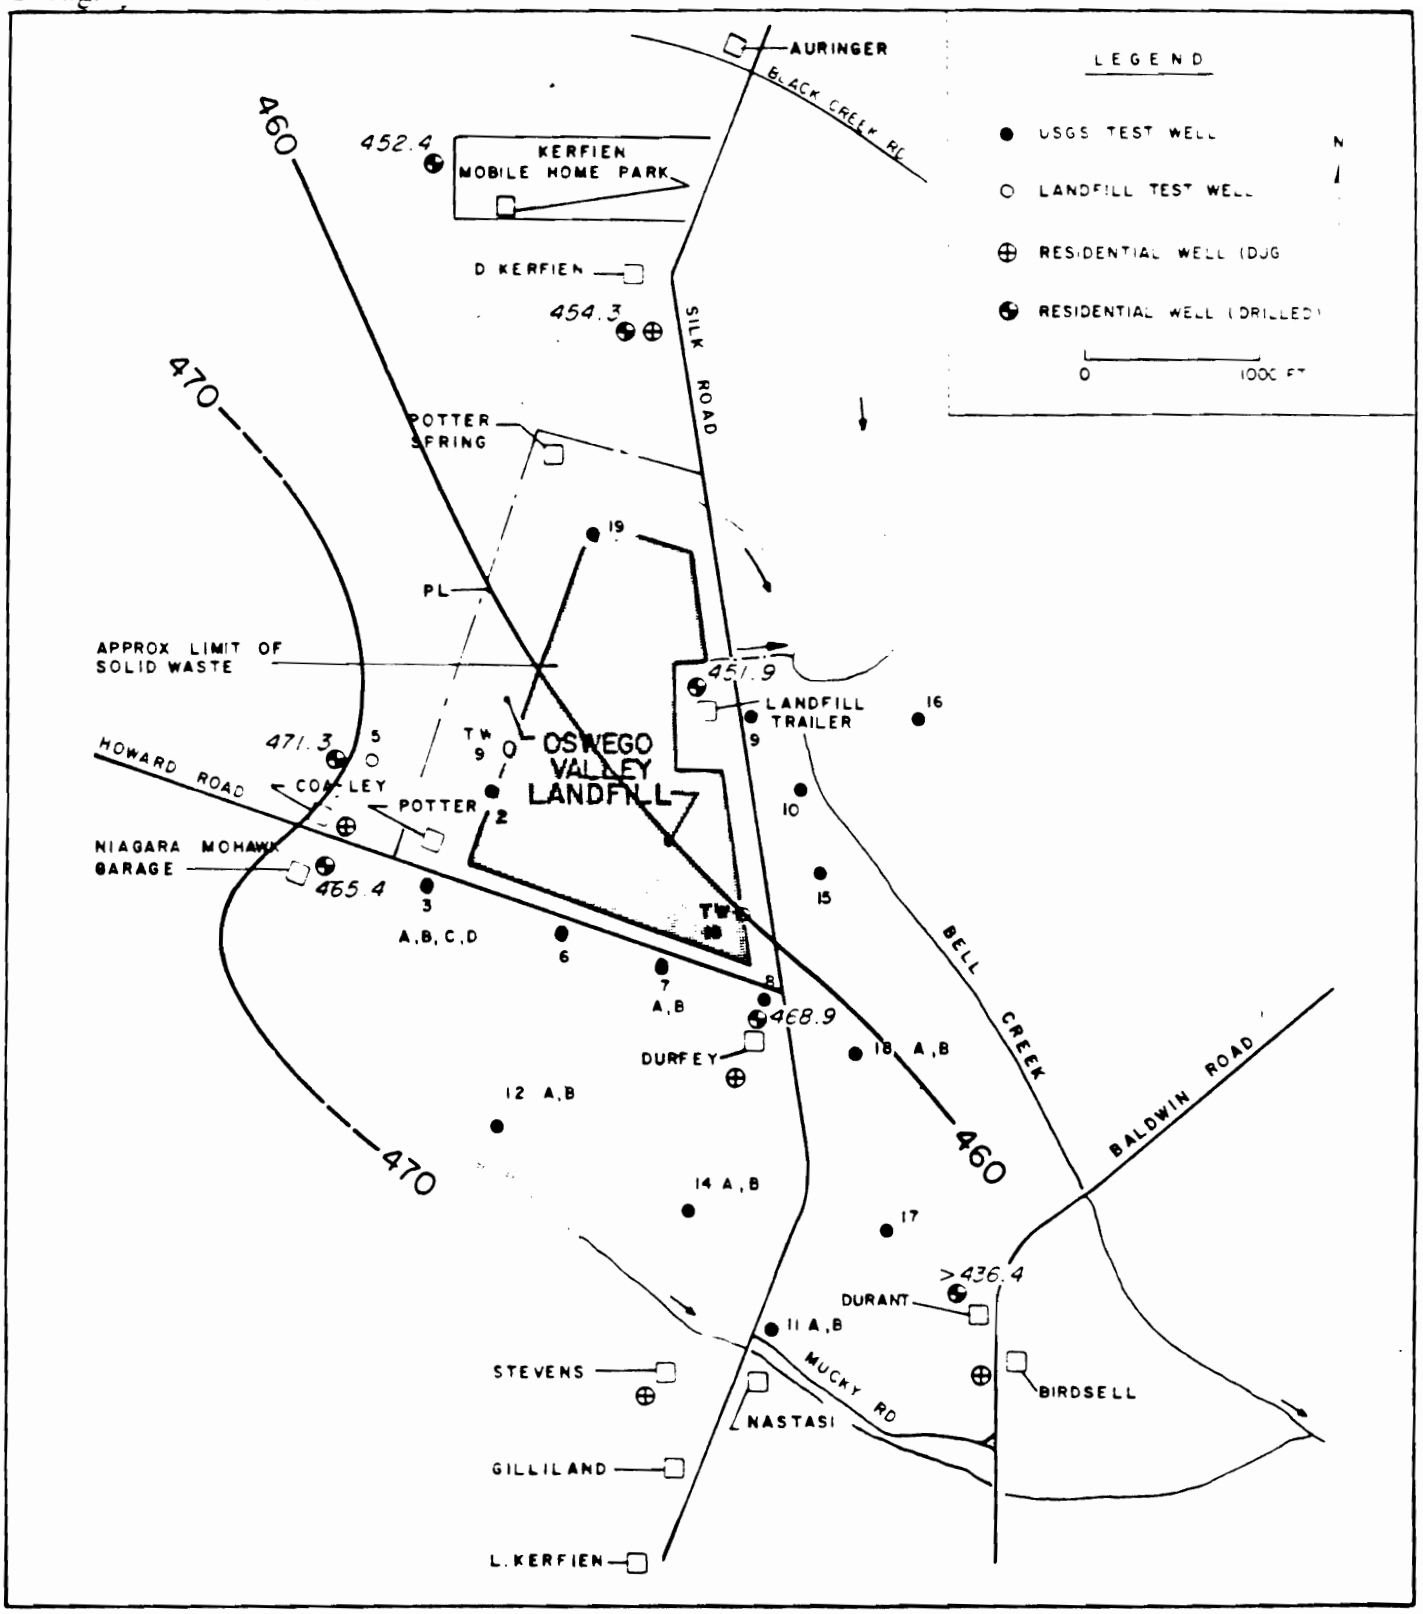
Water levels from wells completed in the bedrock aquifer (Table 5) were used to construct the piezometric surface map shown in Figure 6. These data indicate that flow in the bedrock aquifer is toward the northeast. This is generally in agreement with the northward regional groundwater flow pattern in the bedrock discussed in published reports (Miller, 1982). Piezometeric levels measured in June 1984 (Table 6) showed a drop on the order of a foot or less, which does not change the configuration illustrated in Figure 6.

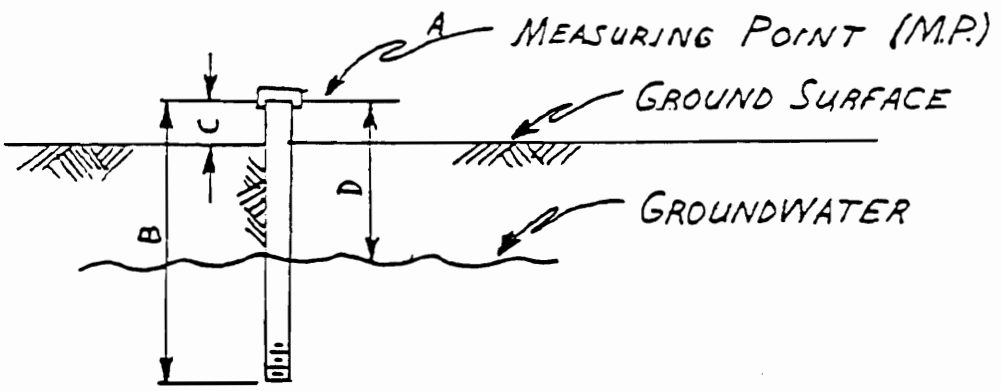
ate	Time (AM/PM)	Dist. to Ground-water (D)	Groundwater Elev. (USGS Datum) (=A-D)	Remarks
5/84	6PM	7.4 FT.	469.5 FT.	PACKING AROUND CASING OPEN TO DEPTH OF 13 FT. BELOW GROUND SURFACE. NO ODOR
/84	3 PM	8.8 FT.	468.1	
/84	11:30AM	8.6	468.3 FT.

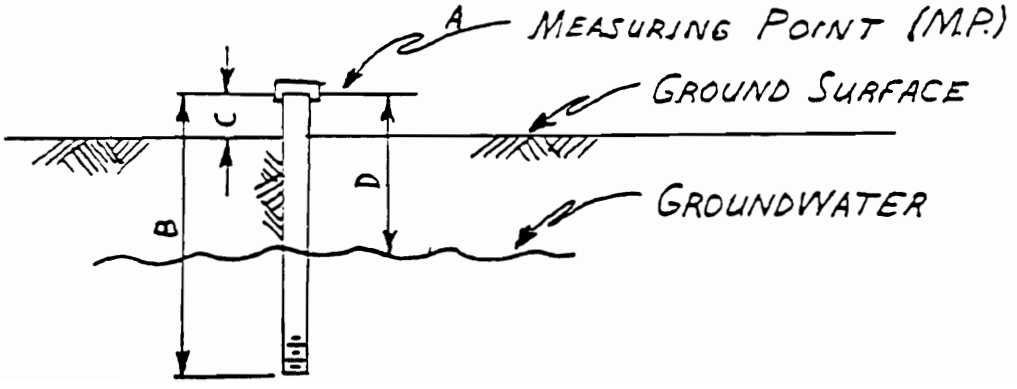
ate	Time (AM/PM)	Dist. to Ground-water (D)	Groundwater Elev. (USGS Datum) (=A-D)	Remarks
25/84	2 PM	8.4 FT.	469.3 FT.	PACKING AROUND CASING OPEN TO DEPTH OF 13 FT. BELOW GROUND SURFACE. N. ODOR.
2/84	3 PM	8.8	468.9	
3/84	11:30 PM	9.5 FT.	468.2 FT.

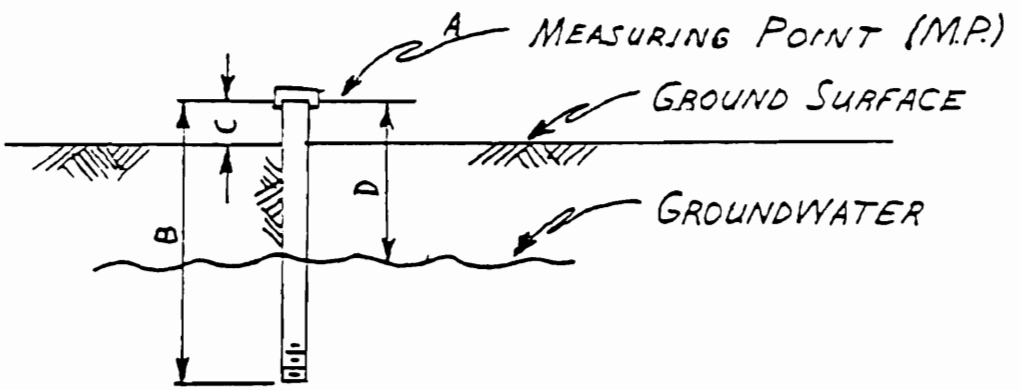
Date	Time (AM/PM)	Dist. to Ground-water (D)	Groundwater Elev. (USGS Datum) (=A-D)	Remarks
7/2/94	2 PM	8.0 FT.	461.8 FT.	IRREGULARITY IN CASING - TAPE CAUGHT AT ±15 FT.

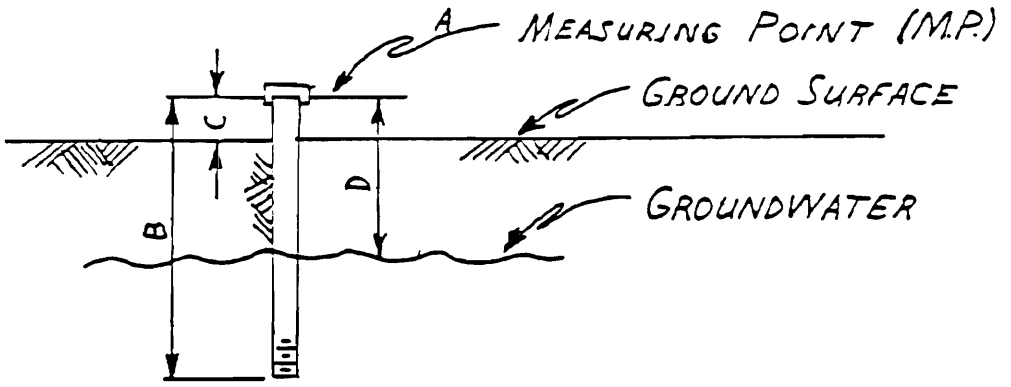
ate	Time (AM/PM)	Dist. to Ground-water (D)	Groundwater Elev. (USGS Datum) (=A-D)	Remarks
2/84	2 PM	8.1 FT.	461.6 FT.	PVC CAP IS SPLIT. 2" DIAM. NO THREADS.
1/84	10AM	8.8 FT.	460.9 FT.	
/

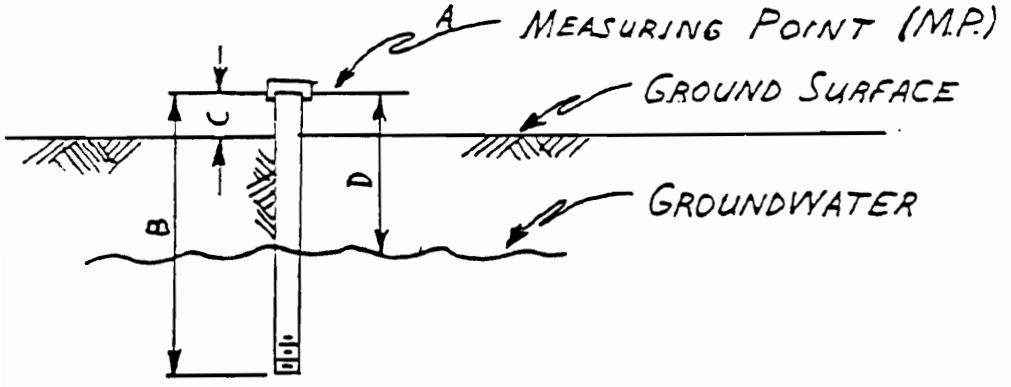
ate	Time (AM/PM)	Dist. to Ground-water (D)	Groundwater Elev. (USGS Datum) (=A-D)	Remarks
3/84	11 AM.	DRY		WELL LOCATED IN BORROW AREA. FORMERLY ±31 FT. DEEP. NO CAP, 2.5" O.D.
1/94	1145 AM	DRY		
/

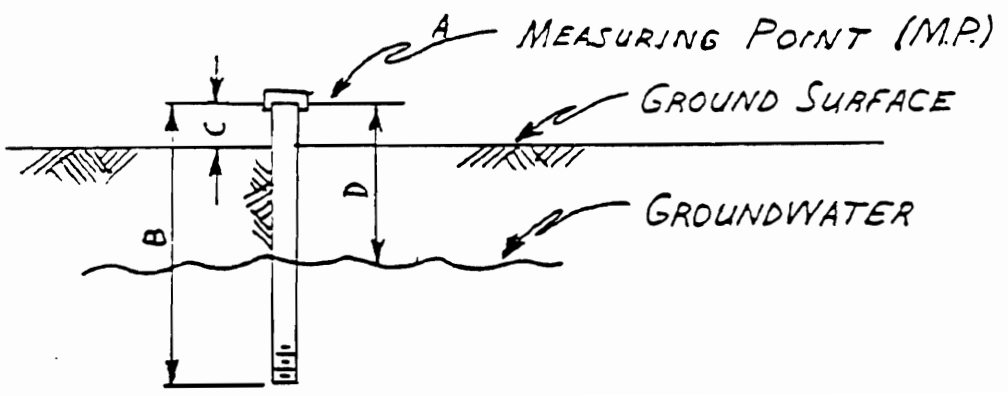
ate	Time (AM/PM)	Dist. to Ground-water (D)	Groundwater Elev. (USGS Datum) (=A-D)	Remarks
2/84	11 AM	3.9 FT.	479.3 FT.	REMOVED 3/4" O.D. PVC RISER PIPE FROM INTERIOR. PIPE HAD GLUED CONNECTIONS.
1/84	12 AM	5.0 FT	478.2 FT.

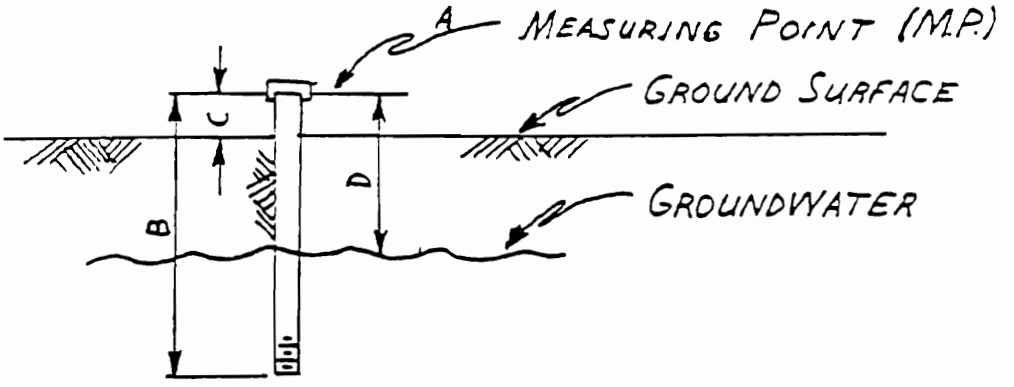
ate	Time (AM/PM)	Dist. to Ground-water (D)	Groundwater Elev. (USGS Datum) (=A-D)	Remarks
-/84	12 PM	DRY	< 471.6 FT.	REMOVED 1/4" ON. RISER PIPE FROM ENTERIOR PIPE HAS GLUED CONNECTIONS.
1/84	12:15 PM	25.6	470.0 FT.	
/

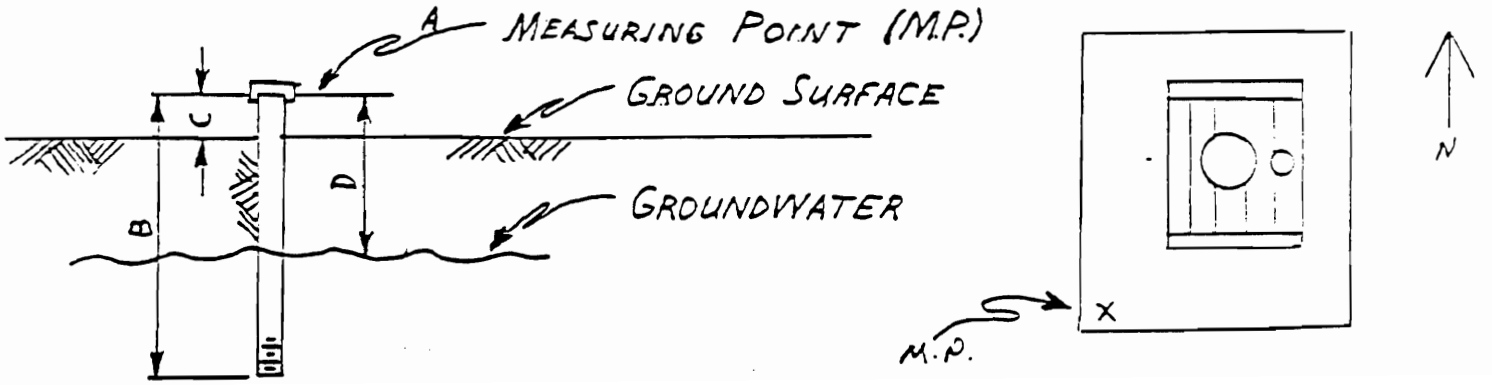
ite	Time (AM/PM)	Dist. to Ground-water (D)	Groundwater Elev. (USGS Datum) (=A-D)	Remarks
25/84				VENT HOLE NOT LARGE ENOUGH TO NUT TAPE THROUGH.
4/84		6.9 FT.	465.2	HAD TO DISMANTLE PART OF COVER.
6/84	11:30 AM	9.3 FT.	462.8	" " "
