PHASE II SITE INVESTIGATION
FINAL REPORT

Pyramid Co. - Ernst Steel Site
Buffalo, New York

prepared for:
Whiteman Osterman & Hanna

September 1988
Ref. No. 2366

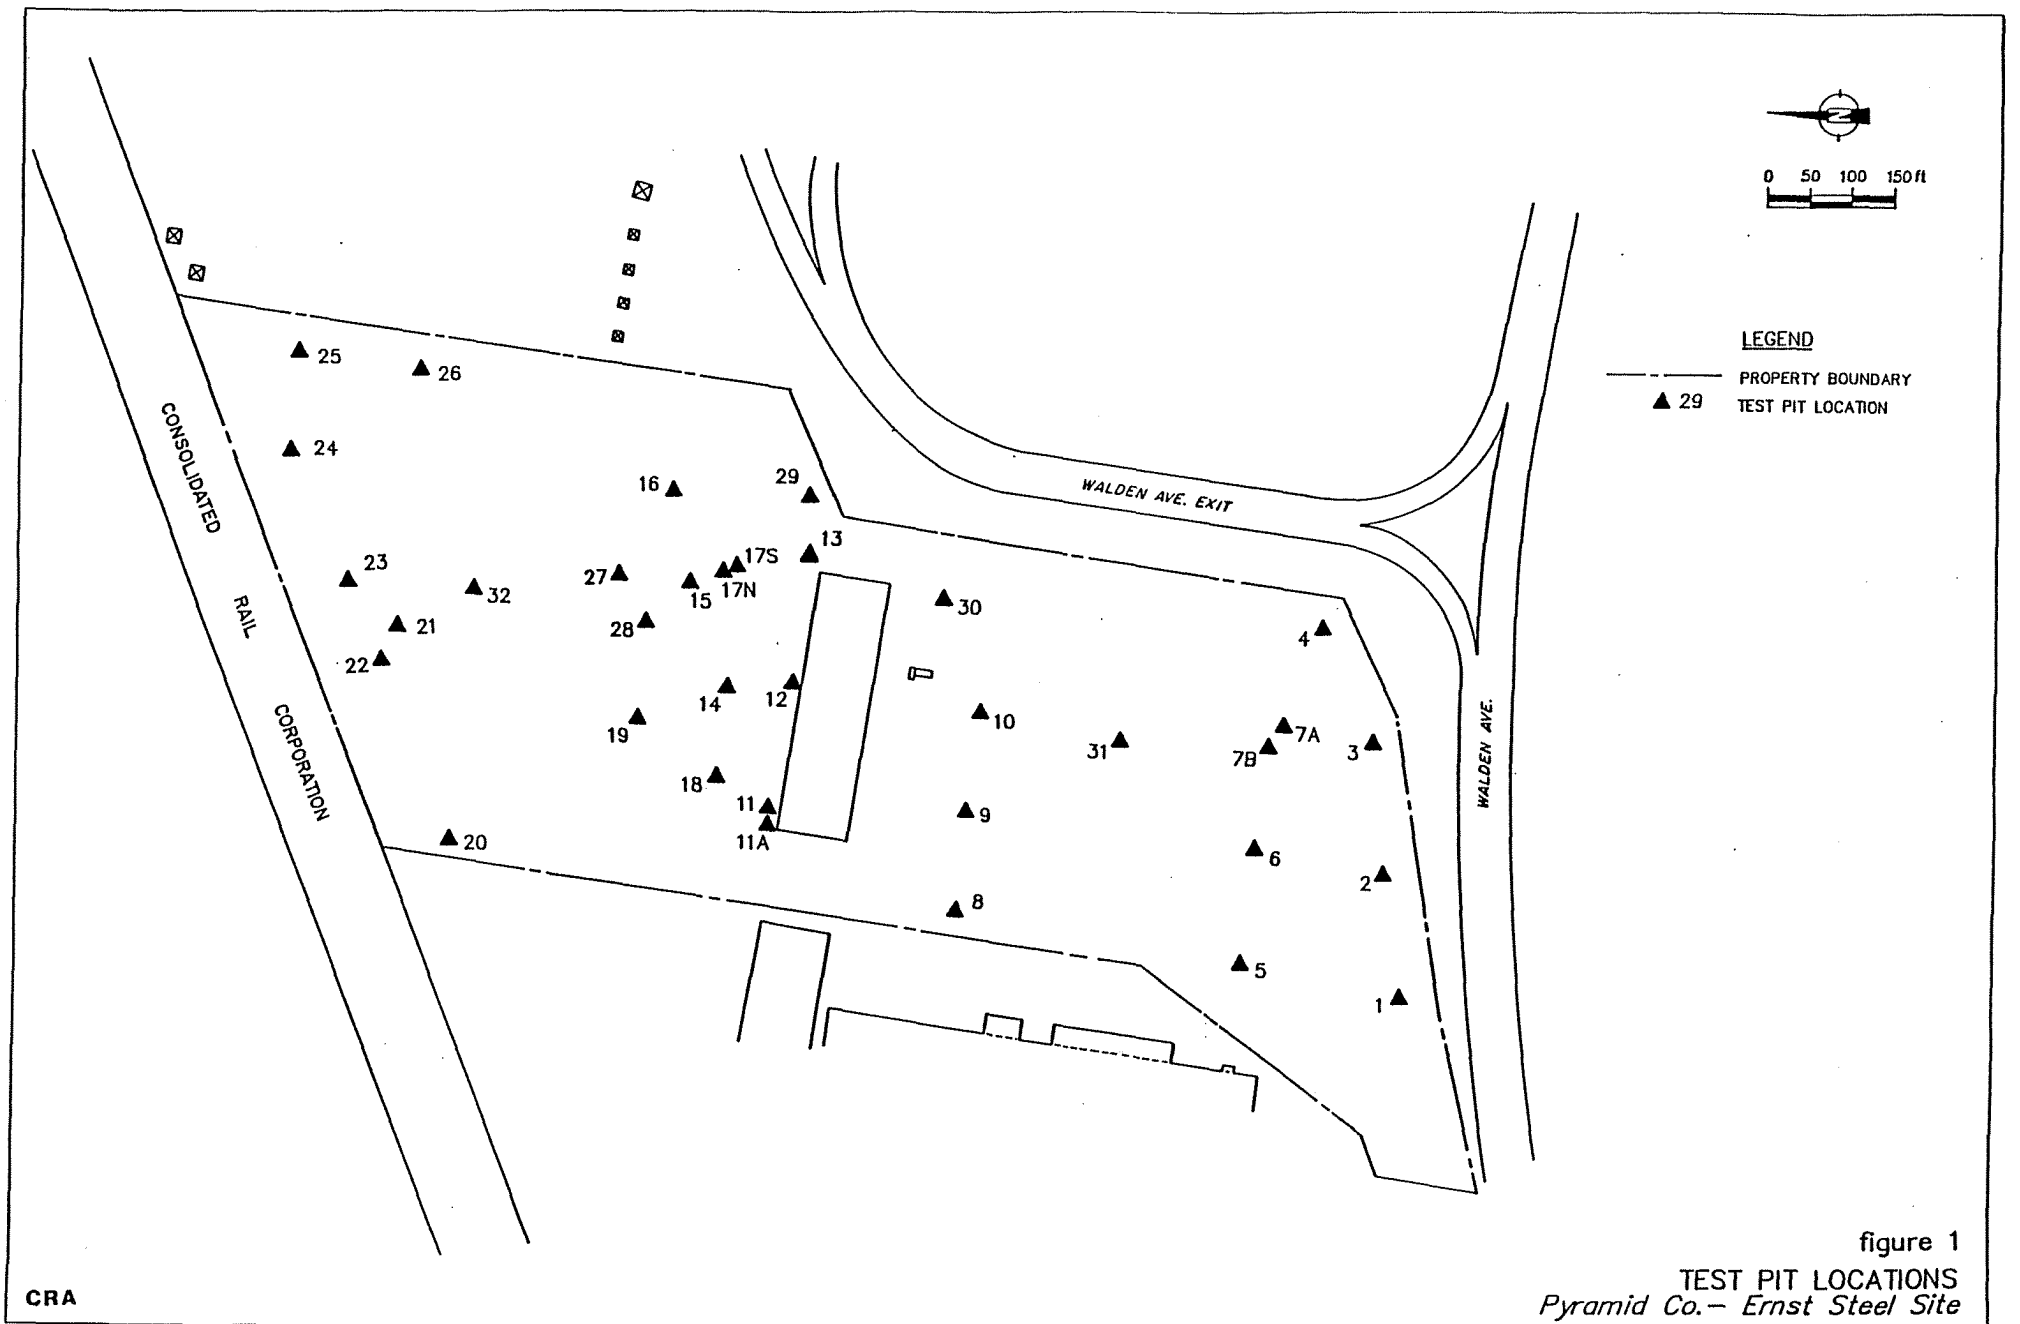
figure 1
TEST PIT LOCATIONS
Pyramid Co.– Ernst Steel Site

CRA then contracted SLC, Inc. of Lockport, NY to provide a backhoe and operator to excavate the test pits. The investigation began on June 9, 1988. On June 10, 1988, work was temporarily suspended pending approval of the Order on Consent from the NYSDEC. Following approval, work resumed and was completed on July 6, 1988. NYSDEC site representatives were present for the completion of the Test Pit Investigation. A total of 32 test pit locations were excavated (see Figure 1).

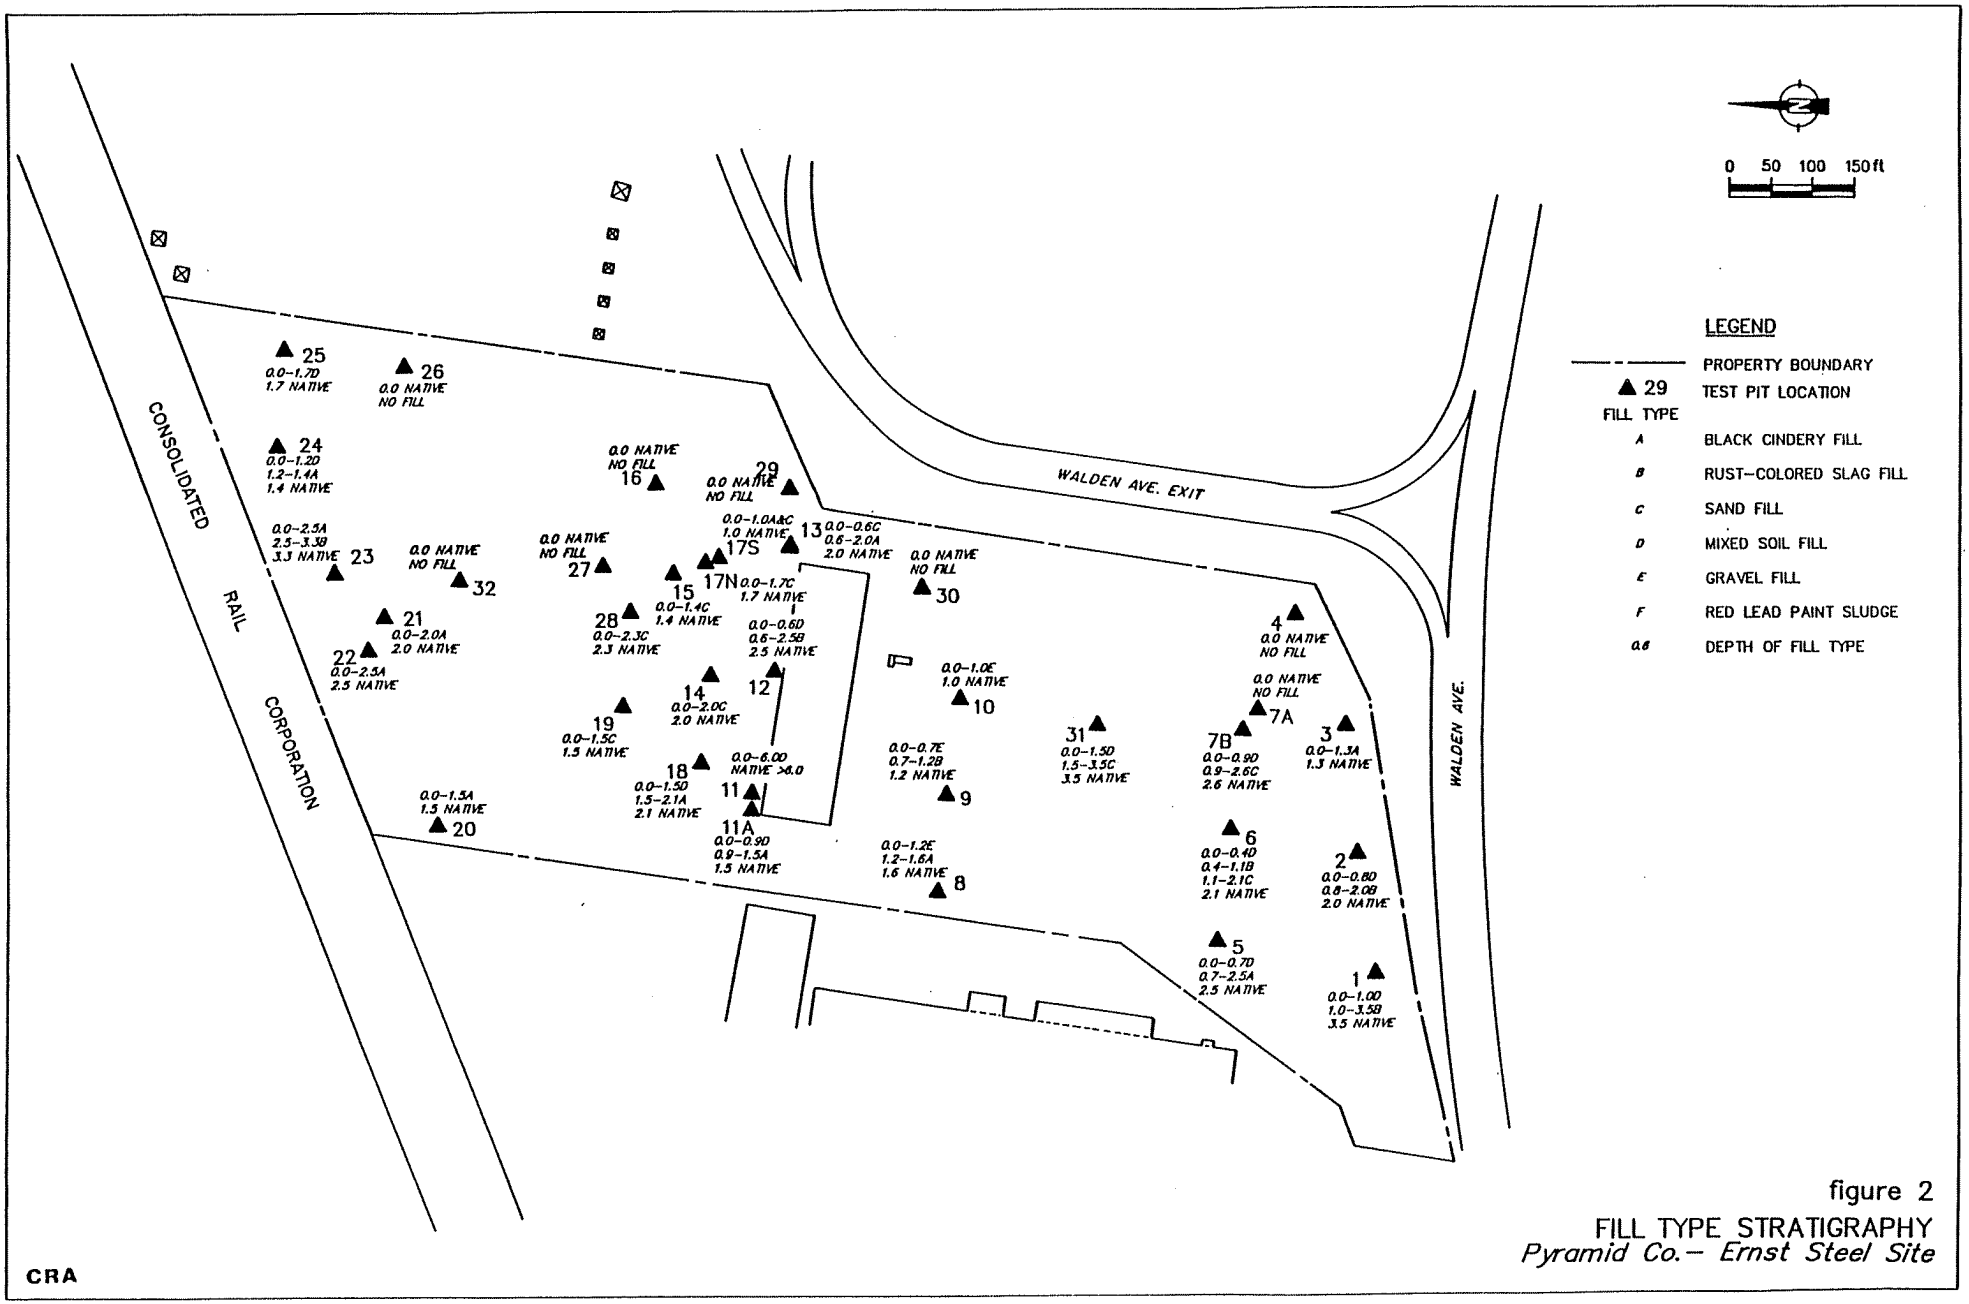
figure 2

1. The Site has been extensively filled. In general, fill is absent or very shallow along the eastern boundary of the Site and deepest in the southern third of the Site. Table 2 and Figure 2 detail the stratigraphic information collected.

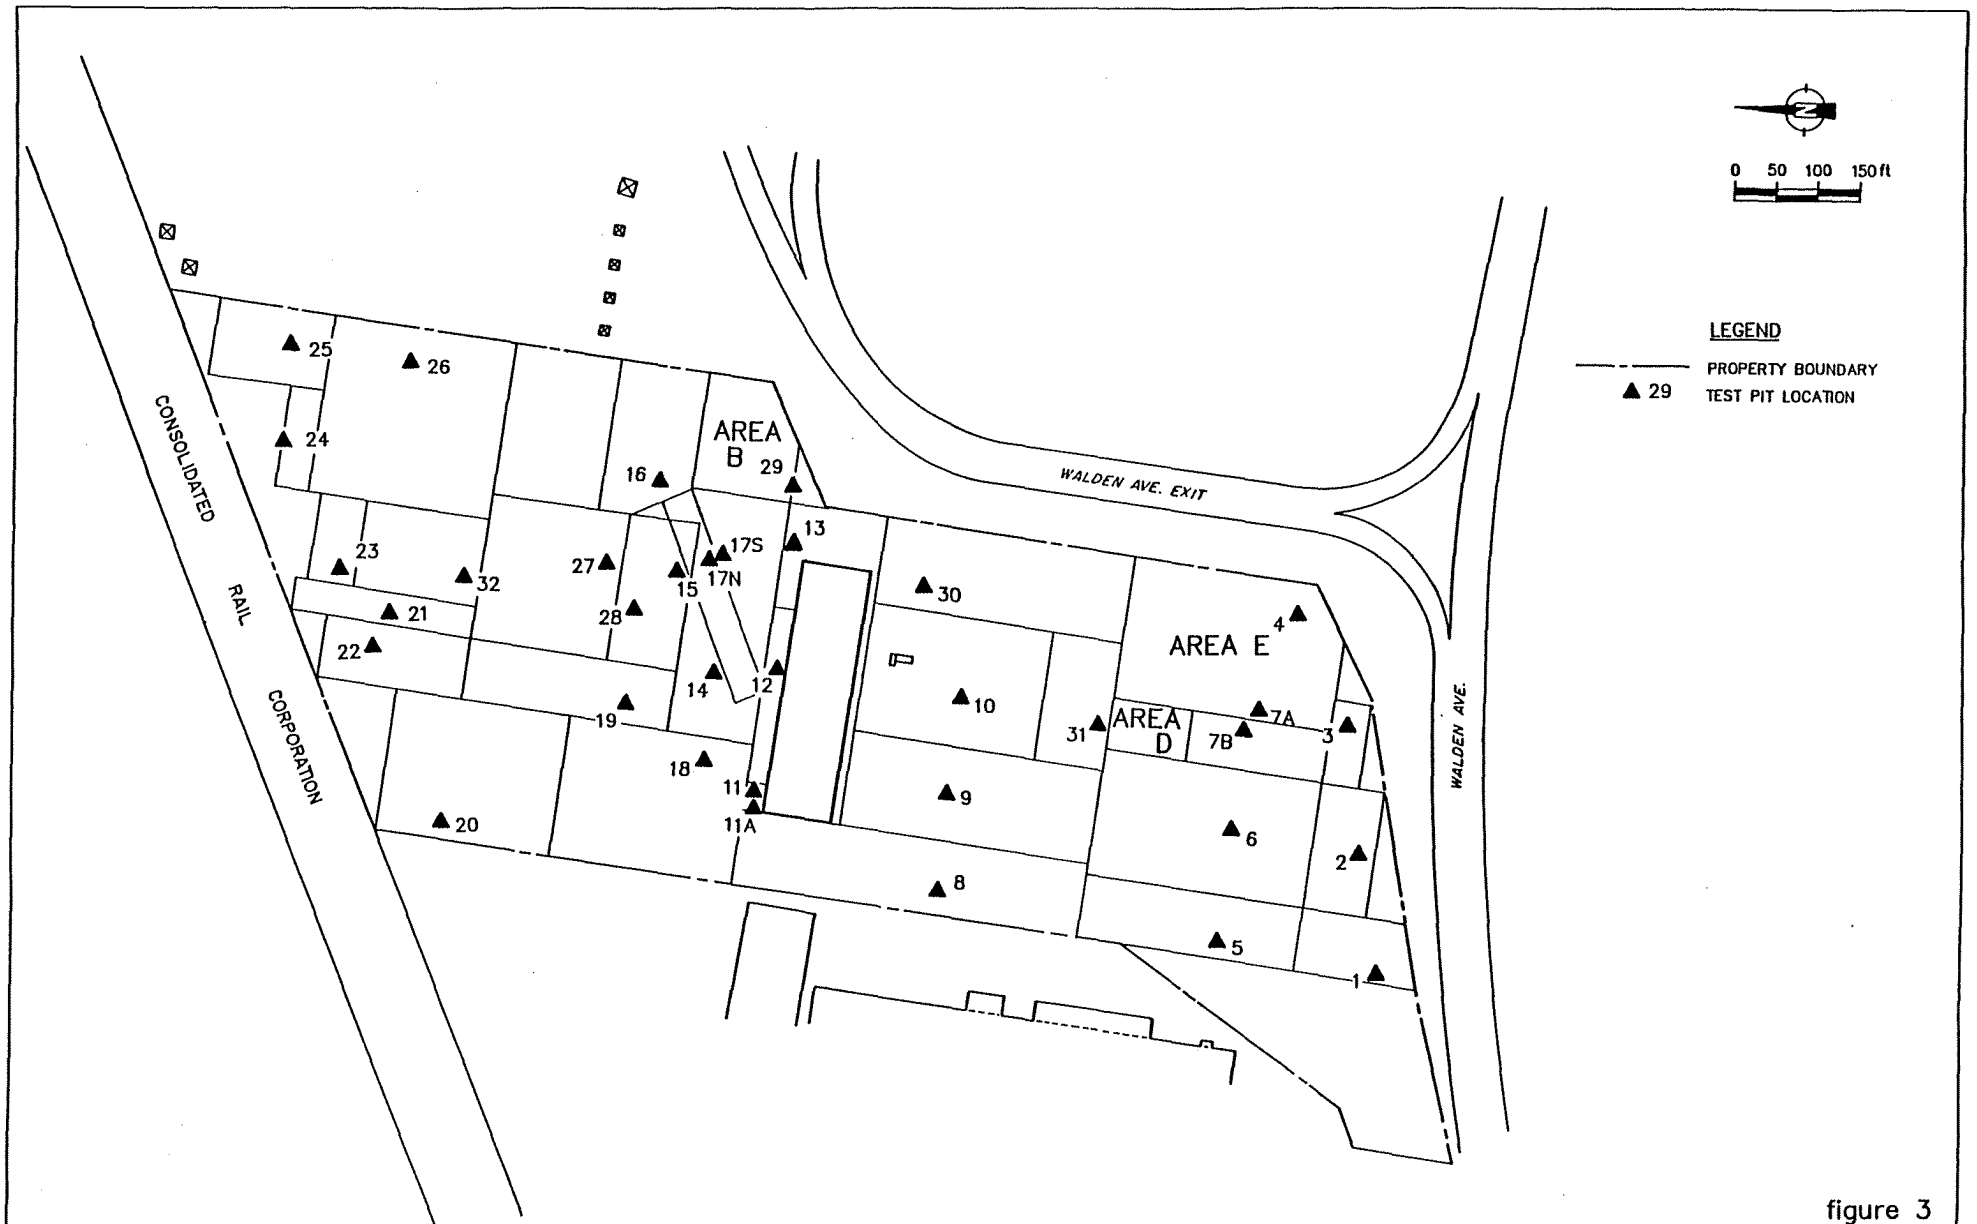
figure 3

Based upon the stratigraphic information obtained and presented on Table 2, the volume of fill present at the Site has been estimated. Table 3 summarizes the calculated volume estimates. Figure 3 shows the areas assigned to each test pit to calculate the estimated volume. As can be seen in Table 3, fill types A, B, C and D are present in relatively equal proportions (6,000 to 11,000 cubic yards each). Only 3,000 cubic yards of gravel fill was observed. The total estimated volume of fill present on the Site is on the order of 37,000 cubic yards.

* Only southern portion of Test Pit Area 32 shown on Figure 3 was used for fill estimation. Northern portion was native material.

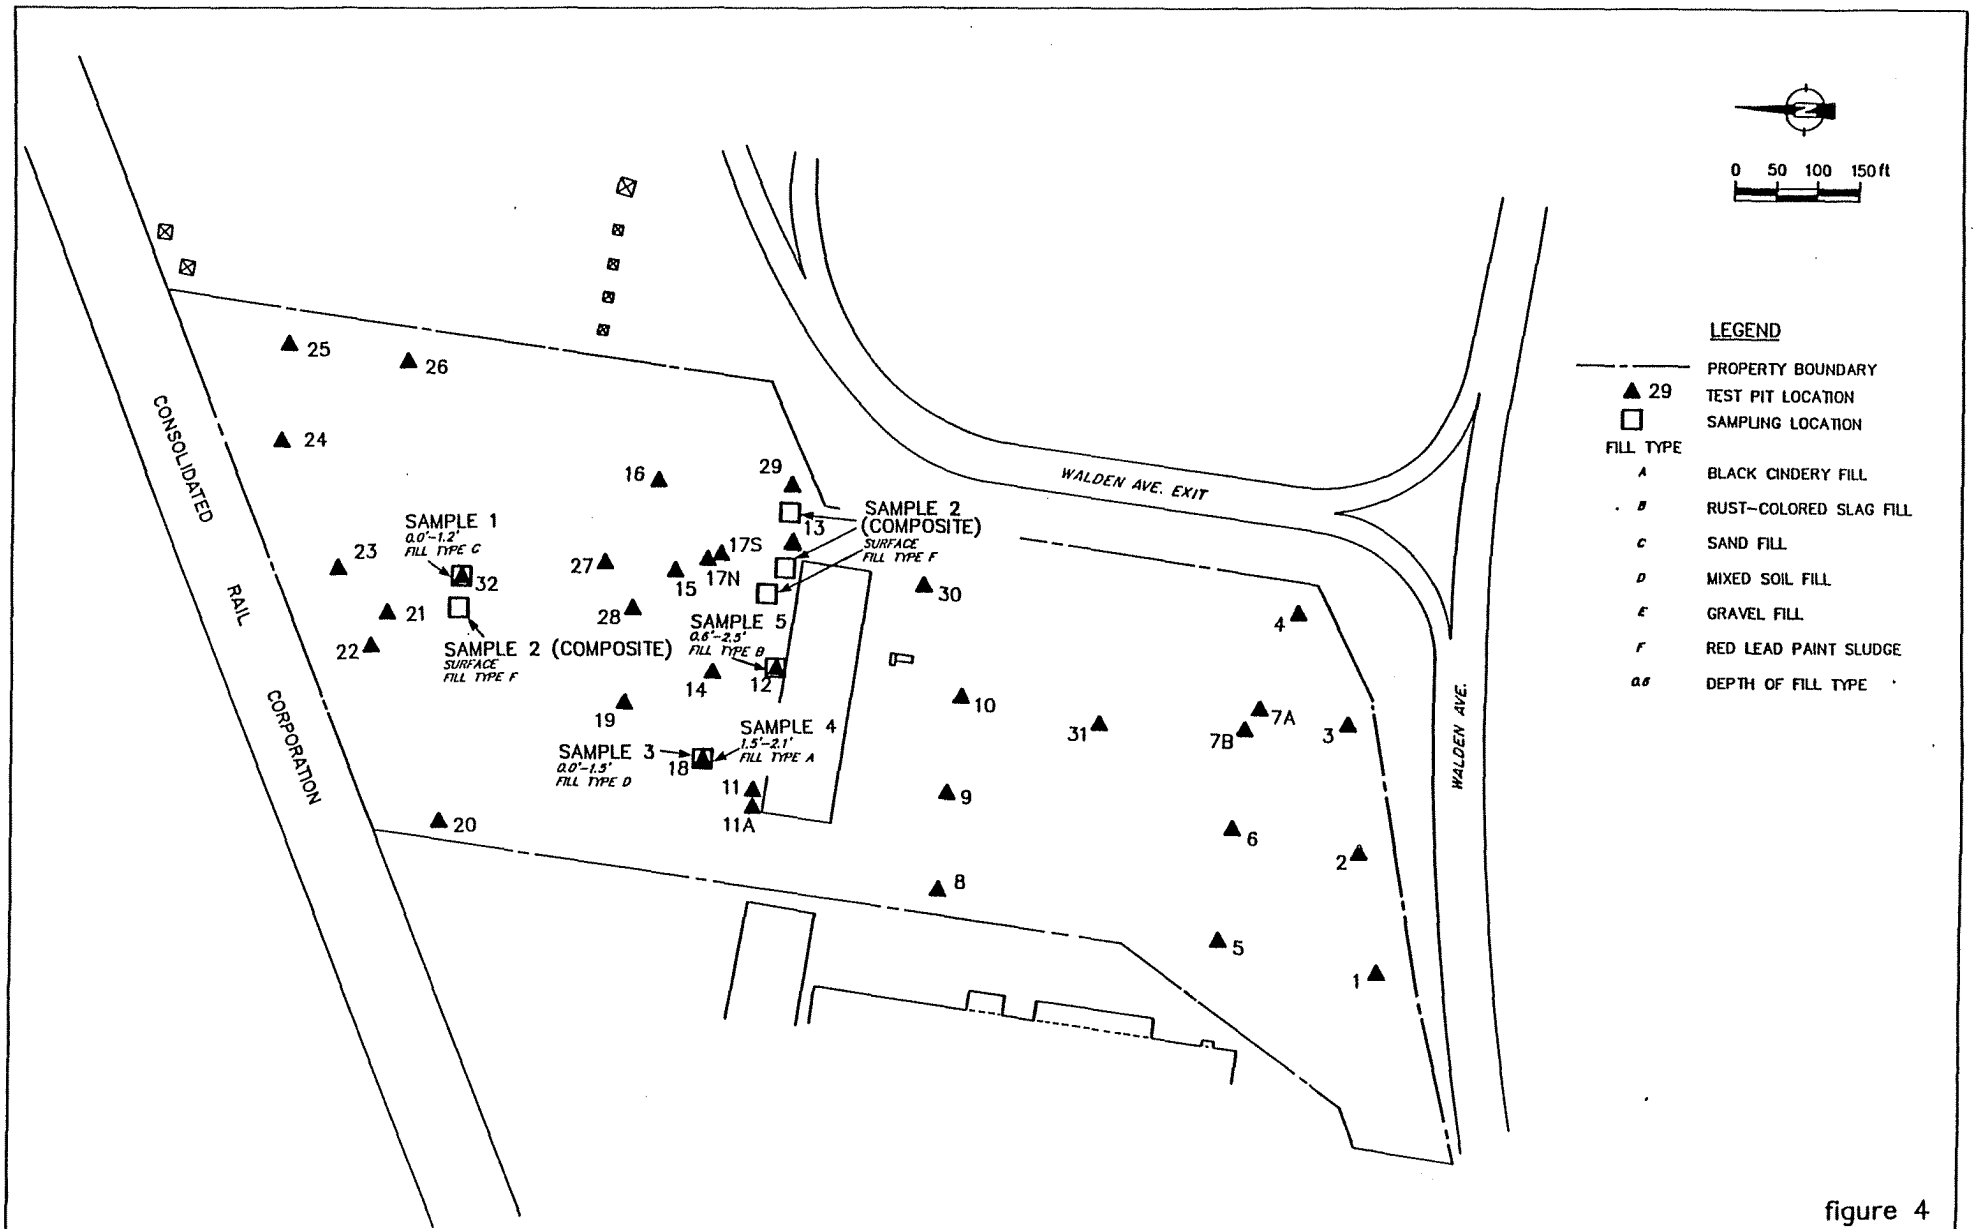
figure 4

The sample locations for the preliminary waste characterization program are shown on Figure 4. Sampling information is summarized in Table 4.

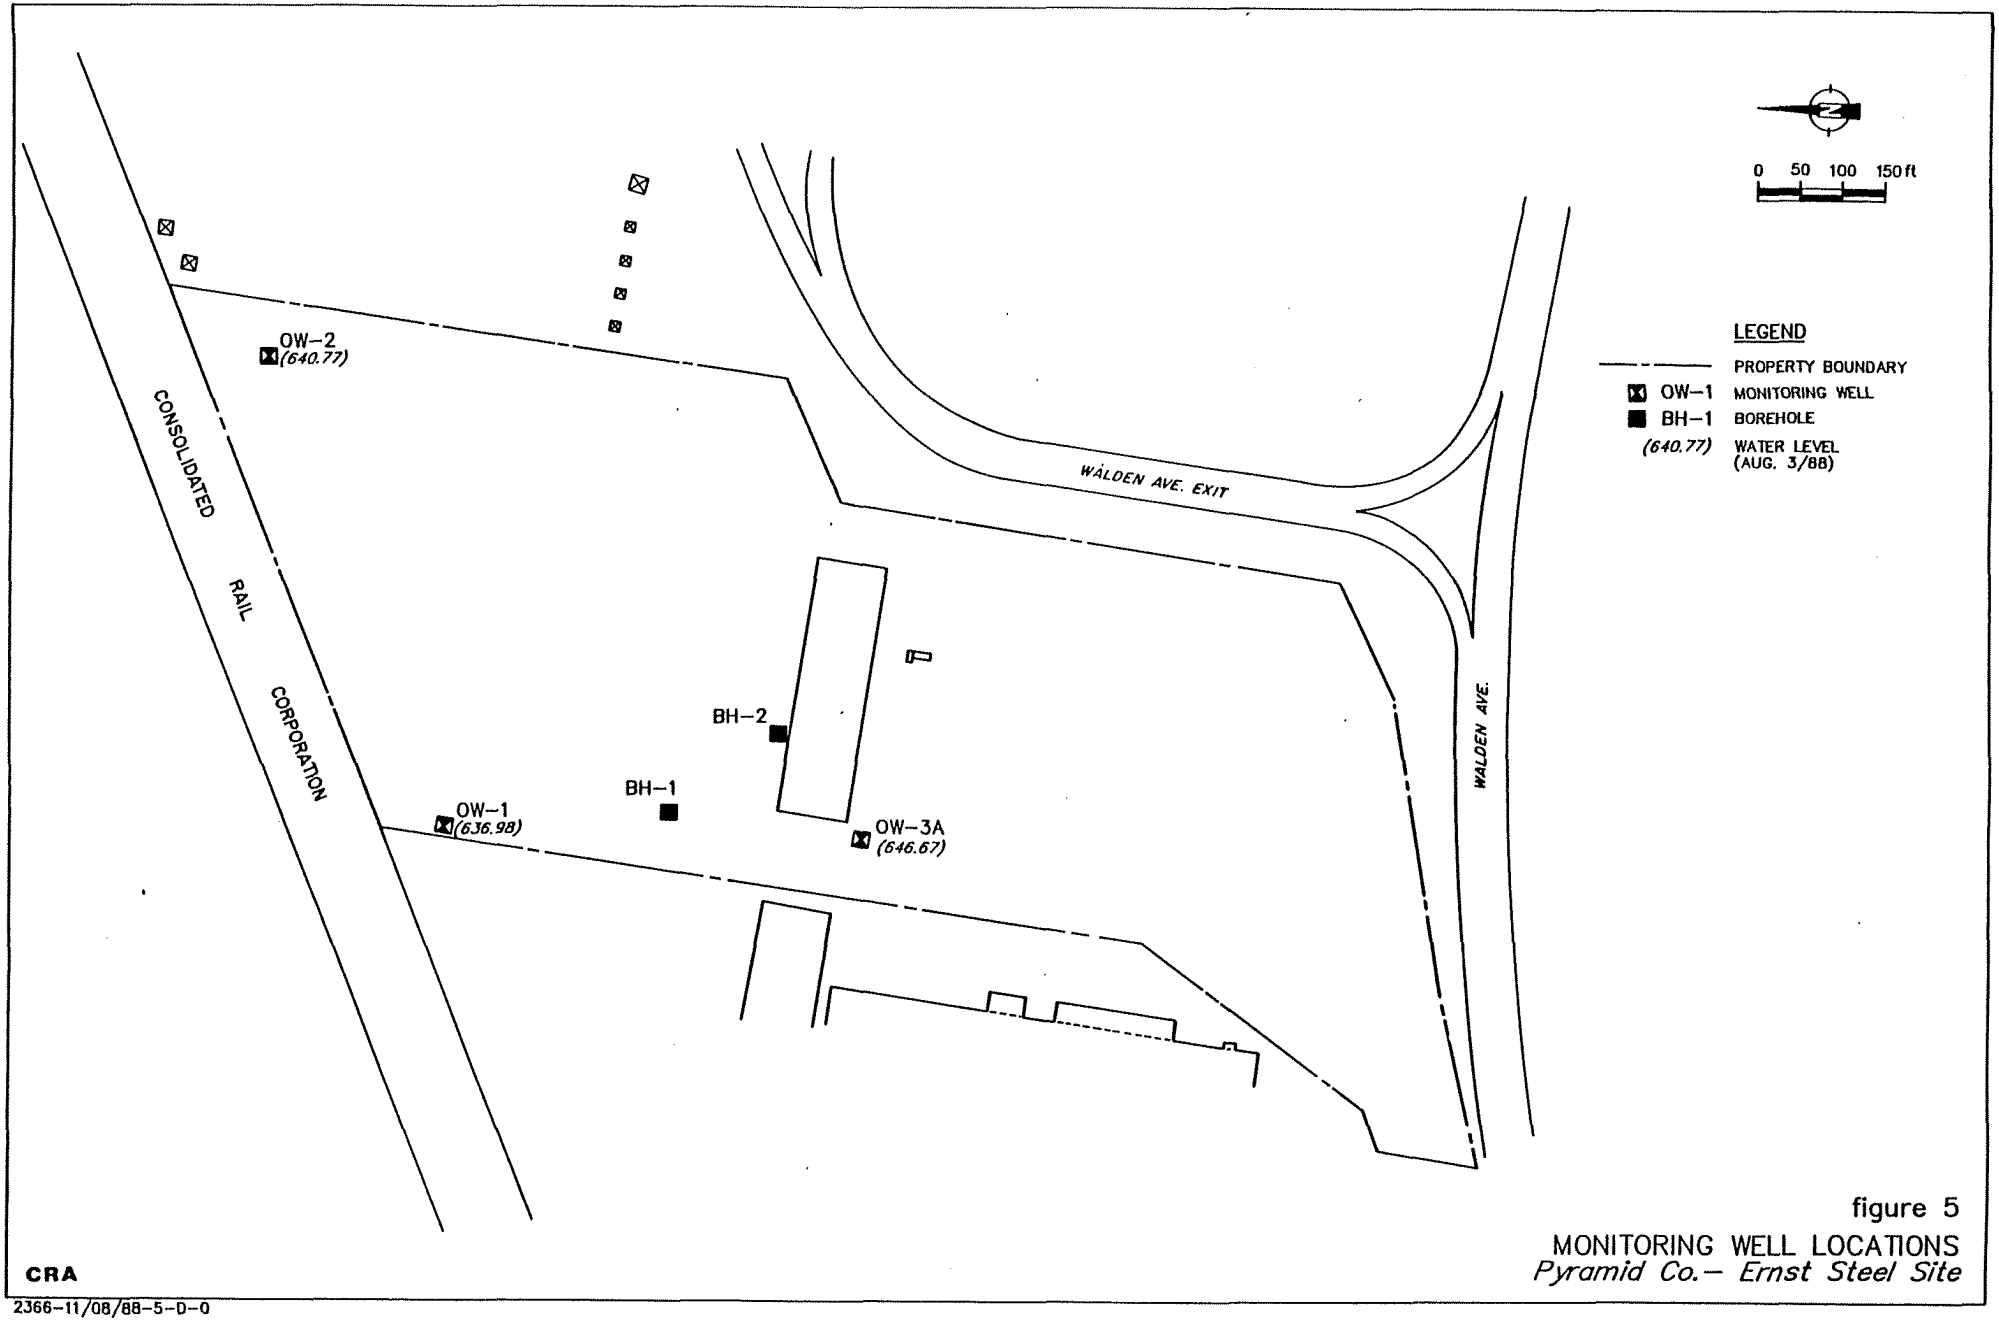
figure 5

In order to investigate the groundwater quality and flow conditions beneath the Site, three monitoring wells have been installed. OW-1 is in the northwest corner of the Site, OW-2 is near the northeast corner of the Site, and OW-3 is located near the center of the Site (see Figure 5). The Monitoring Well Installation Program began on July 13, 1988, and was completed on July 18, 1988. Monitoring well locations were selected to avoid conflicts with future site usage. NYSDEC site representatives were present for the majority of the monitoring well installation program and assisted in the selection of locations.

The three monitoring wells installed to date are in the locations specified in the Work Plan. The necessity for a fourth installation was investigated on September 19, 1988 by the drilling of two additional boreholes at the locations shown on Figure 5. Due to the absence of groundwater and following discussions with the NYSDEC site representative, a fourth monitoring well was determined, with the concurrence of NYSDEC personnel, not to be required.

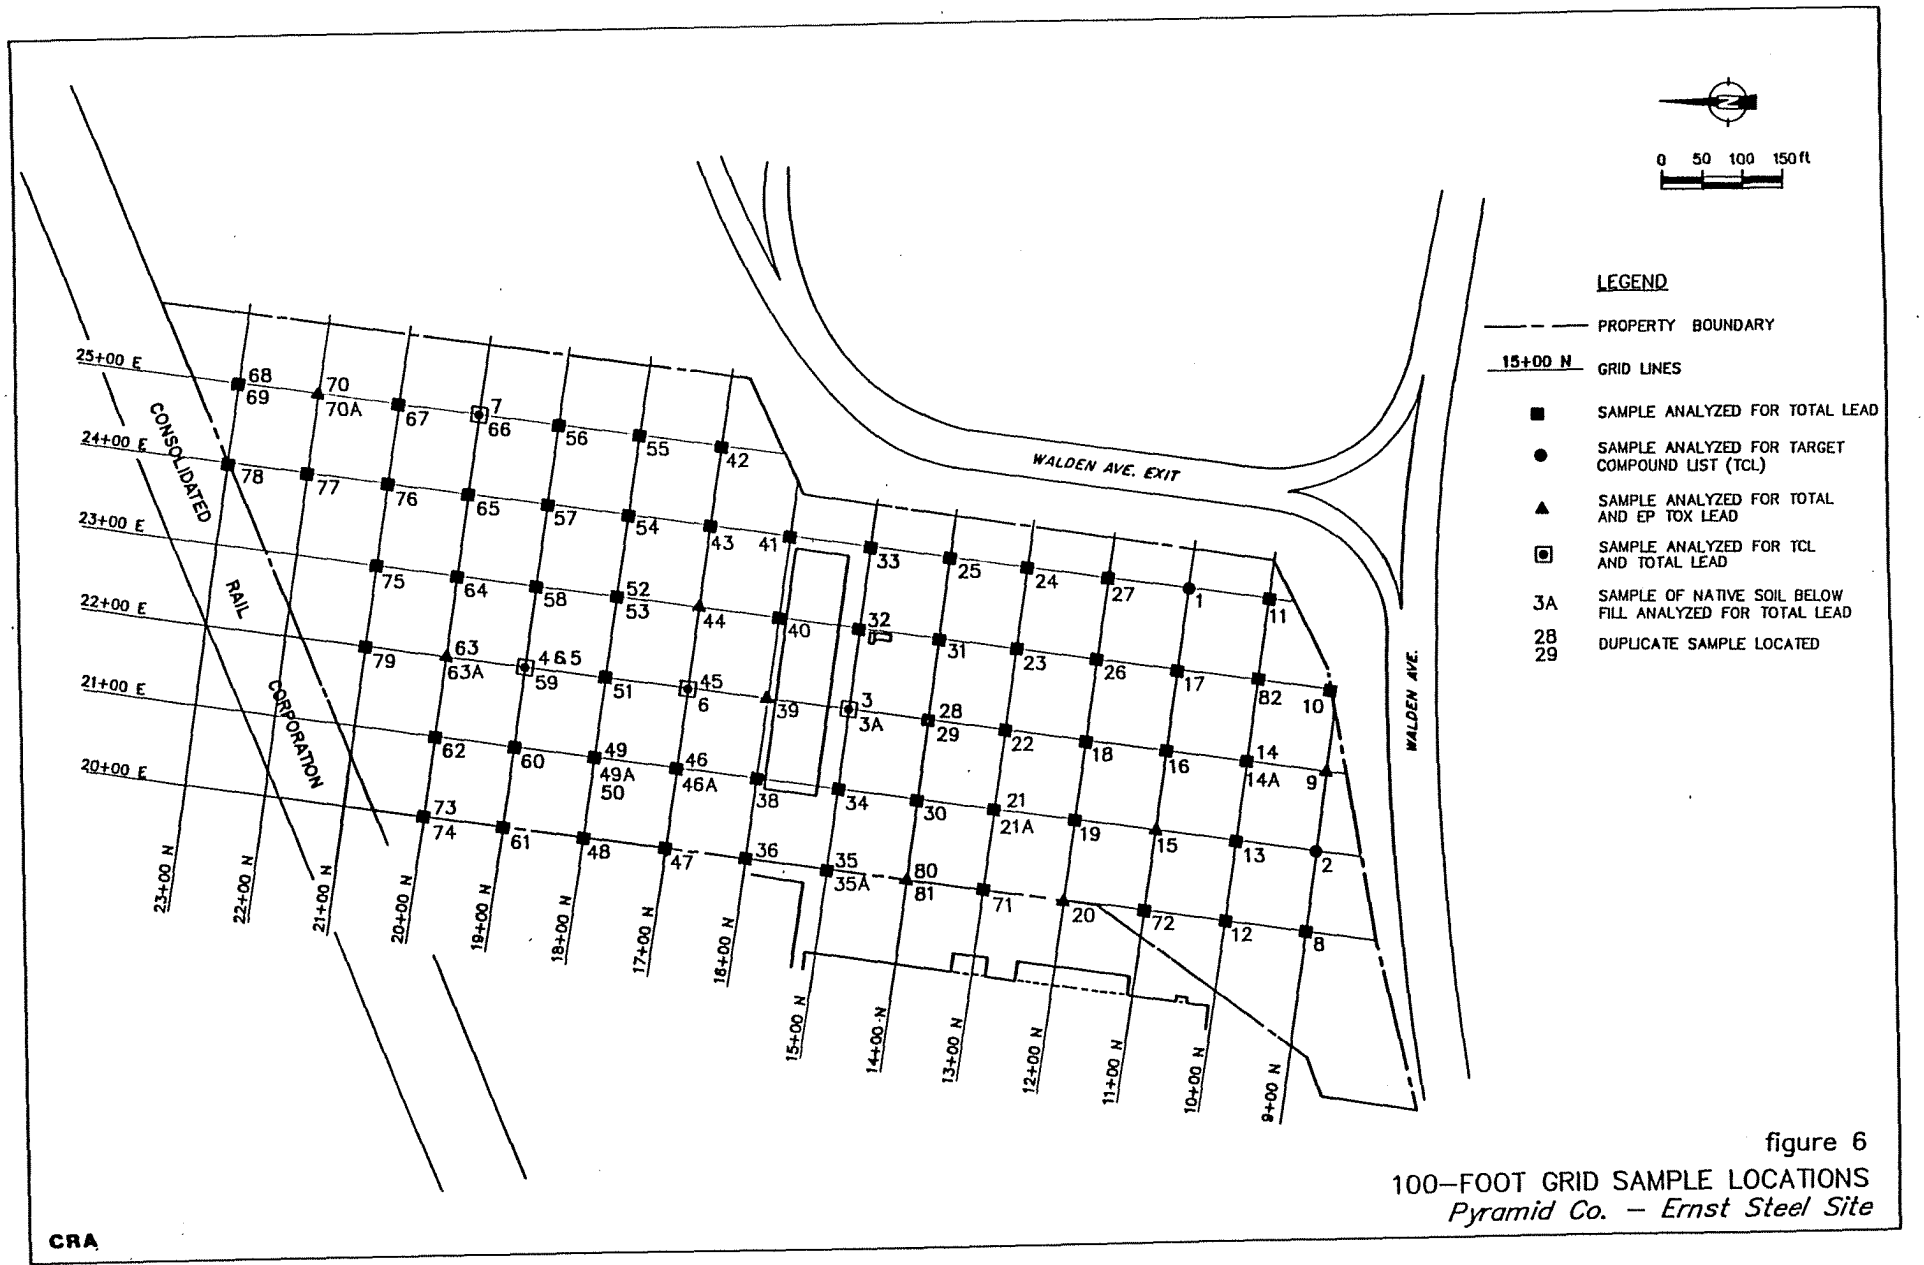
figure 6

On August 17 and 18, 1988, a 100-foot sampling grid was established on the Site. At each grid point, samples of the entire fill horizon extending from just below the surface material to the top of the underlying native soils were collected and analyzed for total lead. The sampling locations (71 locations) are presented in Figure 6. At eight sampling locations, duplicate soil samples were collected for QA/QC purposes for a total of 79 samples. The analytical results are presented in Appendix D and summarized on Figure 7.

To confirm the waste characterization, additional samples were collected of the entire fill strata at six locations (plus one duplicate sample) and analyzed for the TCL. The sampling locations are presented on Figure 6 and the analytical results are presented in Appendix E.

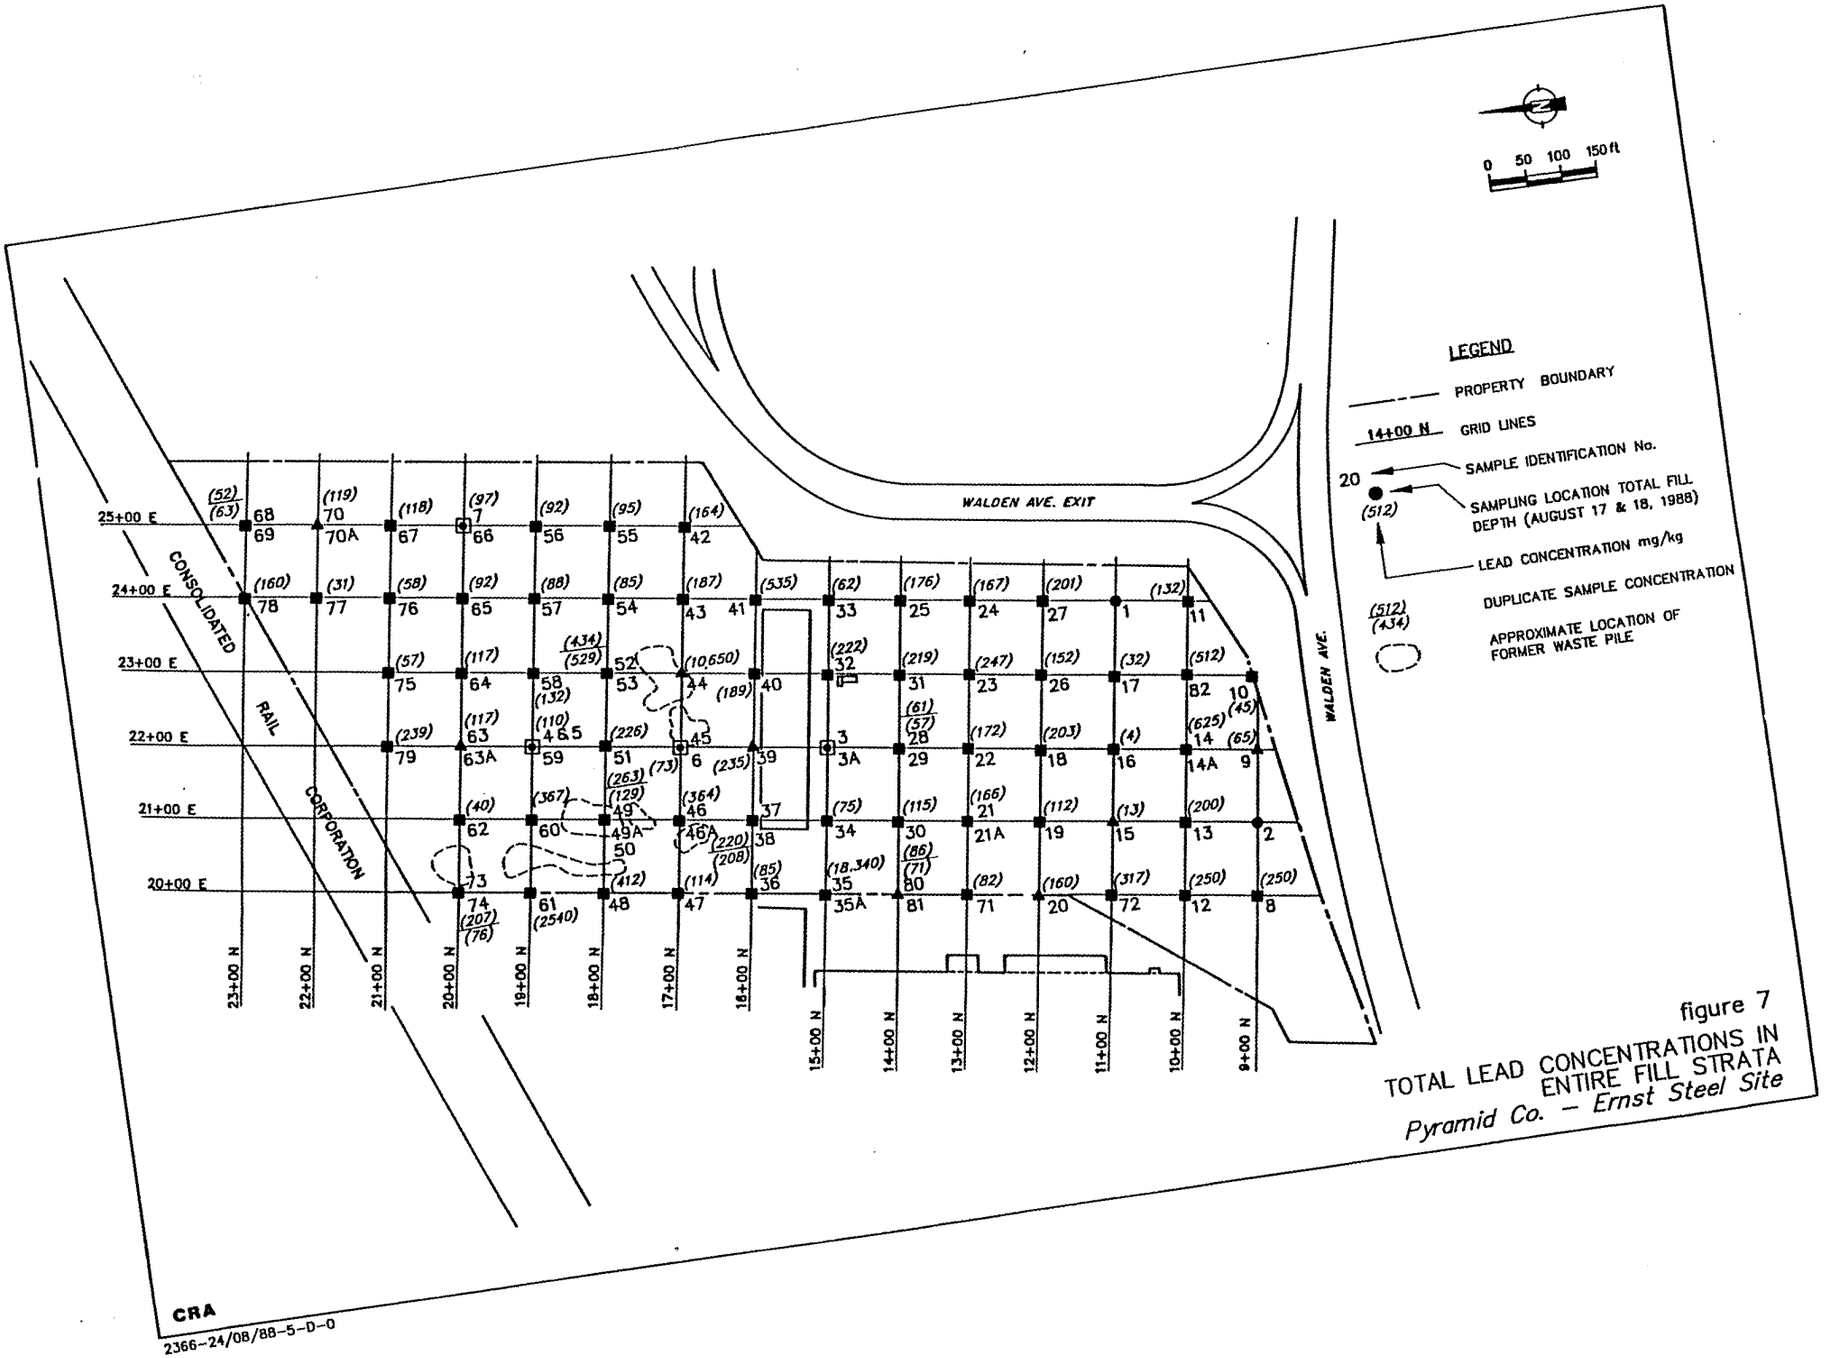
figure 7

The isolated single occurrence of lead concentrations above 1,000 ppm in the southern portion of the Site may be an artifact of sampling. During sampling, a small area (approximately 1 square foot) with an orange/red material was noted. Some of this material was placed in the sample. During collection of this material, the remains of a paint can were found. No other observances of the orange/red

The Interim Remedial Measures Plan has already been established for the Site, i.e. removal and proper disposal of all soils with lead concentrations above 1000 ppm. It is recommended that a small volume of material from the isolated area in the southern portion of the Site also be excavated and appropriately disposed.

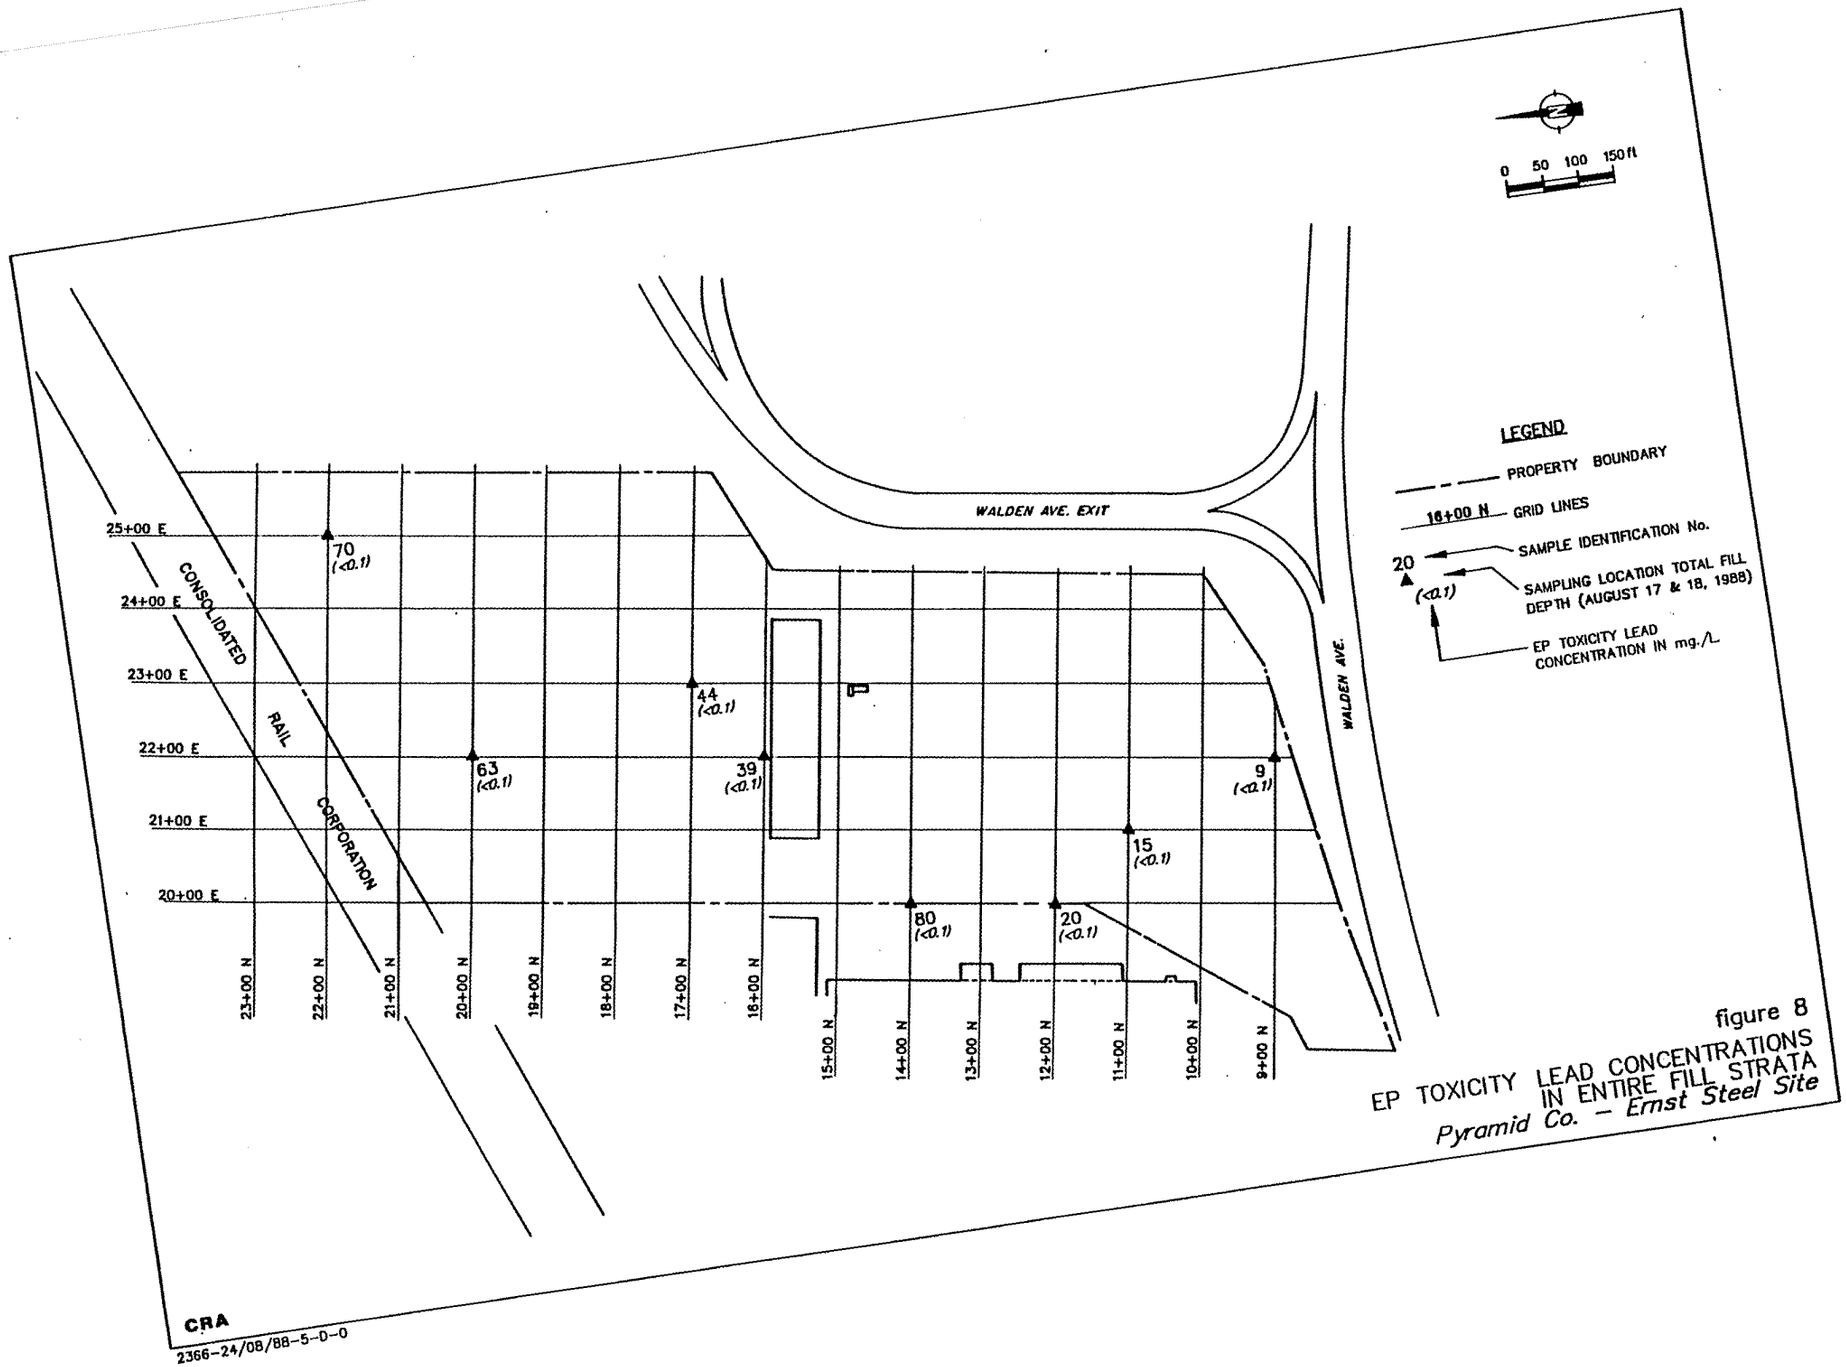
figure 8

At eight of the 71 locations, the sample was analyzed for EP Toxicity lead as well as total lead. The locations of the EP Toxicity sample points and analytical

results are summarized in Figure 8. The analytical results are presented in Appendix D.
