PHASE II SITE INVESTIGATION
FINAL REPORT

Pyramid Co. - Ernst Steel Site
Buffalo, New York

prepared for:
Whiteman Osterman & Hanna

September 1988
Ref. No. 2366

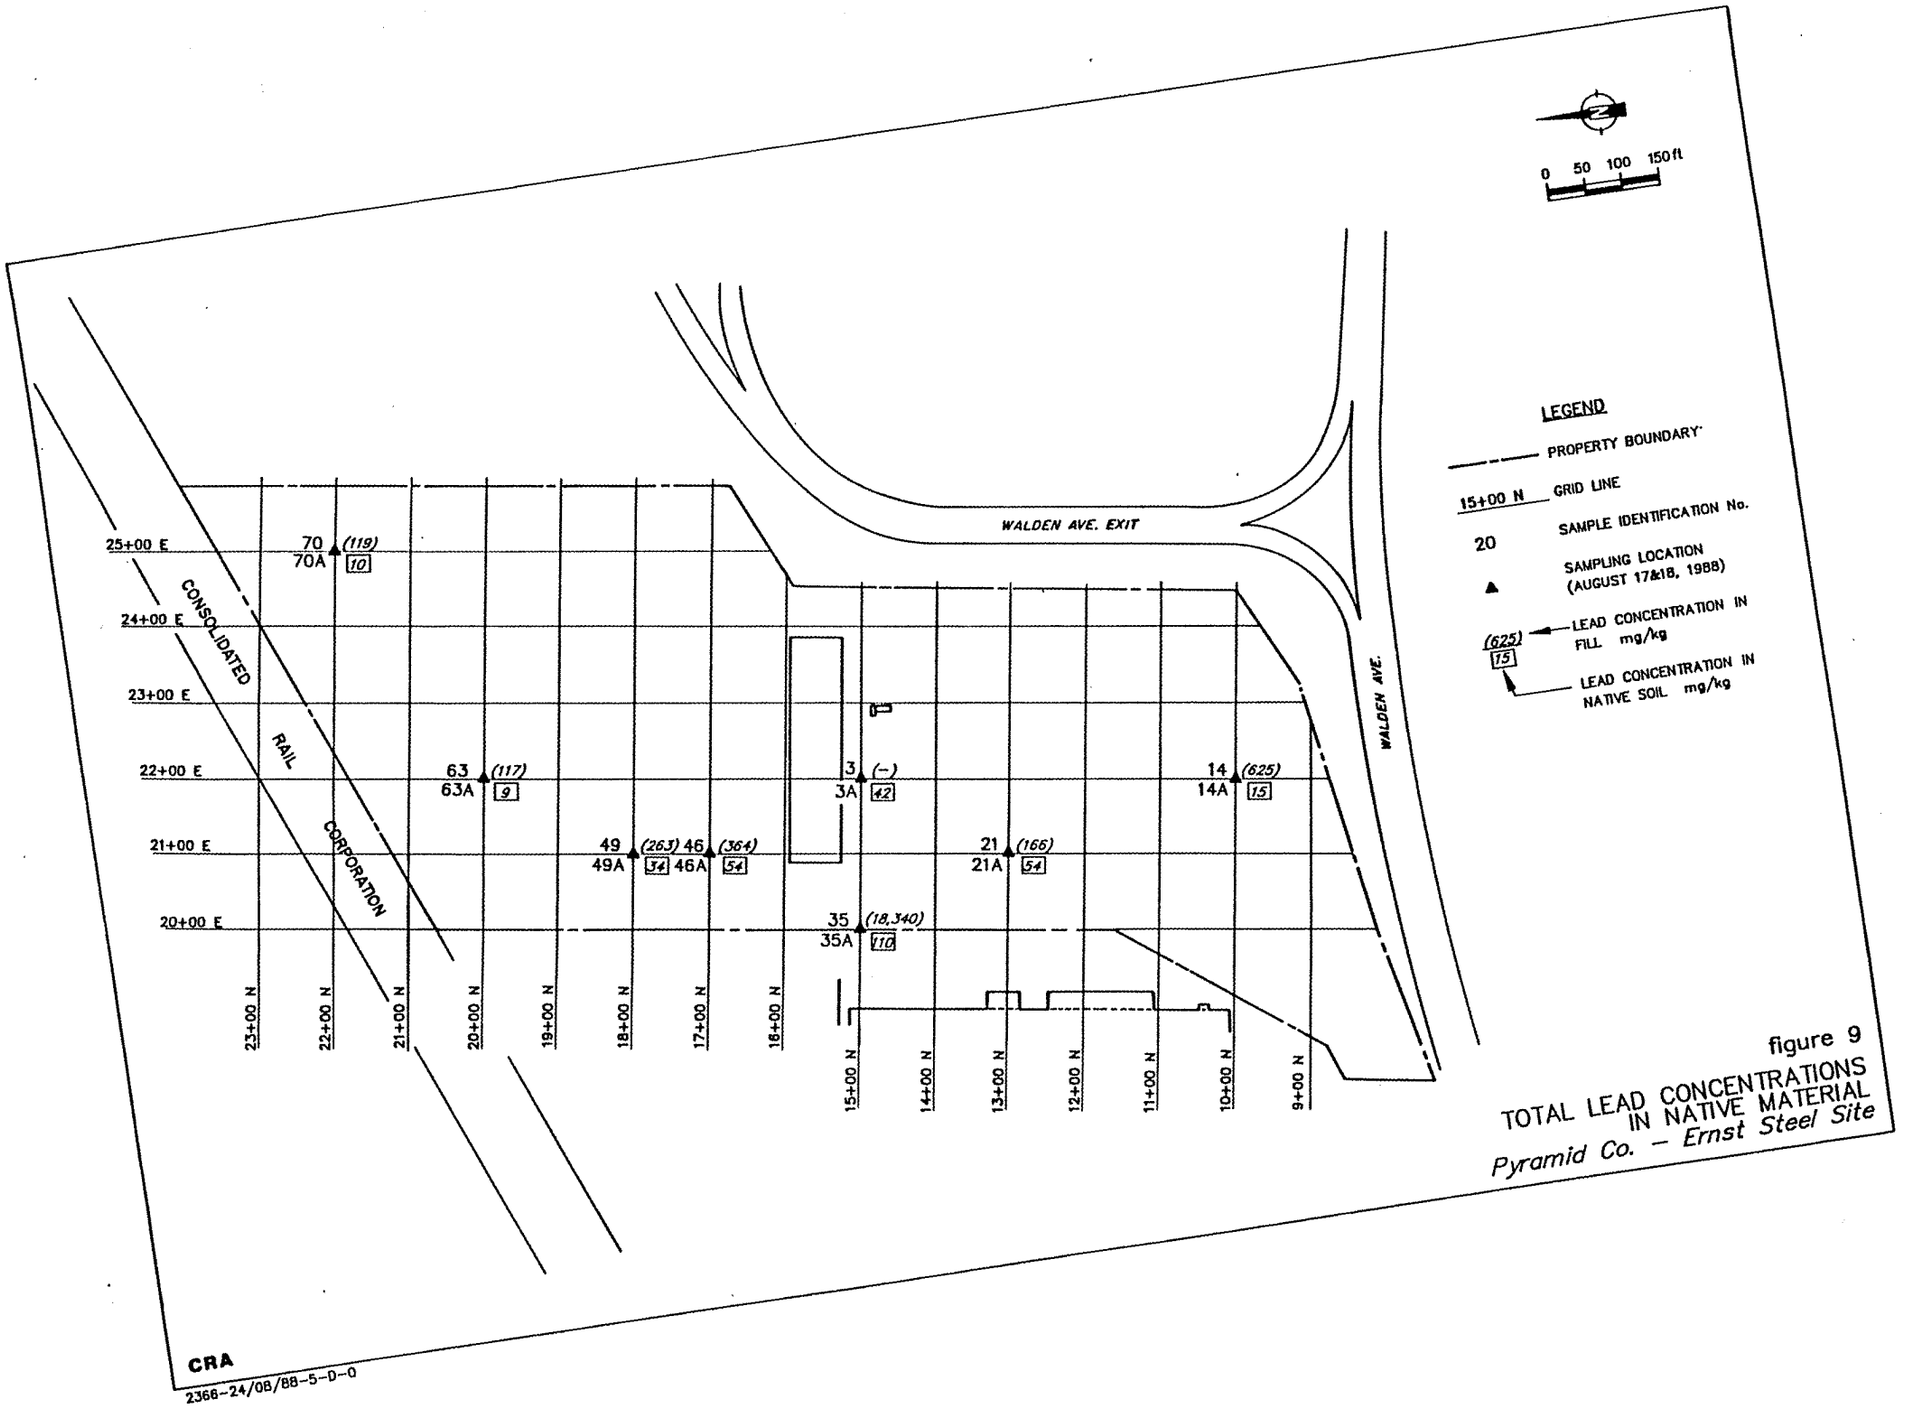
figure 9
TOTAL LEAD CONCENTRATIONS IN NATIVE MATERIAL
Pyramid Co. – Ernst Steel Site

At eight additional locations beneath the area of fill presence, samples of the underlying native material were collected and analyzed for total lead. Figure 9 presents the locations of native soil sample collection as well as the concentrations of total lead in the native materials and overlying fill material at each of these sample points. The analytical results are presented in Appendix D.

The immediate interest in the southern half of the Site is to gain access to the underlying native soils which have been demonstrated to be clean (see Figure 9). At the same time, it is imperative that the plan for final Site remediation be kept in mind to insure that an overall acceptable plan of remediation is attained for the entire Site and not just the southern half. Consequently, although this proposed plan deals only with the fill material from the southern half of the Site, it is anticipated that the scope of the plan could be enlarged to accommodate the handling of

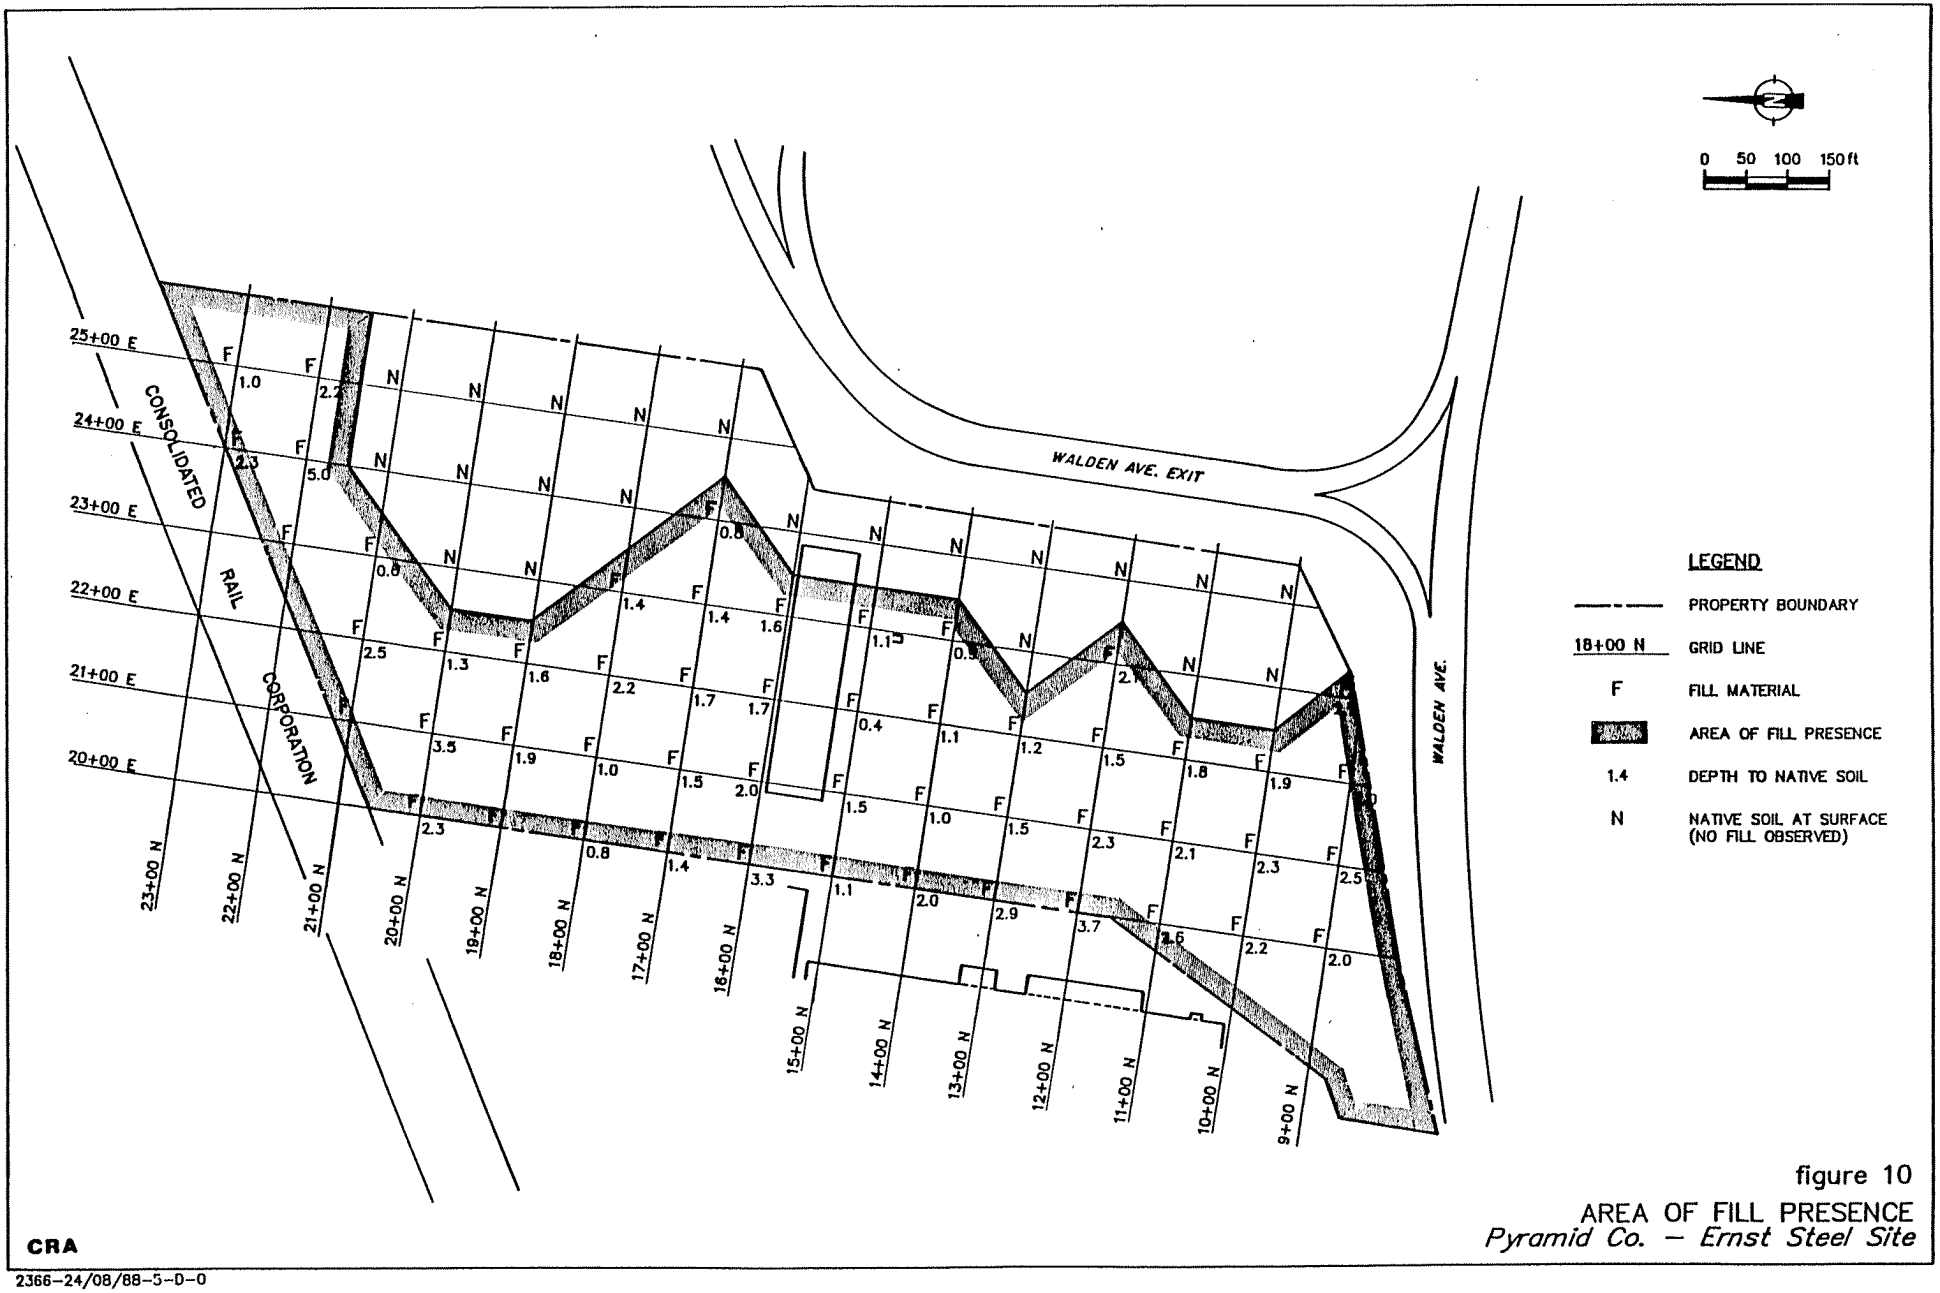
figure 10

As a result of the site work performed, the areal extent of fill has been delineated. Figure 10 presents the boundaries of this area and the depths of fill.

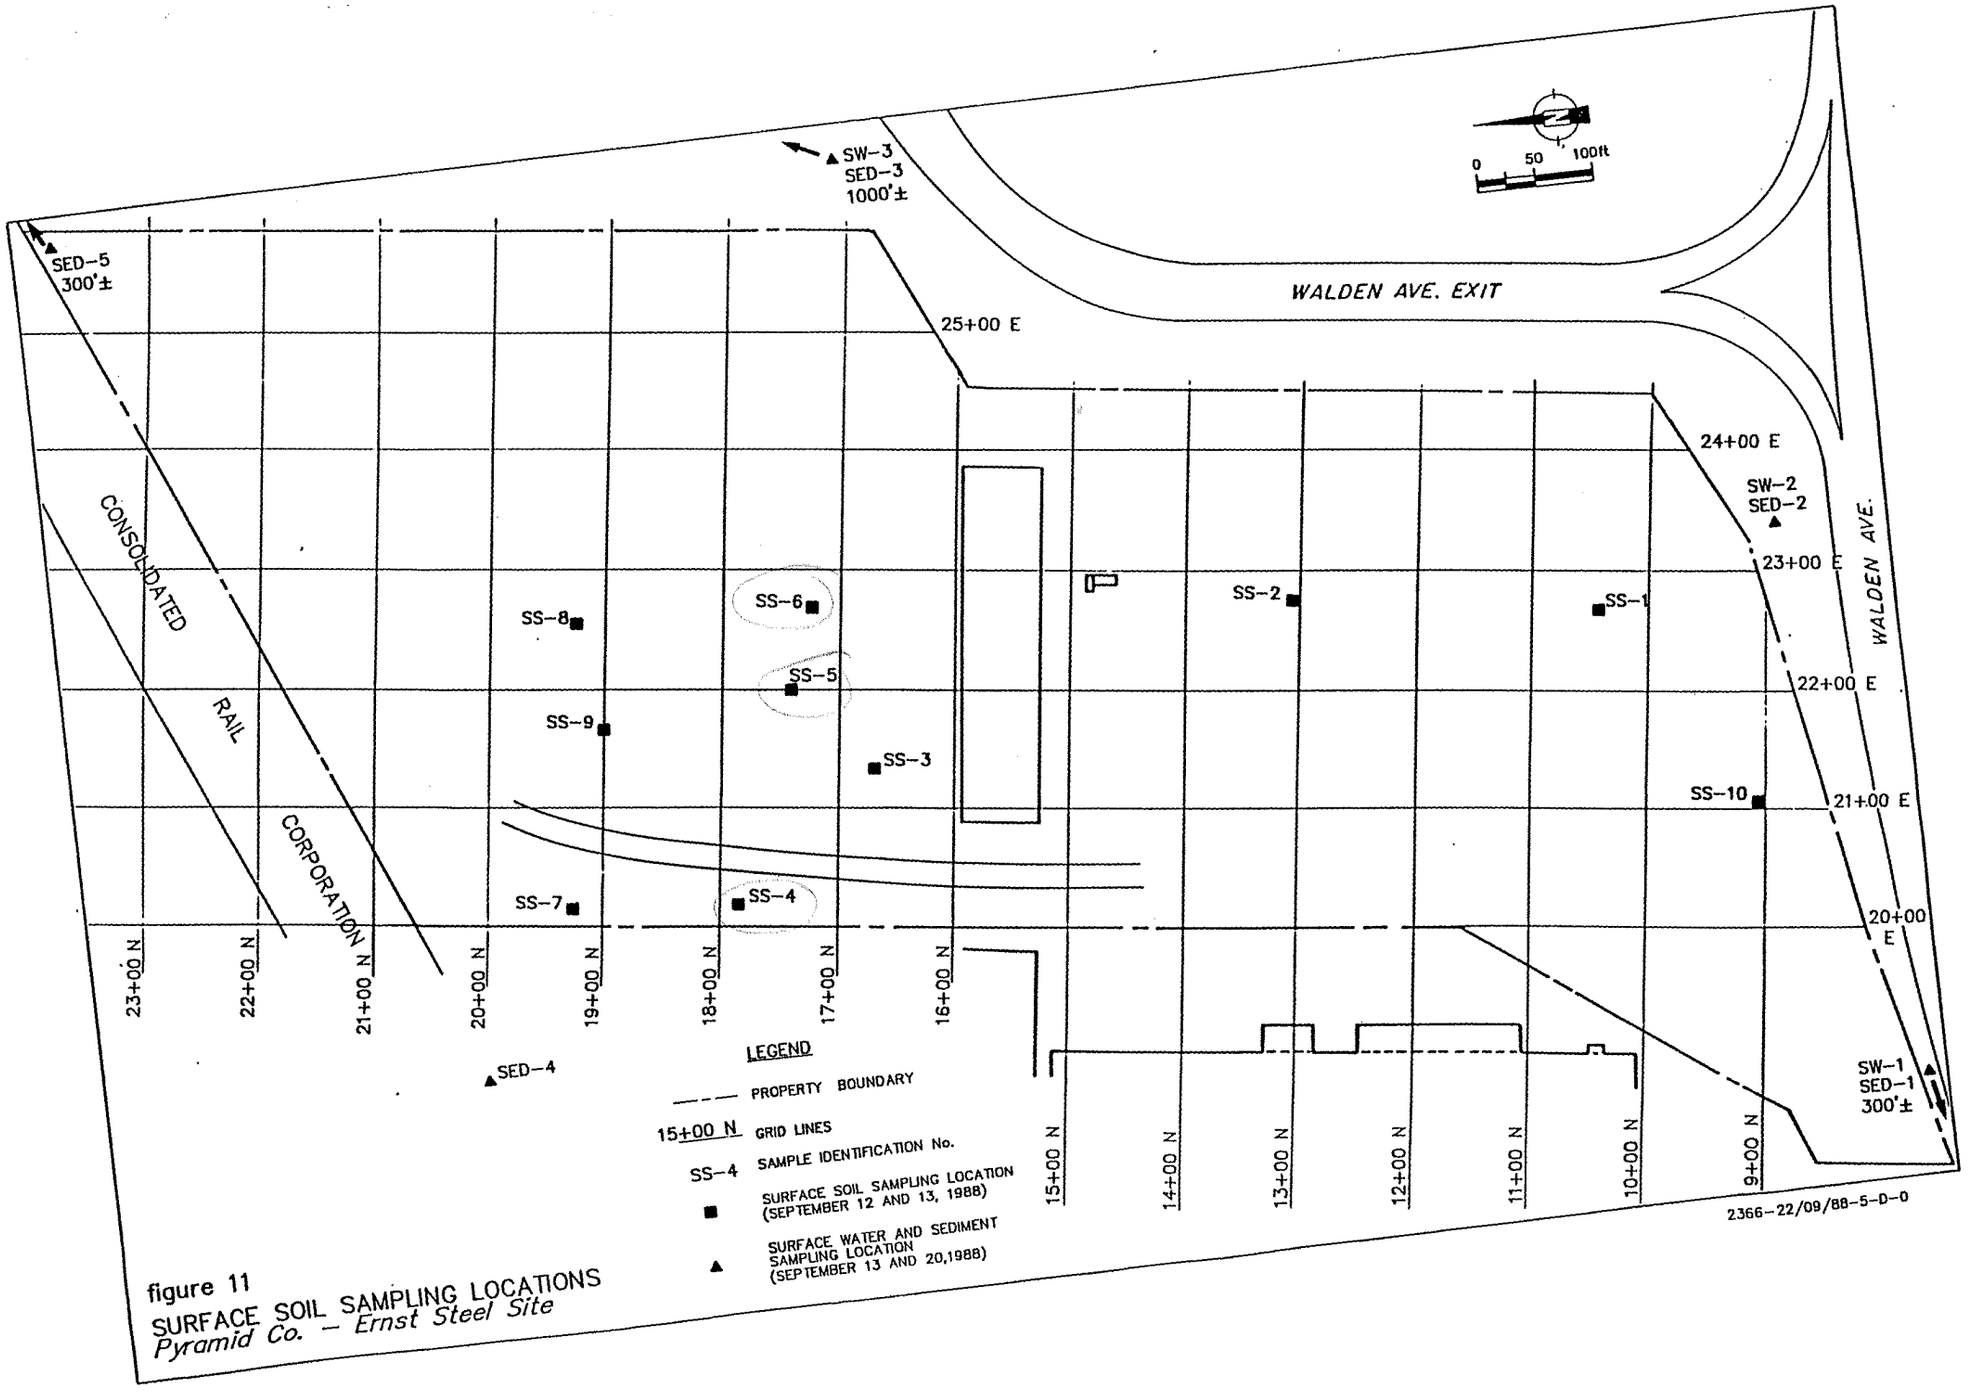
figure 11
SURFACE SOIL SAMPLING LOCATIONS
Pyramid Co. — Ernst Steel Site

Figure 11. These locations were selected in concurrence with the NYSDEC site representative. Each sample was collected from the upper one-foot of the fill material. This depth was suggested by the NYSDEC field representative as representative of the surface soil. Previous sampling activities have characterized the entire fill strata.

Surface water and sediment samples were collected from the ditches bordering the Site as specified in the Work Plan. The locations from which samples were collected are presented on Figure 11. The ditch along the

south side of the Site contained surface water at the southwest corner of the Site. A surface water sample and a sediment sample were collected at this location. It is noted that the surface water at this location appeared to flow to the west. The remainder of the south ditch was dry between the southwest corner and the surface drain at the southeast corner of the Site. Surface water flowing from the surface drain was sampled prior to the flow entering the ditch. A sediment sample was collected at this location. The flow then continued along the south ditch to the east and north until discharging into the Scajaquada Creek. Surface water and sediment samples were collected from the ditch prior to discharge into the Creek. The north ditch was dry. Consequently, no surface water samples could be collected in the north ditch, however sediment samples were collected at two locations (SED-4 and SED-5).

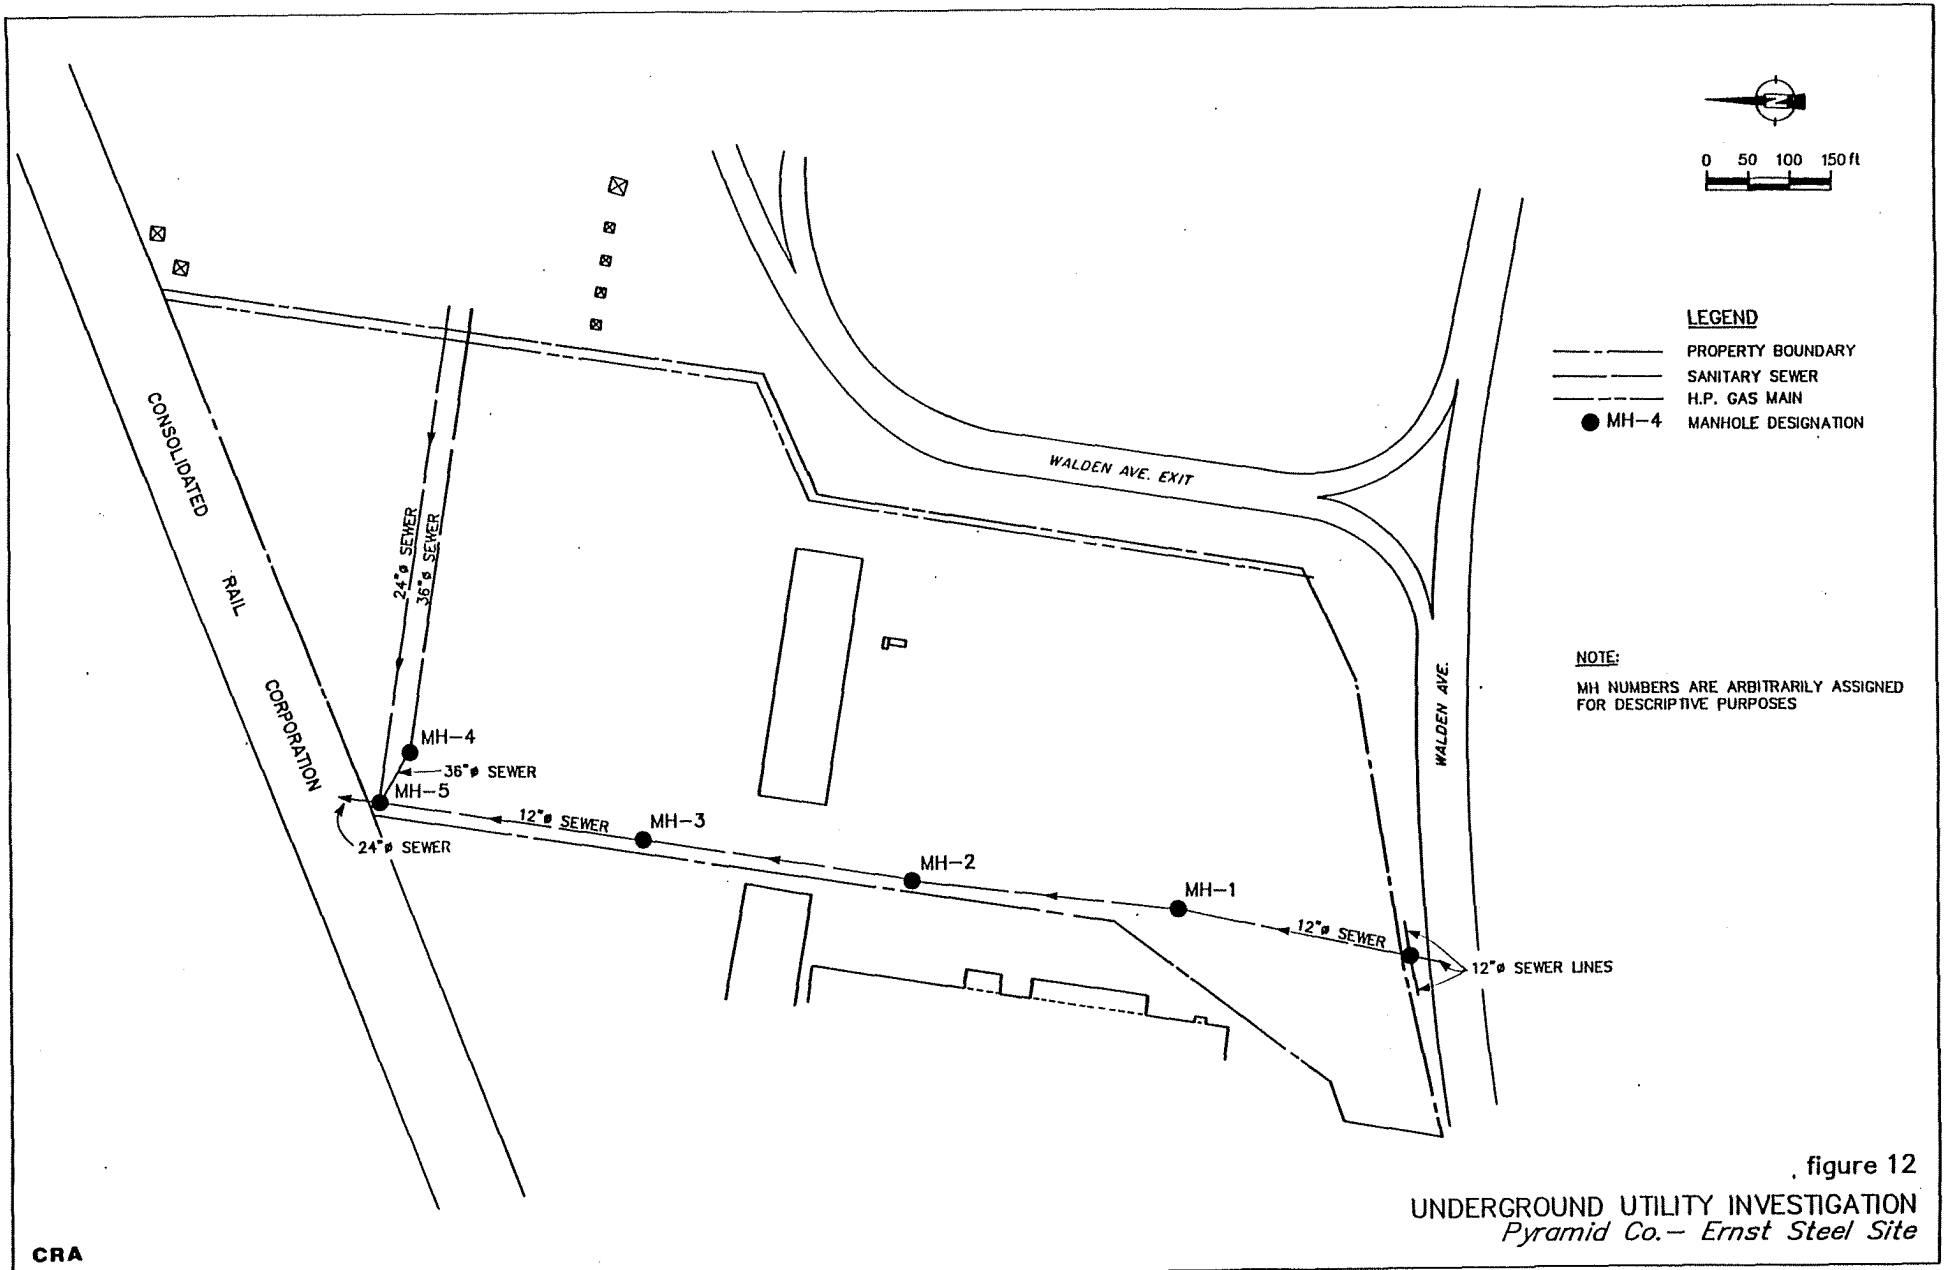
figure 12

A visual inspection of MH-1 and MH-3 identified a single flow stream to the north with no other apparent stubs. MH2 has a welded steel plate on top and therefore, could not be inspected. MH-4 has a stub heading east and a stub heading northwest (to MH-5). Although flow in the sanitary sewer system could be heard in the manhole, there was no detectable flow observed in this manhole. MH-5 has a stub entering from the south. This is the 12-inch diameter north-south line. Effluent from this line cascades to the bottom of MH-5. There is also a 36-inch diameter line

heading southeast (to MH-4), a 24-inch diameter line heading due east and a 24-inch diameter line heading nearly due north. Visual observation of flow conditions in MH-5 indicate that the direction of flow leaving MH-5 is through the 24-inch diameter line to the north. This line is the deepest service (lowest invert elevation) in the system.

The sanitary sewer has been observed to be quite deep. During visual inspection of MH-5 the invert of the north-south line was measured to be approximately 17 feet below the rim of the manhole. The bottom of MH-5 was measured to be approximately 23-feet below the rim.
