SITE INVESTIGATIONS AND REMEDIAL ACTION ALTERNATIVES LOVE CANAL

Task IV
South Storm and Sanitary Sewers

Division of Solid and Hazardous Waste
New York State Department
of Environmental Conservation
Albany, New York

August 1983

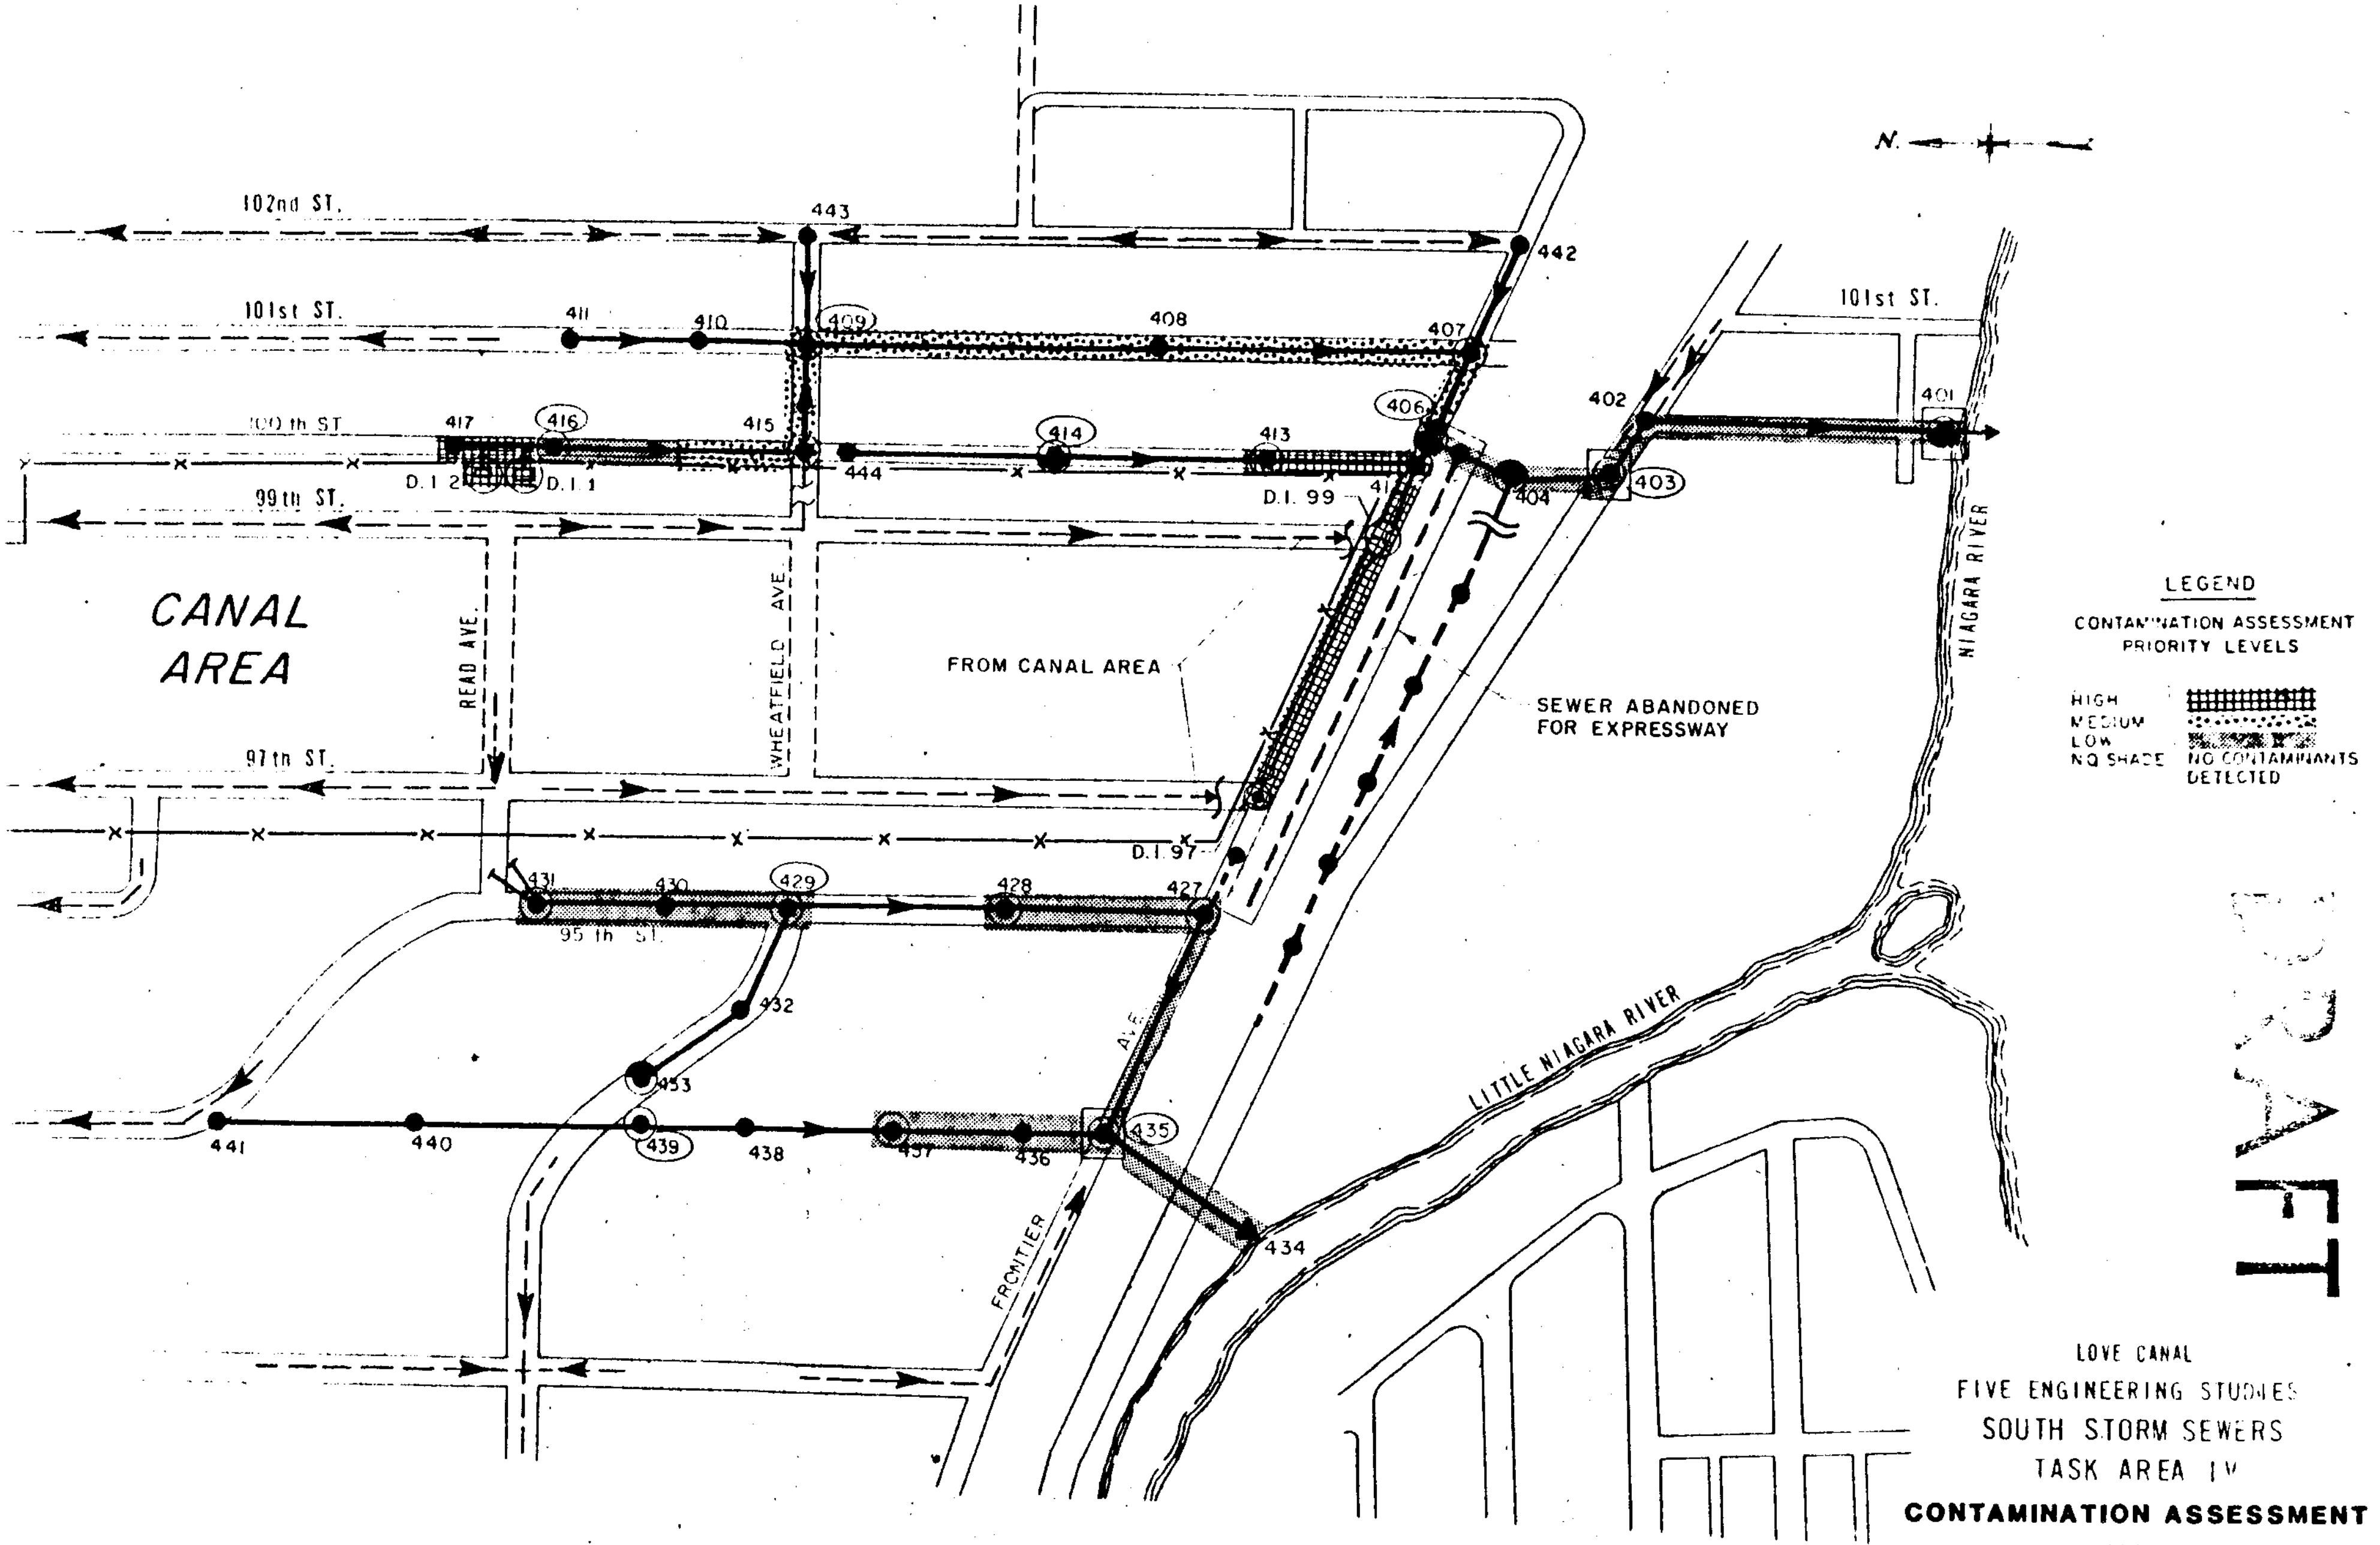
FIGURE 6-2

LOVE CANAL
FIVE ENGINEERING STUDIES
SOUTH STORM SEWERS
TASK AREA IV
CONTAMINATION ASSESSMENT MAP

Thirteen storm sewer sampling locations in Task Area IV exhibited varying degrees of contamination. Most of the contamination was found in the sediment samples; however, two liquid samples with Love Canal-related contamination were found.

The storm sewer samples which exhibited low contamination assessment priority levels were found at MH Nos. 403, 404, 416, 435, 427, and 431. The low level contamination consisted primarily of heavy metals and phthalates. In MH 431, trace quantities of phenanthrene, anthracene, and fluoranthene were found. These organics are derivatives of hydrocarbons which could have come from any number of sources. No specific Love Canal area-related contamination was found in storm sewers designated as having low contamination assessment priority levels.

Seven (five sediment, two liquid) stormwater sampling points were found to contain Love Canal-related contaminants at medium or high levels. The five sediment sample locations are all on primary migration pathways from the canal area. Love Canal-related contaminants found in each of these manholes are listed below:

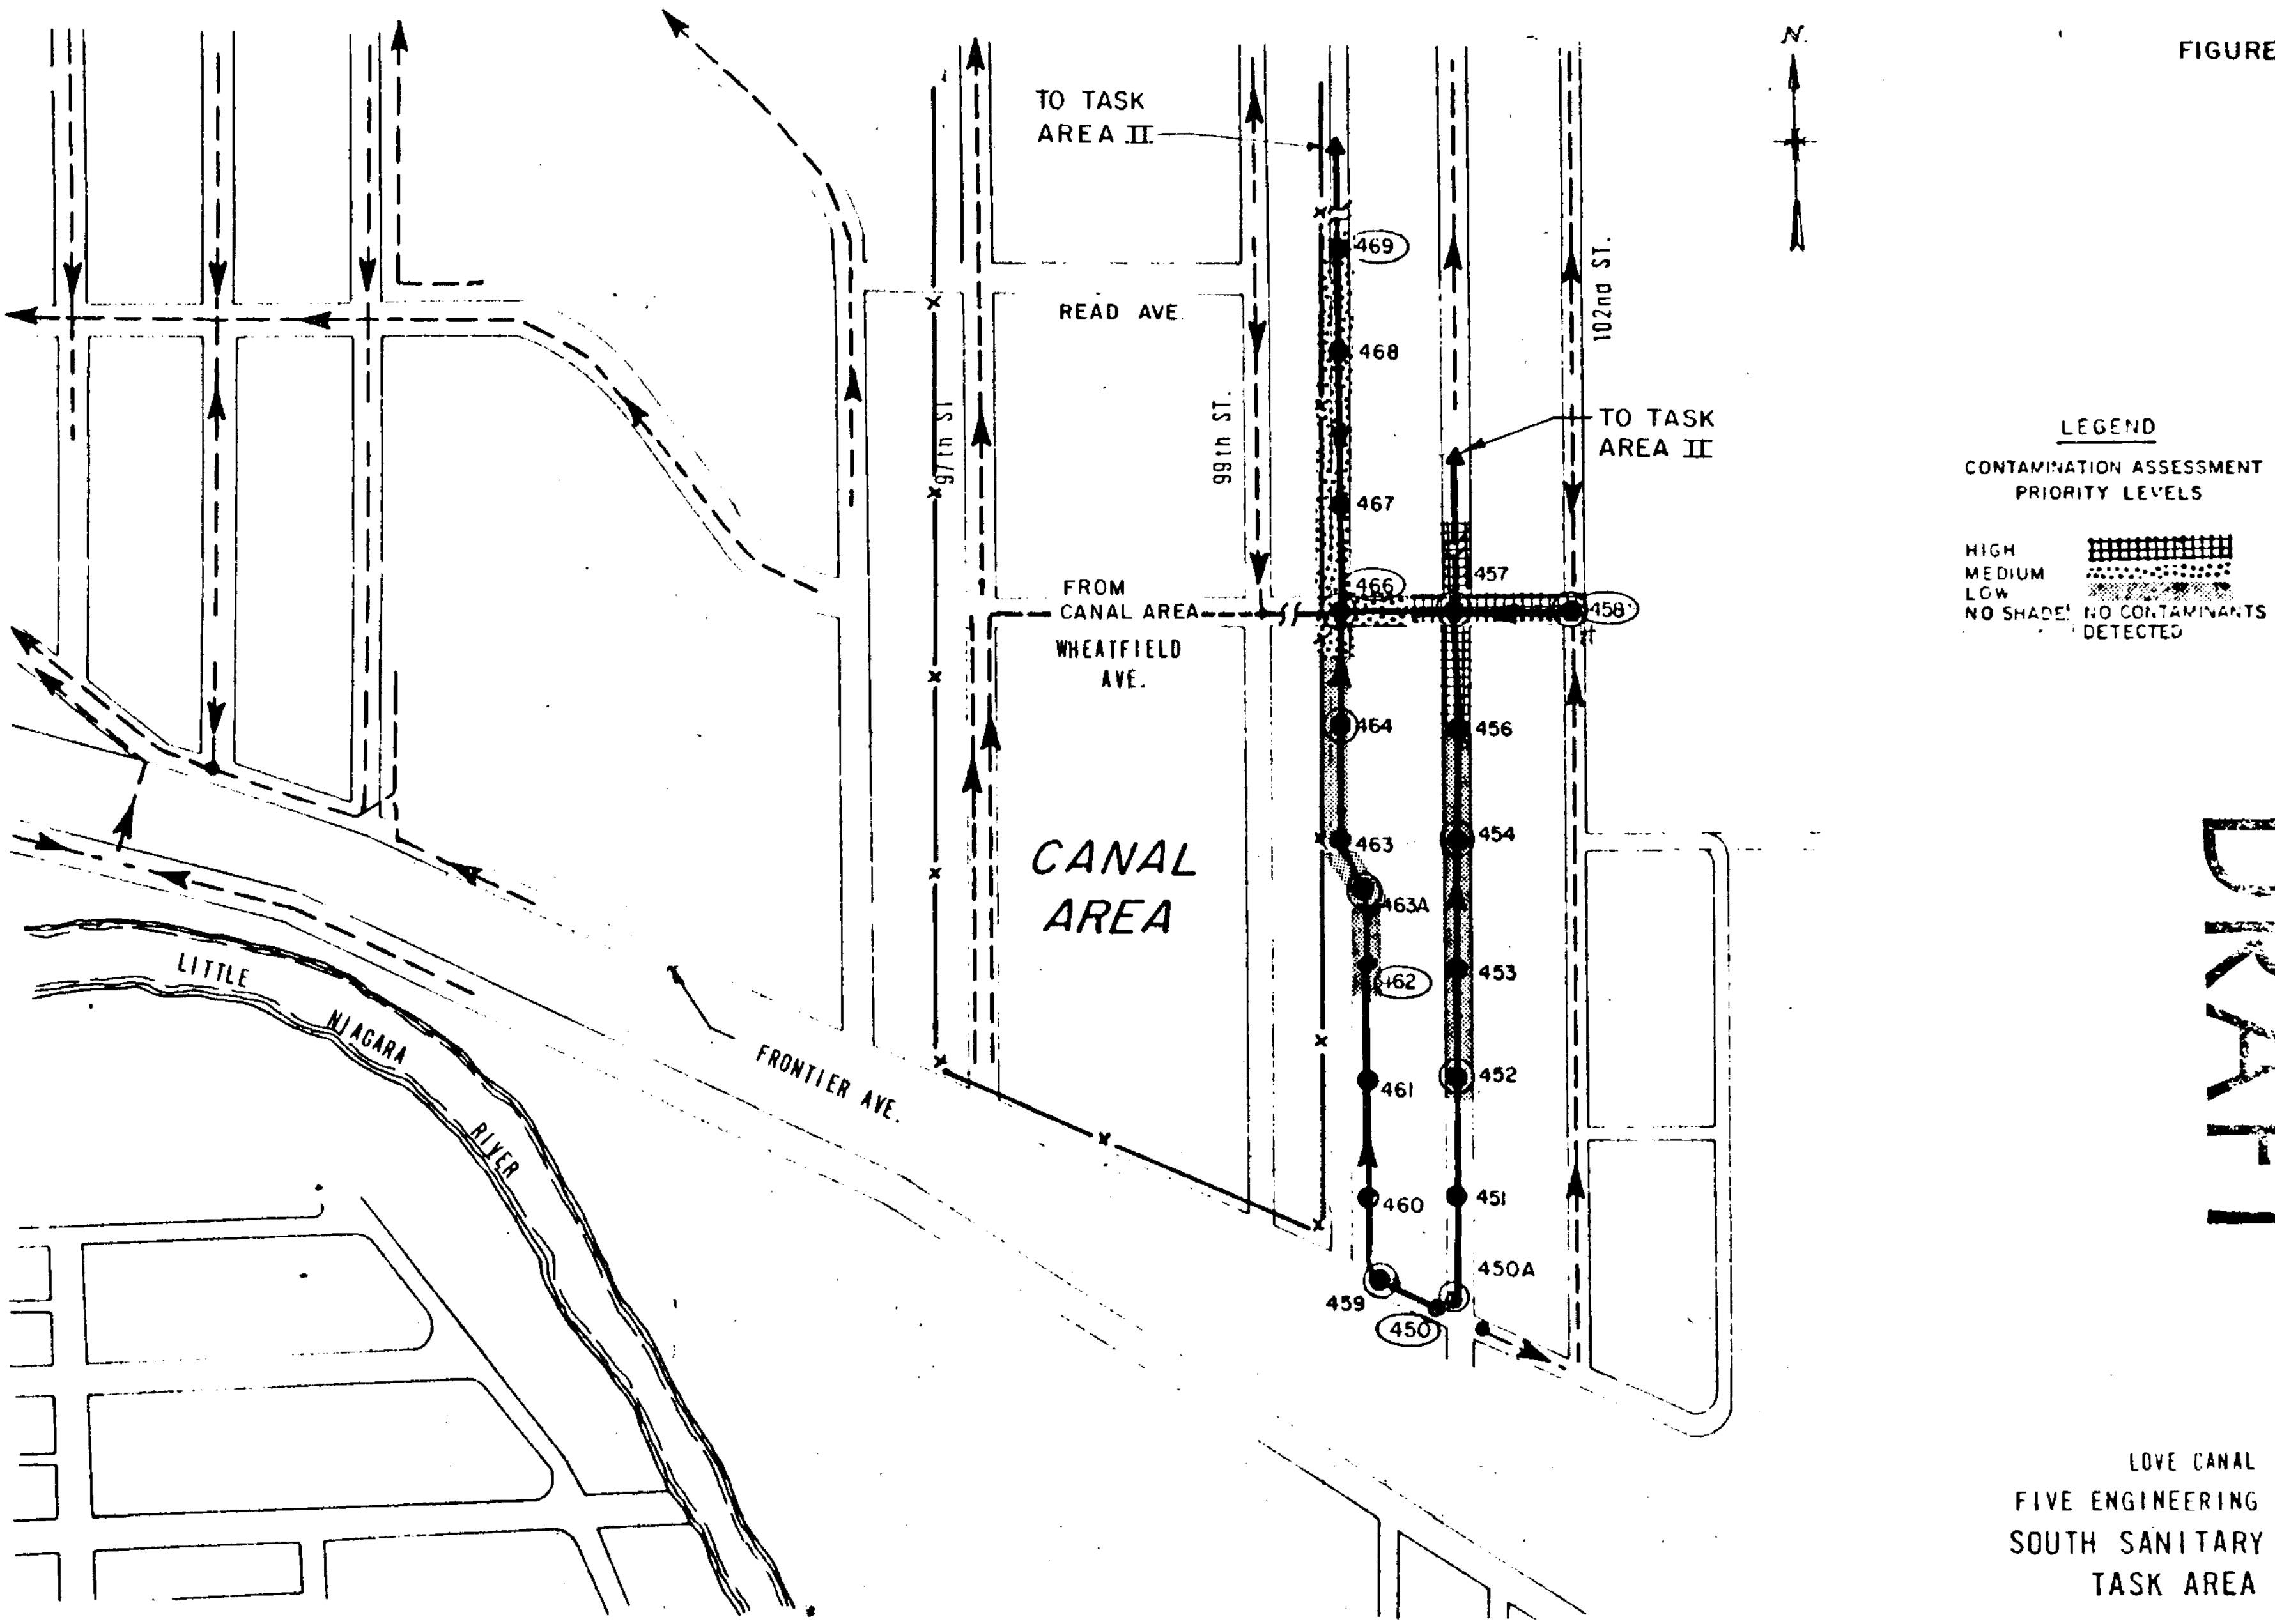
FIGURE 6-3

LOVE CANAL
FIVE ENGINEERING STUDIES
SOUTH SANITARY SEWERS
TASK AREA IV

The sanitary sewer sediment samples which exhibited low contamination assessment priority levels were found at MH 464 and MH 454. The contamination consisted primarily of heavy metals and phthalates. At MH 463A, heavy metals and phthalates were found in the liquid sample. Because no Love Canal-related contaminants were found, this manhole has been assigned a low contamination assessment priority level.

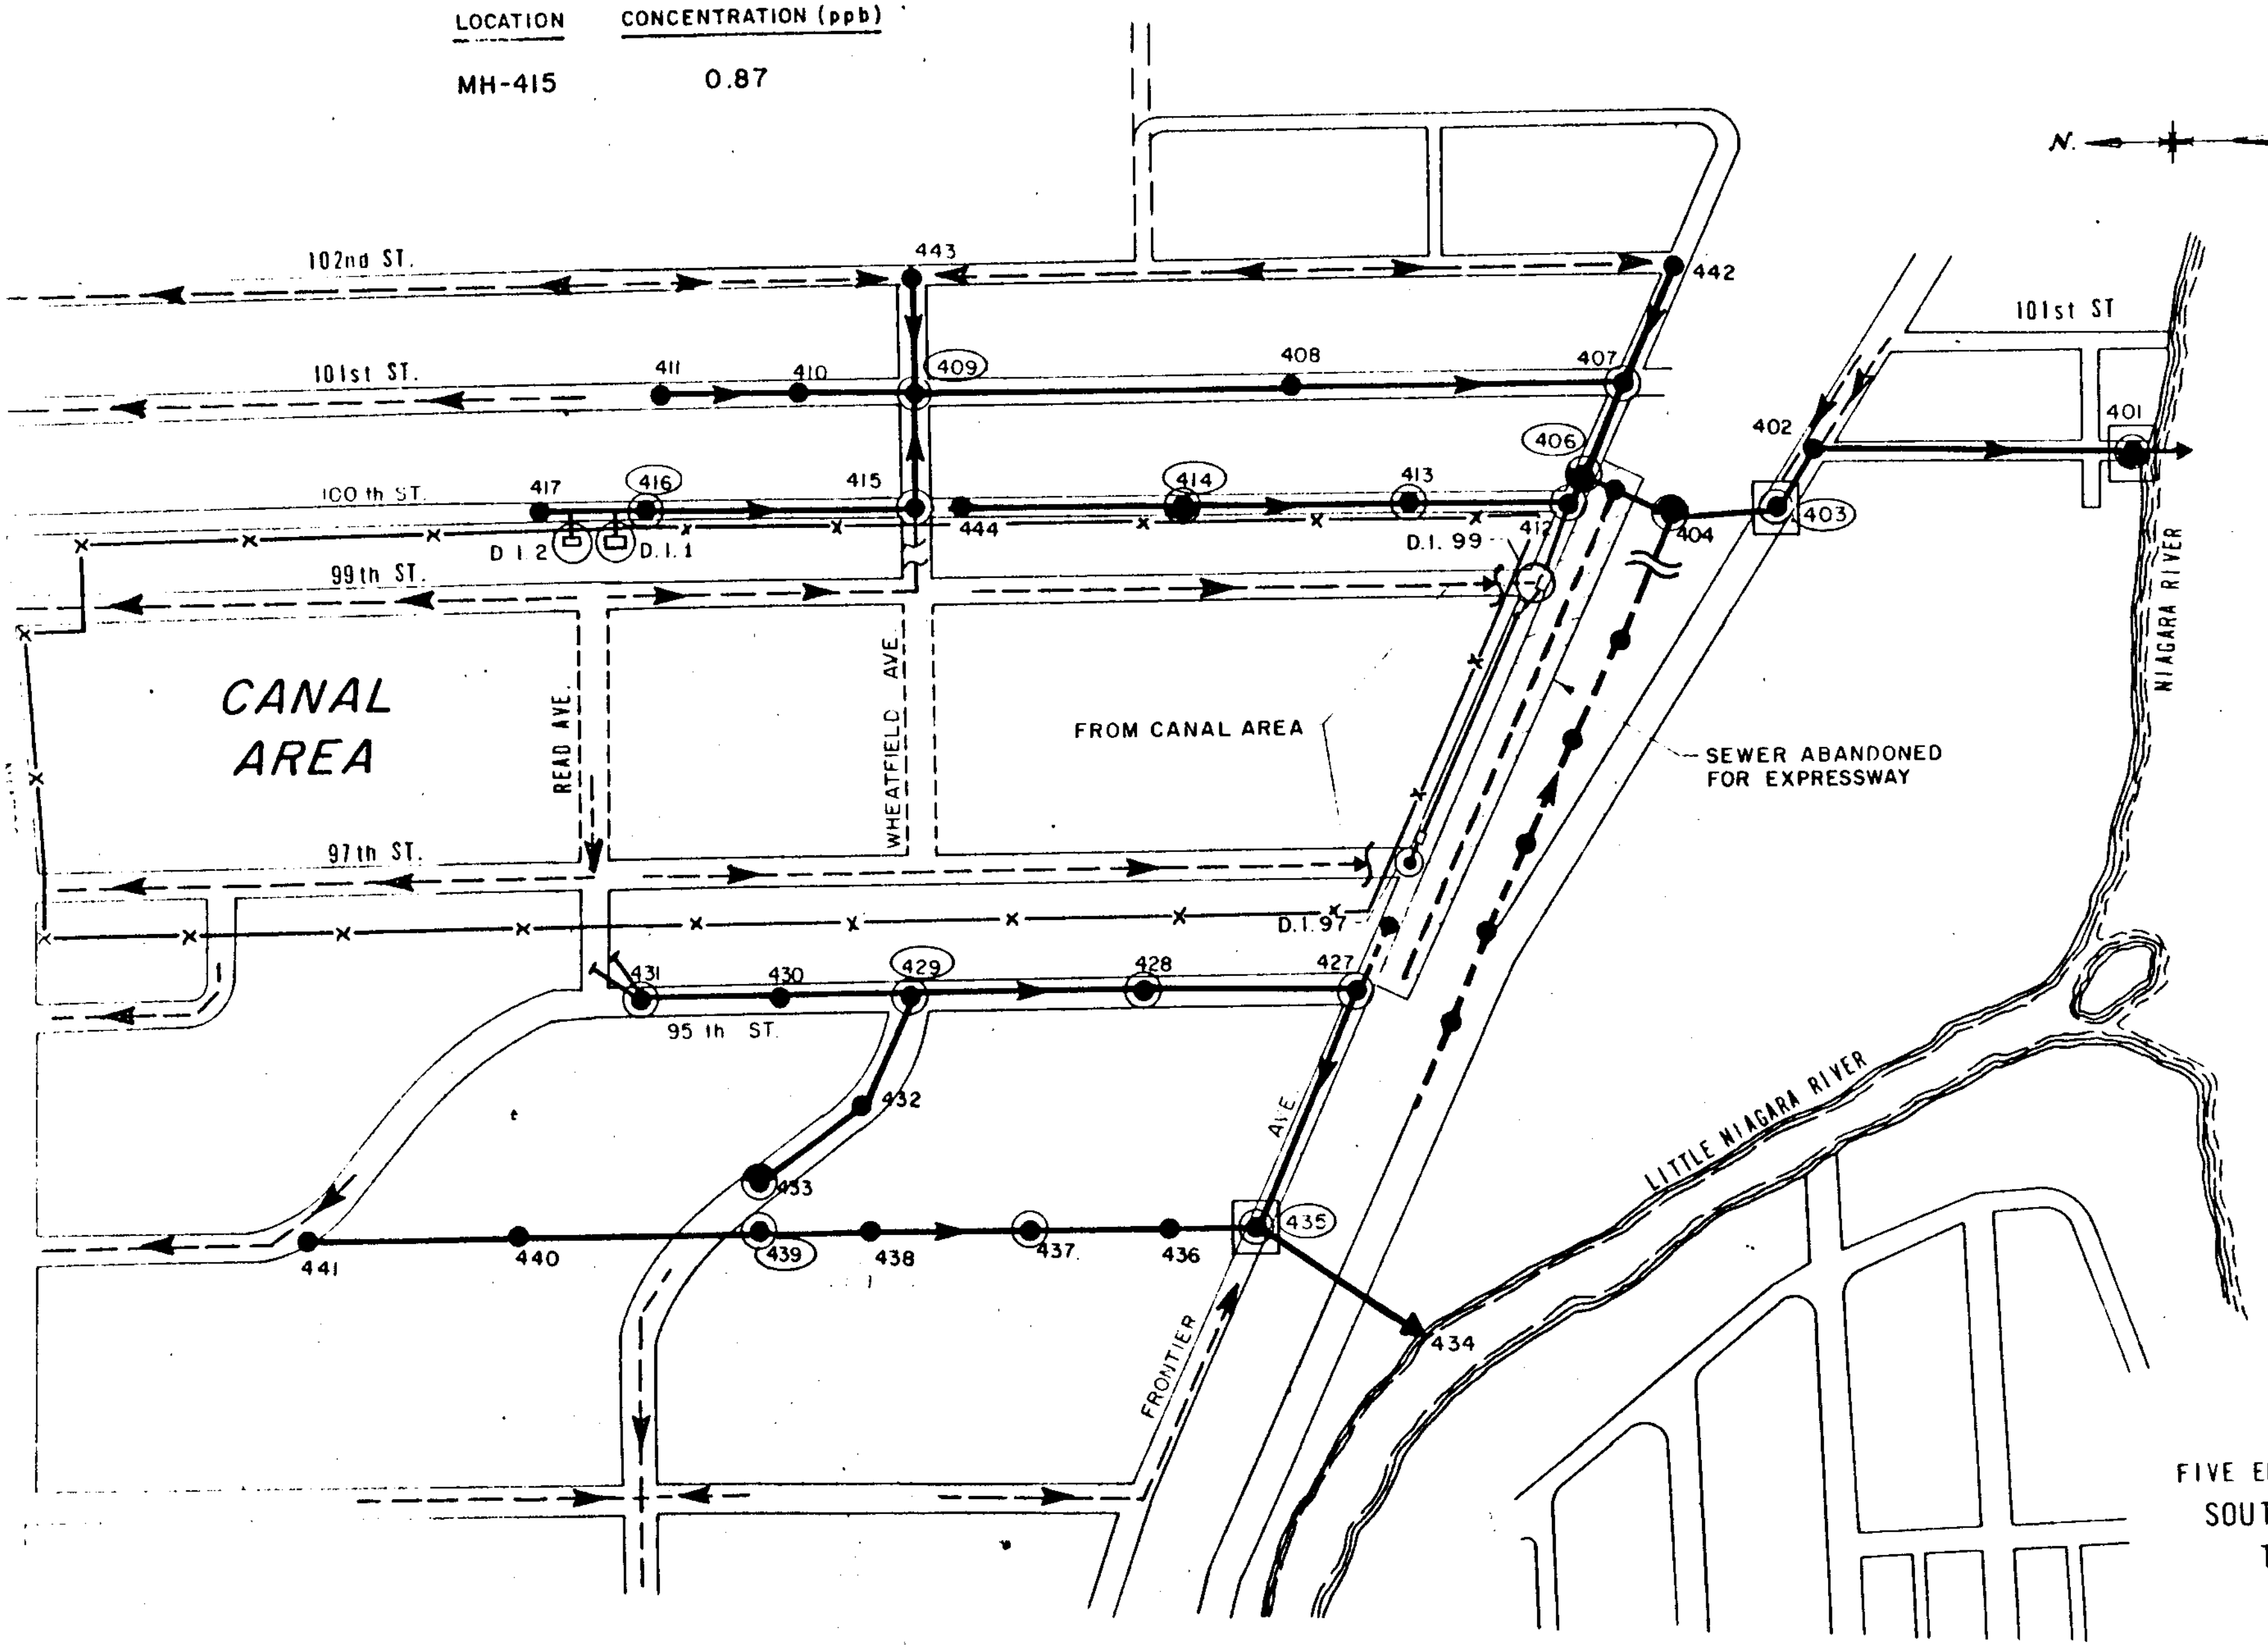
DIOXIN HOT SPOTS

LOCATION	CONCENTRATION (ppb)
MH-415	0.87

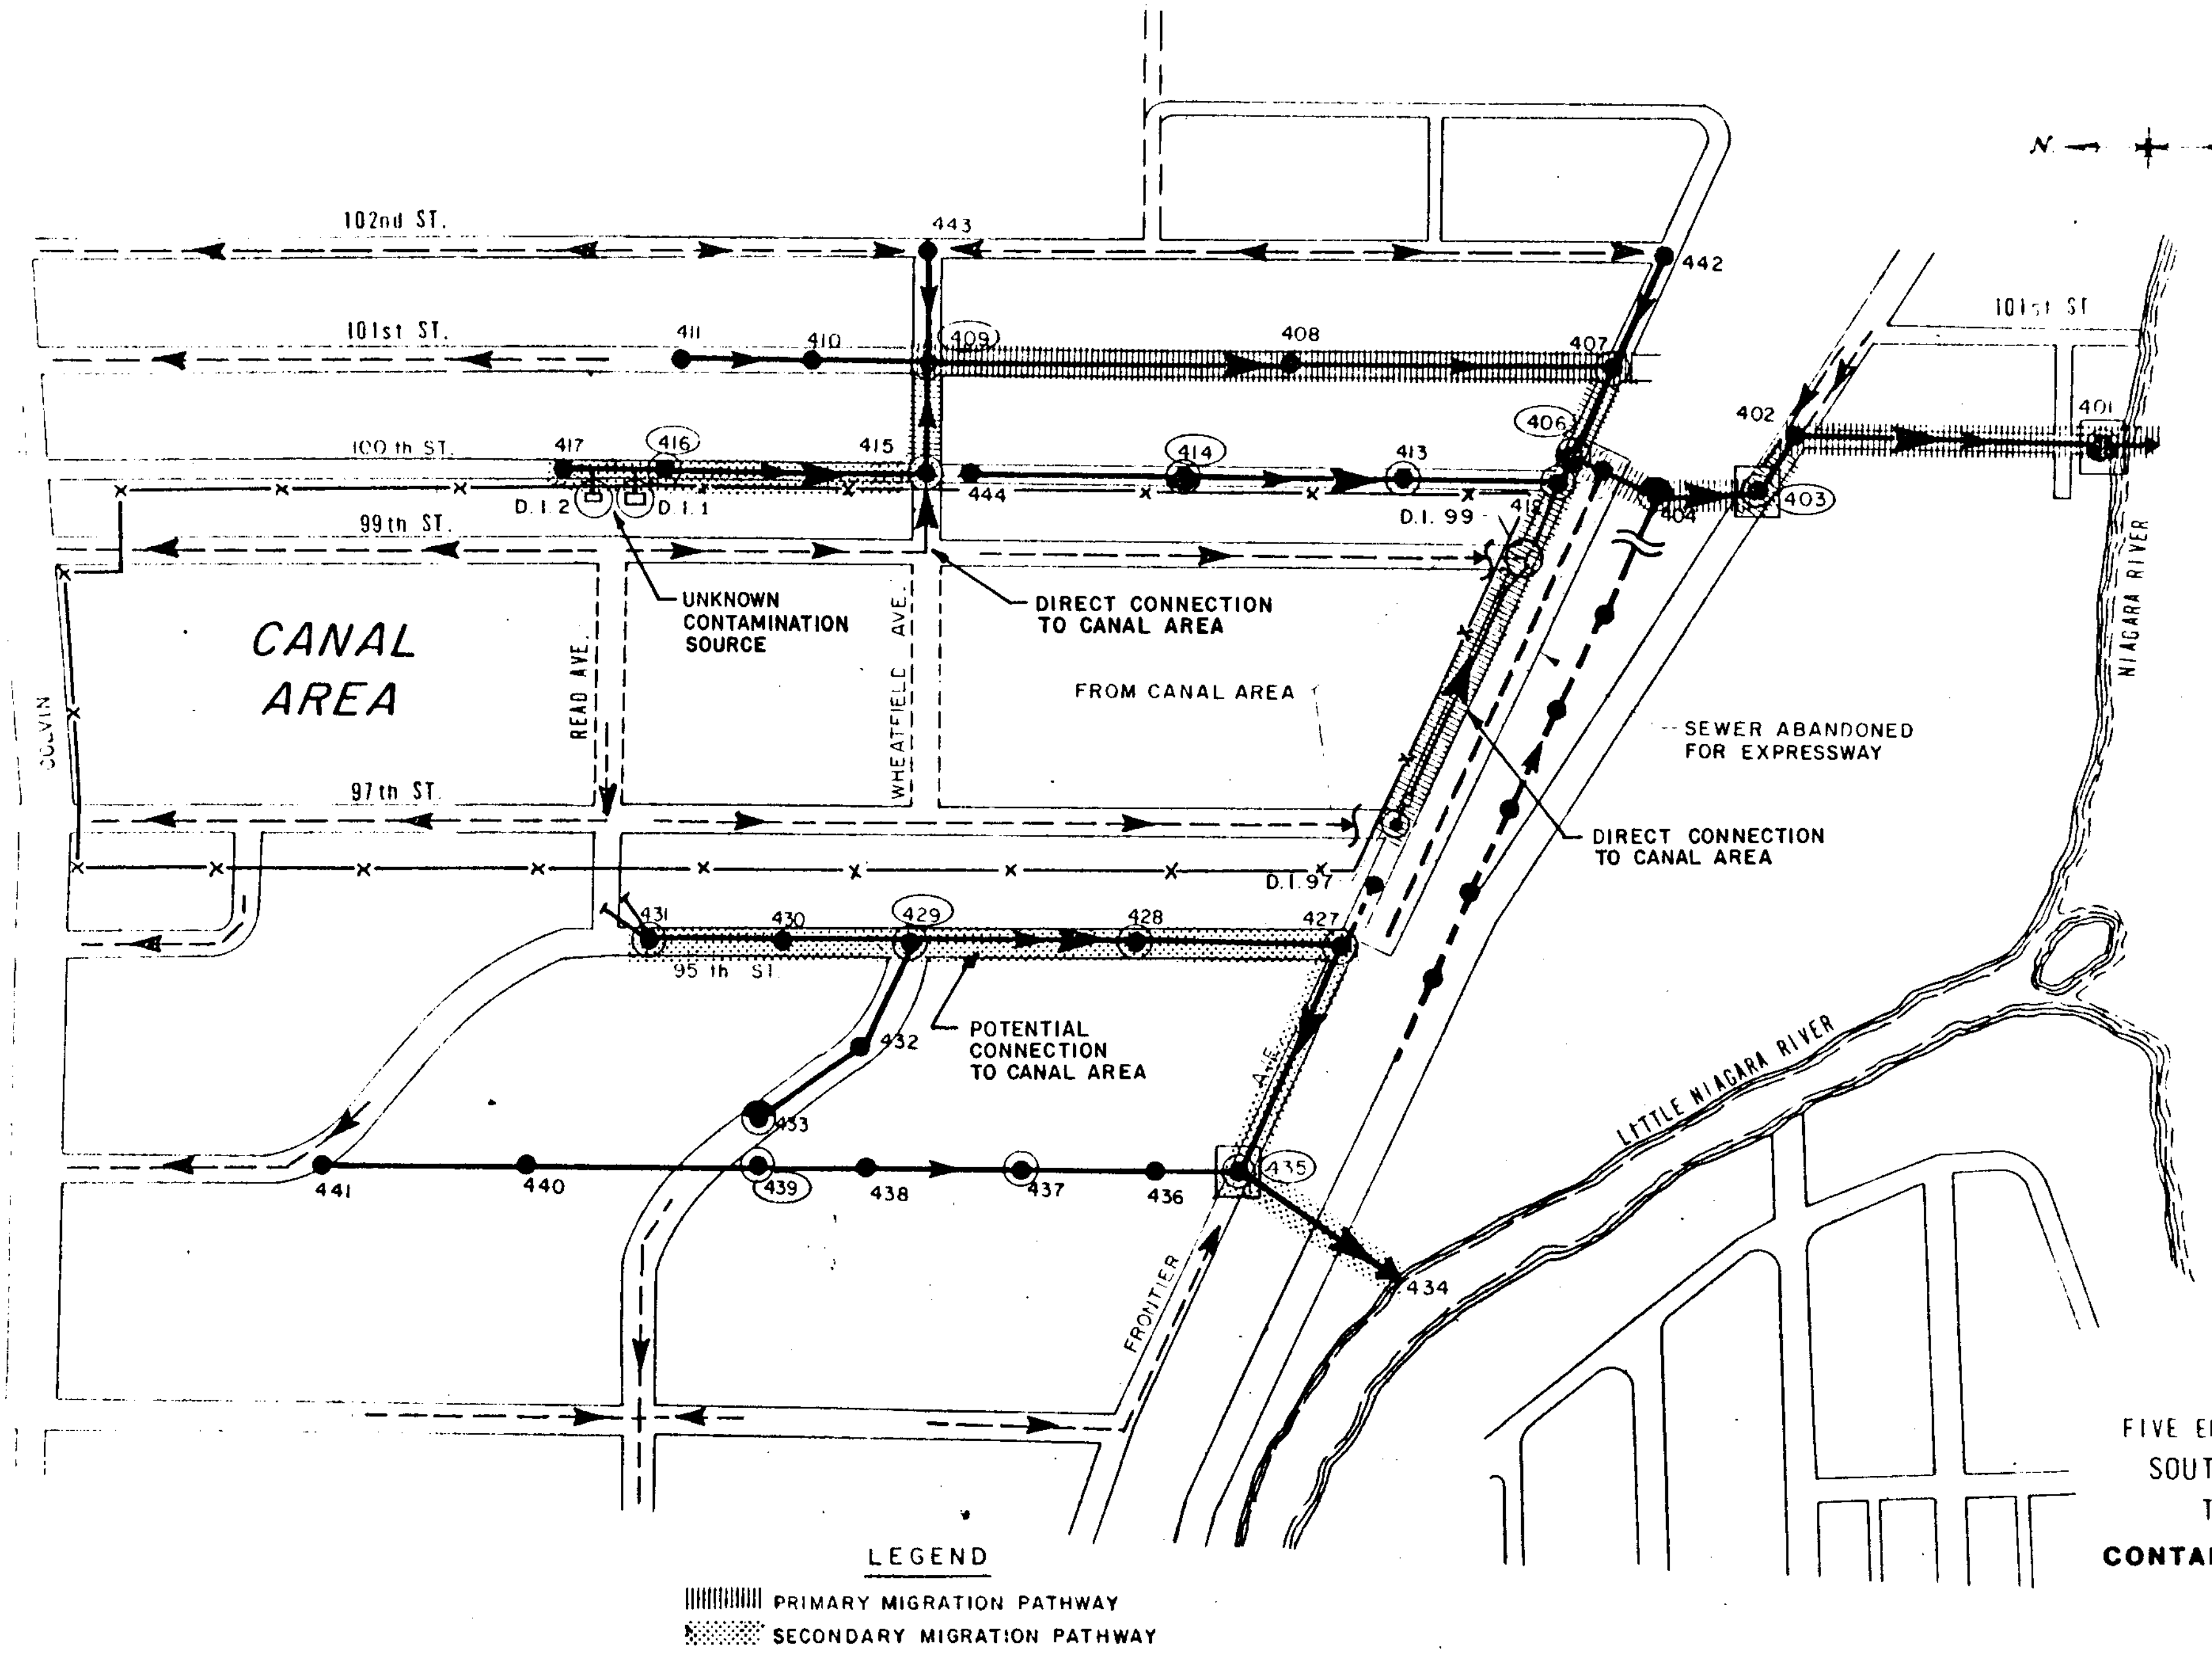
FIGURE 6-5

LOVE CANAL
FIVE ENGINEERING STUDIES
SOUTH STORM SEWERS
TASK AREA IV

CONTAMINANT MIGRATION PATHWAYS

A secondary pathway has been identified which is a possible cause for the contaminated segment of the storm sewer system on 95th Street which borders the western edge of the canal area. This sewer reach may have been contaminated via migration of contaminants through fissures in the clay soil between 97th Street and the canal or indirectly by over and runoff. During the excavation of the tile drain system in the southern section of the canal area, a geologic sand lense was discovered four feet below the surface apparently intersecting the canal from east to west. This sand lense could possibly extend to 95th Street causing the contamination in the 95th Street sewers. Tile field systems on 95th Street homes facing west may also have contributed to contamination if any of these tile fields were connected to the storm sewers on 95th Street.
