INSTALLATION RESTORATION PROGRAM

PHASE I - RECORD SEARCH

NIAGARA FALLS AIR FORCE RESERVE FACILITY, NEW YORK

DECEMBER 1983

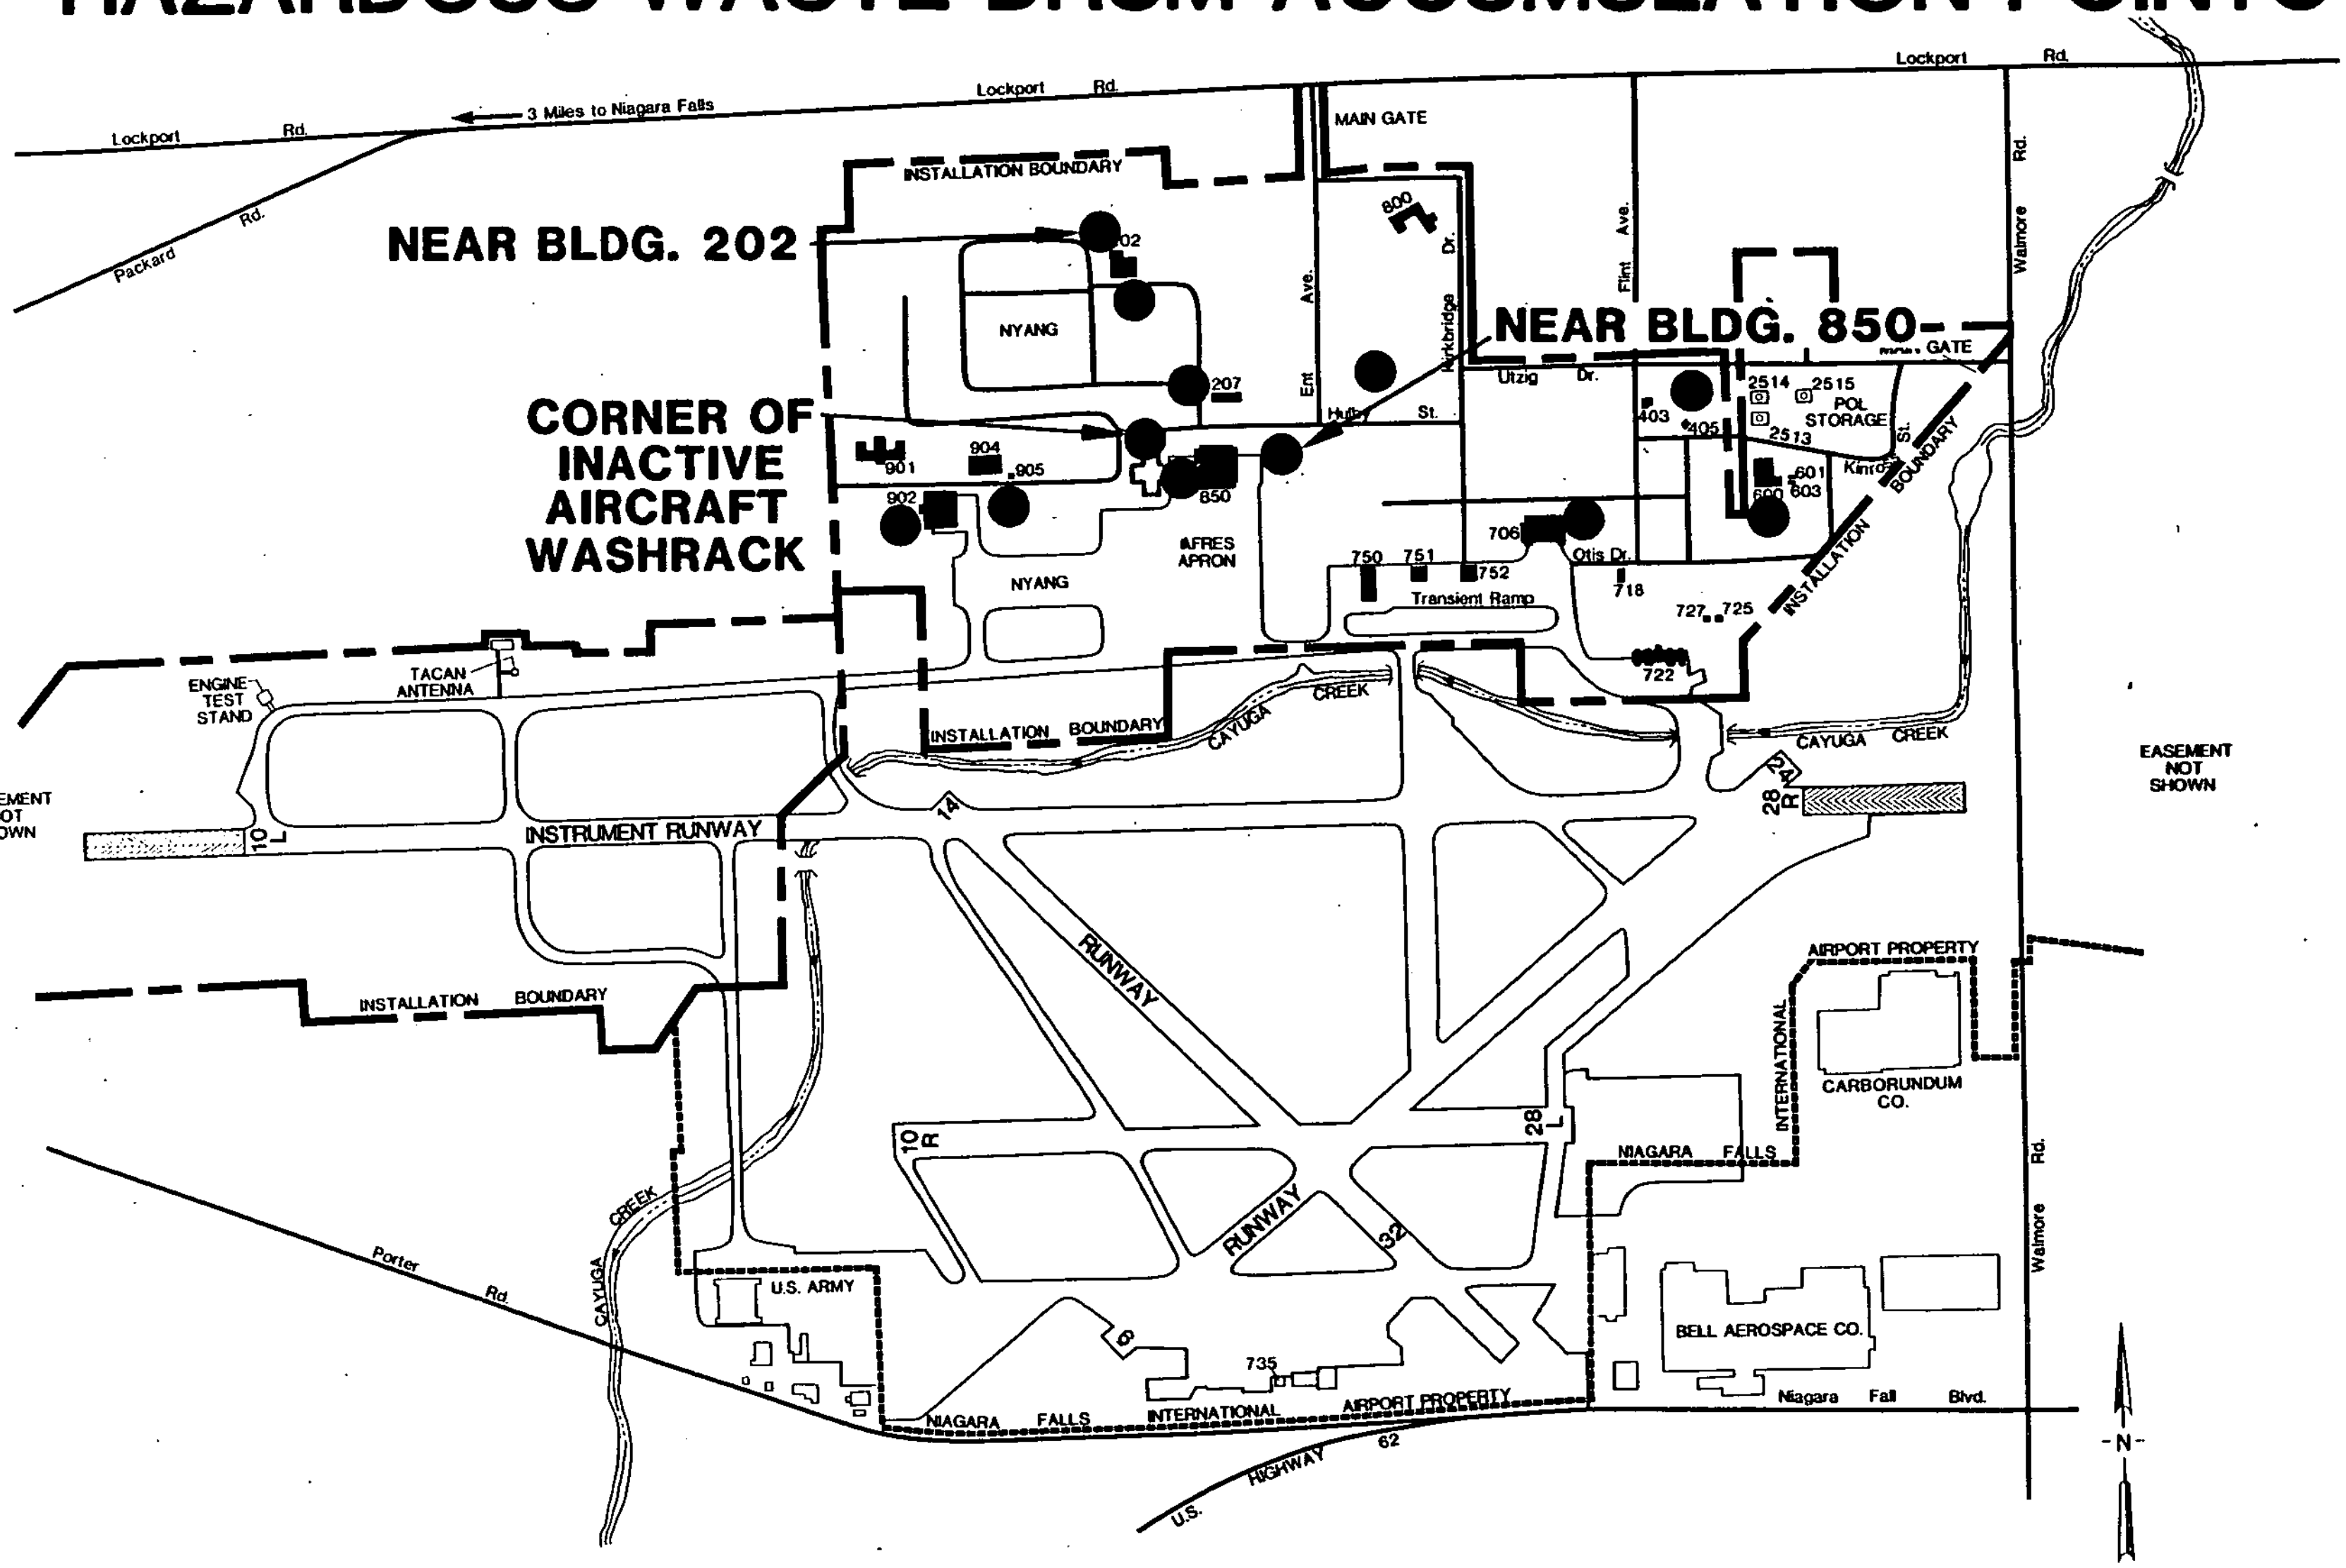
FIGURE 4.2

In 1978 the use of these waste storage tanks was discontinued in favor of segregated drumming of wastes. There have been at least four sites dedicated to drum accumulation and storage on installation since that time. Behind Bldg. 202, NYANG accumulated a number of drums for an undetermined period of time (see Figure 4.2). The drums have recently been removed, but stains on the gravel indicated previous spillage in the area. NYANG also stores its waste drums on a concrete pad in an area formerly used as a BOMARC missile site (see Figure 4.4). The pad is not diked and there was visual evidence of minor spills during the site visit including evidence of a spill migrating to surface drainage. Other waste accumulation areas are indicated in Figure 4.2.

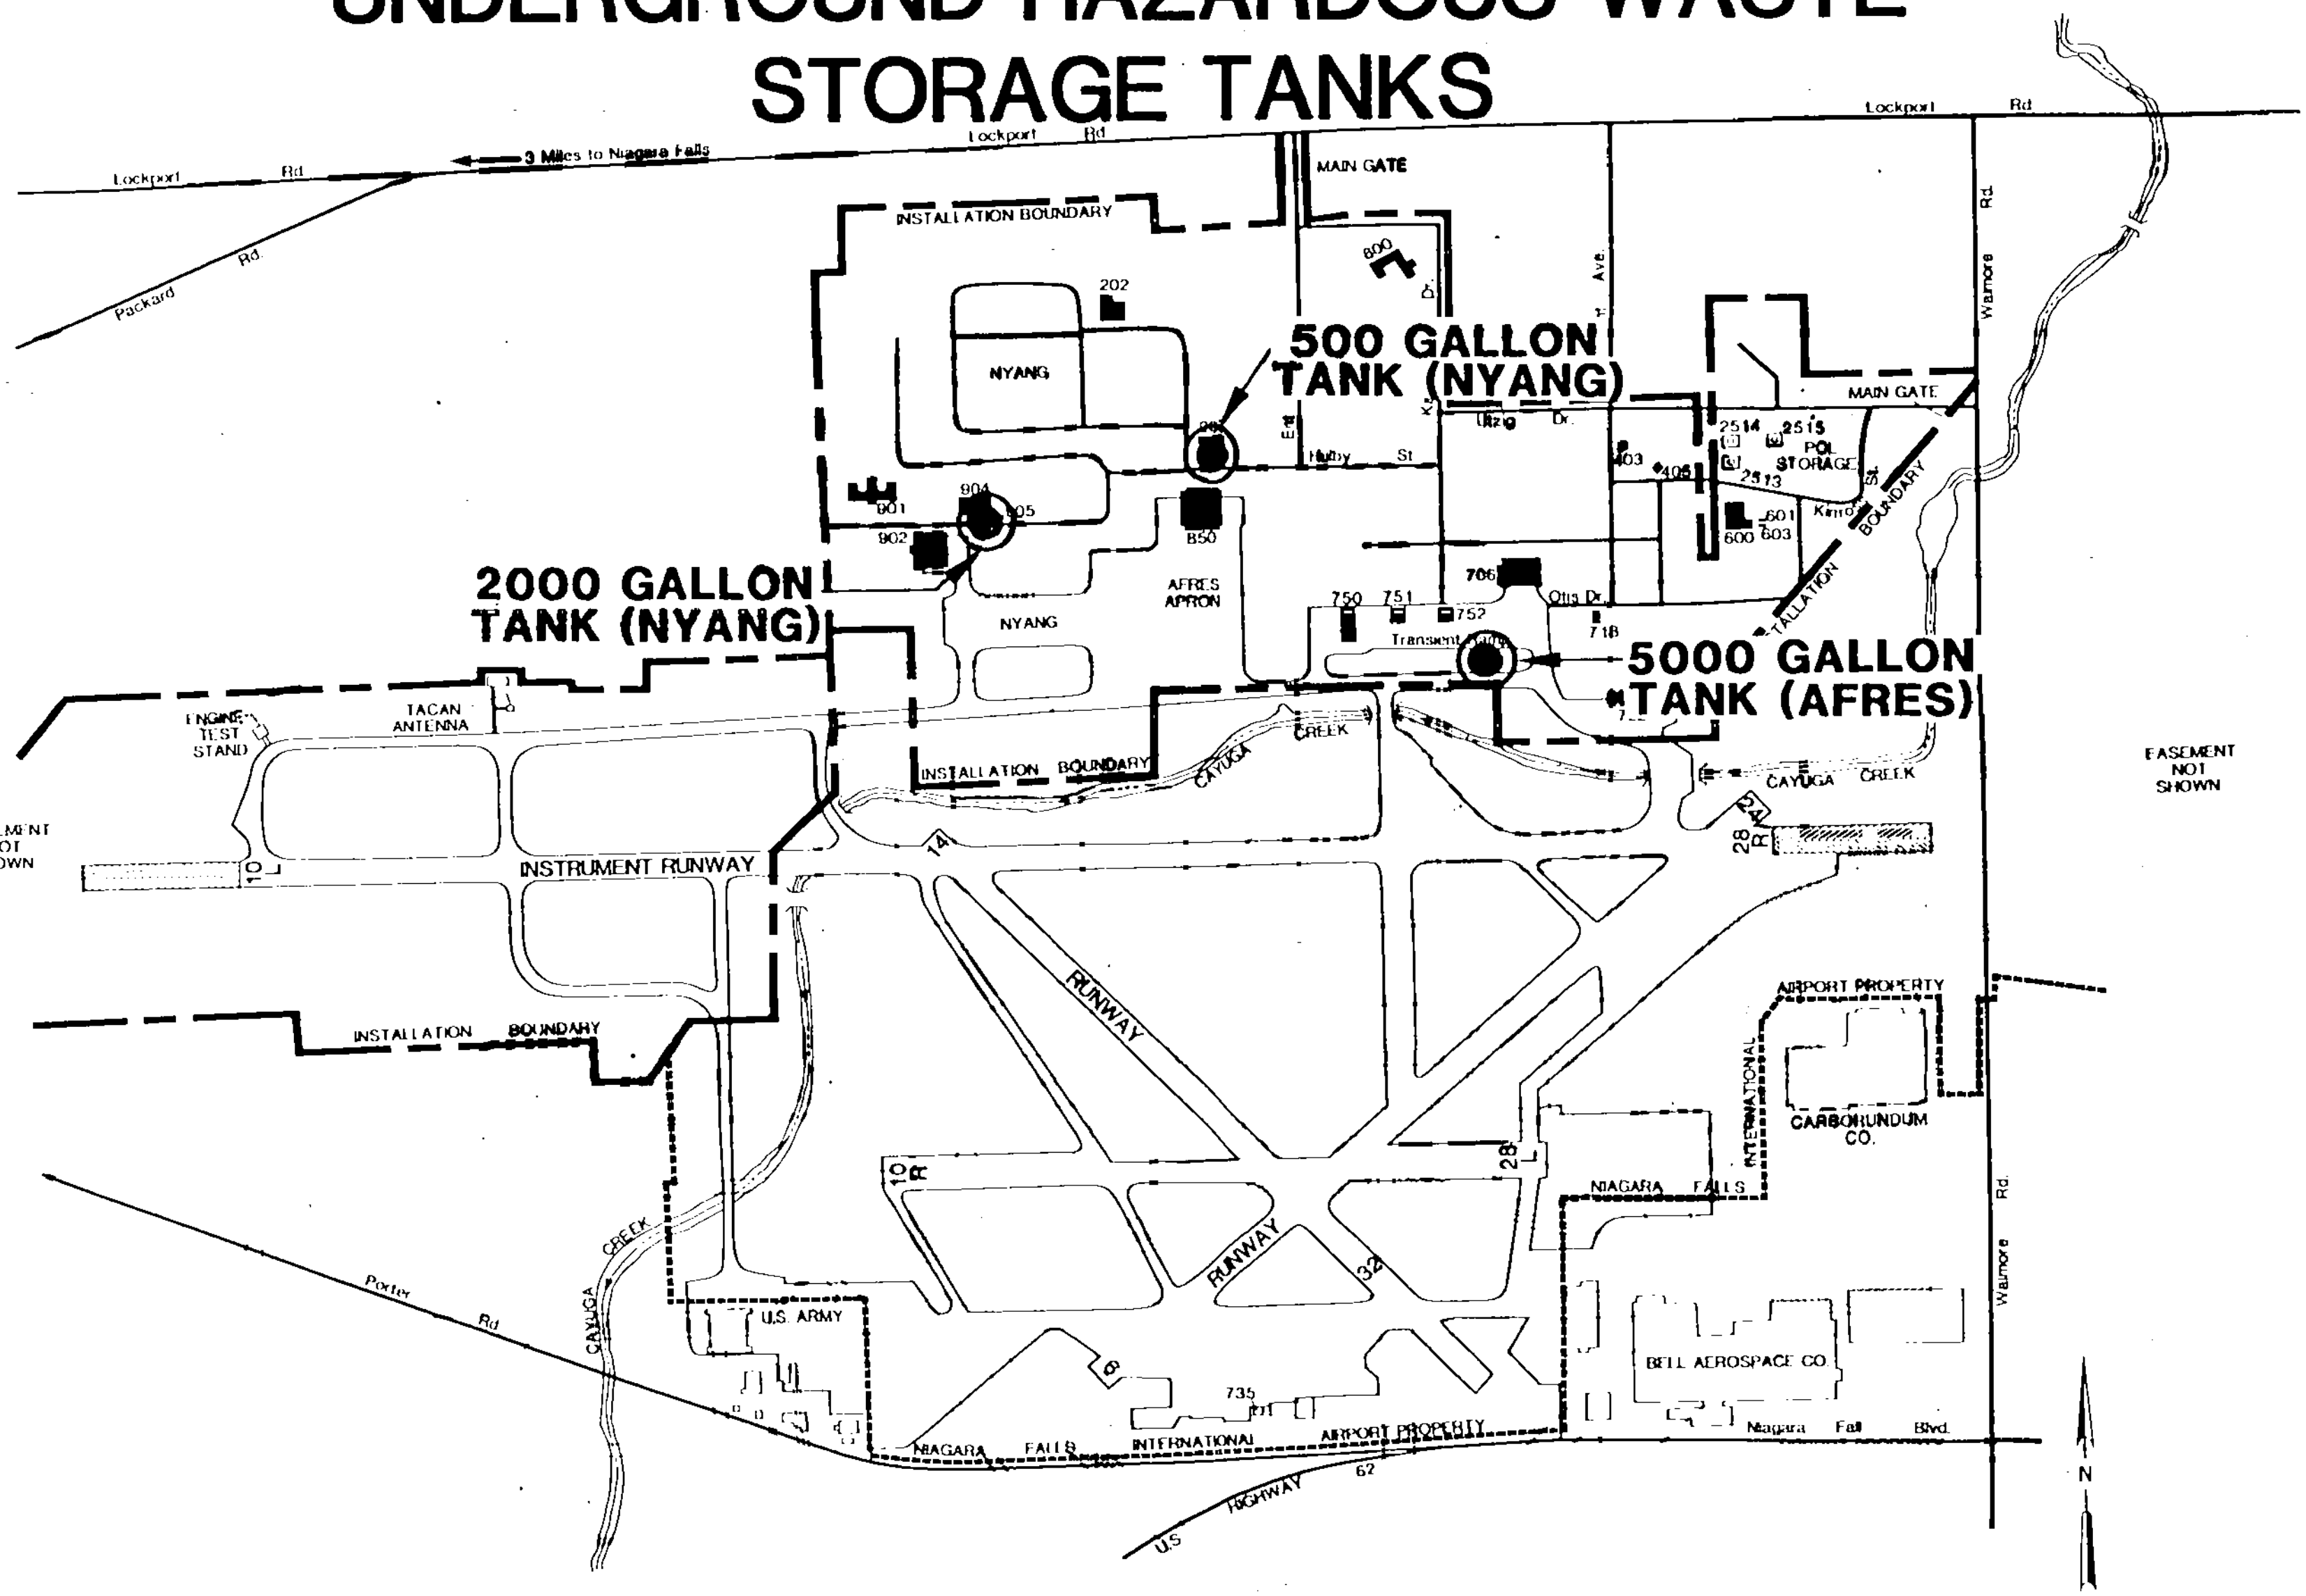
FIGURE 4.3

UNDERGROUND HAZARDOUS WASTE STORAGE TANKS

The 2000 gallon underground tank located near Bldg.'s 905 & 902 was used for MOGAS storage until the early 1970's when it became a "slop" tank for liquid hazardous waste from the NYANG hangar (see Figure 4.3).

There are three underground waste storage tanks located at Niagara Falls AFRF (refer to Figure 4.3). It is recommended that the Installation Environmental Program empty these tanks and pressure-test them for leaks. If leaks are detected, then a ground-water monitoring progam should be established around the relevant tanks.

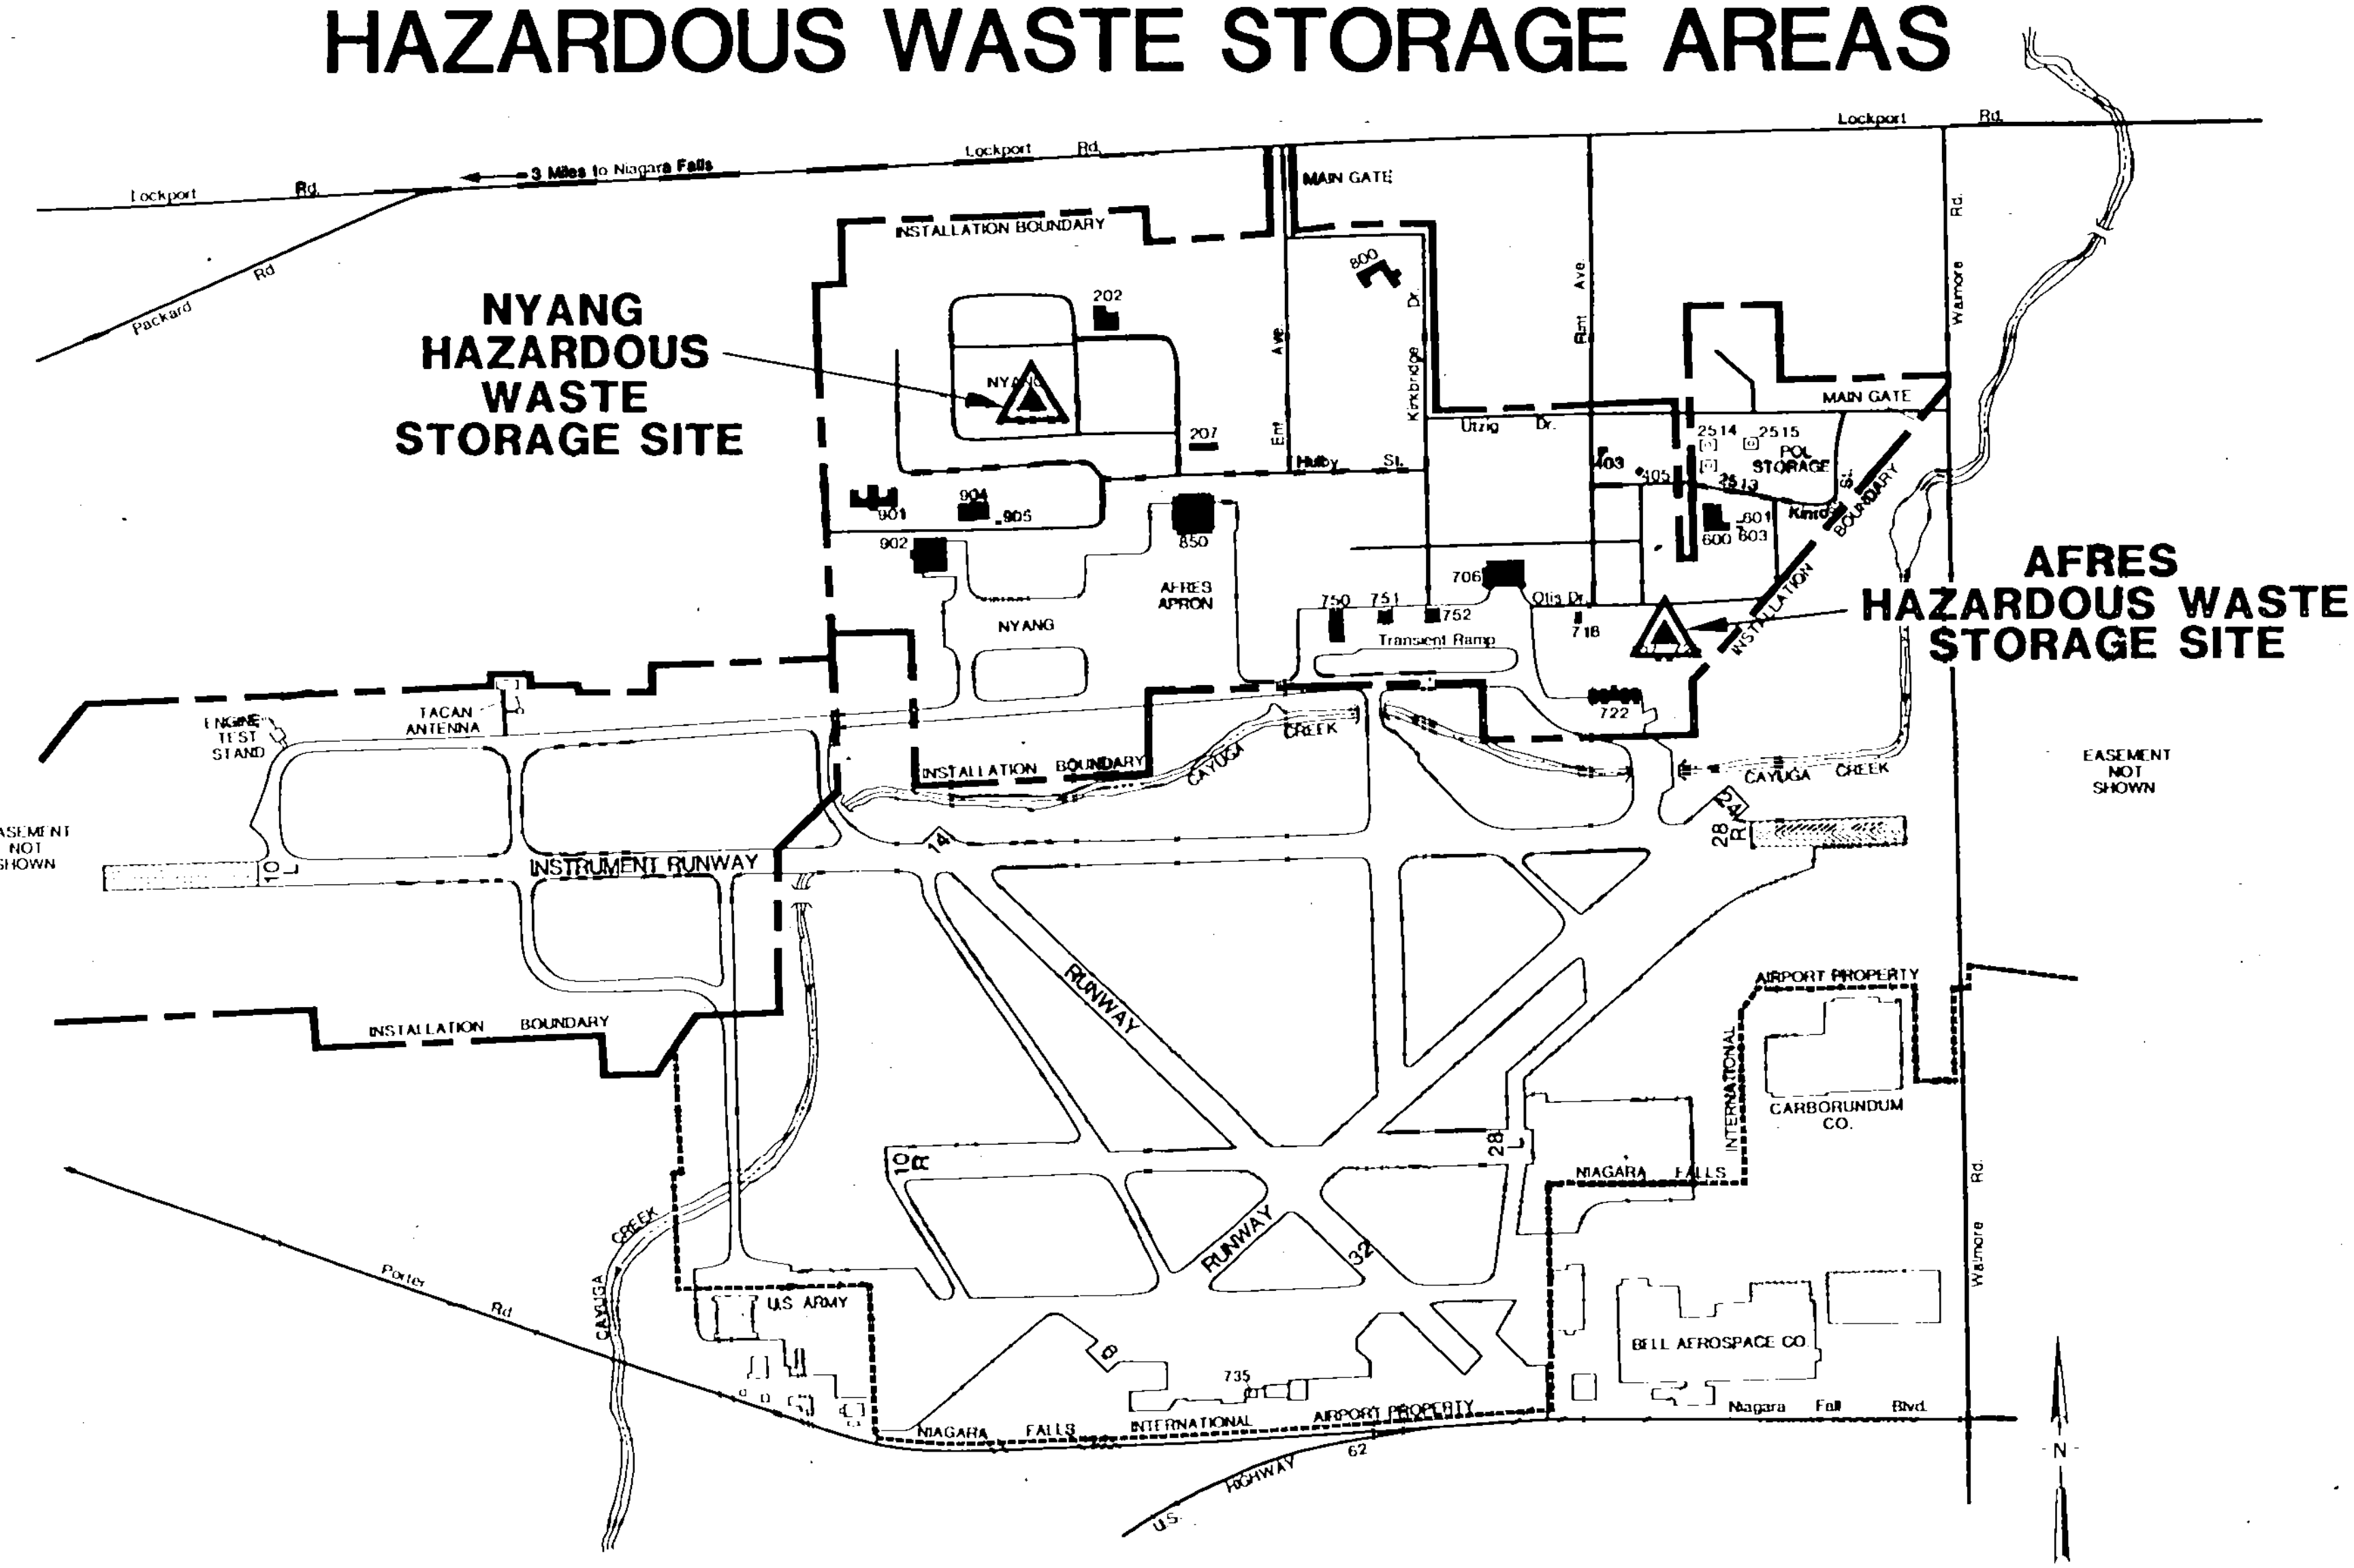
FIGURE 4.4

The AFRES Hazardous Waste Drum Storage Area has a fence and an asphalt floor. It is unbermed and uncovered area (see Figure 4.4). Approximately 200 drums were in storage at the time of the site visit, most of them off the ground on pallets, or on other drums. There was no visual evidence of spills from this site, but one interviewee reported seeing damaged barrels after winter snow plowing operations in the area. AFRES also accumulates drums from its hangar on a corner of an old aircraft washrack by Bldg. 850 (see Figure 4.2). There was no visual evidence of spills at this site. Other waste accumulation points are indicated in Figure 4.2.

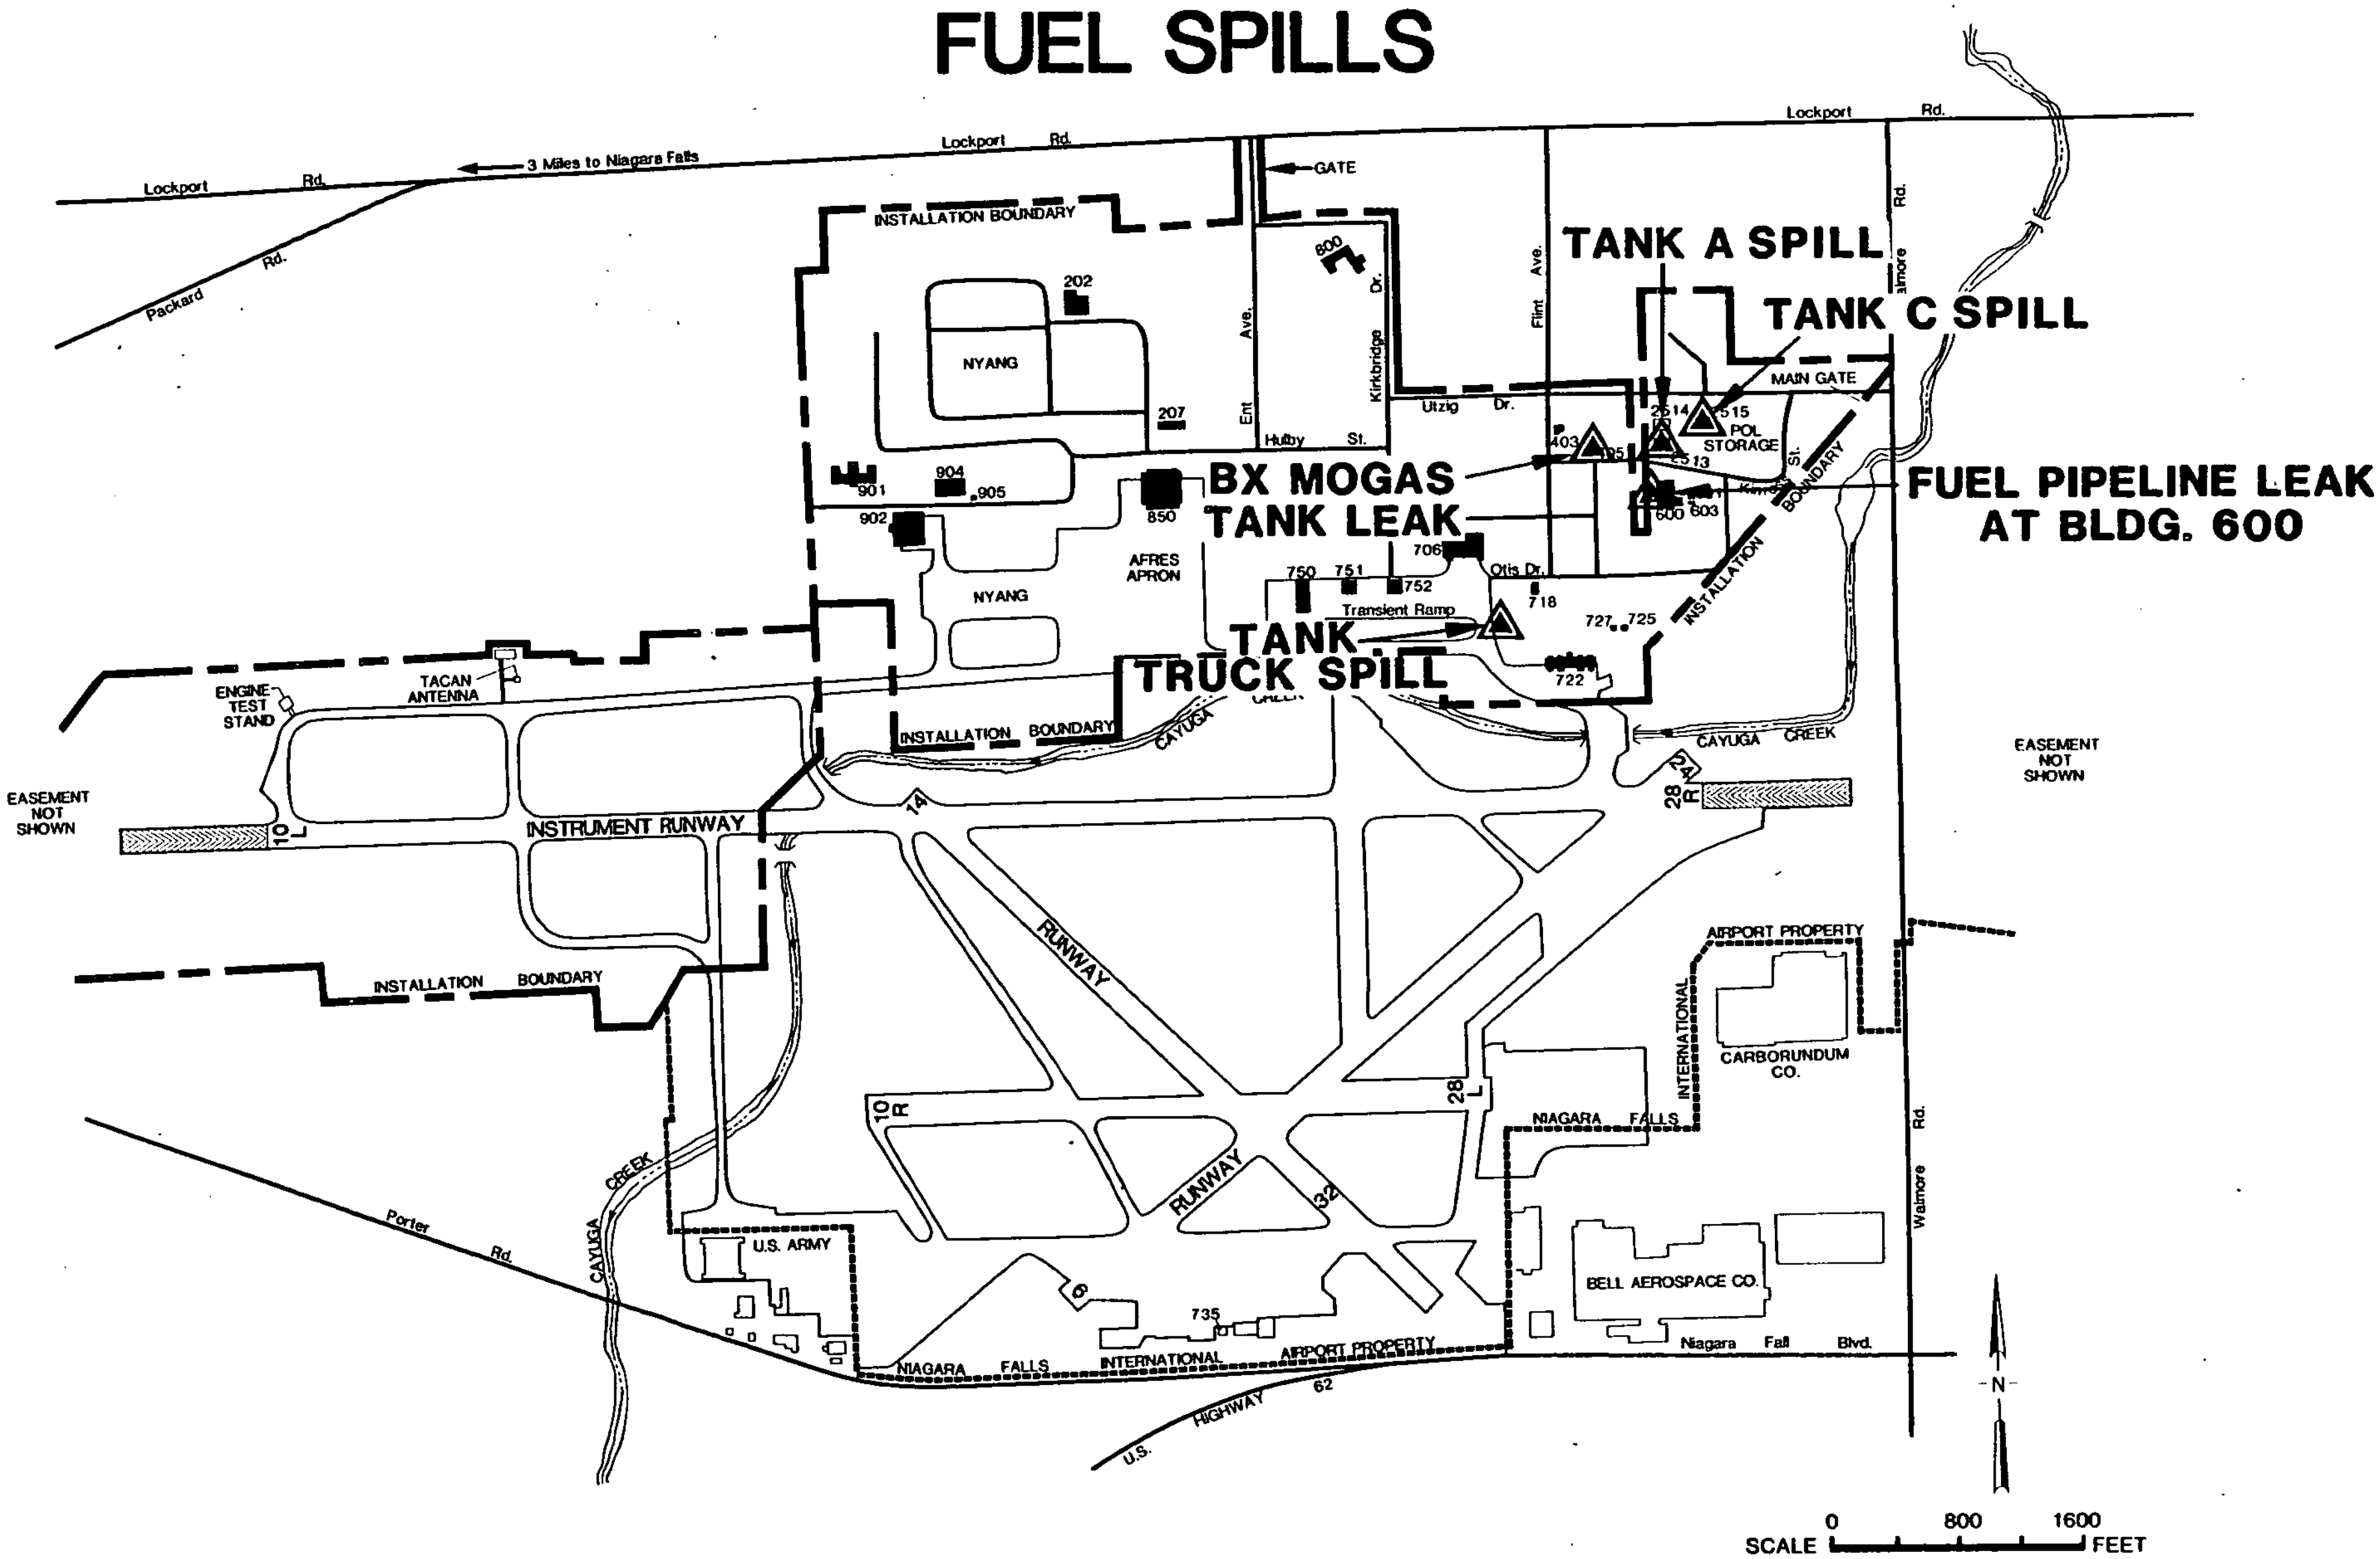
FIGURE 4.5

With respect to leaks, four significant leaks have occurred at Niagara Falls AFRF. They include two JP-4 leaks in the underground piping associated with the POL storage area, one leak in the old JP-4 hydrant system and a MOGAS leak at the BX service station (see Figure 4.5).

FUEL SPILLS

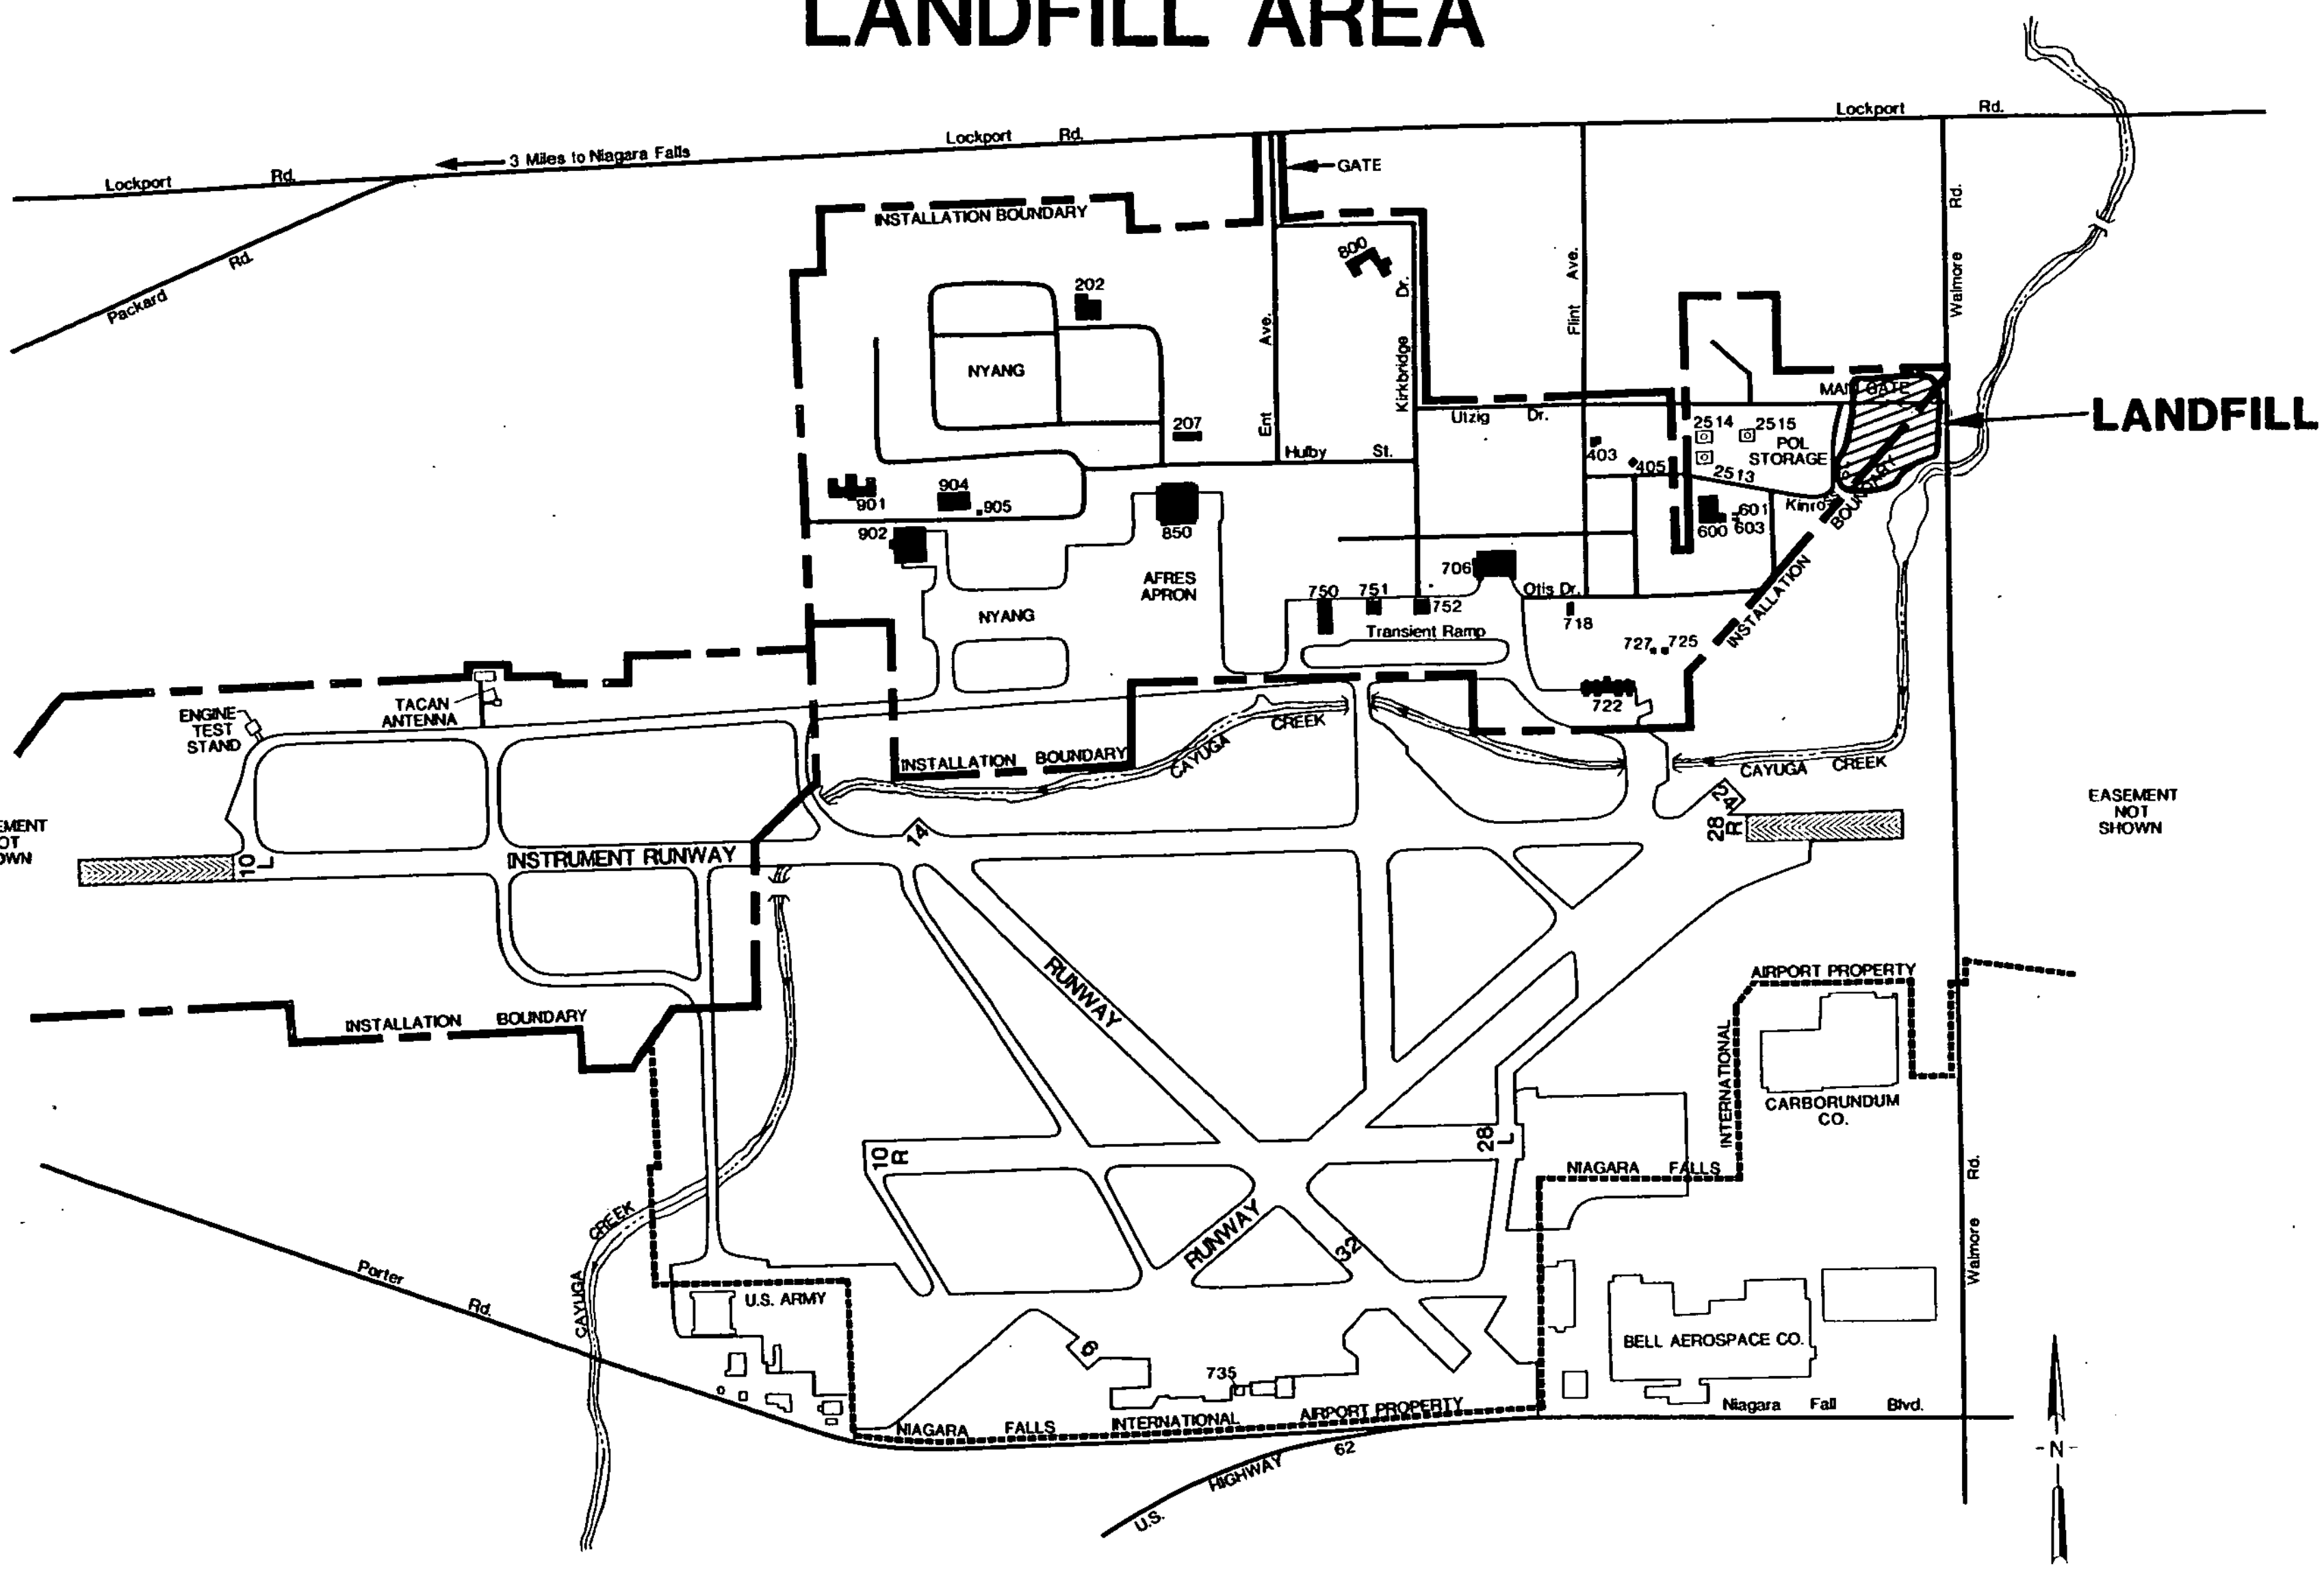
FIGURE 4.6

One landfill operation was identified in the northeast corner of Niagara Falls AFRF. Its approximate location is marked on Figure 4.6
