INSTALLATION RESTORATION PROGRAM

PHASE I - RECORD SEARCH

NIAGARA FALLS AIR FORCE RESERVE FACILITY, NEW YORK

DECEMBER 1983

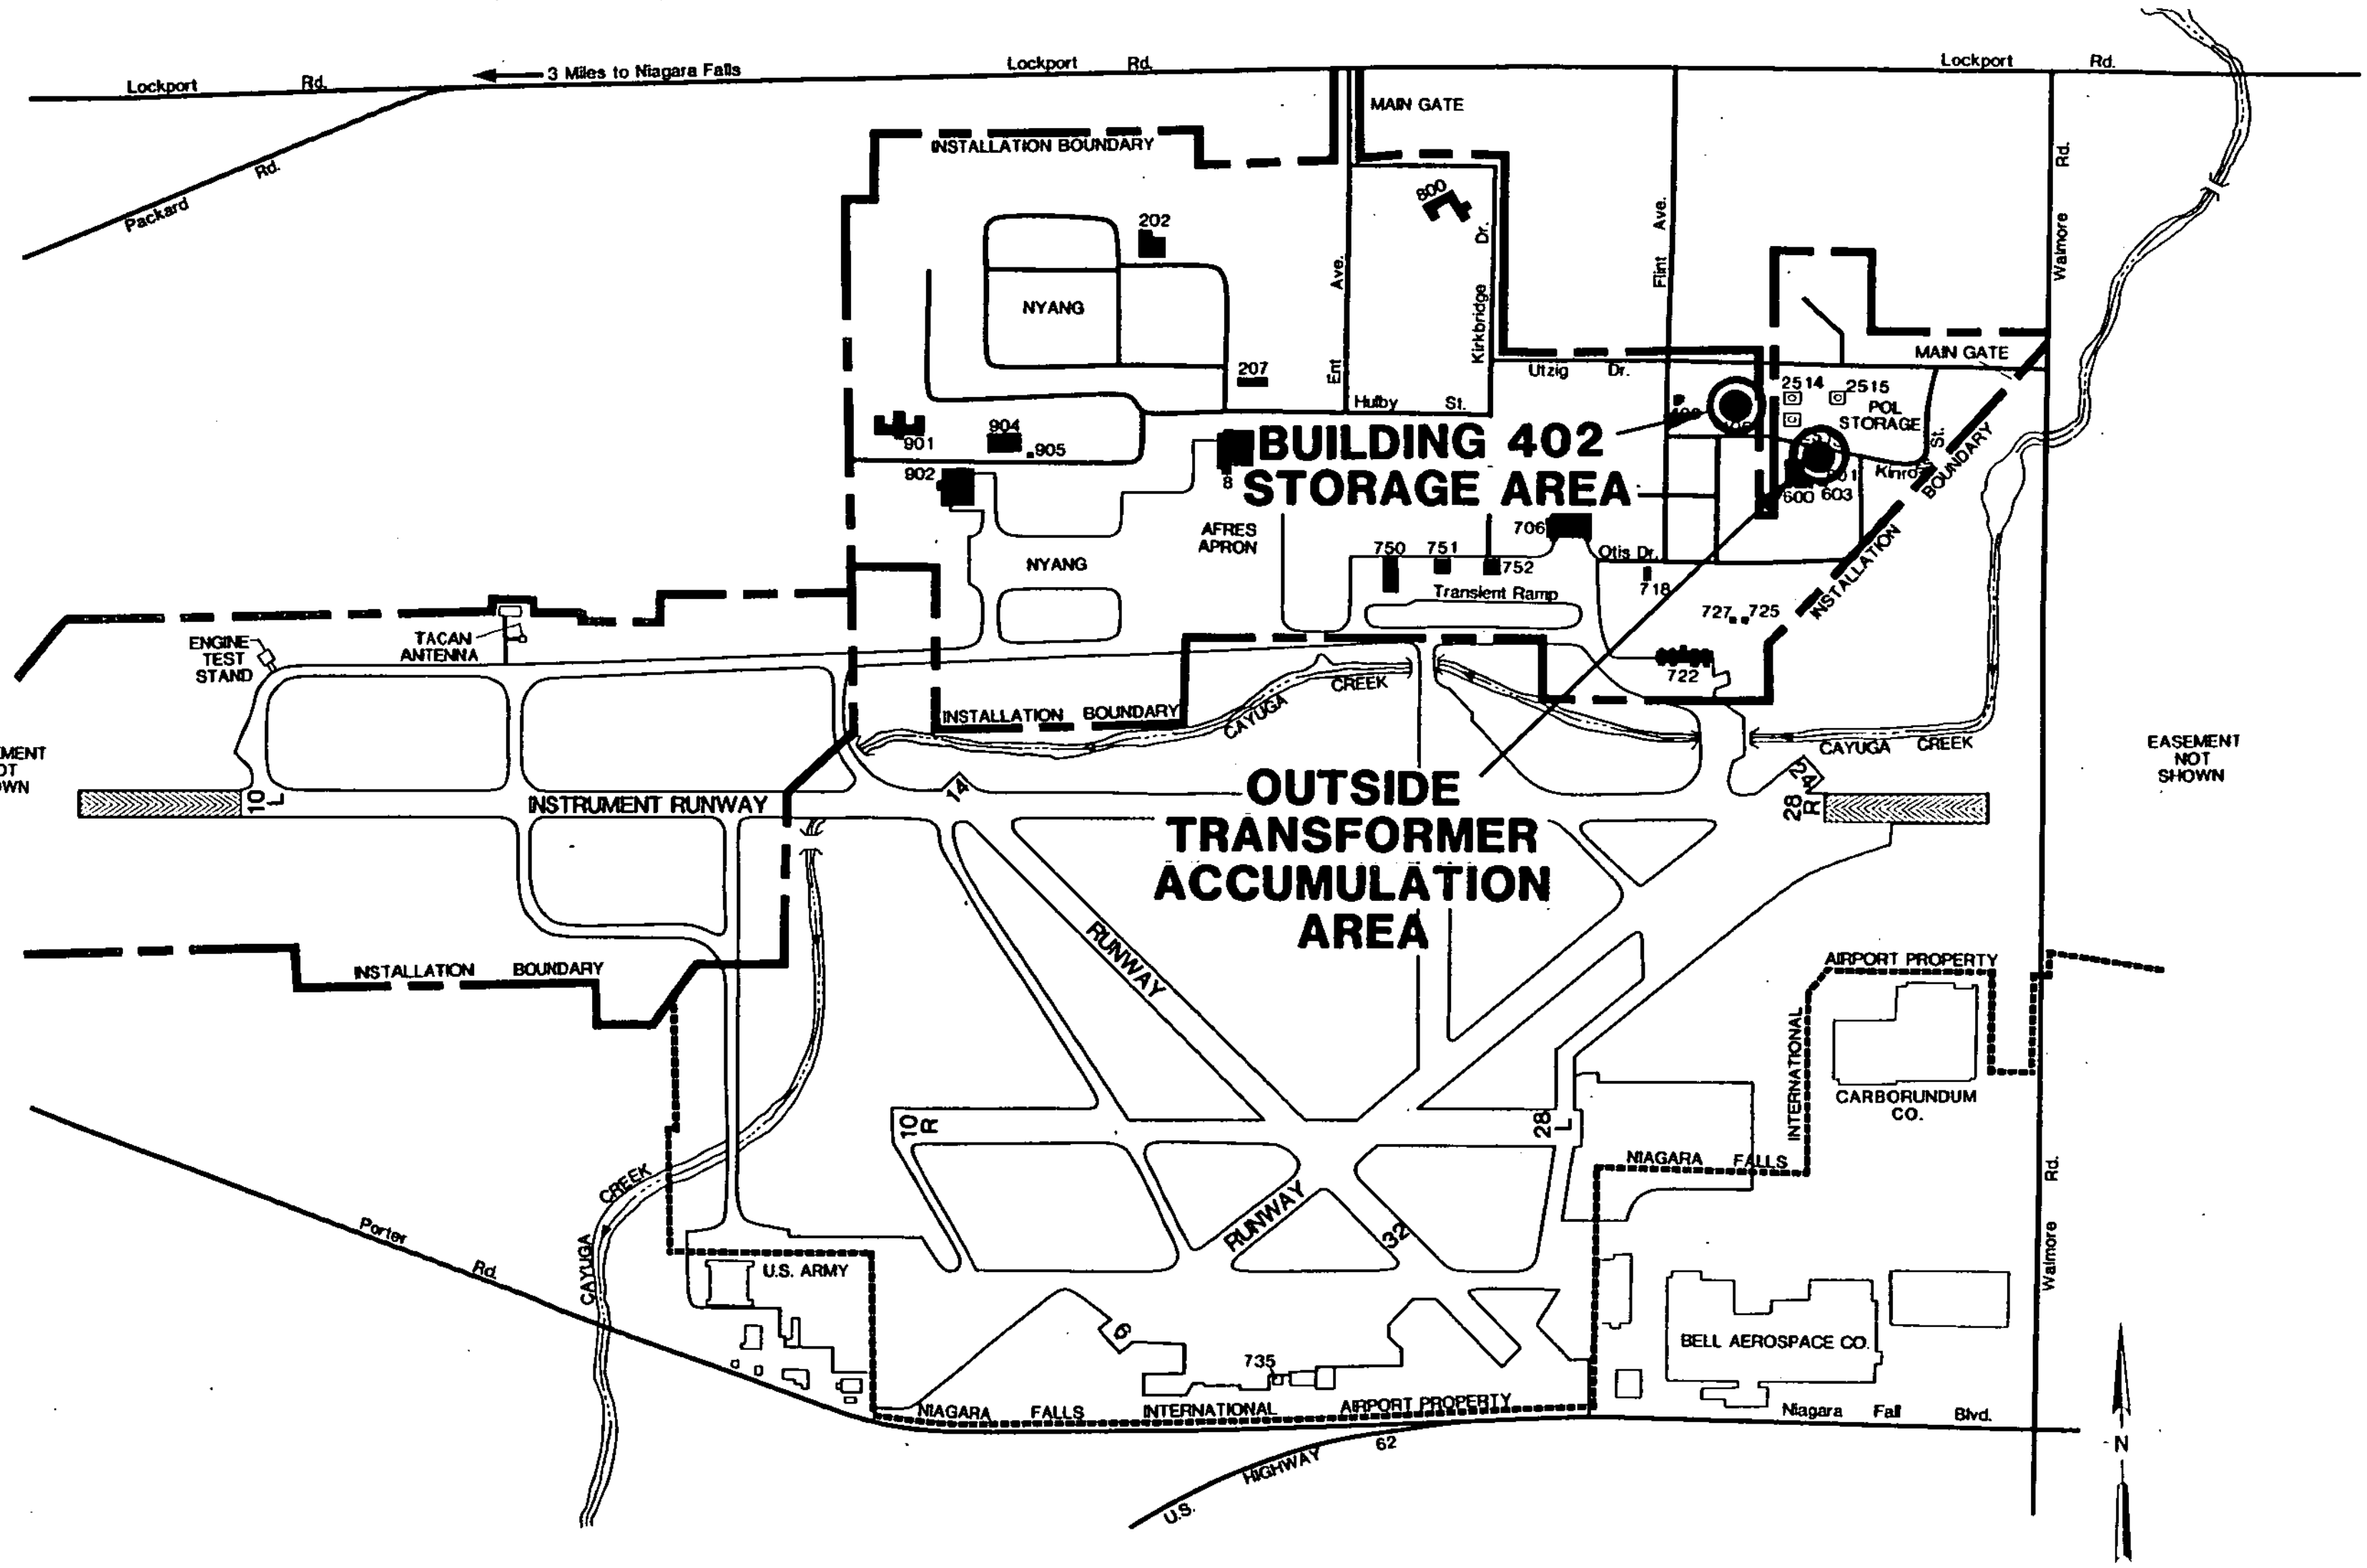
FIGURE 4.8

The Outside Transformer Storage Area (Figure 4.8) near buildings 601/603 was relocated to another area on installation during the time of the site visit. Although subsequent testing has indicated that some of these transformers contained PCB-contaminated dielectric, there was no indication that any of these devices leaked onto the ground. The Inside Transformer Storage Area in building 402 is enclosed and on a concrete pad. The area is not curbed but an inspection of the concrete pad

The Outside Transformer Storage Area (Figure 4.8) near buildings 601/603 showed no indication that any transformers had leaked onto the ground. The potential for contamination at this site, therefore, is considered to be very small. The Inside Transformer Storage Area in building 402 is enclosed and on a concrete pad. No leaks were reported by personnel working in the area. The potential for contamination in this site, therefore, is considered to be very small.

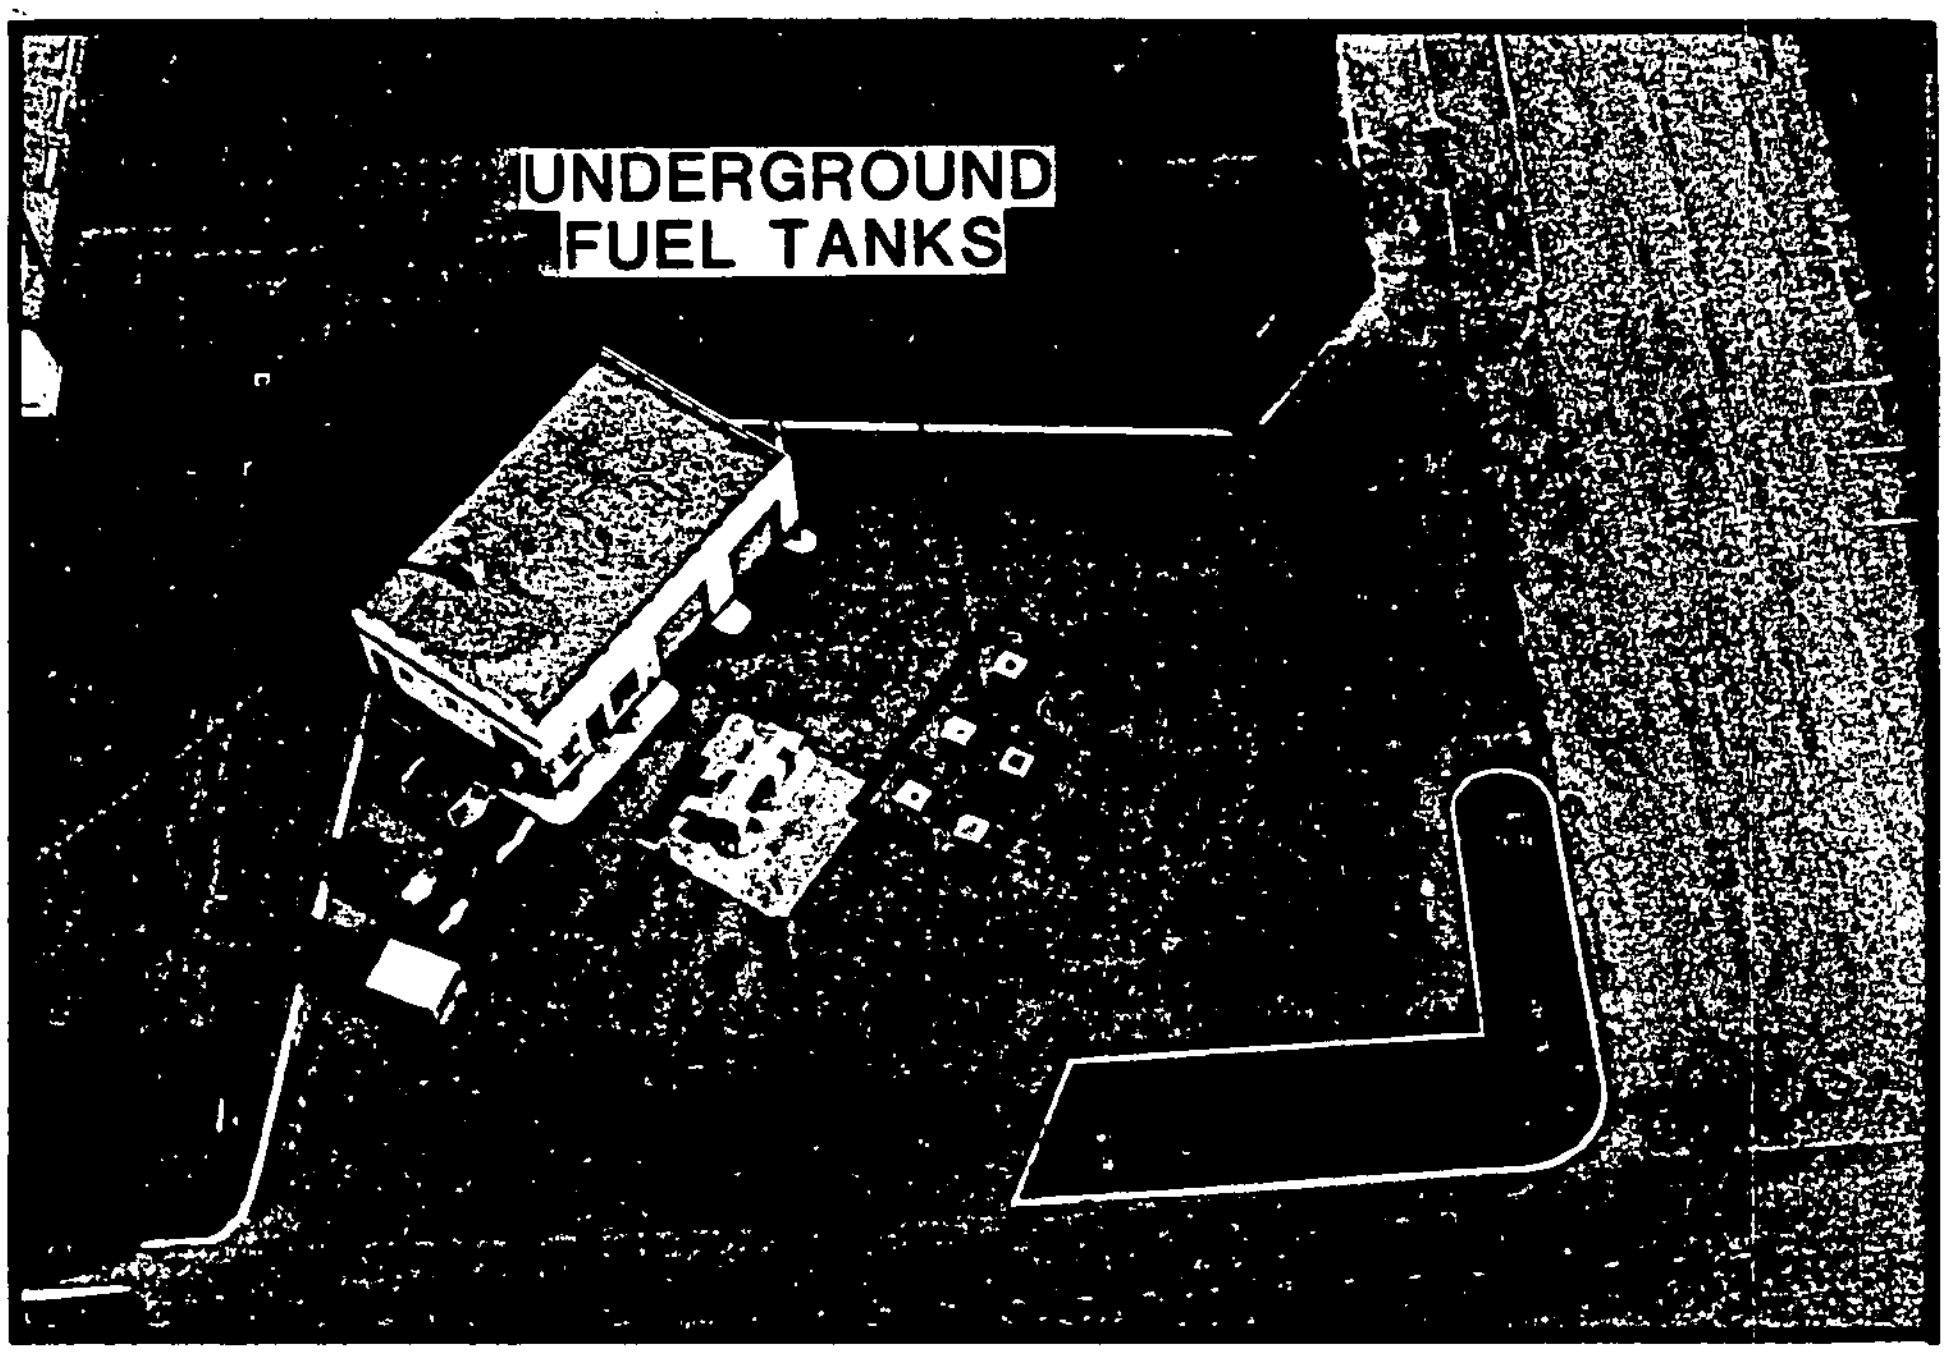
BX Service Station

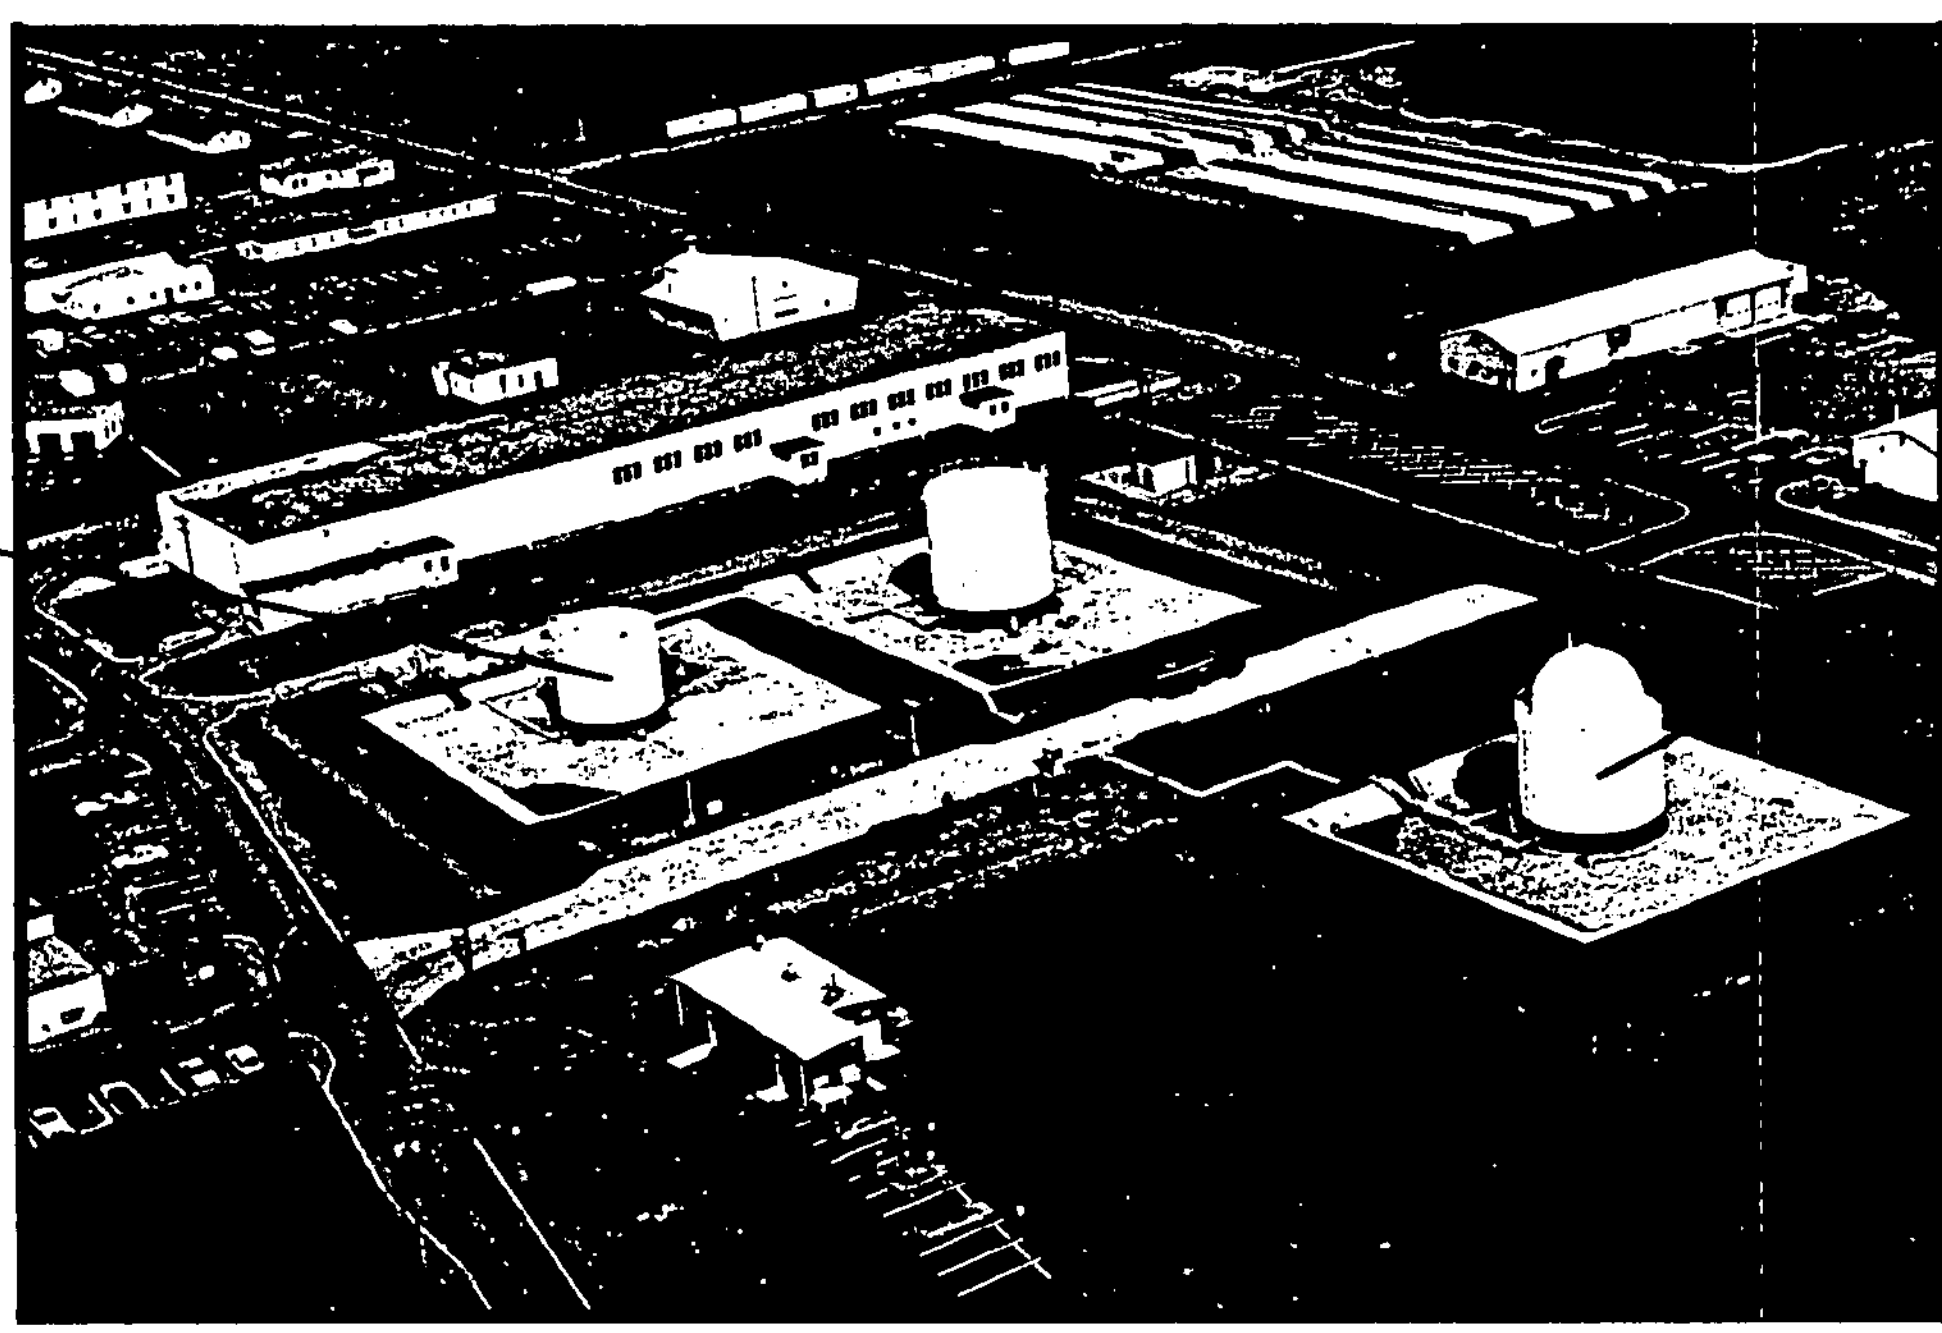
POL Storage Area

The POL storage area leaks occurred when the underground inlet pipe to JP-4 storage tank A developed a leak in 1979 and when the inlet and outlet pipes to tank C developed leaks in 1982. Both leaks were detected when fuel began to surface in the area of the underground pipes and appeared in storm water drainage. In the case of Tank A, the fuel surfaced near the fuel pump house and inside the diked area. In case of Tank C the fuel appeared between the diked area and the tank truck loading facilities and in the oil water separator that drains the diked area. In both cases the fuel lines were pressure tested and found to lose pressure at a rapid rate. Subsequent removal of the pipe found the black iron pipes badly corroded with numerous small holes on the bottom side. This indicates the leaks developed over an extended period of

TANK A

TANK C
