DECEMBER 2021

GROUNDWATER MONITORING REPORT

FOR
FORMER MOBIL SERVICE STATION 99-MST - 979 MAIN STREET (1001 MAIN STREET) BCP SITE NO. C915260 CITY OF BUFFALO, ERIE COUNTY, NEW YORK

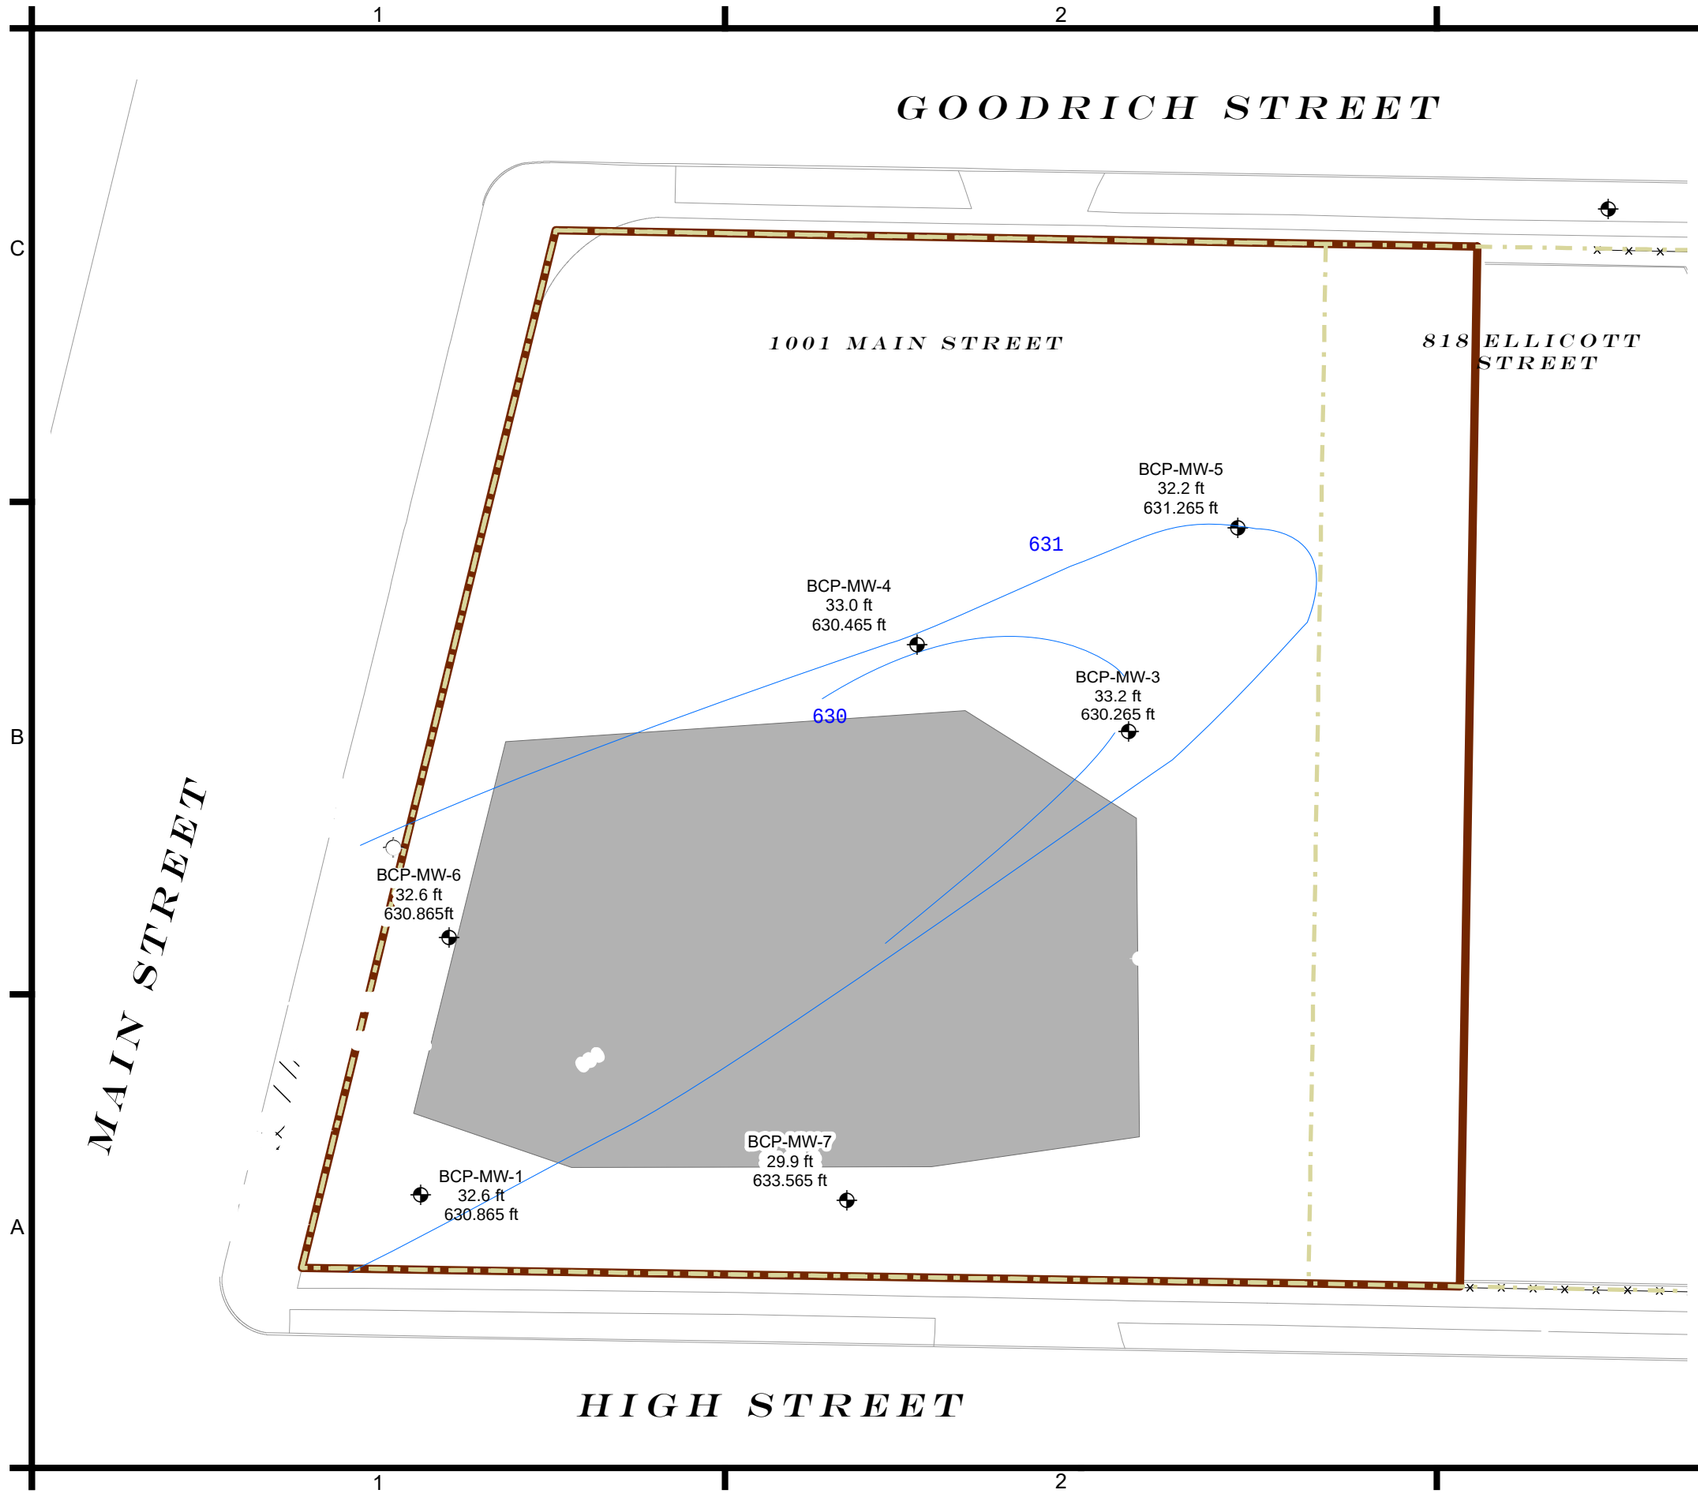
FIGURE 3

Figure 3 presents groundwater elevation contours.

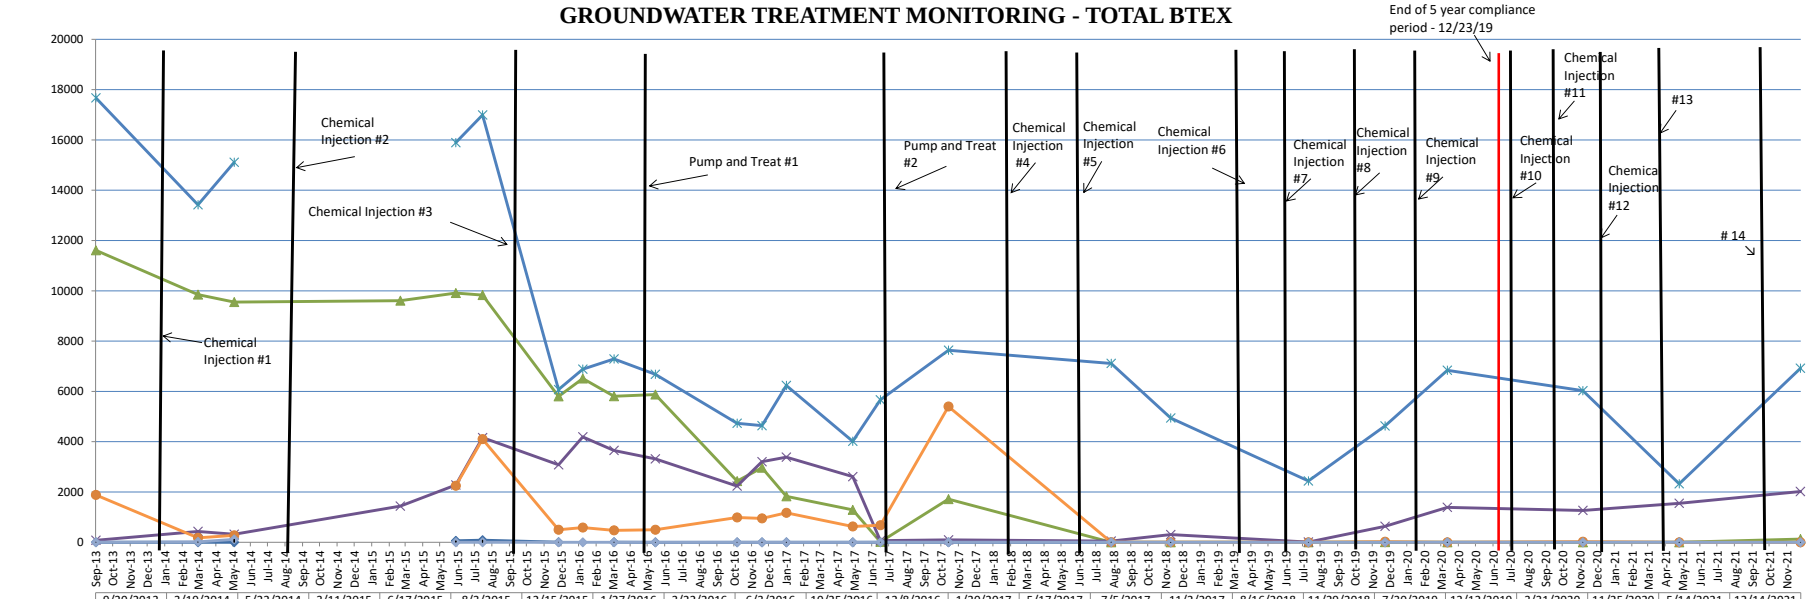
GROUNDWATER TREATMENT MONITORING - TOTAL BTEX

Table 3-2 attached to the end of this report presents detected VOC concentrations from December 2012 to December 2021. **Figure 4** presents total BTEX concentrations from each monitoring well. Lab analytical reports are provided in **Appendix A**.

MW-3 had a total VOC concentration of 174.9 ug/l which is a significant increase from the previous sampling event that had a total VOC concentration of 4.8 ug/l. The total BTEX concentration in MW-3 increased from 0 ug/l during the May sampling event, to 126.49 ug/l for the most recent December sampling event. The BTEX and total VOC concentrations reached their highest levels since the 2017 sampling events.

The October 2021 injection event appeared to be successful in most wells but slightly inefficient in three of the other wells. This could have a correlation with the time period between when the wells were injected and when the samples were collected from the wells. C&S recommends the following:
