SANITARY SEWER INVESTIGATION AND REMEDICATION

COLVIN BOULEVARD AND 96TH STREET

**GLENN SPRINGS HOLDINGS, INC.
NIAGARA FALLS, NEW YORK**

**MARCH 2011
REF. NO. 009954 (21)**

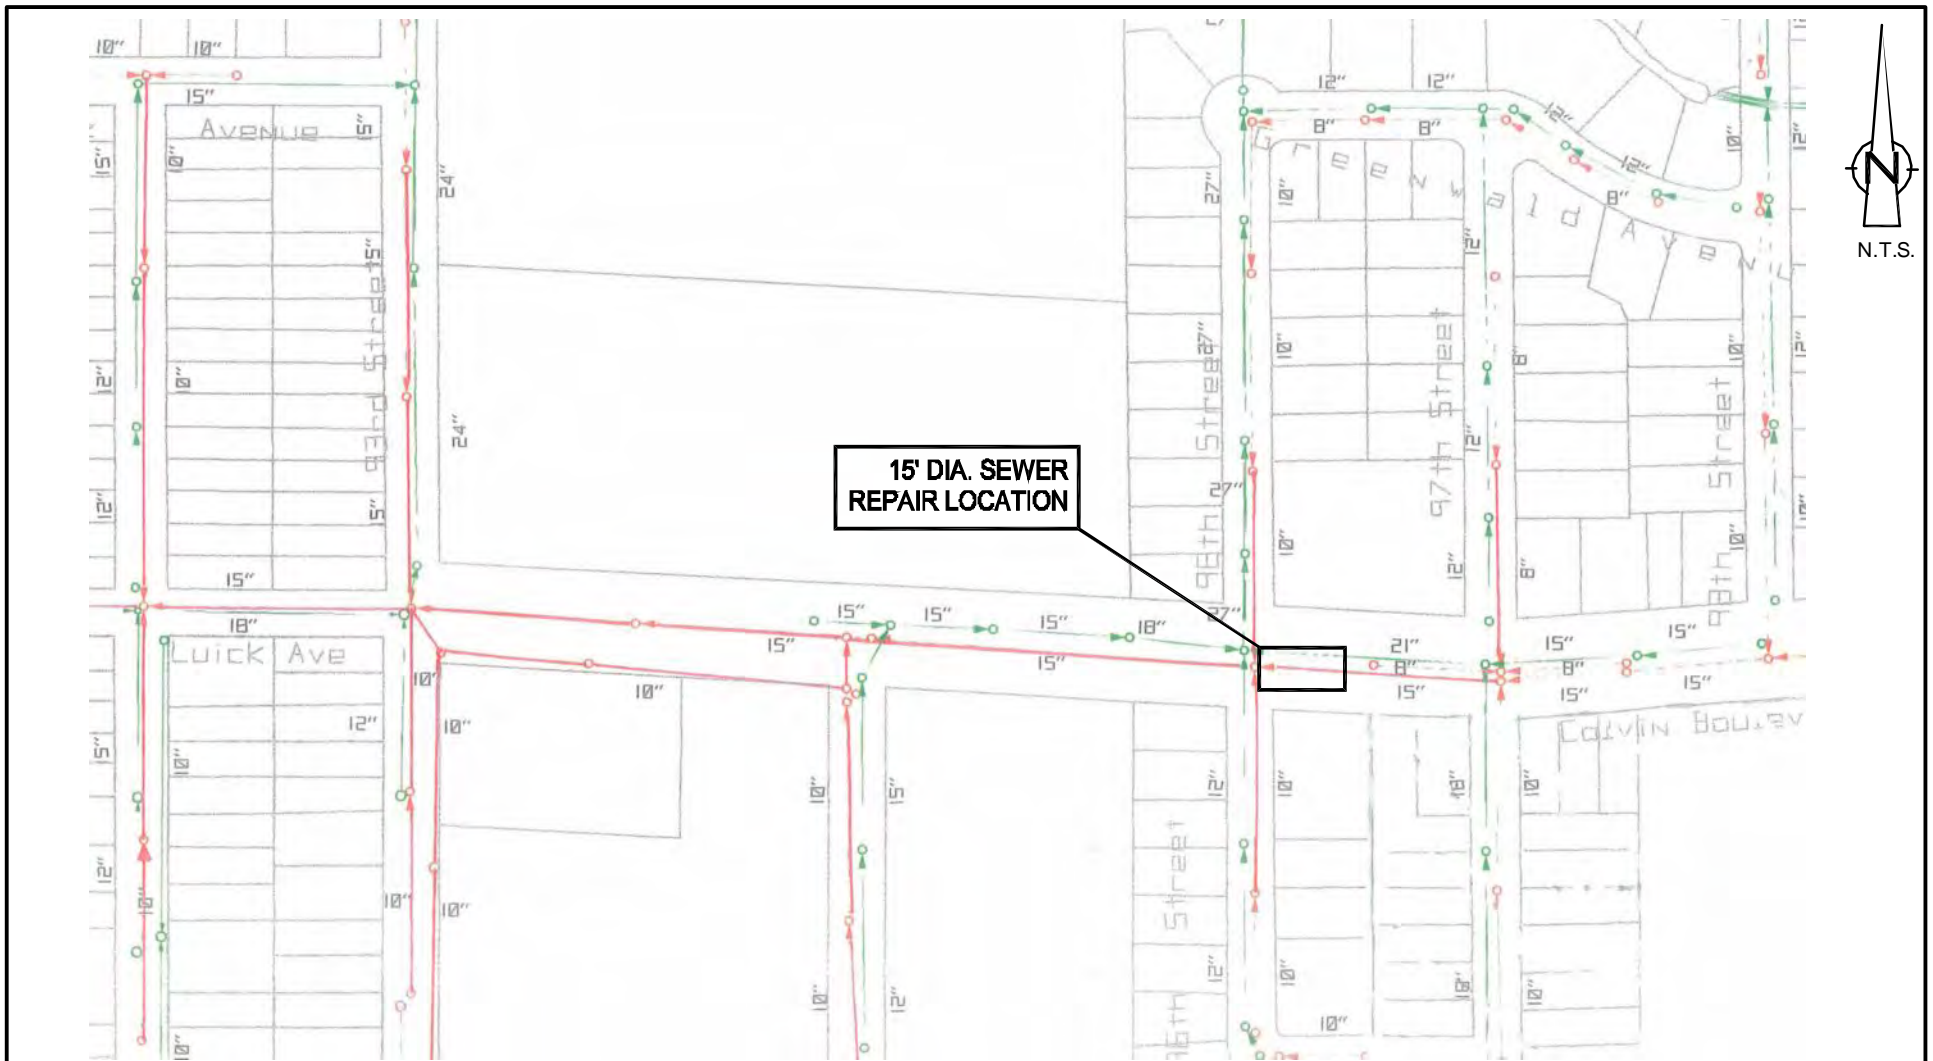
figure 2.1

The video inspection identified a deflection (i.e., low spot) in a 50-foot section of the sanitary sewer beneath the median area of Colvin Boulevard immediately east of the 96th Street. As part of the NFWB LaSalle Area Spot Sewer Repair project, this section of sewer was to be excavated and replaced to eliminate the low spot. The location of the 50-foot section of sanitary sewer is shown on Figure 2.1 and a plan and profile of the area to be repaired is shown on Figure 2.2.

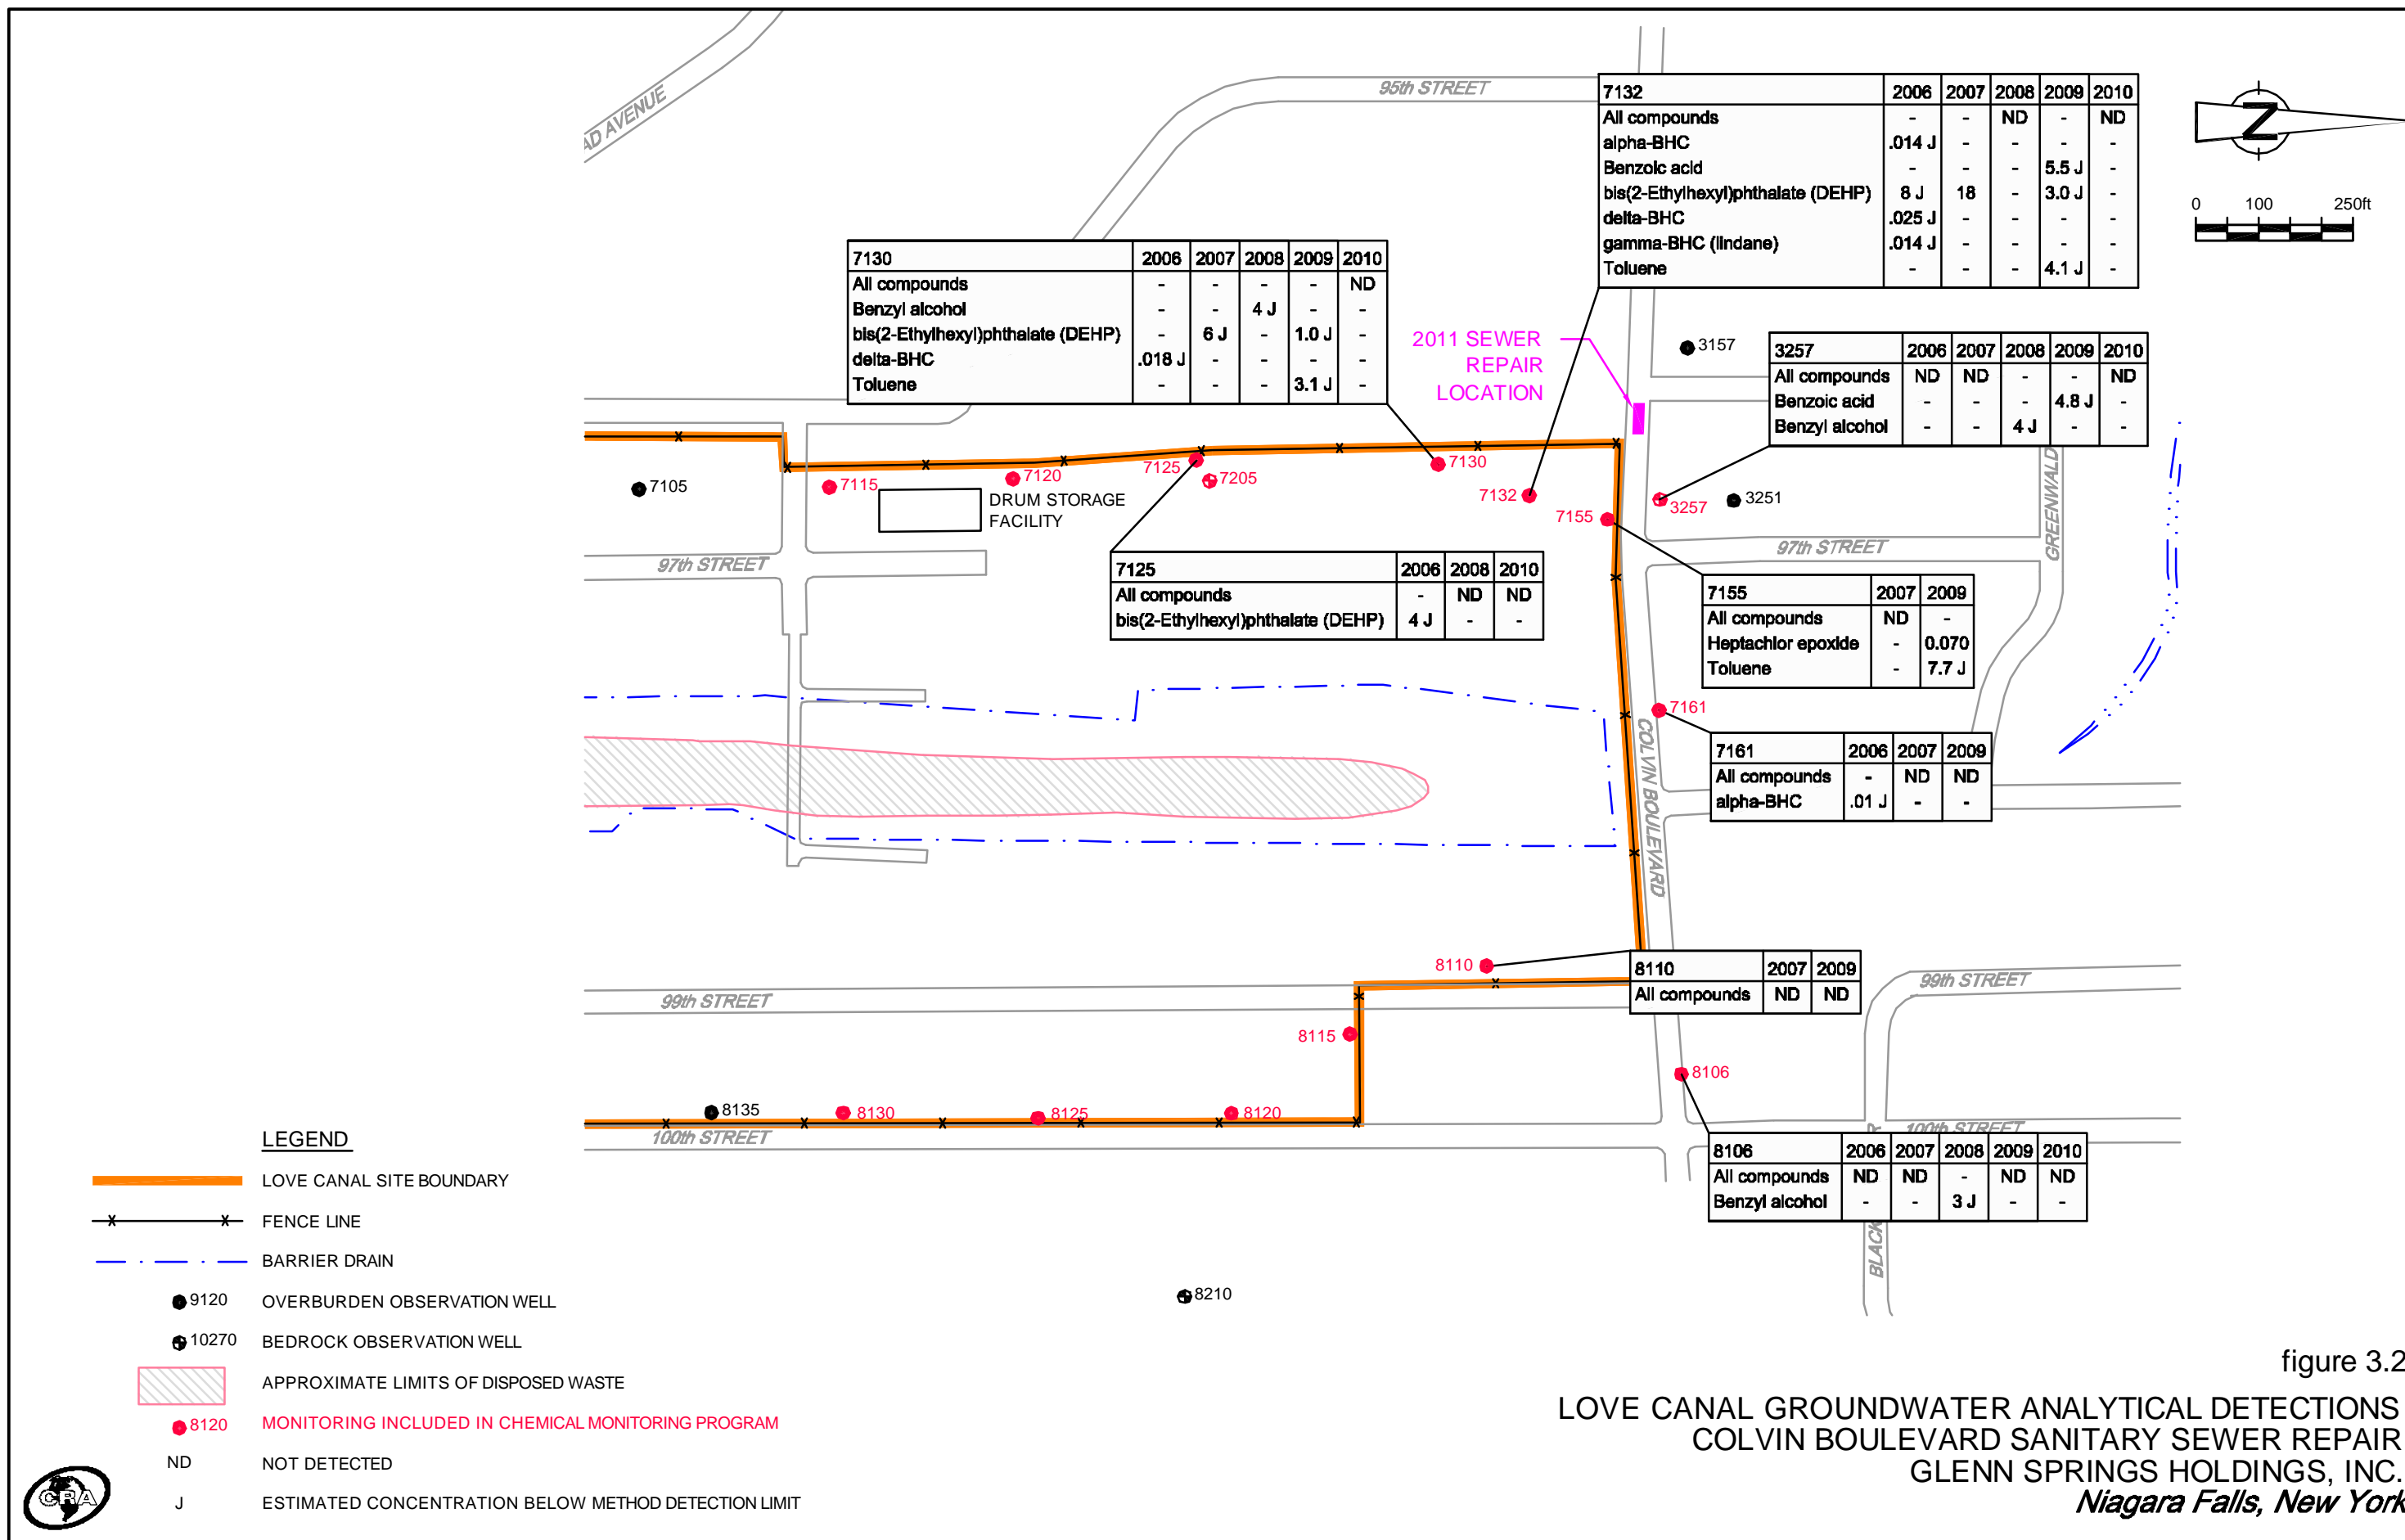
figure 3.2
LOVE CANAL GROUNDWATER ANALYTICAL DETECTIONS
COLVIN BOULEVARD SANITARY SEWER REPAIR
GLENN SPRINGS HOLDINGS, INC.
Niagara Falls, New York

Select monitoring wells on and around Love Canal are sampled on an annual basis to monitor the condition of the groundwater in and around the Love Canal. Several overburden and bedrock groundwater monitoring wells along the north boundary and in the northwest corner of Love Canal (closest to the sewer repair area) are sampled annually for VOCs, SVOCs, Pesticides, and Polychlorinated Biphenyls (PCBs). The locations of these wells in relation to the section of sewer being repaired are shown on Figure 3.2. All results have been non-detect with the exception of a few detections below 10 parts per billion (ppb). The analytical results for the past 5 years (2006 through 2010), deemed most representative of current conditions at the Site, are presented in Table 3.1.

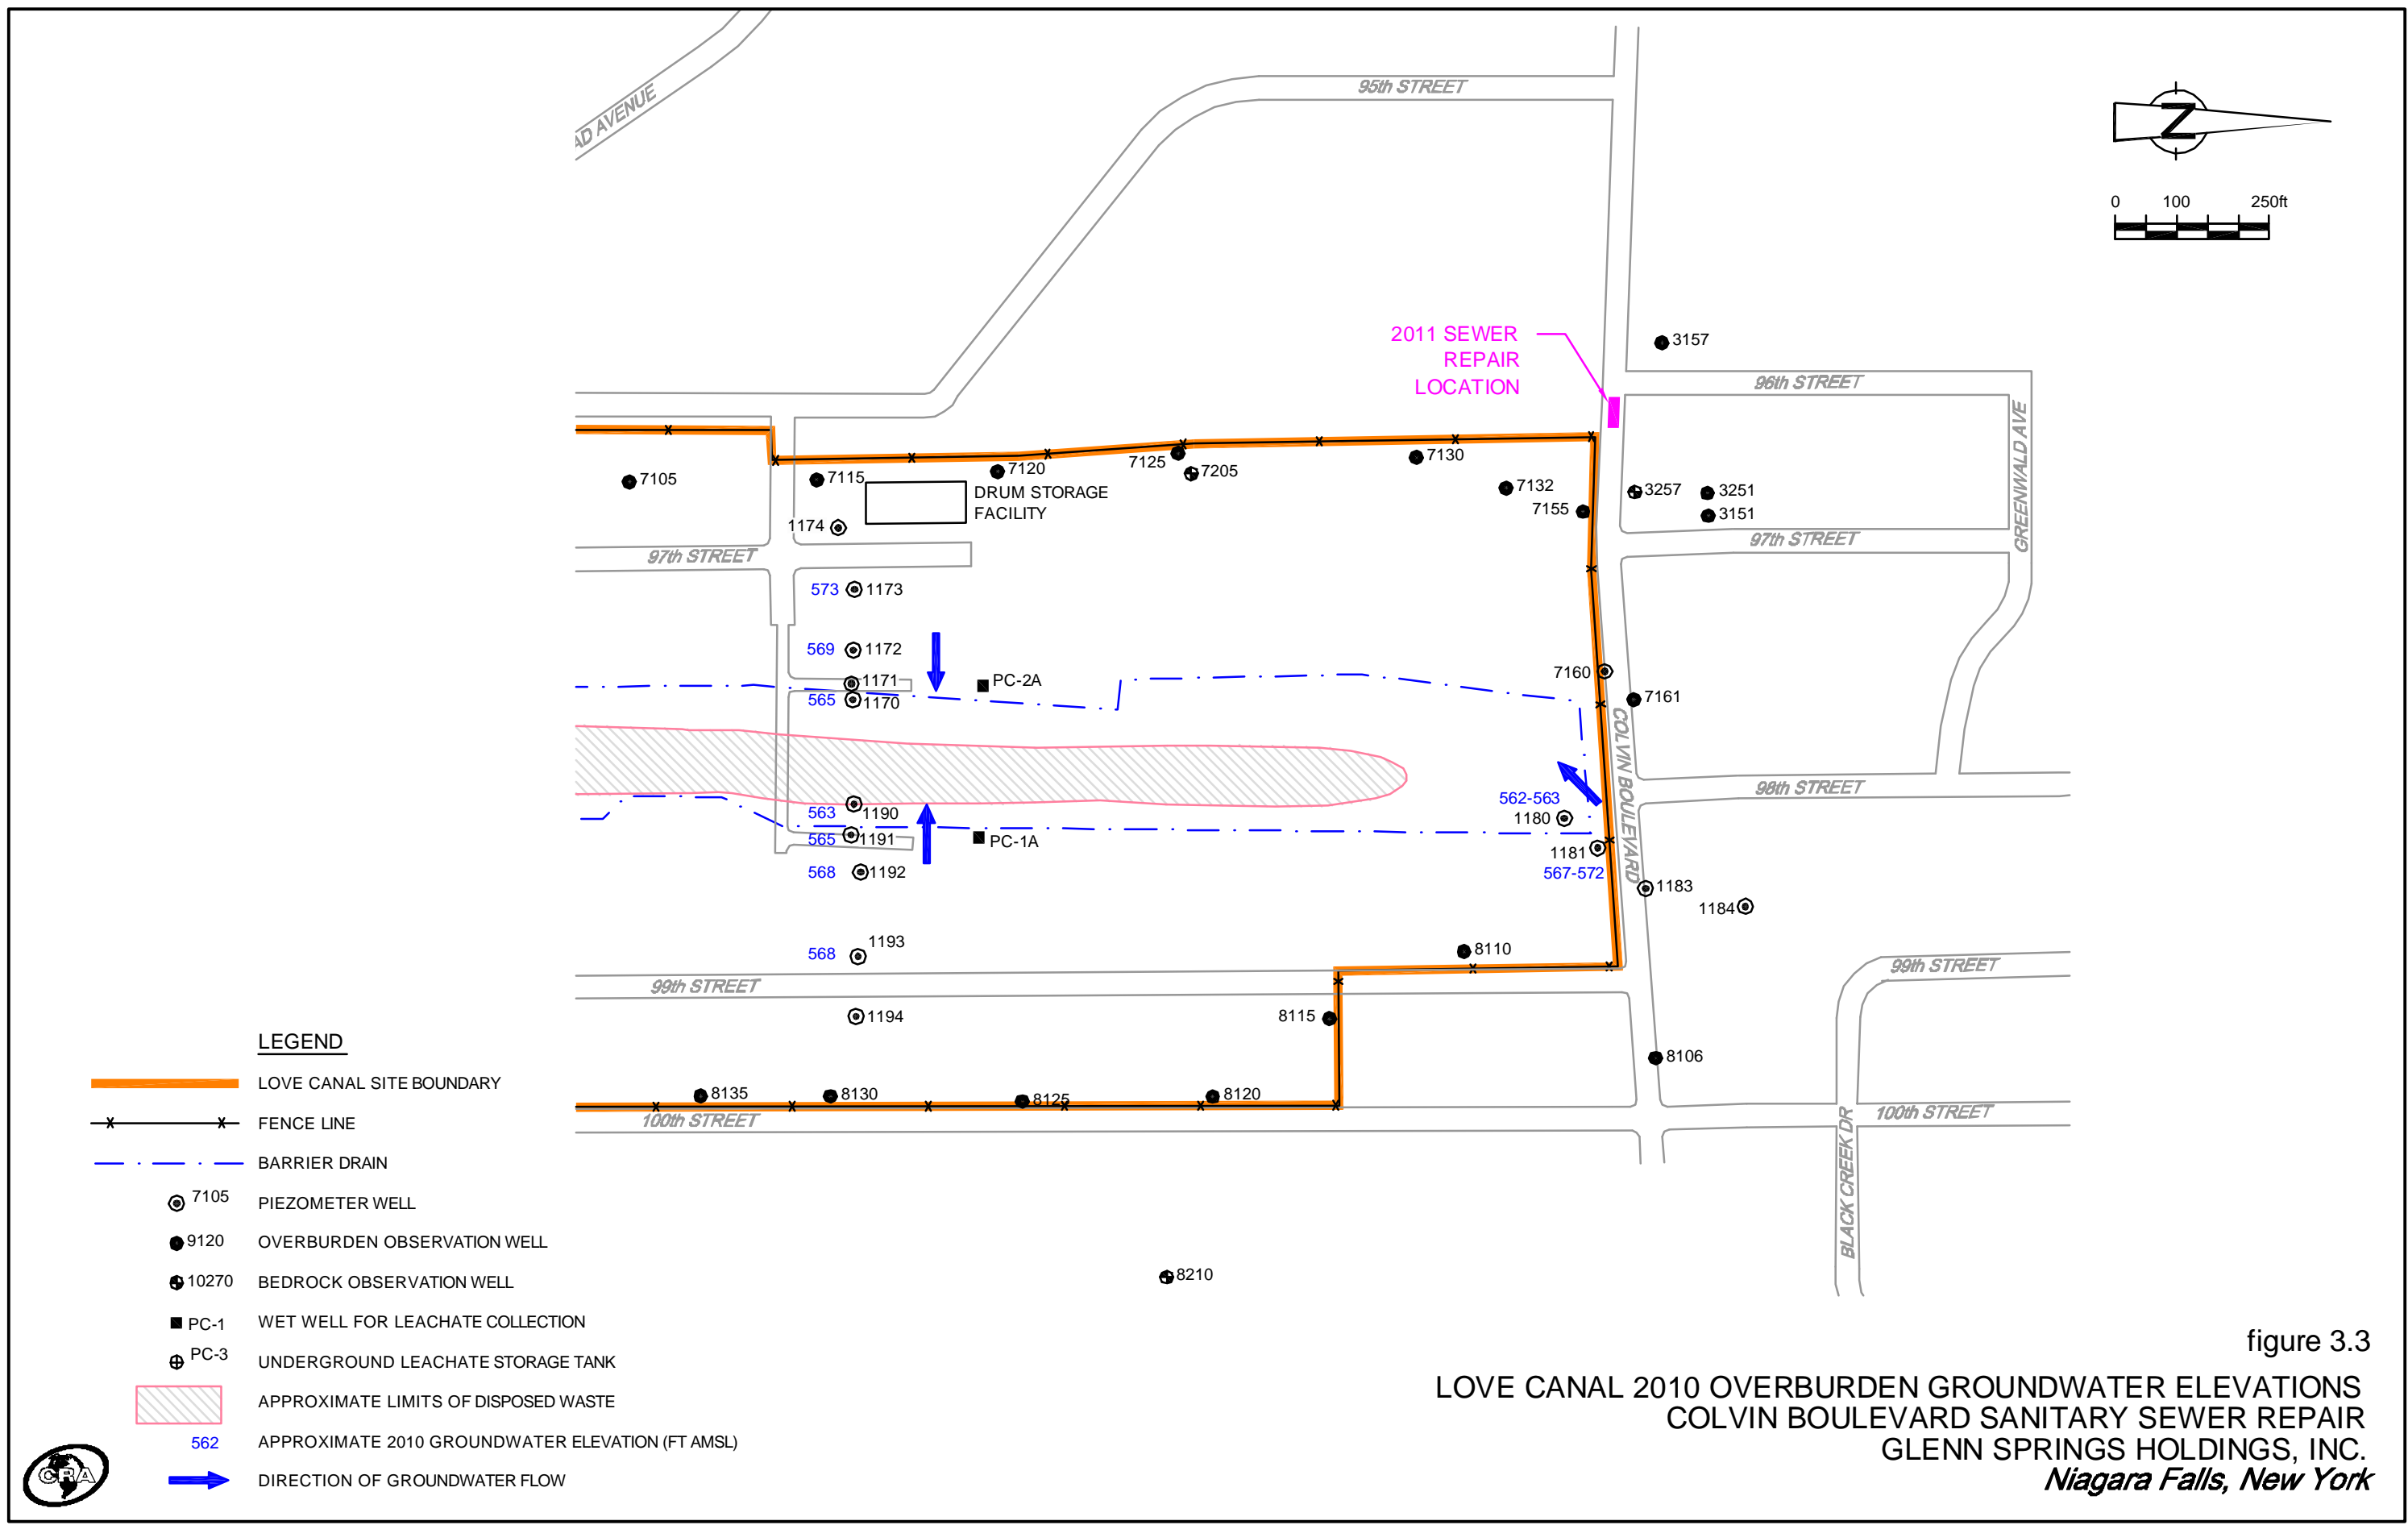
figure 3.3
 LOVE CANAL 2010 OVERBURDEN GROUNDWATER ELEVATIONS
 COLVIN BOULEVARD SANITARY SEWER REPAIR
 GLENN SPRINGS HOLDINGS, INC.
Niagara Falls, New York

Overburden and bedrock groundwater monitoring wells are monitored on a quarterly basis for groundwater elevations. Several of these are overburden monitoring wells within clusters along the alignment of the collection system. The locations of these wells are shown on Figure 3.3. As shown on Figure 3.3, Cluster 1180 (located along Colvin Boulevard east of the sewer excavation site) and Cluster 1170 (located in the northwest portion of the landfill south of the sewer excavation site) show inward gradients towards the barrier drain both currently and historically.

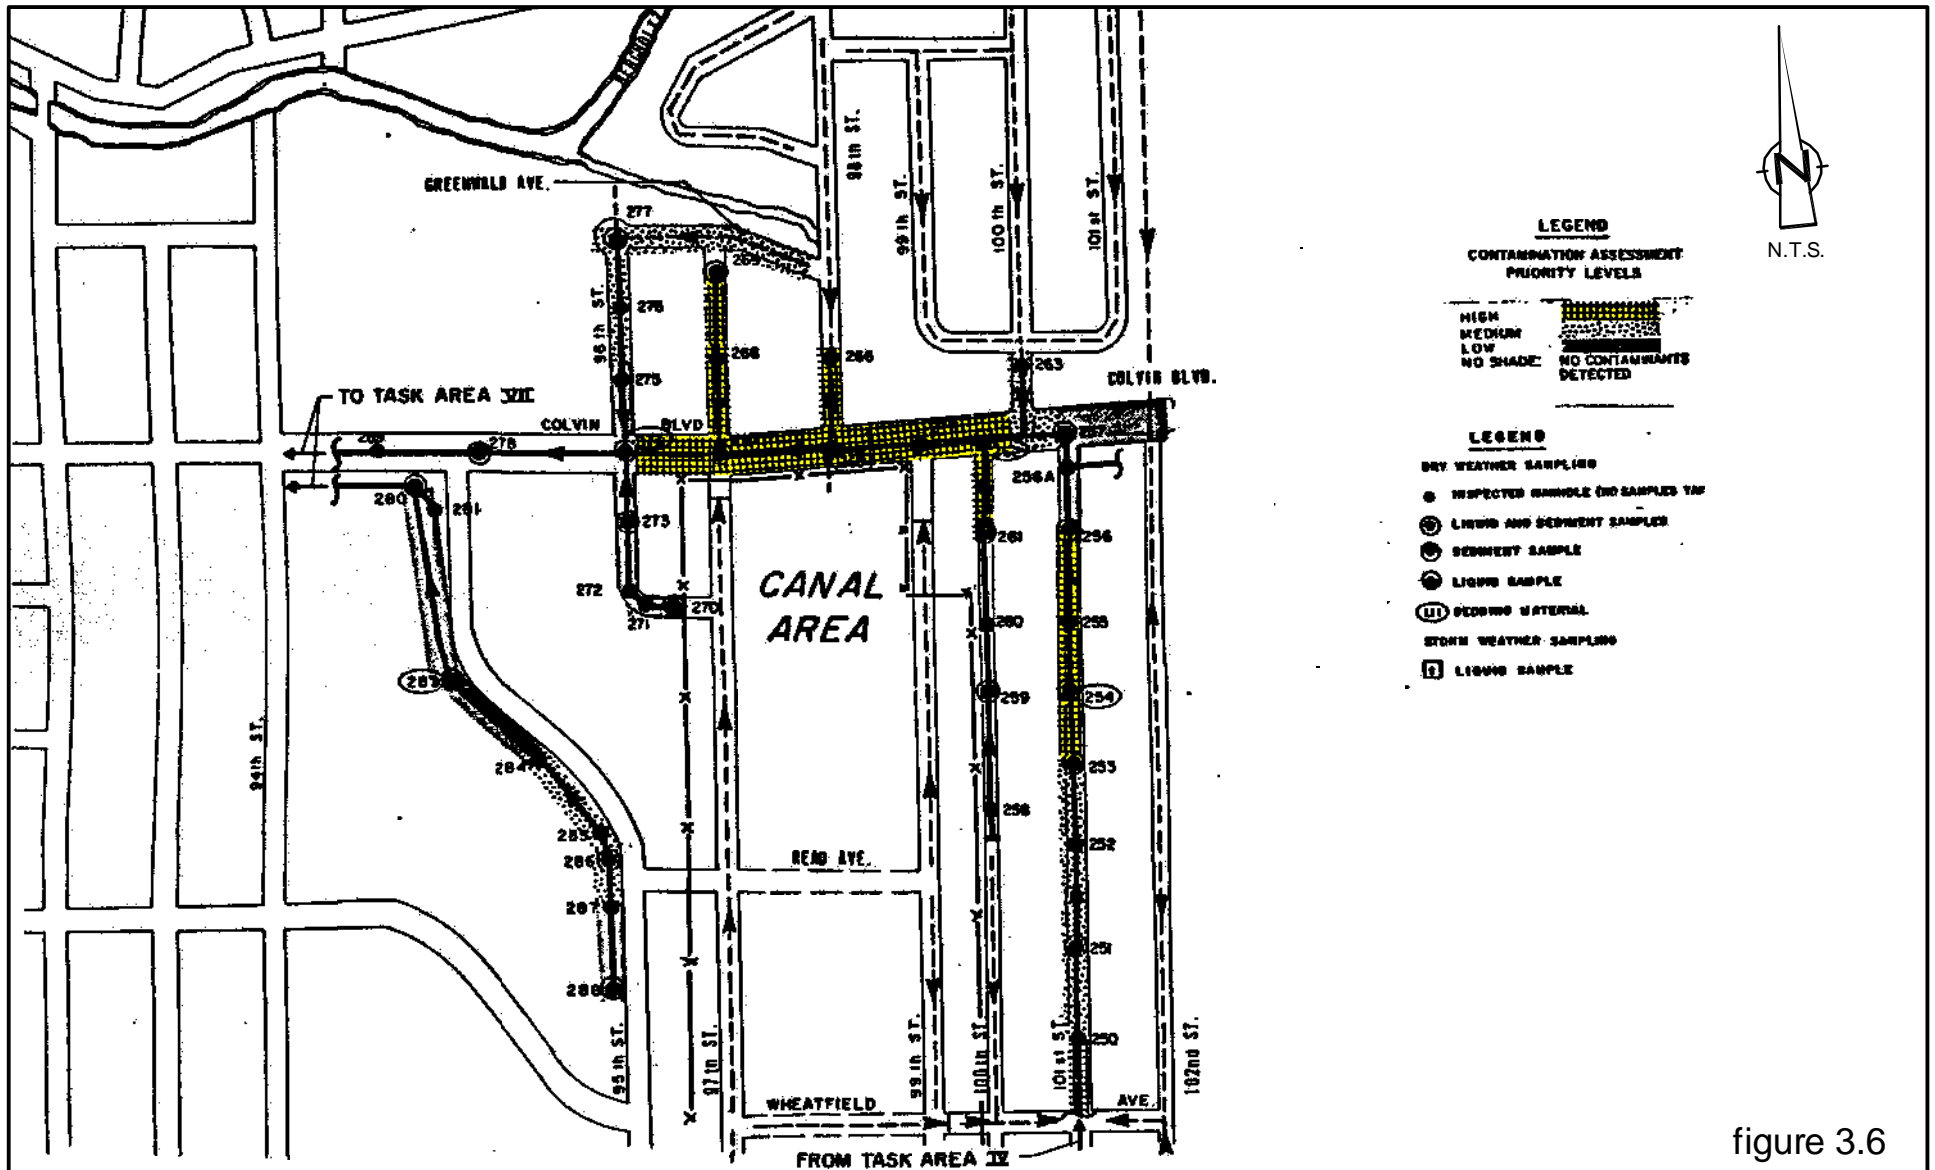
figure 3.6
 HISTORIC SANITARY SEWER IMPACTED SEDIMENT AREAS
 COLVIN BOULEVARD SANITARY SEWER REPAIR
 GLENN SPRINGS HOLDINGS, INC.
 Niagara Falls, New York

Sample results from the 1983 Malcolm Pirnie, Inc. report show elevated chlorinated organic concentrations in the sediments within the sanitary sewer along Colvin Boulevard east of 96th Street but not west of 96th Street. The sample locations are presented on Figure 3.5. Areas of impacted sediments are shown on Figure 3.6. A
