CLIENT NAME: Honeywell		SITE LOCATION: HB-TP-55		PROJECT NO. 49362
PHOTO NO. 59	DATE: 6/6/12

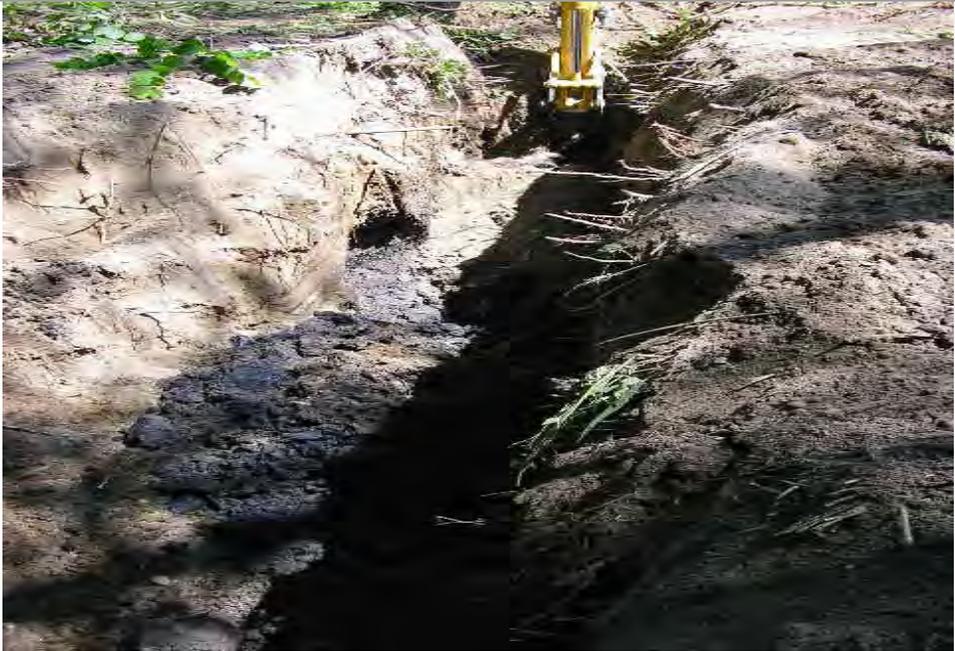
CLIENT NAME: Honeywell		SITE LOCATION: HB-TP-55AN	PROJECT NO. 49362
PHOTO NO. 84	DATE: 6/7/12

DESCRIPTION Looking South along HB-TP-55BS.

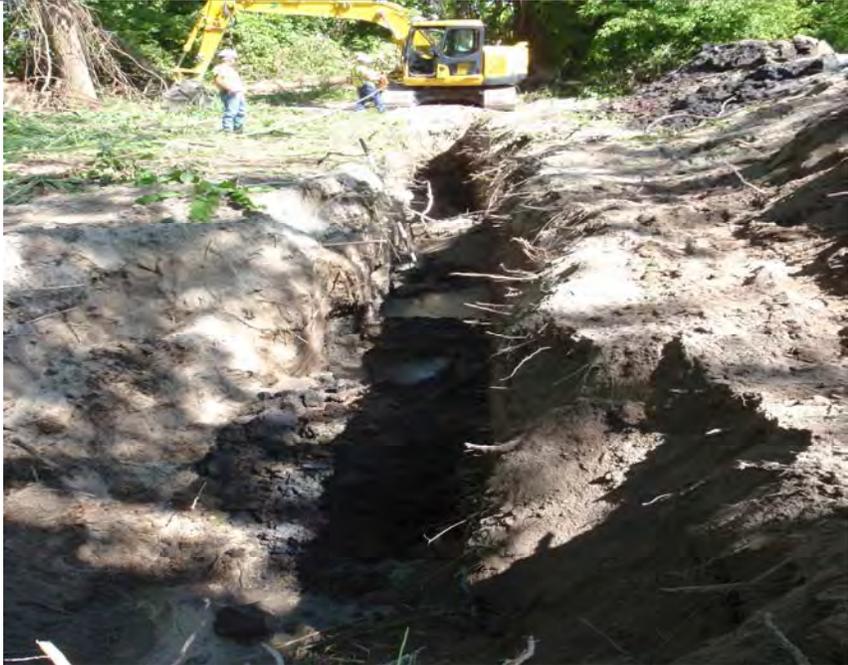
CLIENT NAME: Honeywell		SITE LOCATION: HB-TP-55	PROJECT NO. 49362
PHOTO NO. 85	DATE: 6/7/12

DESCRIPTION Looking south along HB-TP-55BS from intersection with HB-TP-55

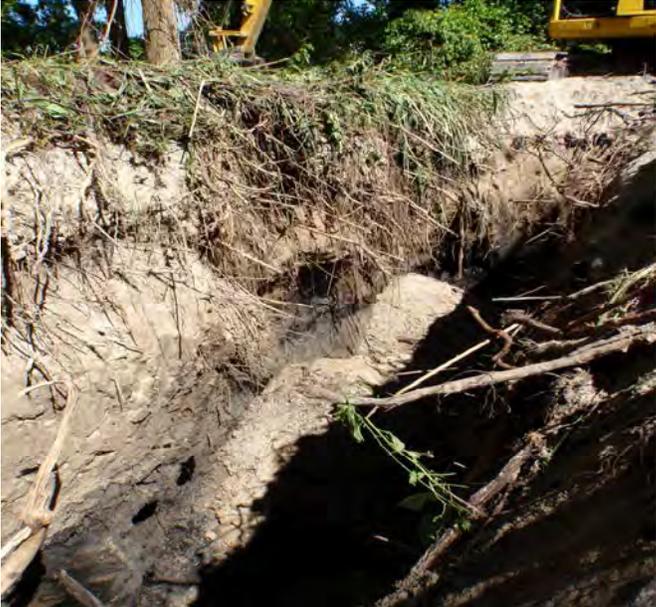
CLIENT NAME: Honeywell		SITE LOCATION: HB-TP-55		PROJECT NO. 49362
PHOTO NO. 88	DATE: 6/7/12

DESCRIPTION East wall of excavation at 35 ft south of intersecion of HB-TP-55 and HB-TP-55BS

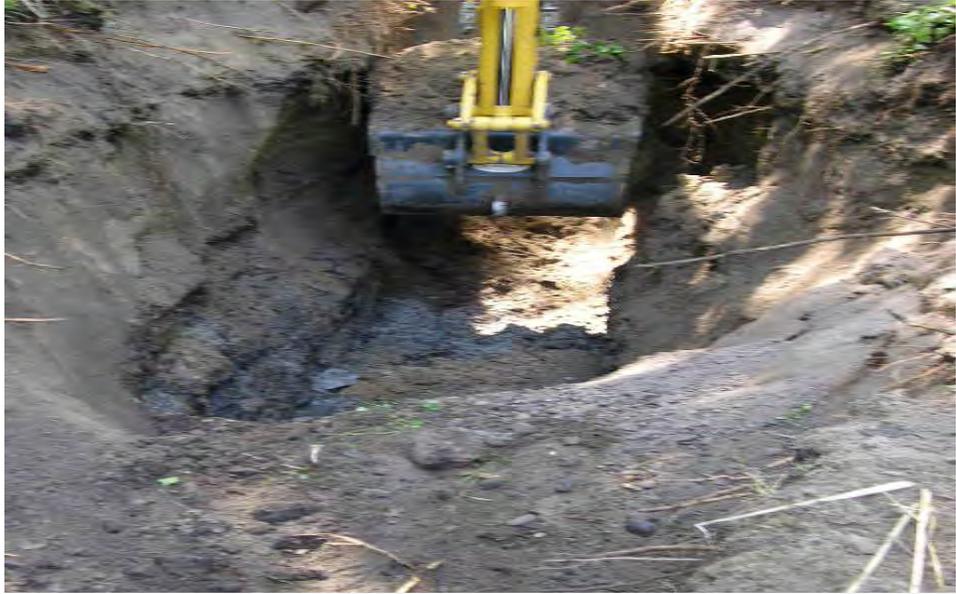
CLIENT NAME: Honeywell		SITE LOCATION: HB-TP-56	PROJECT NO. 49362
PHOTO NO. 99	DATE: 6/11/12

DESCRIPTION Looking South west along test pit HB-TP-56 from approximately 410 ft to 400 ft from the South West Corner of HB-TP-56.

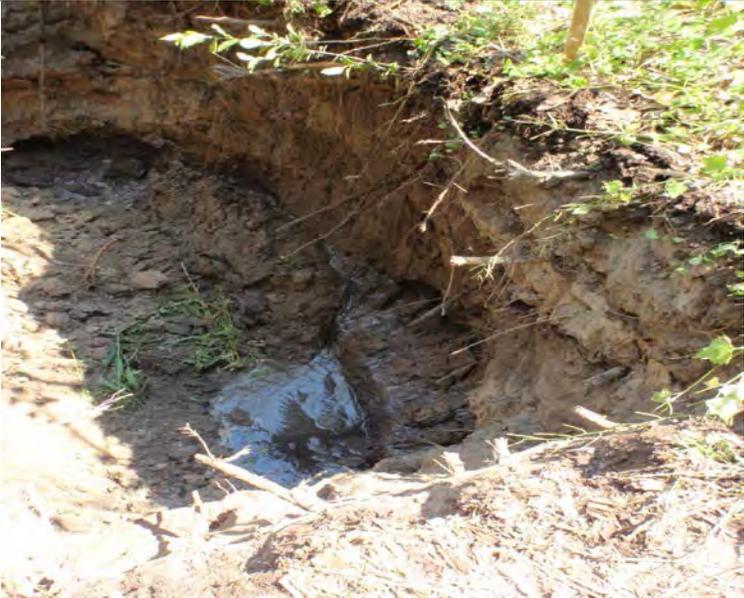
CLIENT NAME: Honeywell		SITE LOCATION: HB-TP-56.		PROJECT NO. 49362
PHOTO NO. 101	DATE: 6/11/12

DESCRIPTION Start of section 508 ft Northeast of Southwestern starting point of HB-T-56.

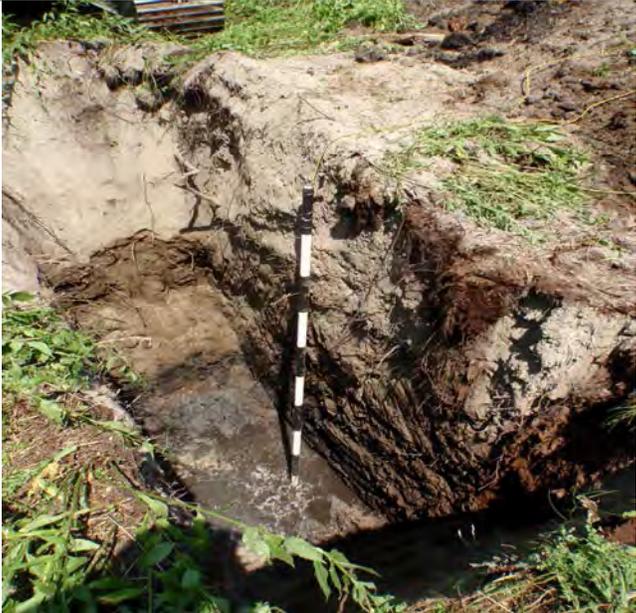
CLIENT NAME: Honeywell		SITE LOCATION: HB-TP-57		PROJECT NO. 49362
PHOTO NO. 109	DATE: 6/11/12

DESCRIPTION Start of section 0 ft Northeast of the Southwestern starting point of trench HB-TP-57.

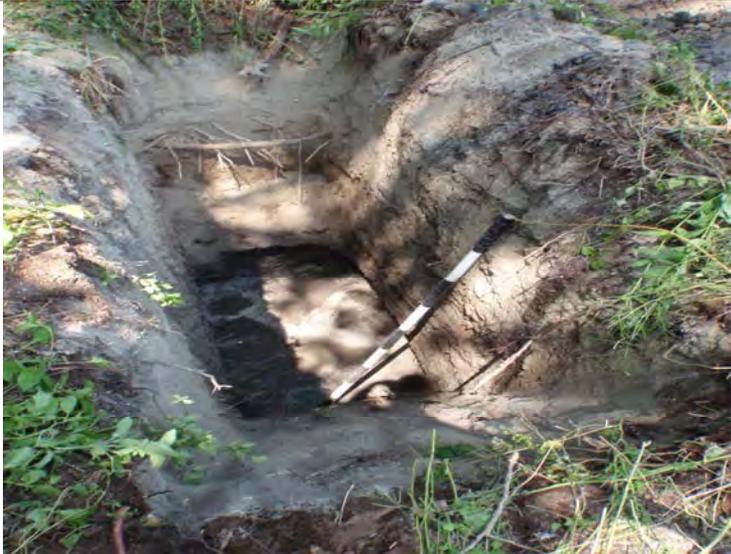
CLIENT NAME: Honeywell		SITE LOCATION: HB-TP-57		PROJECT NO. 49362
PHOTO NO. 110	DATE: 6/11/12

DESCRIPTION Start of section 50 ft Northeast of the Southwestern starting point of trench HB-TP-57

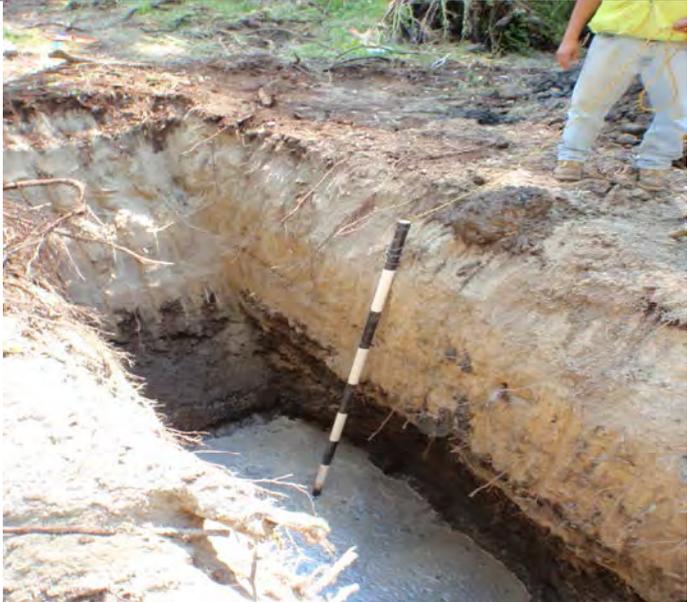
CLIENT NAME: Honeywell		SITE LOCATION: HB-TP-57		PROJECT NO. 49362
PHOTO NO. 111	DATE: 6/11/12

DESCRIPTION Section 167 ft Northeast of the Southwestern starting point of trench HB-TP-57

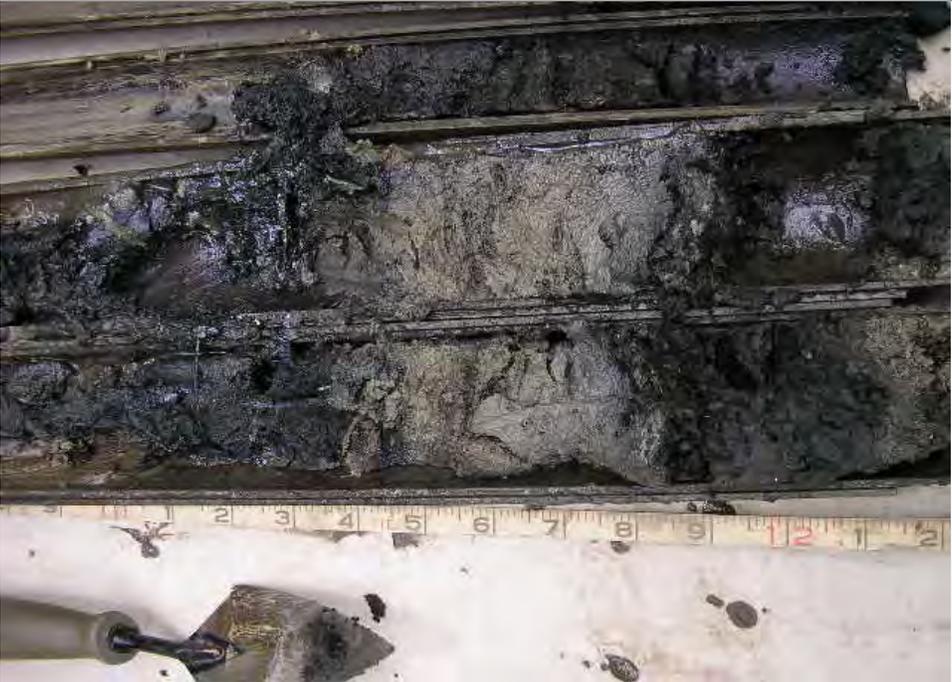
CLIENT NAME: Honeywell		SITE LOCATION: HB-SB-254	PROJECT NO. 49362
PHOTO NO. 125	DATE: 6/13/12

DESCRIPTION Marl 18-20 ft bgs at HB-SB-254.

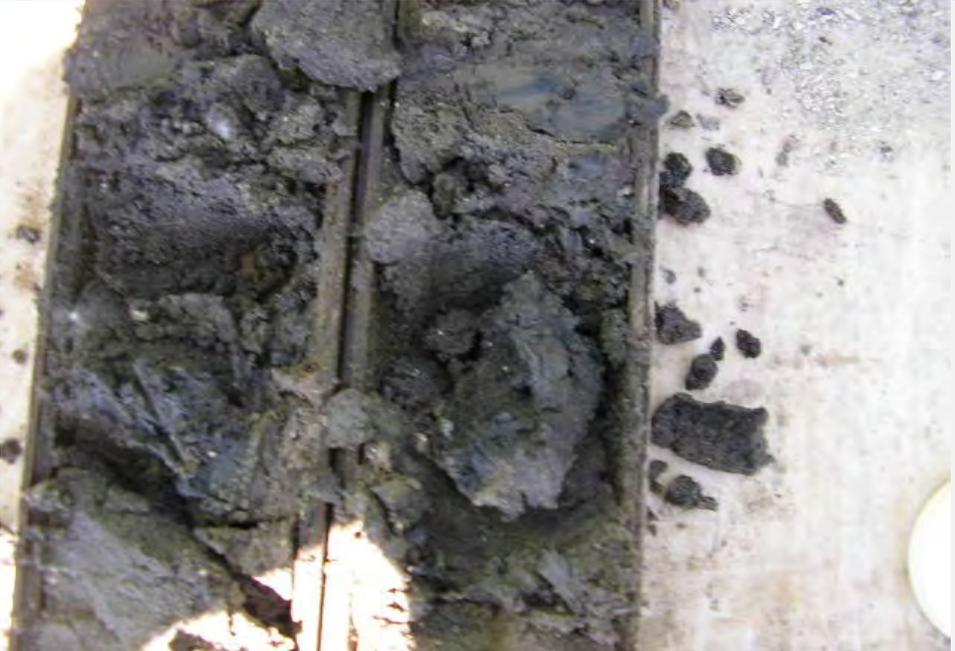
CLIENT NAME: Honeywell		SITE LOCATION: HB-SB-262	PROJECT NO. 49362
PHOTO NO. 130	DATE: 6/14/12

DESCRIPTION Sandy marl with wood fragments at 12.5-13 ft bgs at HB-SB-262.

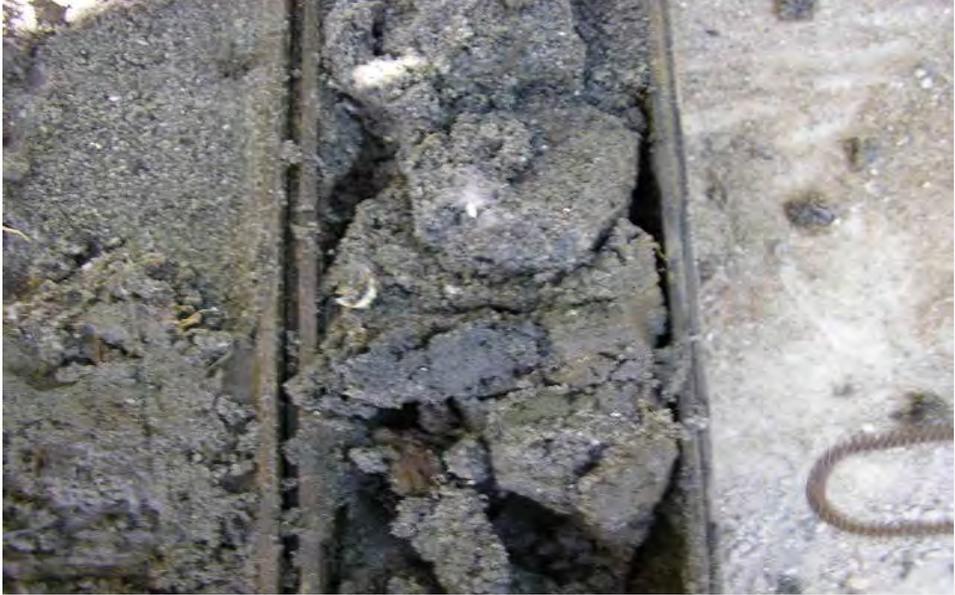
CLIENT NAME: Honeywell		SITE LOCATION: HB-SB-262	PROJECT NO. 49362
PHOTO NO. 131	DATE: 6/14/12

DESCRIPTION Sandy marl with shells at 13.5-14 ft bgs at HB-SB-262.
